Williams, Jack N. , Barrell, David J. A., Stirling, Mark W., Sauer, Katrina M., Duke, Grace C. and Hao, Ken X. 2018. Surface rupture of the Hundalee fault during the 2016 Mw 7.8 Kaikōura earthquake. Bulletin of the Seismological Society of America 108 (3B) , pp. 1540-1555. 10.1785/0120170291

1 **Surface rupture of the Hundalee Fault during the M_w7.8 2016 Kaikōura Earthquake**

The Hundalee Fault is one of at least 20 faults that ruptured during the $M_w7.8$ 2016 Kaikōura Earthquake in the northeast of the South Island of New Zealand. Here, we document a 12 km onshore section of the Hundalee Fault that exhibited surface rupture from this event. To the northeast of our observations, the fault crosses the coast and independent seabed surveys show the 2016 rupture continued at least 2 km offshore. No surface rupture was observed across the southwestern section of the Hundalee Fault, which crosses hilly vegetated terrain and poorly consolidated valley-floor sediment. However, previous InSAR analyses suggests that a 9 km length section of the fault did rupture. Hence, the minimum length of the 2016 rupture along the Hundalee Fault is 23 km. Field measurements indicate oblique dextral-r

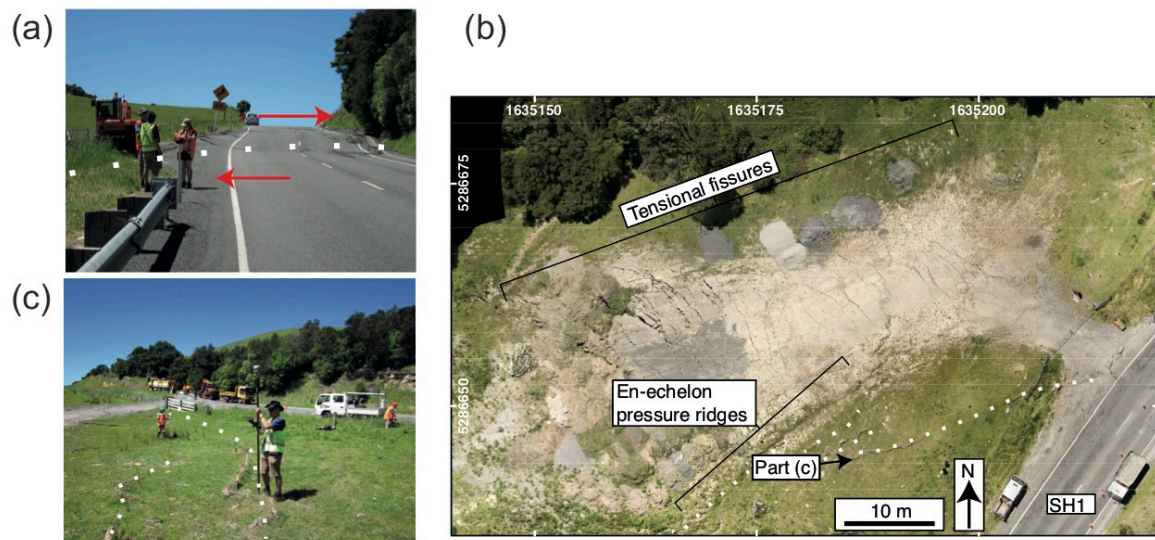
Figure 4

The southernmost unequivocal evidence of Kaikōura Earthquake surface rupture along the Hundalee Fault is a ~200 m northeast-trending rupture that crossed State Highway 1 (SH1) 3 km north of Hundalee, henceforth referred to as the SH1 Hundalee locality (Fig. 3a). Here, we recorded 1.7 ± 0.2 m of dextral offset and 1.0 ± 0.2 m uplift to the northwest, across the paint markings at the margin of the road (Fig. 4a, Table 1). In a paddock immediately west of SH1, the rupture was defined by sinuous left stepping *en-echelon* pressure ridges that ran at a high angle to a series of tensional fissures (Figs. 4b and c). To the northeast of SH1, the rupture could be traced as far as the margin of a landslide that was reactivated by the earthquake.

Figure 4: View northeast along State Highway 1 (SH1), 21 November 2016, at the SH1 Hundalee site (Fig. 3a), ~3 km north of Hundalee. (a) The Hundalee Fault has obliquely offset the road carriageway by 1.7 ± 0.2 m dextrally (arrows), and 1.0 ± 0.2 m up to the northeast. (b) Orthophoto of surface ruptures (white lines) in paddock on the southwest side of SH1, adjacent to the SH1 Hundalee site, derived from photos taken by UAV. Coordinates in New Zealand Transverse Mercator (NZTM). Location and perspective of part c also indicated. (c) View east-northeast towards the SH1 Hundalee offset, 22 November 2016, showing sinuous compressional turf rolls (white lines) in the foreground, resulting from Hundalee Fault surface rupture.

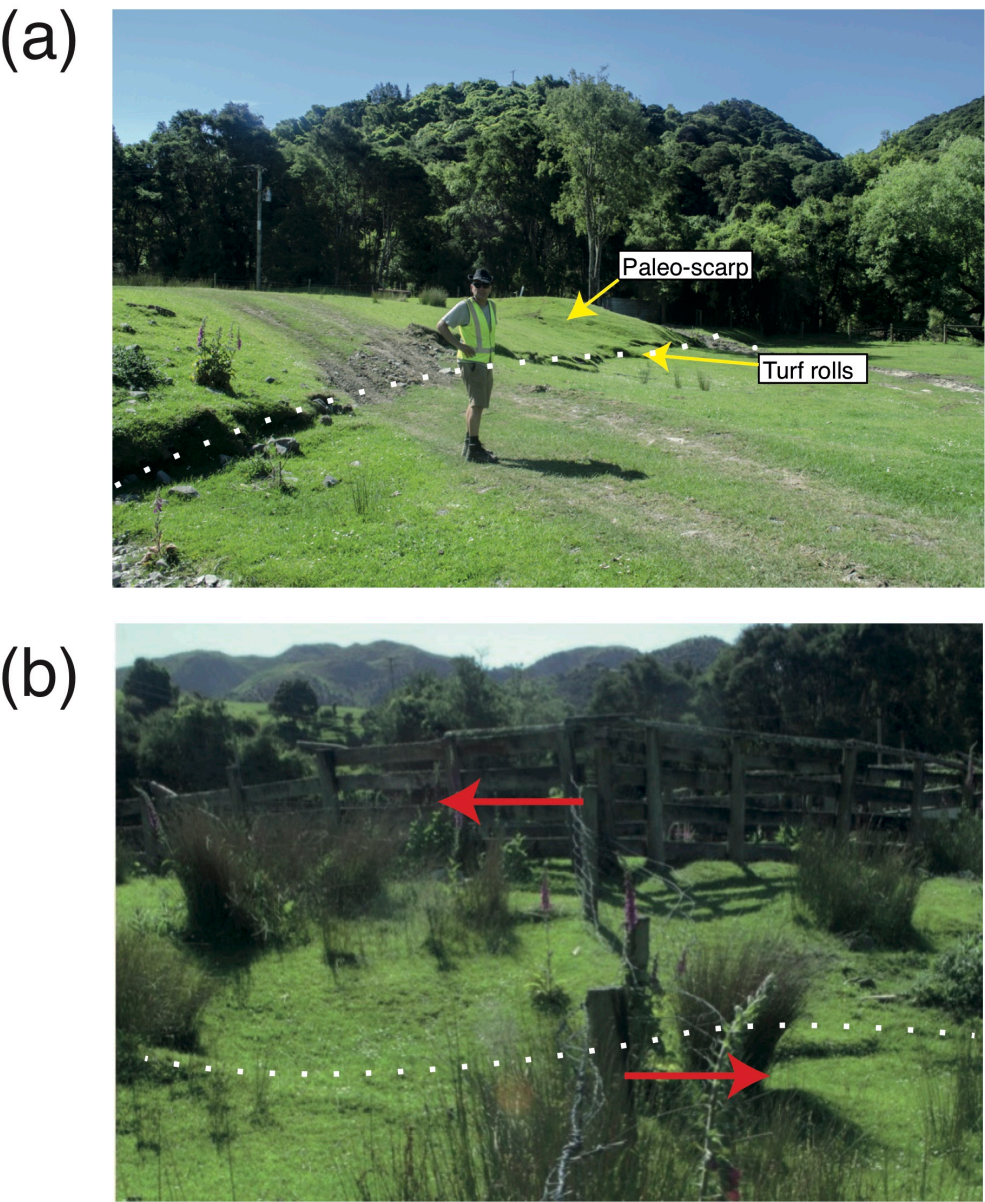
Surface rupture was identified on a south bank terrace of Okarahia Stream about 3.8 km to the northeast of the SH1 Hundalee locality (Fig. 3a). The 190-m long north-trending trace exhibits 0.5 ± 0.1 m of uplift to the west (Fig. 5a), in which slabs of soil and roots were bent and buckled to form ‘turf rolls’ (e.g. Beanland et al., 1989; Little et al., 2018). Fences that cross the scarp at a high angle indicate 0.6 ± 0.15 m of sinistral offset (Fig. 5b, Table 1). There is a topographic step at the same

754
755 Figure 5: Surface ruptures at the Okarahia locality (Fig. 3a). (a) Dotted white line identifies 2016
756 surface rupture, characterized by a 0.5 ± 0.1 m high scarp with prominent turf rolls, taken 23
757 November 2016 looking west. A suspected pre-existing fault scarp at this location is evident in the
758 background. (b) Sinistral-reverse offset (arrows) of 0.6 ± 0.15 m of a fence that crosses the scarp
759 (dotted white line) at a high angle and results in dilation of the fence. Photo taken looking northwest.
760

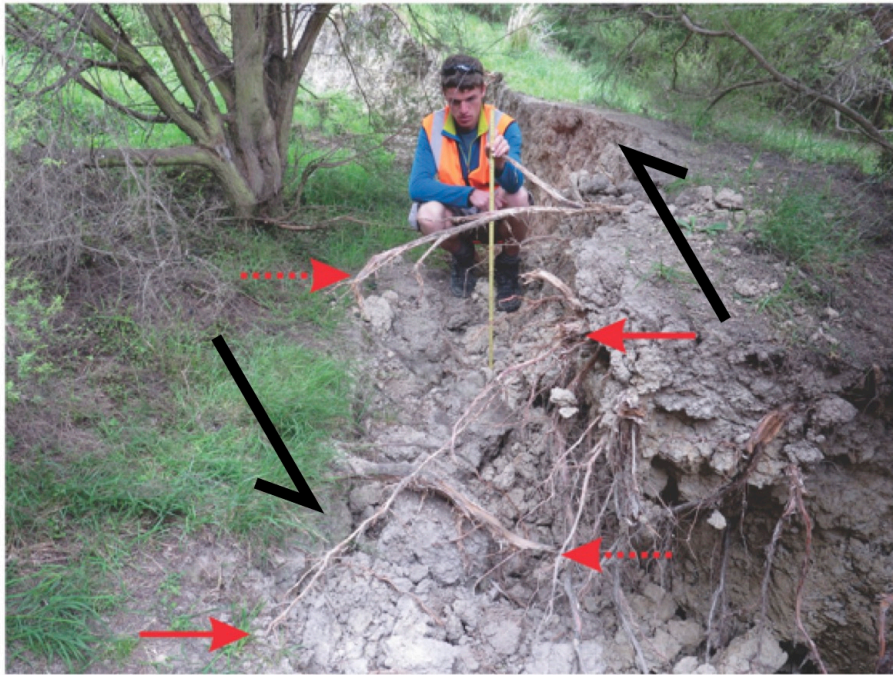
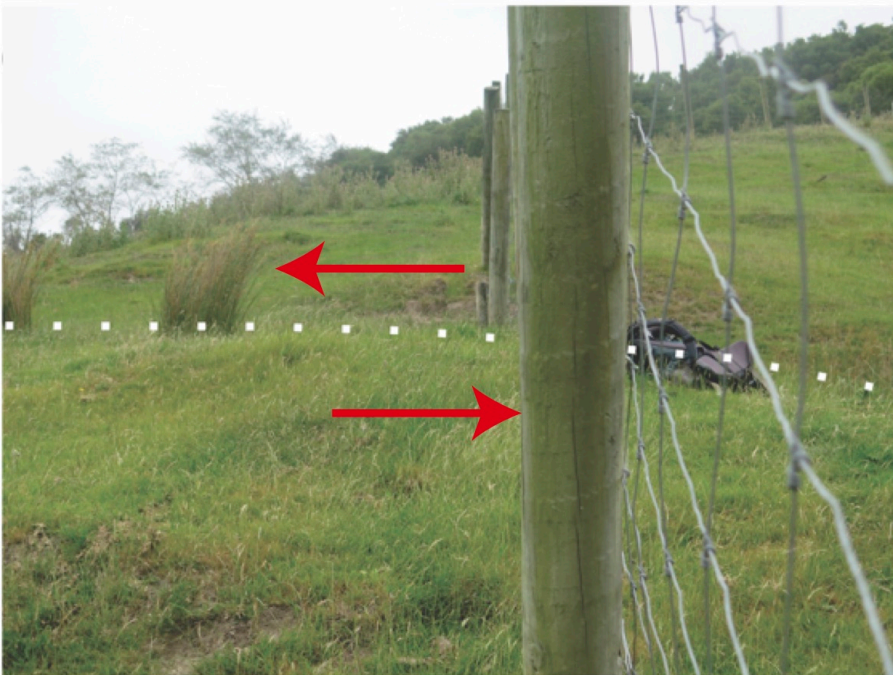
Figure 6

Overall offset was 0.9 ± 0.1 m upthrow to the northwest and as much as 0.9 ± 0.1 m sinistral (Table 1). This low degree of uncertainty was achieved by matching broken, or stretched but unbroken, tree roots where the rupture crossed a stand of trees (Fig. 6a). Furthermore, the 2016 scarp crosses several fence-lines at a high angle to the fault, and these provide displacement markers that allow a sinistral component of offset as small as 0.3 ± 0.1 m to be defined with confidence (Fig. 6b, Table 1).

Figure 6: (a) Looking southwest at the 2016 rupture through a strand of trees along the Glenstrae locality (northernmost Glenstrae site; Fig. 3a, Table 1), 20 December 2016. We matched the ruptured ends of a large root (dashed arrow), and a small root was stretched but not broken (solid arrows). Both markers demonstrated a sinistral shift of 0.9 ± 0.1 m as shown by shear sense indicators. (b) Telephoto view southeast across the fault scarp (dotted white line) looking along a fence at the southern end of the Glenstrae sector (Fig. 3a, Table 1), 20 December 2016. The scarp is ~ 0.3 m high,

769 with a sinistral component of 0.2 ± 0.1 m recorded by the fence post offset. This is the smallest offset
770 we were able to measure accurately on the Hundalee Fault.

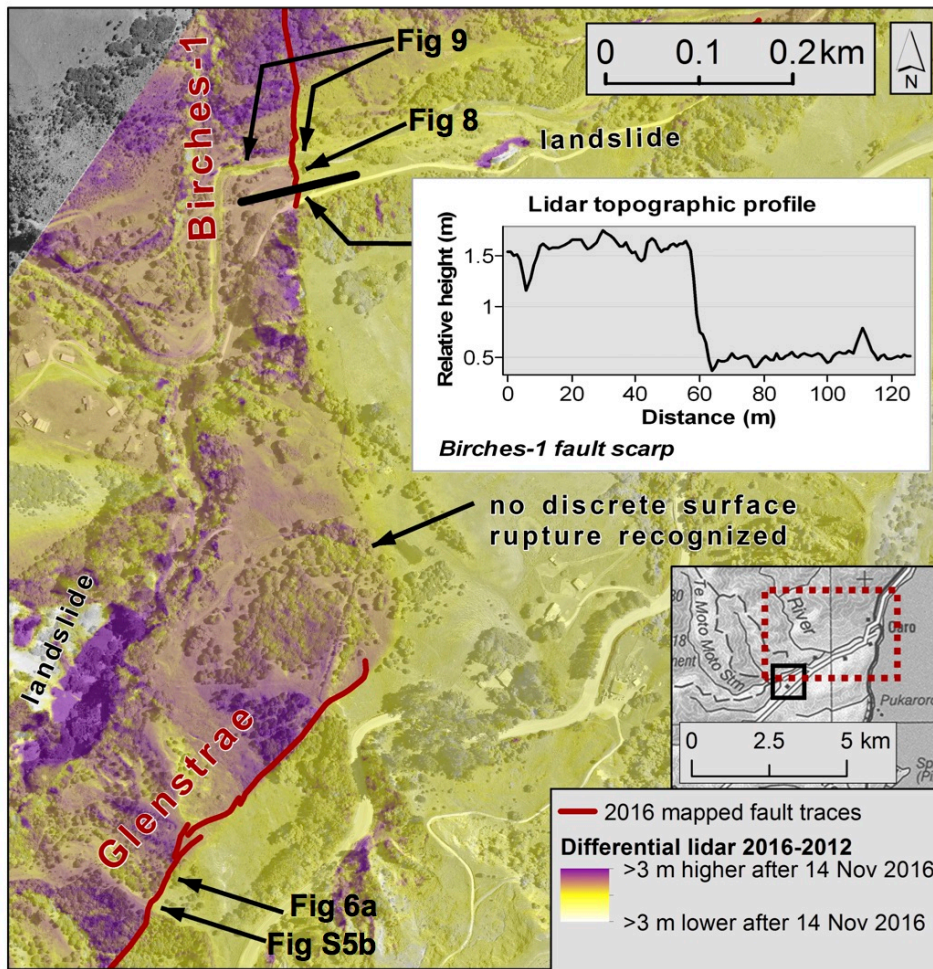
Figure 7

differential lidar indicates a lineament with relative uplift, however, no surface rupture was observed (Fig. 7). It is unclear whether the deformation through this area consisted of flexure or simply involved rupture that was not recognizable due to the steep and vegetated terrain.

Figure 7: A continuation of 2016 surface rupture between The Birches and Glenstrae localities as revealed by differential lidar. The background image is the post-earthquake aerial photo mosaic at 0.2 m pixel resolution, rendered in greyscale and captured during the 2016 lidar acquisition flight. This is overlain transparently with a lidar differencing model, derived from a digital elevation model (DEM) generated from lidar acquired in 2012 that was subtracted from a DEM generated from post-earthquake lidar (Clark et al., 2017). The 2016 fault mapping is based on GPS surveying, and supplemented by identification of ruptured ground in the post-earthquake imagery. The reference to 14 Nov 2016 in the legend is for simplicity and assumes that all the elevation change occurred coseismically; though we cannot exclude the possibility that some may have occurred in the time interval between the two lidar acquisition flights. Inset map shows area covered by this diagram (solid

783 box) in relation to Fig. 3b outline (dashed box). Profile through lidar differencing model is also shown
784 (height relative to 2012 model) and was used to estimate vertical offset at Birches-1 (Table 1).

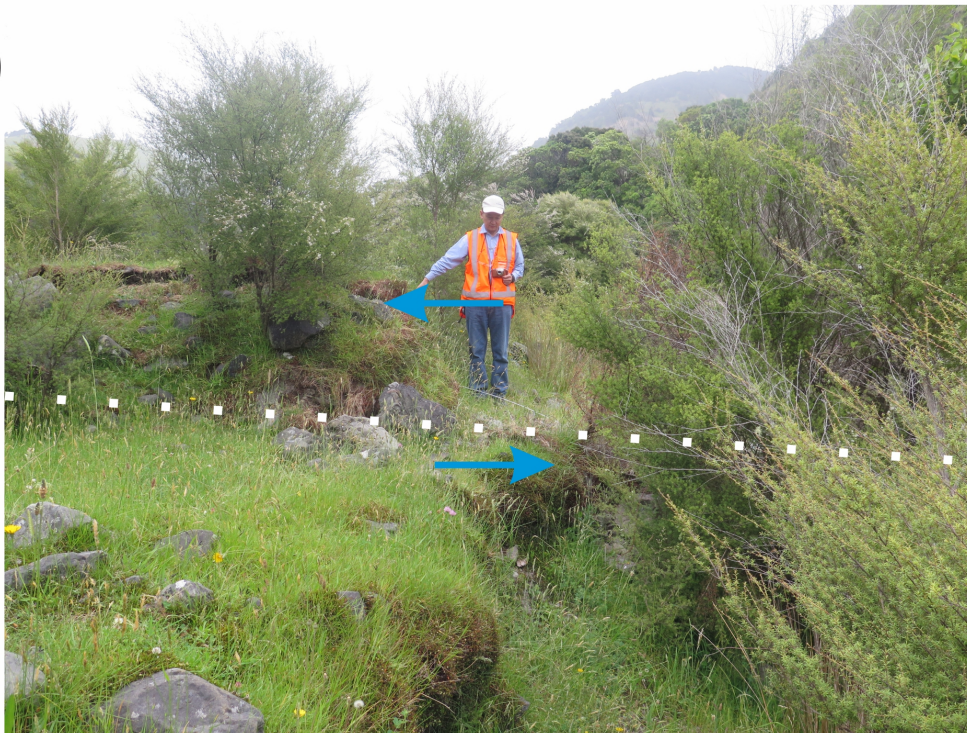
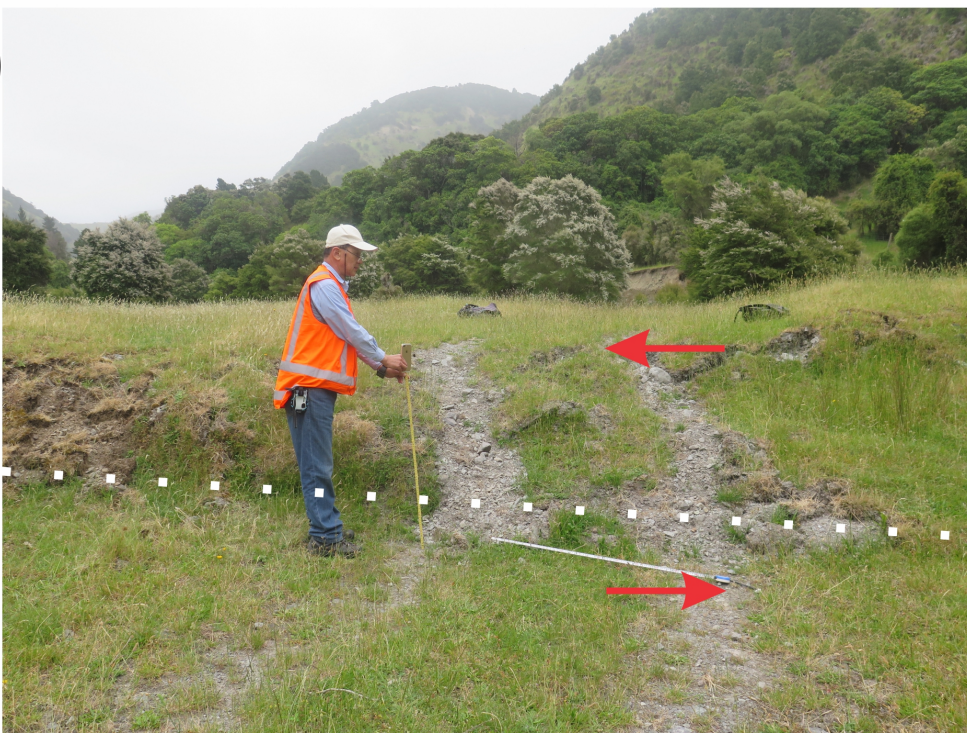
786 Figure 8: (a) View west towards the Birches-1 fault trace across low-level terrace on the south bank of
787 Te Moto Moto Stream (Fig. 3b), 20 December 2016. Minimal soil development suggests the terrace
788 surface is at most a few hundred years old. (a) the steep, vegetated, bank (white dotted line) down to
789 the active stream channel (out of sight to right) has a sinistral offset of 1.1 ± 0.2 m across the fault
790 (arrows), and the vertical component is also 1.1 ± 0.2 m. (b) The ruts of a vehicle track (arrows

792 marking right-hand rut) 30 m south of the photo (a) scene clearly illustrates the oblique sinistral and
793 up-to-west shift.
794

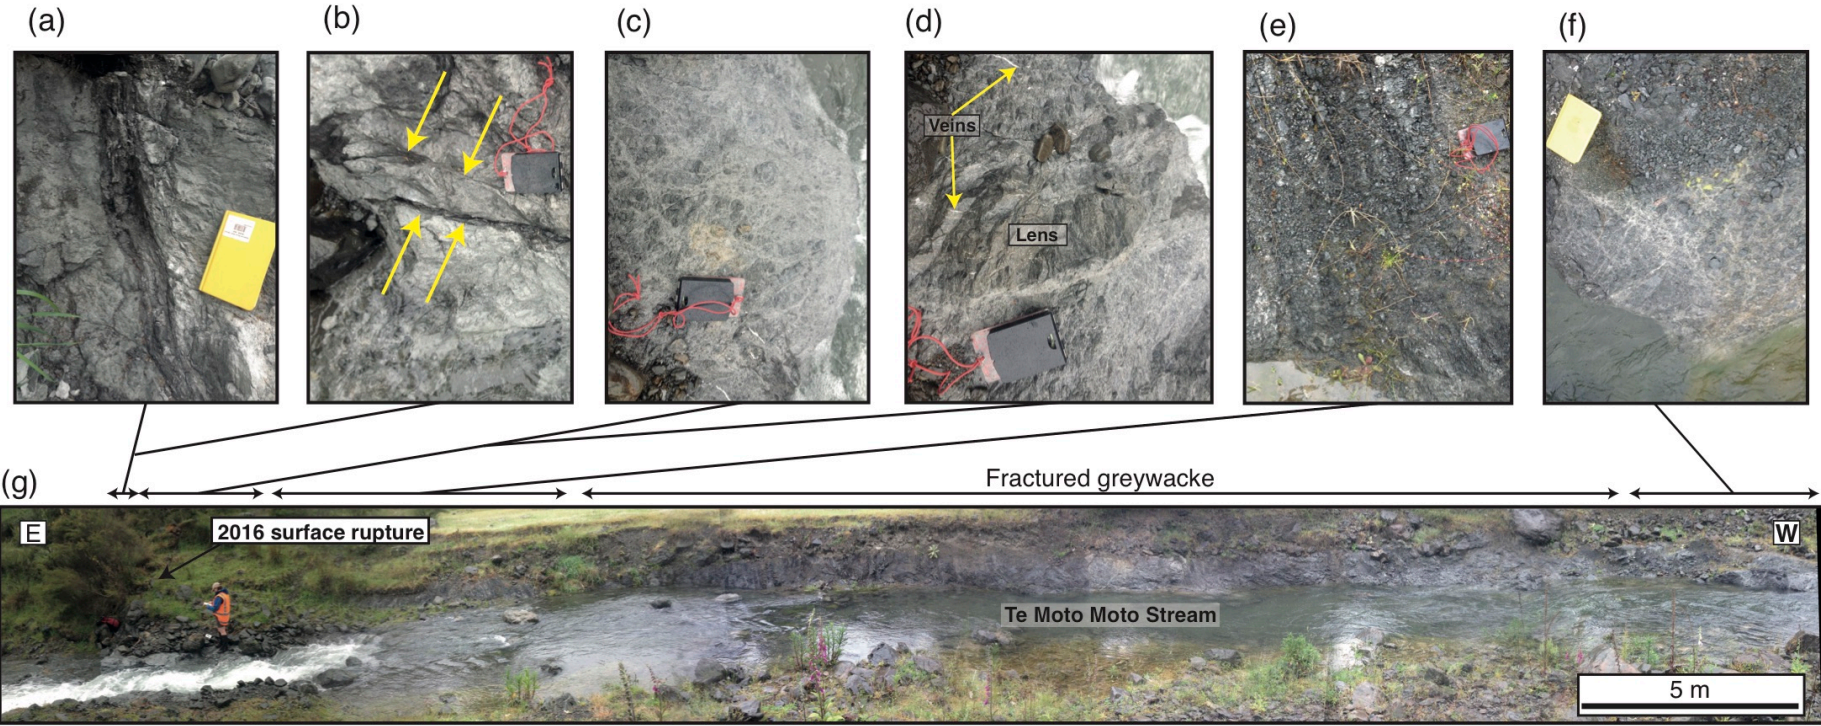
795 **Figure 9**

Where the Birches-1 fault scarp crosses the Te Moto Moto Stream, a ~60 m wide sequence of fault rocks derived from the Pahau Terrane greywacke is exposed on the uplifted side of the fault (Fig. 9). Adjacent to the rupture trace, there is a ~5 m wide zone of pale grey fault breccia that contains rare lenses of intact rock of up to 30 cm across. Anastomosing fault gouges <10 cm thick and dipping approximately 60° to the NW (Fig. 9a) are contained within the breccia. Fine-grained black material also occurs in a subsidiary network of gently dipping fractures. However, it is not clear if these represent gouges derived from attrition of fault rocks or frictional-melt derived pseudotachylyte in injection veins (Fig. 9b). *En echelon* veins less than 1 cm wide are also observed within the breccia (Fig. 9d). Upstream from the fault breccia zone is highly fractured greywacke, though the original sedimentary bedding is still apparent (Fig. 9e). The intensity of fracturing progressively decreases westward, although there are still some <1 m thick intervals of fault breccia (Fig. 9f). Under conventional models of fault zone structure (e.g. Chester and Logan, 1986; Chester et al., 1993; Caine

et al., 1996), the ~5 m thick sequence of gouges and breccias adjacent to the rupture trace would be considered to comprise the fault core, and the damage zone would be represented by the fractured greywacke.

797 Figure 9: Bedrock exposure of the Hundalee Fault at Birches-1 locality. (a) <10 cm thick gouge which is located close to the 2016 surface rupture. (b) Thinner
798 subsidiary gouge-filled fractures. (c-d) Greywacke derived breccia that comprises the fault zone within 5 m of the surface rupture. (e) Heavily fractured
799 greywacke that lies up-section from the greywacke but in which the original bedding is still visible. (f) Localized zone of fault breccia located at western end
800 of exposure, which may constitute a secondary strand of the Hundalee Fault and that does not show any surface rupture from the Kaikōura Earthquake. (f)

801 Entire exposed fault rock sequence of the Hundalee Fault along the Te Moto Moto stream, constructed from stitched images. Entire fault-rock sequence is
802 >60 m thick. Length of compass clinometer is 8 cm and notebook is 20 cm respectively
803

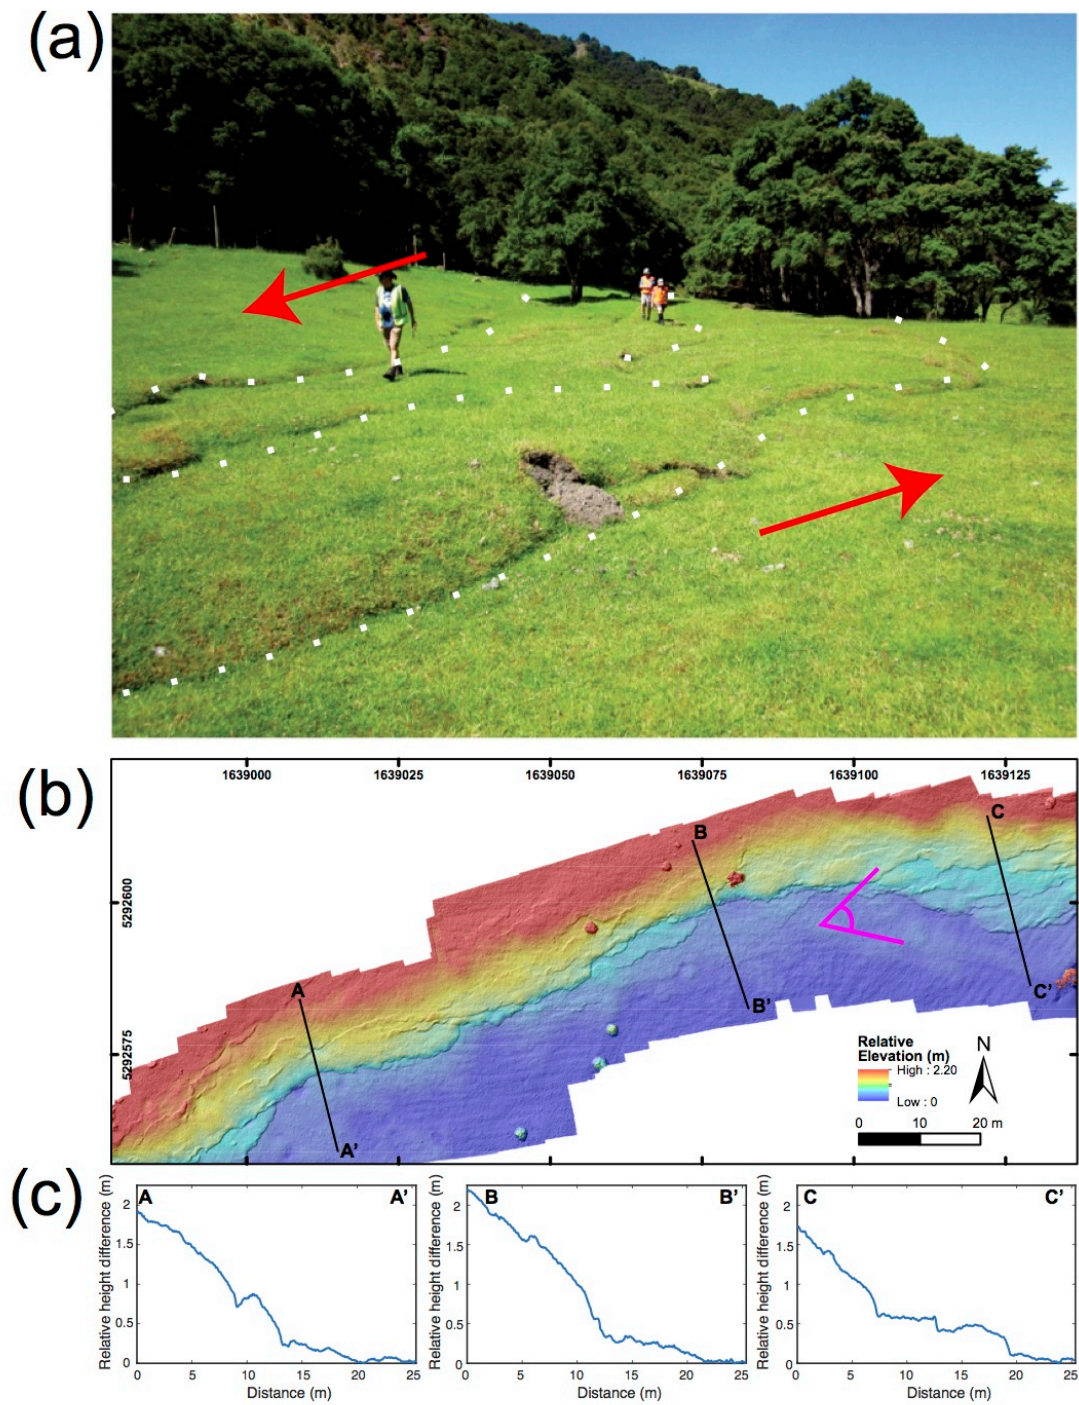
Figure 10

Figure 10: (a) View east-northeast along the Oaro Left Bank-1 fault scarp, ~200 m northeast of the Oaro River channel, showing multiple distributed rupture traces (dotted white lines), taken 22 November 2016. Up-to-the-northwest throw is accompanied by a subordinate sinistral component, identified from a fence-line offset (not shown, see Fig. S1, available in the electronic supplement to this article). Although ~10 m above river level, the flipped turf in the foreground reveals a very

immature soil developed on angular greywacke fine gravel, quite unlike the sub-rounded greywacke pebble bedload of the Oaro River. This terrace is interpreted to be a landslide dam-break aggradation fan, no more than a few hundred years old. (b) Digital elevation model (DEM) of surface ruptures at the Oaro Left Bank-1 locality, constructed from UAV derived photogrammetry model. The two lines with an angle symbol in between, indicates part (a) field of view. Map projection is NZTM/NZGD2000 Datum. (c) Three profiles through the DEM, with letters corresponding to transects indicated in part (b). These illustrate the distributed ground deformation and warping across at >20 m wide zone. Relative height differences should be regarded as a minimum as profiles are too narrow to cover the entire width of the deformation zone.

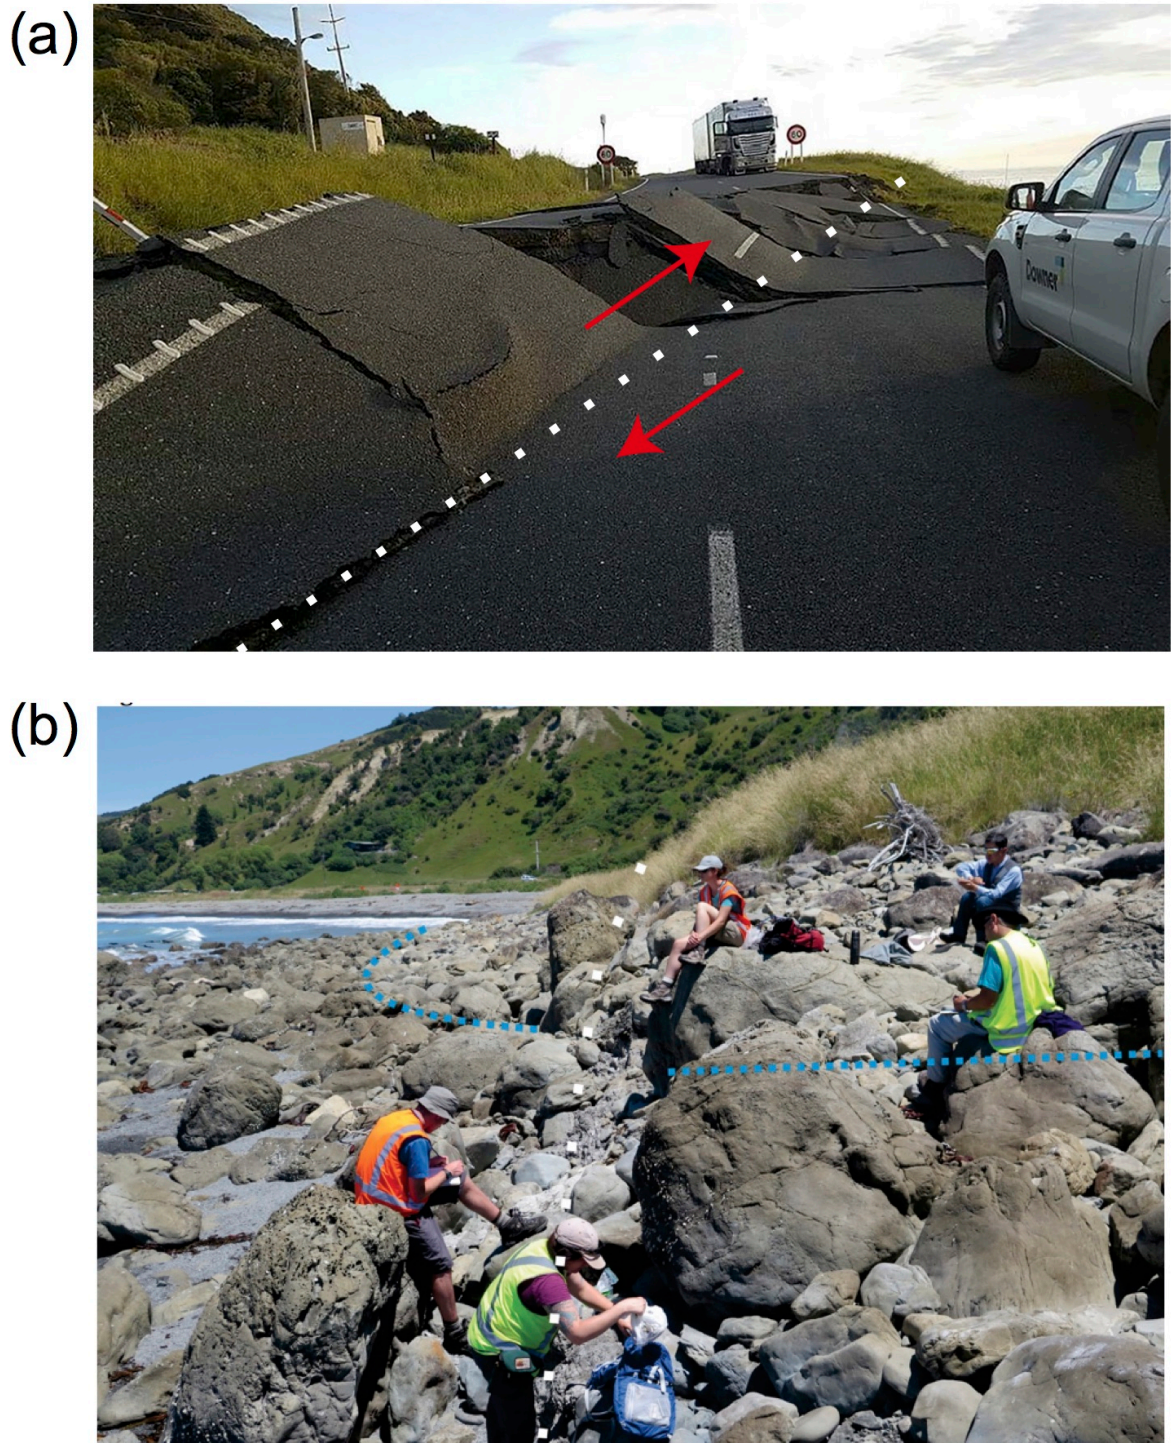
Figure 11

The largest measured horizontal offset of the Hundalee Fault 2016 ruptures is across a prominent 450 m northeastern trending trace (SH1 Coast-2), which is along trend from the Oaro left Bank-4 trace (Fig. 3b). The trend of the rupture at this locality and that of the SIMT railway and SH1 differ by only $\sim 20^\circ$ (Fig. 11a), making projection of piercing points difficult, especially as both the road and rail curve at the rupture location. By comparing pre- and post-earthquake aerial photography and matching up the painted road lines (including the marginal rumble strips), we determined an offset of 3.7 ± 0.5 m dextral and 1.5 ± 0.5 m vertical (Table 1). By applying a near-vertical fault plane to these measurements, Litchfield et al., (2018) calculated a net slip of 4.0 ± 0.7 m, which is the largest measured across the Hundalee Fault for this event. In the shore platform, the 2016 rupture and associated uplift exposed fault gouge within greywacke on the upthrown side of the fault (Fig. 11b). These localities mark the southernmost extent of coastal uplift that formed during the Kaikōura Earthquake (Clark et al., 2017). Multibeam bathymetry surveying of the seafloor identified a scarp that is continuous with our onshore mapping of the Hundalee Fault and extends for at least 2 km towards the edge of the Kaikōura canyon system (Stirling et al., 2017; Litchfield et al. 2018).

Figure 11: (a) Rupture (dotted white line) and uplift of State Highway 1 (SH1) at the coast (SH1 Coast-2 locality, Fig. 3b) where the maximum amount of onshore displacement (3.7 ± 0.5 m dextral, 1.5 ± 0.5 m vertical) was measured across the Hundalee Fault. Photo taken November 14, 2016 and supplied by the NZ Transport Agency. (b) View WSW along the fault scarp (white dotted line) across the beach face north of Oaro, near the SH1 Coast-2 locality, taken 21 December 2016. The vertical

movement, up to the NNW (right), as measured at SH1, is 1.5 ± 0.5 m. The closely-spaced dots denote an approximate a line of equal elevation on the pre-earthquake shoreface, above which the rocks are bleached, and highlight the lateral and vertical shift across the fault. In the foreground, mapping team members are sampling fault gouge exposed on the uplifted side of the fault.
