Evaluating Incidental Thermal Performance Improvements of a Historic Timber-Framed Building in Central Hereford

Christopher J Whitman¹

¹Welsh School of Architecture, Cardiff University, Cardiff, Wales, CF10 3NB, UK.

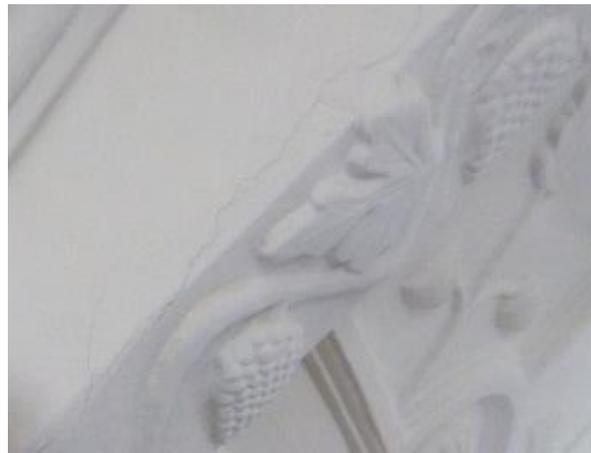
Figure 2. Detail of plaster ceiling, Old Mayor's Parlour. Source: (Author's own, 2016)

As noted previously, the lack of insulation to the roof raised some concern over the possible concentration of condensation on the cold surface of the 17th century decorative plaster ceiling. This would most likely under conditions of high vapour pressure, coupled with a large diurnal temperature variation. The highest vapour pressure recorded in the OMP was 1557Pa, occurring at 15:30 on 12/05/2016 at a dry-bulb temperature of 23°C. Tracing this vapour pressure across on the psychrometric chart, condensation would occur at a dew point temperature of 13.5°C. Within the following 24 hours, the minimum internal dry-bulb temperature was 18.6°C and the minimum external temperature 11.1°C. As such, it is possible that the internal surface temperature of the ceiling could have dropped, in places, below the dew point temperature and condensation may have occurred. Equally, on the day with the largest diurnal temperature oscillation, the 28/04/2016, a maximum vapour pressure of 913Pa was recorded at a temperature of 17°C. The internal dry-bulb temperature then dropped to 11.6°C with a minimum external dry-bulb temperature of 5.6°C. Given that the dew point temperature for the maximum vapour pressure measured (913Pa) would be 5.7°C, there again exists a small possibility that conditions for condensation may have occurred. In order to prove this, further monitoring of surface temperatures of the plaster ceiling would be required.

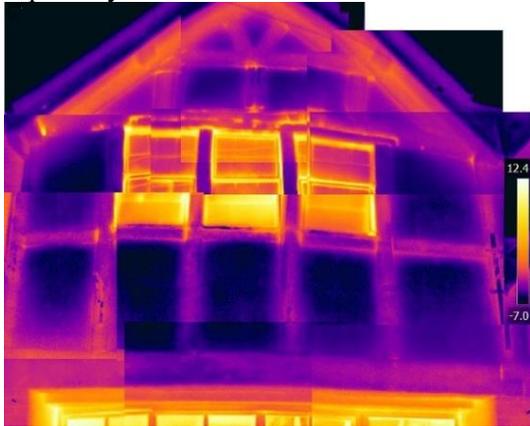
Figure 4 shows that the new infill panels are performing better than the surrounding timber-frame. The weak points of the façade are the windows and some joints between the timbers of the frame, especially around the first floor window.

Figure 4. Thermography of east façade.

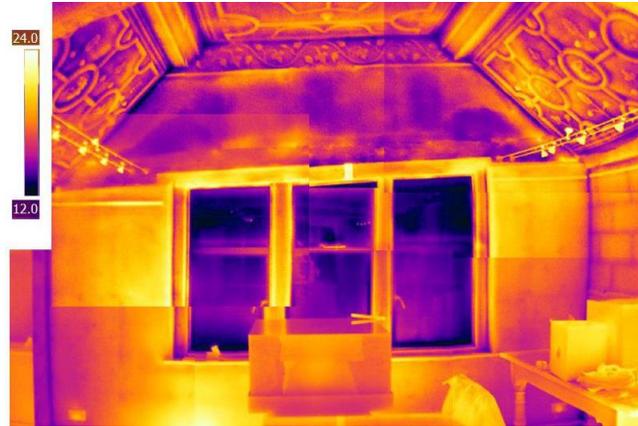
Figure 5. Internal thermography of east façade.

Figure 5 shows the efficacy of the internal lining, with no noticeable cold bridging or temperature difference across the internal surface. The upper portion of the wall with no internal lining is however cooler, with marked cold spots in the recesses of the historic plasterwork. Whilst the physics of heat flow dictates that recesses and junctions will naturally be cooler, this image still raises concern over the decision not to internally line the upper portion or introduce roof insulation. The rationale of minimising intrusion and damage to the historic fabric is understandable but potentially, over time, may lead to the concentration of condensation and accelerated decay. This issue is explored further below.
