Building Performance Evaluation of a 14th Century Pargetted House: Hygrothermal comfort and energy efficiency

CHRISTOPHER J. WHITMAN¹

¹Welsh School of Architecture, Cardiff University, Cardiff, Wales, UK

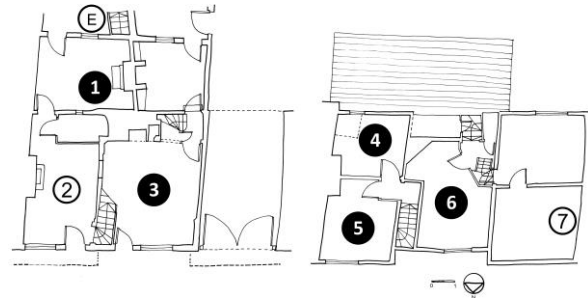
Figure 2. Ground (left) and first floor (right) plans showing hygrothermal monitoring locations. Open circles Lascar® sensors, solid circles TinyTag®.

Measurements were taken at half hour intervals from 11/03/17-16/08/17. During this time the property was unoccupied due to the ongoing conservation work. As such the results show that only the front bedrooms (locations 5 & 7 Fig.2) achieved any hygrothermal comfort during March. This was due to the electric heating used in both rooms to reduce the risk of frost damage to the 17th century pargetting. The heating was maintained for longer in front bedroom 5 to enable the in situ U-value monitoring. Being uninhabited, no space heating is provided in the rest of the house and hygrothermal comfort is only achieved in mid-May once external ambient conditions had also reached comfort conditions.

The reasons for hygrothermal comfort not being achieved are a combination of low temperatures and high relative humidity (Fig.3), with high relative humidity being a common problem on the ground floor. In two monitoring positions (2&3) relative humidity was recorded in excess of that measured externally. This may be partly due to the current uncontrolled connection of these spaces to a subterranean cellar.

measurements in the front bedroom of no.27 show that with heating, comfort can be achieved. Equally the controlling of the connection to the cellar should assist in resolving the high levels of relative humidity measured on the ground floor. However, further monitoring is recommended as the conservation of this building progresses

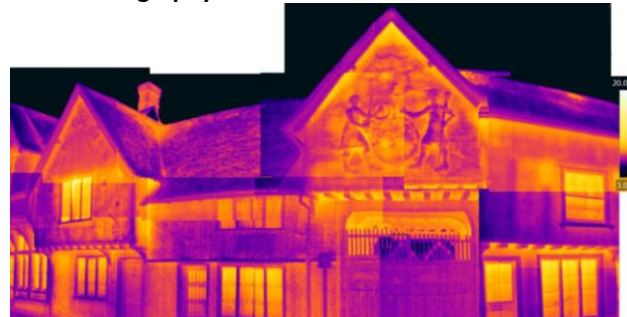
Figure 4. Thermography of north façade 12/03/17 6:30am. External temperature 10.5°C. Source: (Author's Own, 2017)

The thermography was undertaken unpressurised with an external air temperature of 10.5°C and internal temperatures between 13-22°C. A complete view of the whole north façade (Fig.4) appears to show that the pargetted upper façade is allowing less thermal transmittance than the lower brick underbuilding of the ground floor. Given the unequal heating of the corresponding internal spaces there may be some degree of error in this conclusion, however, the internal temperature of the ground floor was substantially lower at 13°C compared to the 16°C of the upper west cross wing bedroom (left) and 22°C of the upper east cross wing bedroom (right). Therefore, it could perhaps be presumed that if all spaces were at an equal temperature the difference in the thermal performance between the pargetting and the brick underbuilding would be even more apparent. Figure 4 also shows the differing thermal performance within the pargetted façade, with the thinner, plainer sections recording a higher surface temperature and therefore greater heat loss as compared to the thicker sculpted features. The

greatest thermal weaknesses of the envelope are however undoubtedly the single glazed windows, the protruding floor of the jettying and the exposed floor over the carriageway .

The thermography showed the single glazed windows and exposed floors, both over the carriageway and the jetttying, to be the areas of greatest thermal weakness. These areas would be relatively easy to address, with little adverse impact on the heritage value of the property. The current windows date from 1870 [5] and as such not one of the most significant features of the building, however it is unlikely that they would be replaced. Although, it would however be possible to repair the windows to increase airtightness, install secondary glazing, insulated internal shutters or thick curtains, all of which would improve the thermal performance of these elements [16]. The insulation of the exposed floors may be more difficult as this would most likely require the lifting of the existing floorboards, with the potential risk of damage that this entails. However, insulating the exposed floors and the roof do not pose the same risks of increased frost damage to the 17th century pargetting that would be involved in the use of IWI, as shown by the THERM® modelling. Given the high significance of the pargetted façades, a trade off could be made in allowing beneficial heat loss through the associated walls, whilst insulating elsewhere, even if this involved some limited loss or damage to historic fabric.

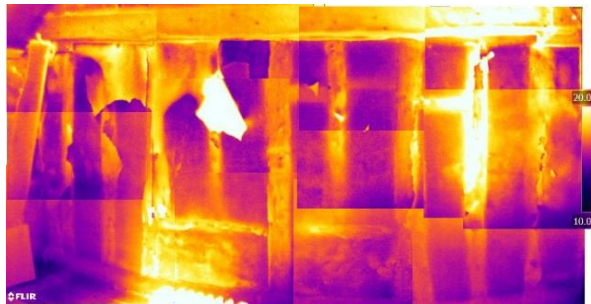
Figure 5. Internal thermography of west cross wing at 1st floor. 12/03/2017 6:30am. Internal temperature 16°C. Source: (Author's own, 2017)

Internal thermography of the north façade of the western cross wing upper bedroom (Fig.5) shows the higher thermal transmittance of the infill panels in comparison to the timber frame. Interestingly, by highlighting the timber-frame, otherwise hidden by the internal wallpaper, it also suggests the previous presence of a central window that may have predated the external pargetting. This demonstrates the advantages of BPE in understanding buildings, above and beyond reviewing their energy efficiency.

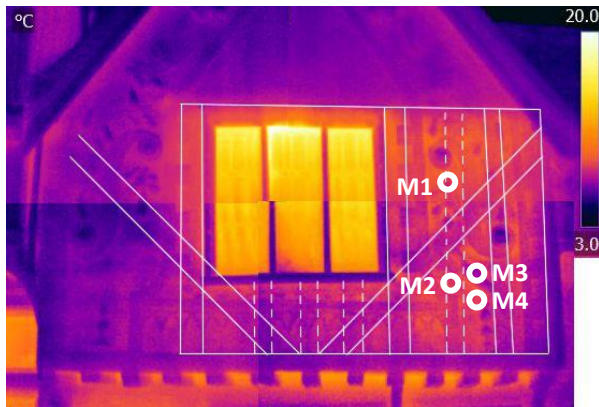
Figure 6. Thermography of eastern cross wing showing location of monitoring positions. M1 & M2 monitored 12/03/17-02/04/17 and M3 & M4 monitored 15/12/19-22/01/20. Source (Author's own, 2020)

On the first occasion (12/03/17-02/04/17) the U-value was measured in two locations (M1 and M2 in Fig.6) on the first-floor elevation of the east cross wing (left in Fig.1).

The locations were chosen to measure two different thicknesses of pargetting, one plain section (M2) and a sculpted gourd or pear standing 40mm proud of the plain surface (M1). On first reading of the thermography it was believed both locations to be in the middle of an infill panel. Unfortunately,

closer inspection following completion of the measurements revealed faint signs of further timber-framing (dotted lines Fig.4), which was subsequently confirmed with the use of an electronic stud detector. This error was exacerbated by the heat flux plate in position M1 being accidentally dislodged after only five days. A second period of monitoring was therefore undertaken (15/12/19-22/01/20), again through two thicknesses of pargetting but this time avoiding the now identified timber-frame members. Position M3 was located to measure the body of an avian form, also 40mm proud of the surrounding plain surface, where M4 was located. The results of all four measurements are presented in Table 2.

The measured U-value at position M2, over a timber-frame member was 0.64 W/m²K, and as such below the UK Building Regulations threshold value (0.70 W/m²K) for retained thermal elements [12]. In the centre of a panel (M3 & M4) the values are higher, however, these are considerably lower than measurements of other historic timber-framed properties, with typical U-values 1.69-2.88 W/m²K [13, 14] for un-pargetted walls, suggesting that pargetting may be considered an early form of external wall insulation (EWI).

That said, the improvement in U-value provided with the increased thickness of pargetting is marginal in monitoring position M4. Assuming that this improvement is purely down to the additional pargetting, this would suggest the pargetting has a thermal conductivity of 1.72W/mK, similar to a hard limestone [15] and therefore not a particularly effective EWI. In the case of monitoring position M1, for the short period that monitoring did occur, the measured U-value was consistently higher than the thinner M2. Some speculation has been made over the influence of increased external surface area of the mouldings, however, further research is required to confirm this.

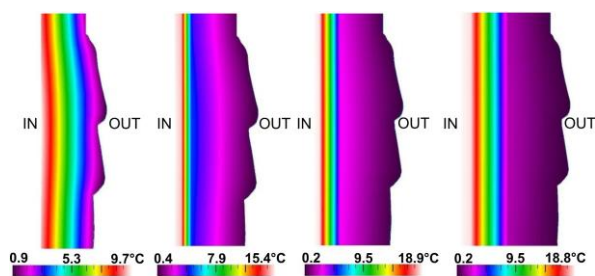
Figure 7. Simulations with THERM® version 7.5 of wall section through decorative pargetting showing temperatures with (left to right) no insulation, 25mm, 50mm and 100mm of wood fibre IWI. Exterior temperature 0°C and interior 21°C. Source: (Author's own, 2017)

The simulation demonstrated (Fig.7) that currently with no insulation, with an internal air temperature of 21°C and an external air temperature of 0°C, the external surface of the most protruding features of the pargetting would be almost 1°C higher than the surrounding air at 0.9°C. Any introduction of insulation will reduce this external surface temperature, thereby raising the risk of frost damage. In the case of the 25mm IWI, the external surface temperature is halved to 0.4°C when the external air temperature is 0°C. With the application of 50mm and then 100mm IWI this drops to 0.2°C, with much of the historic wall being below 1°C. Given the heritage value of this historic pargetting it is unlikely that this potential increase in risk of frost damage can be outweighed by the reductions in energy demand that would be achieved. As no decorative pargetting is present on the ground level, potentially this could be internally insulated with 25mm of IWI resulting in a 7% reduction in energy demand.
