Damage detection in a composite wind turbine blade using 3D scanning laser vibrometry

Ryan Marks¹, Clare Gillam¹, Alastair Clarke¹, Joe Armstrong² and Rhys Pullin¹

Abstract

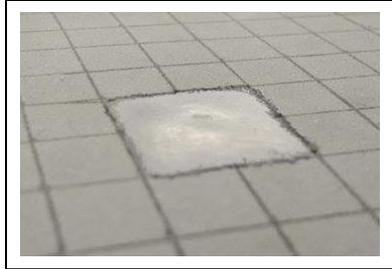
The blade was secured at the base to a steel stanchion and supported on both sides of the area of investigation. The blade was impacted using a 20mm radius impactor with impact energy of 10 Joules in an INSTRON dynatup 9250HV impact test machine. The impact caused BVID on the surface as shown in Figure 3. The impact was representative of a hail stone impact.

Figure 3. BVID on the turbine blade after being impacted. The retro-reflective beads have been removed around the impact site for clarity.

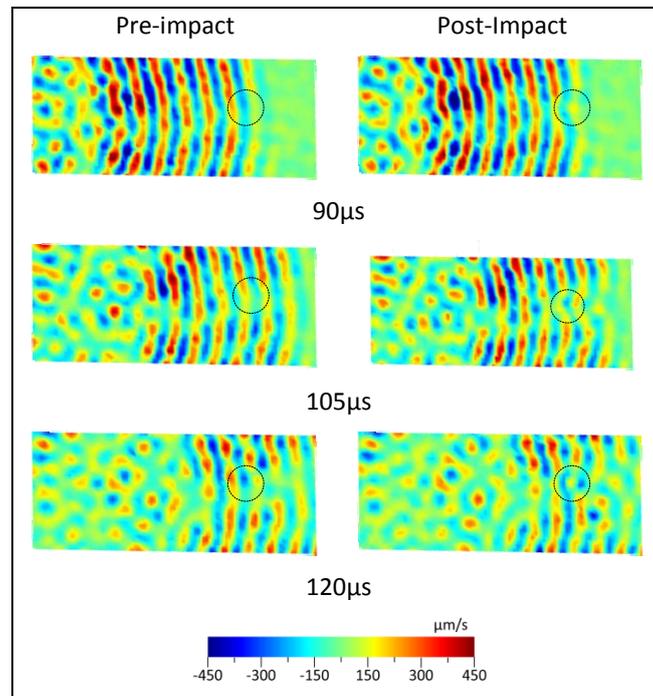
As the A_0 Lamb mode is mostly out-of-plane, this component was isolated and plotted separately for clarity as shown in Figure 6. It is evident that the out-of-plane component of the Lamb wave interacts with the damage causing a disruption in the wave front. This suggests that the unintelligibility of the interaction of the A_0 mode with the damage in the resultant magnitude plots in Figure 4 and Figure 5 is mostly caused by noise from the in-plane components.

Figure 6. 100kHz excitation out-of-plane component highlighting the Lamb wave interaction with the impact damage

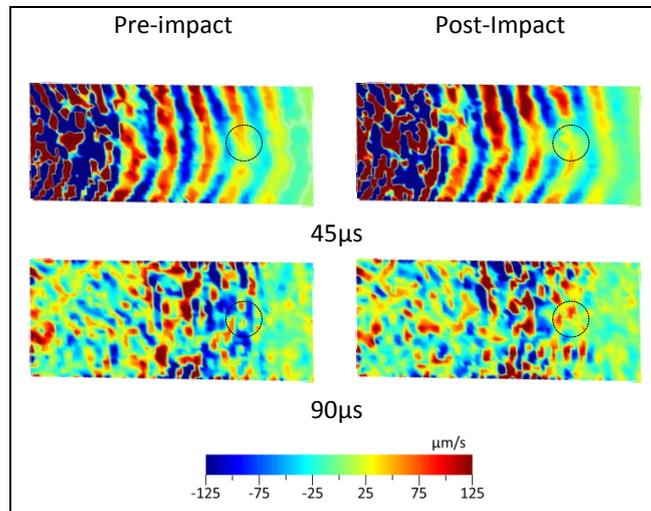
Figure 9. 200kHz excitation out-of-plane component highlighting the Lamb wave interaction with the impact damage

The results at 45µs show that there is possibly some interaction with the S_0 mode. This may be indicated in the post-impact results where there is a significantly lower amplitude than in the pre-impact results due to the presence of the impact damage. This can be justified by the shorter wavelength of the 200kHz excitation S_0 mode compared to that of the 100kHz excitation. However, there appears to be no disruption in the wave front to the right of the impact site which also suggest that there is limited interaction with the impact damage. It is therefore not conclusively possible to determine the presence of the impact damage using the S_0 mode from the 200kHz excitation by visual observation alone.

It is difficult to determine from these results whether the A_0 mode is influenced by the presence of the damage as demonstrated at 90µs. It is apparent there is a difference in the results and it could be argued that the reduction in amplitude in the post-impact results was due to the presence of the damage. However, due to the high levels of disturbance in the wave front this is also by no means conclusive.

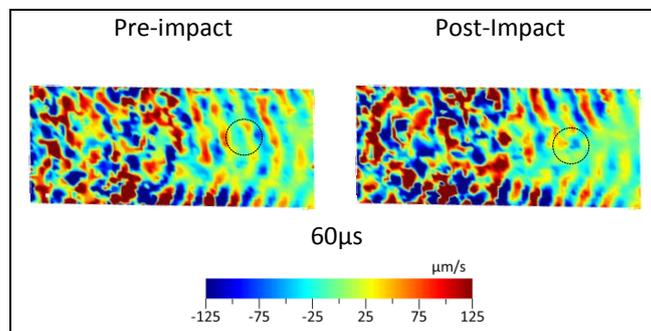
Figure 12. 300kHz excitation out-of-plane component highlighting the Lamb wave interaction with the impact damage

As with the 200kHz excitation, the S_0 mode interacts with the damage. This is shown in the post-impact results by a fringe of low amplitude to the right of the impact damage. However, as also with the 200kHz excitation, due to the high levels of disturbance in the wave it is not possible to determine A_0 mode interaction with the damage.

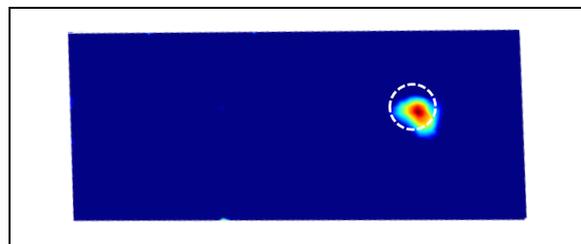
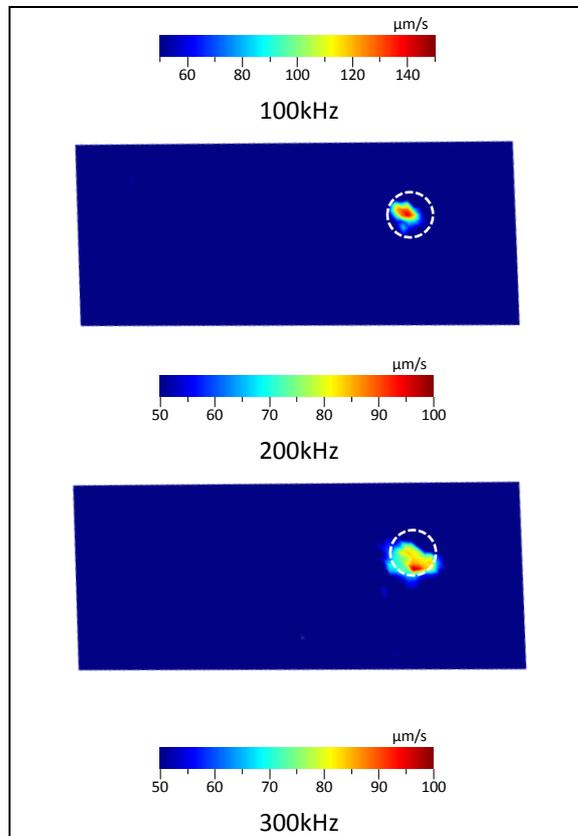
Figure 13. RMS baseline subtraction analysis of the out-of-plane component of the Lamb modes

From the time domain results presented, it is apparent that the A_0 Lamb mode does interact with the damage although it is difficult to identify the presence of damage on the structure without carefully examining the results. It therefore would be advantageous to identify the presence of the BVID and quantify it using comparative post processing methods. A computationally inexpensive post-processing technique is baseline subtraction. Subtracting the waveforms of the out-of-plane component of the post-impact dataset from the waveforms of out-of-plane component from the pre-impact dataset identifies the region on the scan area where there is a significant change. By calculating the root-mean squared (RMS) velocity values for the resulting subtracted waveforms of each measurement point over the whole measurement period, the region of significant change in waveform, and hence the location of the damage can be identified. The RMS baseline subtraction analysis for the out-of-plane component of the Lamb wave is presented in Figure 13. Only the out-of-plane component has been considered as it was shown to significantly interact with the damage. The impact site is denoted by the dashed line.

For each excitation frequency the impact site has been clearly identified by this technique. The peak RMS values for the 100kHz excitation are greater than those for the 200kHz and 300kHz excitations. This is because of the lower attenuation of the lower frequency. The RMS values the plate area outside of the impact site are not zero. This is because of small differences in experimental setup between the pre and post impact vibrometry scans. This has resulted in a small phase difference which when subtracted results in low amplitude signals being produced. In addition to this, low amplitude reflections result due to Lamb wave interaction with the damage and hence cause an additional change in signal.

The size of the area influenced by the defect appears to vary depending on excitation frequency. Using the Polytec PSV software, it was possible to measure the size of the area of peak RMS. Taking

measurements across the peak for each excitation frequency found the average length of the area affected by the presence of the damage to be 12.6mm, 7.8mm and 14.9mm, for the 100kHz, 200kHz and 300kHz results respectively. Surprisingly the average length of the area affected by the presence of the damage increases from the 200kHz excitation results to the 300kHz excitation results as the reduction in wavelength should be more sensitive to the impact damage.

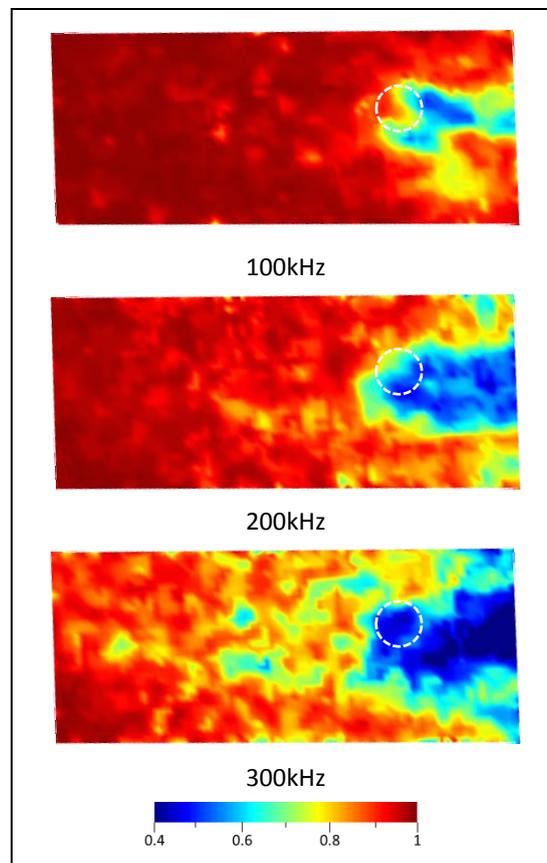
Figure 14. Out-of-plane cross-correlation coefficient results

It is evident that the Lamb wave interaction with the impact damage significantly alters the waveform when compared to the pre-impact waveforms.

The results from the 100kHz excitation show that there is little difference in waveform in-front (left hand side of Figure 14) of the impact damage. There is a significant, localised reduction in correlation downstream (right) of the impact damage. There is an increased area of lower correlation behind the impact damage in the results from the 200kHz excitation. In addition to this, there is also a minor reduction in correlation in front of the impact damage. The 300kHz results show an increased area of lower correlation behind the impact damage when compared to the 200kHz results as well as reduced correlation in front.

The increased area of lower correlation demonstrates that higher frequency Lamb waves are more sensitive to interaction with damage due to their smaller wavelength. At the higher frequencies there is also a reduction in correlation in front of the impact damage. This is most likely due to reflections from the damage.

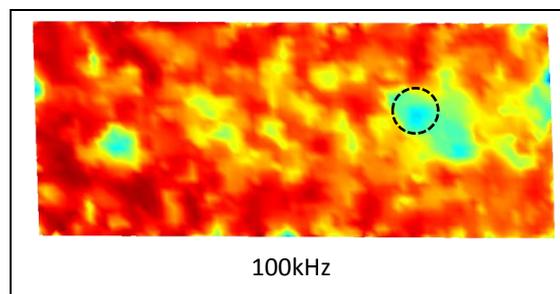
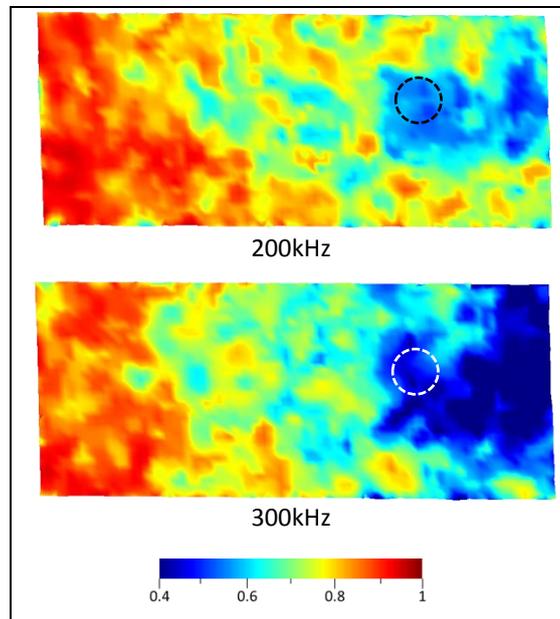
Figure 15. In-plane cross-correlation coefficient results

It is apparent that the propagation of the in-plane component of the Lamb wave is affected by the presence of the impact damage. The 100kHz results clearly indicate a difference in the two Lamb wave signals at the of the impact damage. Comparing this with the out-of-plane results it is evident that there is less reduction in cross-correlation coefficient in this region.

Unlike the out-of-plane results, there is a significant reduction in cross-correlation coefficient over a much larger region of the area of investigation. This can be justified by the scattering of the in plane modes due to the microstructure. It was demonstrated by comparing the resultant magnitude plots with the out-of-plane plots for the 100kHz excitation that a significant level of noise could be attributed to the in-plane components. This is due to the random placement of the chopped fibres. In fibre composite materials the in-plane Lamb wave components are influenced by the fibre direction⁵³ therefore inhomogeneity of the fibre directions will have a more significant influence the noise on the in-plane components than the out-of-plane.

The results from the 200kHz excitation identify a region of reduced cross-correlation coefficient surrounding the impact site. The region is larger than that of the 100kHz excitation and is similar to that observed in the out-of-plane results. This can be attributed to the shorter wavelength of the higher frequency excitation. Like the 100kHz excitation, there is a region of reduced cross-correlation coefficient

upstream of the impact site. This suggests that the in-plane component of the Lamb wave is partially reflected by the presence of the impact damage which is not possible to determine by studying the time-domain plots alone.

The results from the 300kHz excitation show a large region of the area of investigation where there is a significant reduction in cross-correlation coefficient. Like the 200kHz excitation, there is a larger area of reduced cross-correlation coefficient to the left of the impact site than that observed in the out-of-plane results. This would suggest that more of the in-plane components were reflected by the presence of the impact damage than the out-of-plane components.

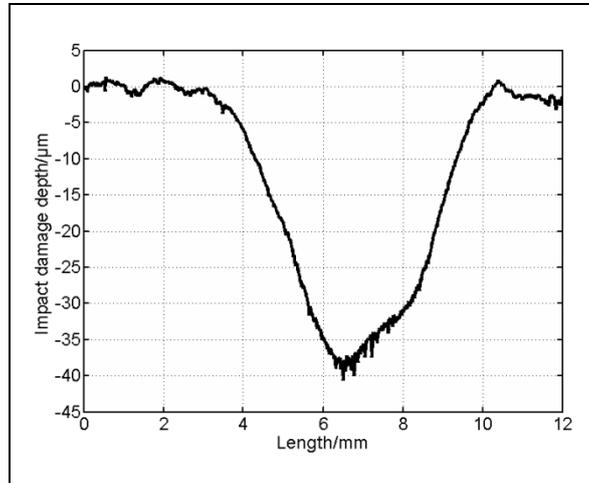
Figure 17. Surface profile of the BVID showing the length and maximum depth of the indentation created.

The depth of the impact damage on the outer face was significantly lower than that of 0.25mm which had been suggested as a quantifiable level for BVID. When inspecting the removed section it was only possible to see the damage at certain angles of viewing in well-lit conditions.

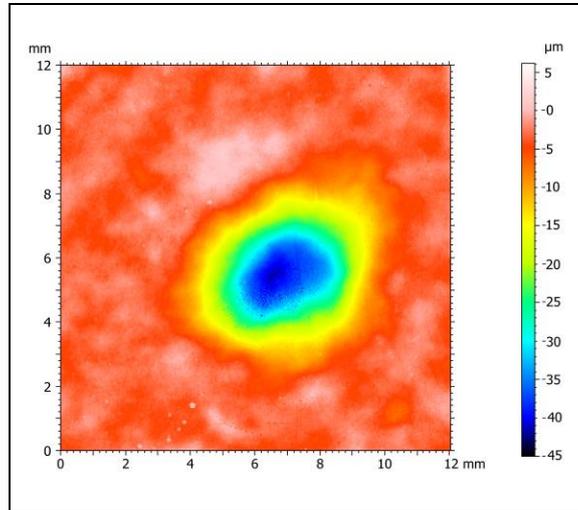
Figure 18. 3D Talysurf scan - Plan view of the BVID.

The 3D measurement shows a clear indentation caused by the impact damage. Though the maximum depth of the indent was found to be 40μm, the 3D measurement shows that only an approximately circular area of around 2mm diameter of the indentation is of this depth. This measurement however does confirm that there was no additional damage caused by the impact damage on the outer surface of the blade.

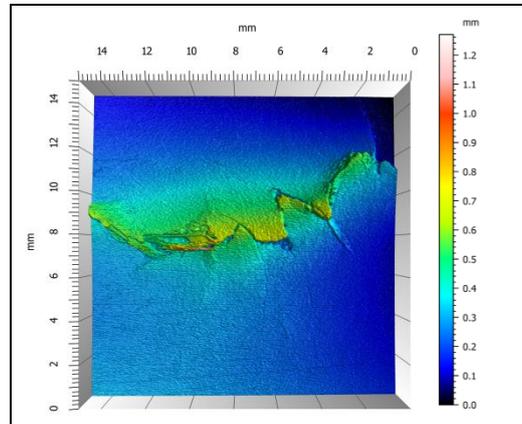
Figure 19. White light interferometry measurement of the crack on the inner face

These results show that the impact resulted in displacing material by approximately 0.9mm along the length of the crack which is photographed in Figure 16. This is significant damage which would affect the structural performance of an operational wind turbine blade.
