Characterisation of fatigue damage in composites using an Acoustic Emission
Parameter Correction Technique

To appear in: *Composites Part B*

Characterisation of Fatigue Damage in Composites Using an Acoustic Emission Parameter Correction Technique

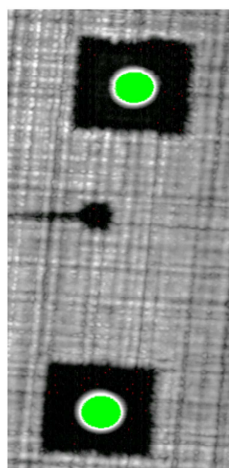
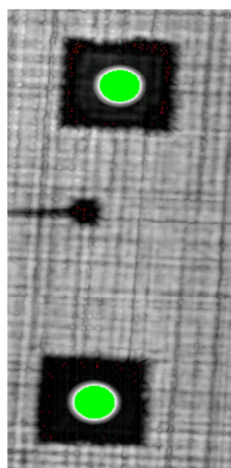
The C-scan images are shown in Figure 5 and reveal the different conditions of the panel during the test. After manufacturing, the C-scan image shows there is no internal damage (Figure 5a). After applying the first 26 loading batches (ending with 21 kN load after 130k cycles) the panel is still without any signs of

internal damage (Figure 5b). The artificial crack location indicates a very slightly higher attenuation, but it is difficult to identify in-plane cracking by C-scan inspection so this cannot be considered conclusive. After impact (Figure 5c), a clear region of high attenuation is observed just above the lower tab indicating the location of impact induced delamination. The dark spot seen centrally in all the images is sensor 5 with its cable exiting to the left of the image also visible. At the end of the test (31 kN load after 285k cycles) no discernible growth in the delamination area can be observed, suggesting that the delamination has not grown during the test (Figure 5d). Again a mild increase in attenuation at the cut plies (just below sensor 5) is observable in Figure 5d but no positive indication of matrix crack growth can be inferred from this.

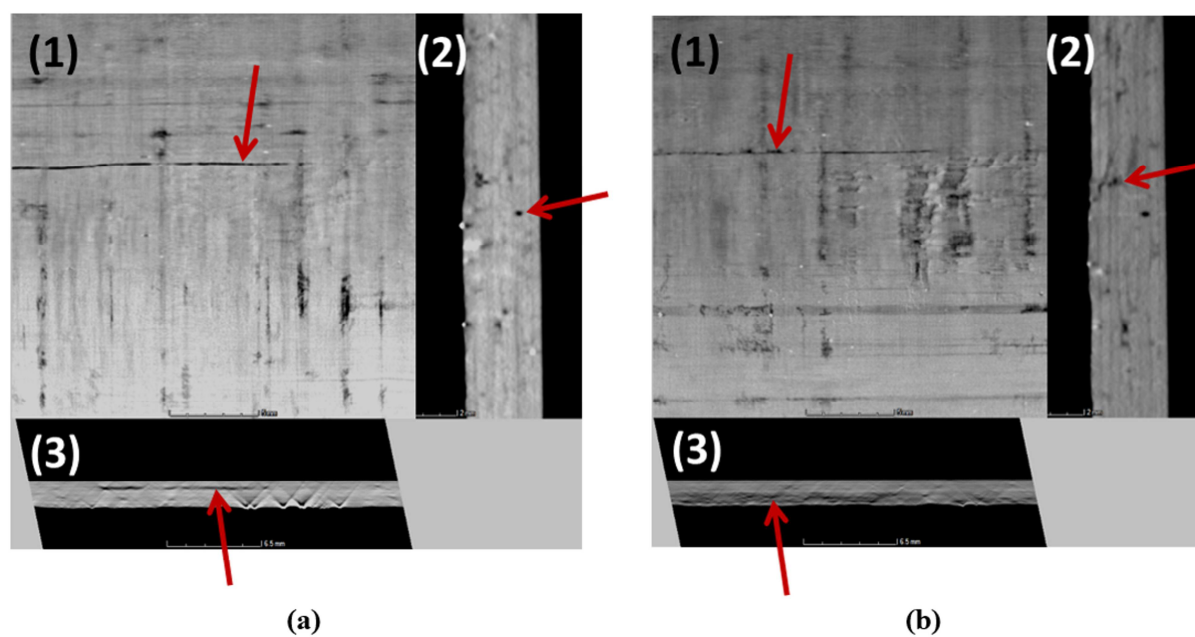
The CT scan results are shown in Figure 6 which show the final condition of the cut ply region after the test. The figure shows two selected slices which corresponding to the third ply depth (Figure 6a) and the sixth ply depth (Figure 6b), i.e. the depth of the cut plies. The main images (1) show an in-plane slice through the material at the stated depth and the two additional images (2 & 3) show orthogonal through thickness slices at the same location. The red arrows indicate a common position that is collocated within all three images. A clear horizontal crack like feature is seen running horizontally left to right in both main images, these cracks correspond to the cut ply positions within the sample. The through thickness slices (2) show corresponding indication of cracking at these positions, appearing as a small black dot because the crack is running out of the plane of the page. Image 3 at a depth of 3 plies also shows a clear indication of cracking. At a depth of 6 plies the crack is less obvious in image 3, suggesting that the crack is less well developed at this depth. By comparing image 2 from both Figure 6 a) and b) it can be seen that the cut plies are miss-aligned and this miss-alignment has restricted the growth of a larger through thickness matrix crack. The CT results, however, confirm that matrix cracking has occurred at the resin rich pockets made at the position of the cut fibres in the laminate.

In the pre-impact stage the cut plies are located in the load path between the two aluminium tabs, where it is expected that the stress will be sufficient to cause cracking in the resin pocket between cut fibres. The x-ray CT data presented in Figure 6 confirms the growth of matrix cracking in this region. Hence there is high confidence that the AE signals selected from the crack region were generated from the observed matrix cracking damage. After the initial AE activity in the cut ply region, no further AE data was observed in this region. This is due to the developed cracks reaching the end of the cut ply region and being arrested by the intact continuous fibres. When plotting the location of the PCT classes as two segments, before and after impact, as shown in Figure 10 it can be seen that prior to impact Class-2 is the dominant class. Hence it is concluded that Class-2 results from the matrix cracking damage mechanism.

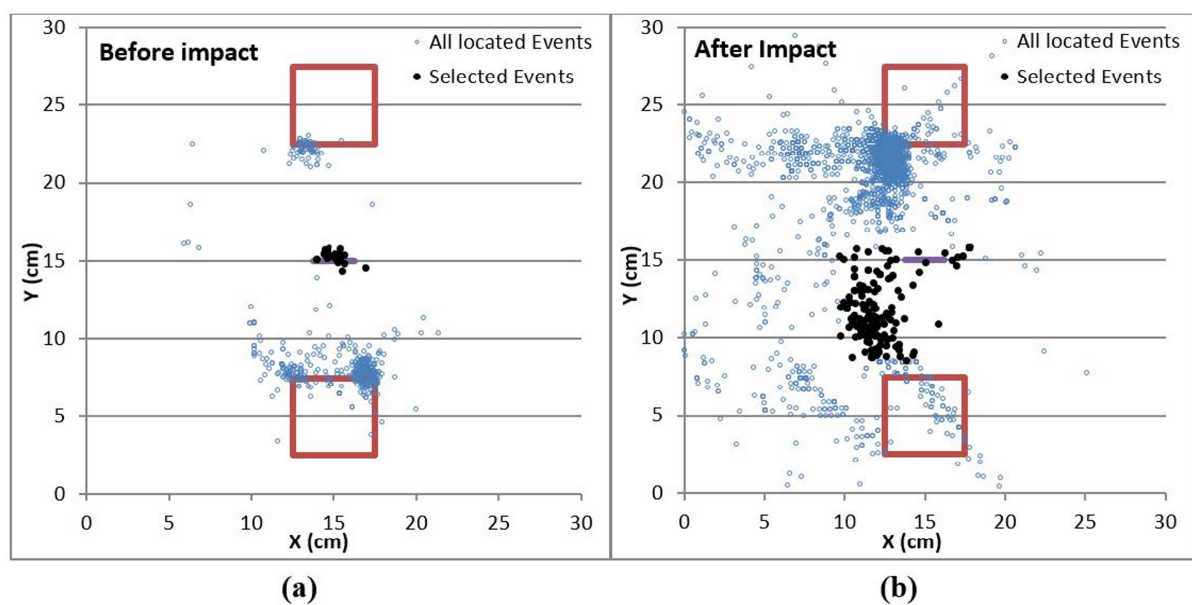
The Delta T results for AE source location using all the five sensors are shown in Figure 7 a) and b) for before and after impact, respectively. In Figure 7a, before impact, events are clustered close to the tab boundaries and at the central area of the specimen at the location of the cut plies. Figure 7b, post impact, shows the events located from the final loading batch (31). High AE activity is observed at the upper tab

location with very little activity observed at the lower tab. A cluster of events is also observed at the location of the impact induced delamination. Additionally, some AE events are located in the unloaded area to the left of the presented image and these events are assumed to be miss-located. Some miss-located events is common in AE testing and often occurs from low amplitude signals where accurate arrival time determination is difficult. The percentage of miss-located events (e.g. $x < 10$) is ~6.6% of the total located events in this data set and therefore these events are not deemed to be significant. These results demonstrate that the Delta T Mapping approach is able to accurately detect and locate signals from noise sources, such as the tabs, and from differing damage mechanisms, such as the matrix cracking and delamination. However to gauge the significance of any located events in a realistic monitoring situation an indication of the source mechanism is required, i.e. signal classification is needed.

In order to characterise the possible damage mechanisms occurring in this test, the AE data is divided into two parts: the pre-impact stage which corresponds to the located AE activity at the artificial crack region (Figure 7a) and the post-impact stage which corresponding to the activity at both damage regions, i.e. artificial crack and delamination area (Figure 7b).

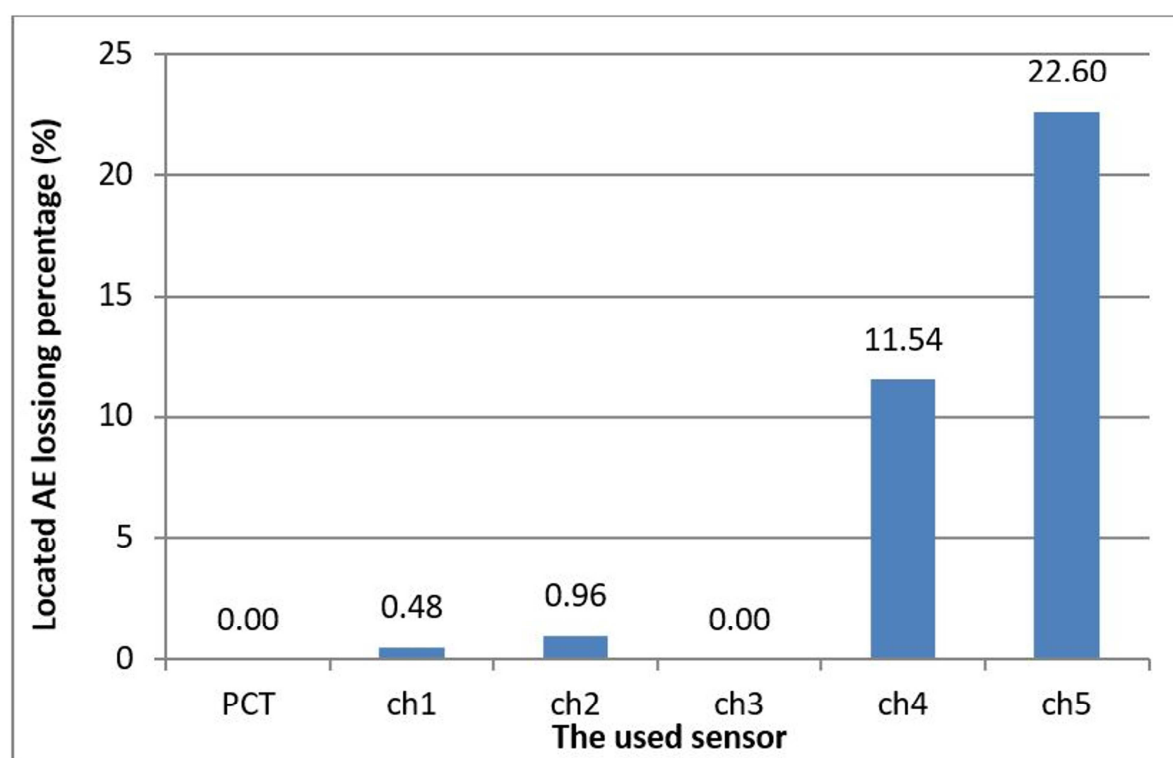
Figure 8 presents the percentage of events for which a sensor was not used in the location calculation, that is the number of events or signals that would be missed if each sensor was considered in isolation. Counter-intuitively; being closest to the damage region, channel 5 is missing signals for over 22% of the events located. When the total number of hits at each channel are considered channel 5 has recorded significantly more than all other channels with a large number of low energy signals that are not registered by sensors further away due to attenuation. This disparity is attributed to the process used for the Delta T Mapping algorithm to group signals closely spaced in time that will likely be from the same event. It is anticipated that the large number of additional hits on channel 5 has caused some errors in correct identification of event groups. Nevertheless, Figure 8 serves to highlight the issue of data loss when only one sensor is considered for classification. Here it would be most intuitive to select channel 5, however that would result in the loss of 22.6% of all located events when all 5 sensors are considered. The PCT technique overcomes this limitation by using corrected data from all sensors to provide an average corrected feature value. So, all data from located events can be considered in any subsequent

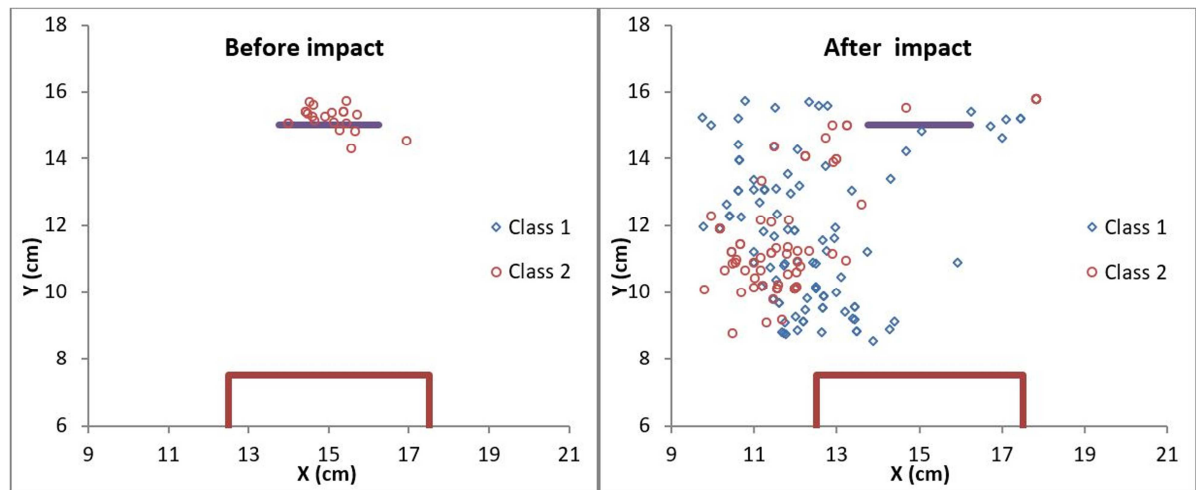
Figure 10. Delta T Mapping locations of the classification results (PCT).

The post impact stage contains events mostly located in the region of the delamination, with a small number of events located near the cut ply region, indicating that some additional matrix cracking might have been induced by the higher applied load of 31kN (Figure 10). Significant activity is seen in the delamination region, despite the C-scan data showing no obvious signs of delamination growth. The AE activity in this region is likely to result from a range of sources including matrix cracking caused by the induced stress concentrations and friction from fretting and movement of the existing damage surfaces. For the data recorded after impact the PCT classification identifies two classes (Figure 10). The signals located at the delamination site are a mixture of class 1 and 2, which is expected due to the varied damage mechanisms present in this area, with class 2 representing matrix cracking and class 1 representing fretting of the delamination surfaces. Out of the small number of signals located near the crack most are class 2 and located in the region of the crack tips and correspond to the observed matrix cracking.
