PERFORMANCE GAP? ENERGY, HEALTH AND COMFORT NEEDS IN BUILDINGS

Abstract: *Research on performance gap suggests that the actual energy consumption in buildings can be twice as much as expected. Energy models rely on predictive indicators and assumptions that are usually done at design stage, without acknowledging behavioural patterns of actual users. Moreover, in the context of performance gap, it is evident that energy efficiency is overemphasised while other key issues such as health and comfort of occupants, indoor air quality, noise levels etc. have been less stressed and discussed. This paper discusses the performance gap using surveys and physical measurements in a case study building at the University of Cambridge and reports findings of a research workshop with graduate students working on environmental performances of the built environment. The workshop addressed research issues related to energy, comfort and health, used as a method to understand the complexities of and trade-off between different aspects of sustainable buildings. According to the results, it is possible to balance energy, health and comfort needs in building projects. Lessons can be learned from the univ

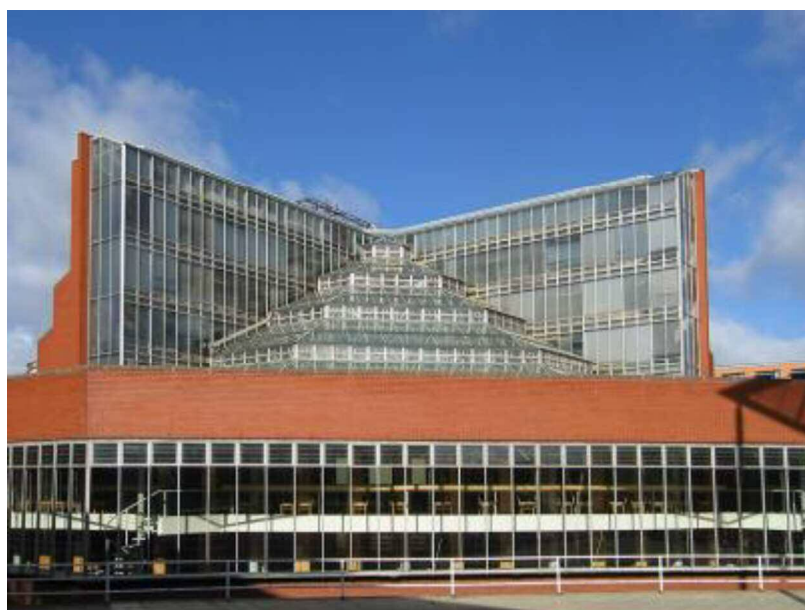
Figure 6: Faculty of History

The selected case study was the Faculty of History in Cambridge (Figure 2). The design of James Stirling was selected based on an architectural competition in 1962. From the beginning, there were concerns about the building's environmental performance 'the building would be subject to solar heat to a fairly large extent' (EMBS files 1963). The building was funded by the Universities Grants Committee (UGC), which meant that the funds had to be spent within a certain time frame and there was pressure to reduce the number of design iterations. The project was well funded; the contract price was £104/m² which amounts to £2440/m² at current prices. The design accommodates the history faculty, with an L-shaped stacked block of 6 levels enclosing a large fan-shaped glazed central space that houses the library. Early in construction, a poor relationship was reported amongst all parties, along with time / cost overruns and leaks were noted during the handover of the building. Due to neighbours' complaints an adjustment and reorientation of the building was made. After two decades of contending with construction and thermal comfort issues, demolition was considered in 1985 but the building was conserved and "grade II" listed in 2000 (Figure 2).

Main reason for poor thermal comfort and high energy use is that 75% of the envelope above the plinth is standard industrial glazing, along with the giant stepped-pyramid skylight of the library (Figure 3). The glazed, double-skin roof in the library was meant to act as a light diffusing layer where the inner layer was obscured to prevent glare and to give shadowless light in the reading area. This was also designed to insulate the cavity between the two skins so that all the louvres in the vertical steps would be closed in winter and opened in the summer to enable ventilation through the stack effect. Artificial light sources in the cavity and the roof provide an 'overhead spectacle'; however, the library space and office spaces are prone to overheating in summer (and draught in

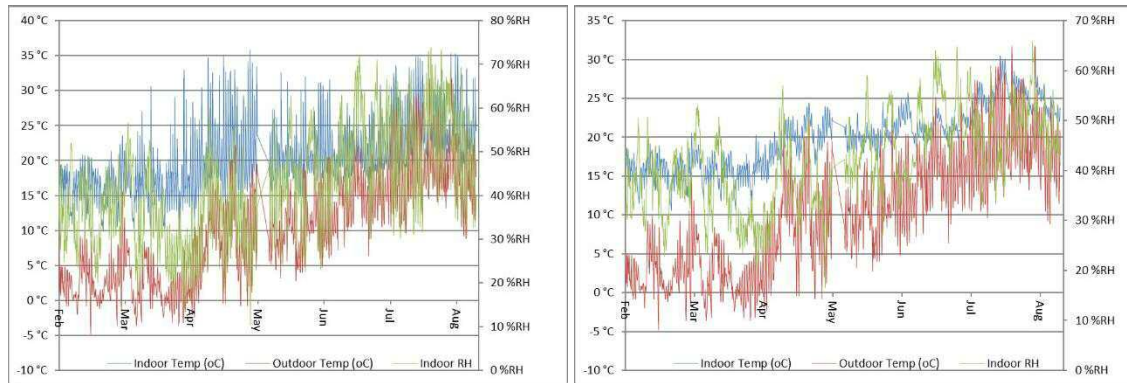
Figure 8: Ground Floor Library (Left); 1st Floor Library (Right) (University of Cambridge)

Figure 4 and Figure 5 show the internal temperatures and relative humidity as well as the external temperatures during one year in different areas of the building. According to the

results, the building has been thermally uncomfortable in almost all areas. The internal temperature in many areas has reached 35 °C; the indoor temperature in the rooms/offices between July and August has frequently been over 30 °C. The temperature in the main library on the ground floor has also fluctuated greatly and in many cases has exceeded 30 °C. Meanwhile, CIBSE Guide A 2015 recommends average summer operative temperatures of 24-25 °C for libraries and 22-25 °C offices, respectively (CIBSE 2015).

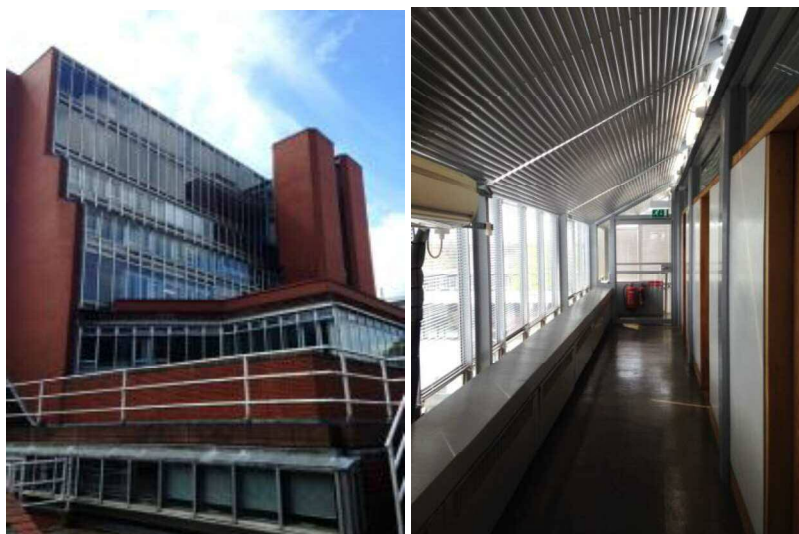
Figure 10: Excessive glazing and solar heat gain contribute to overheating

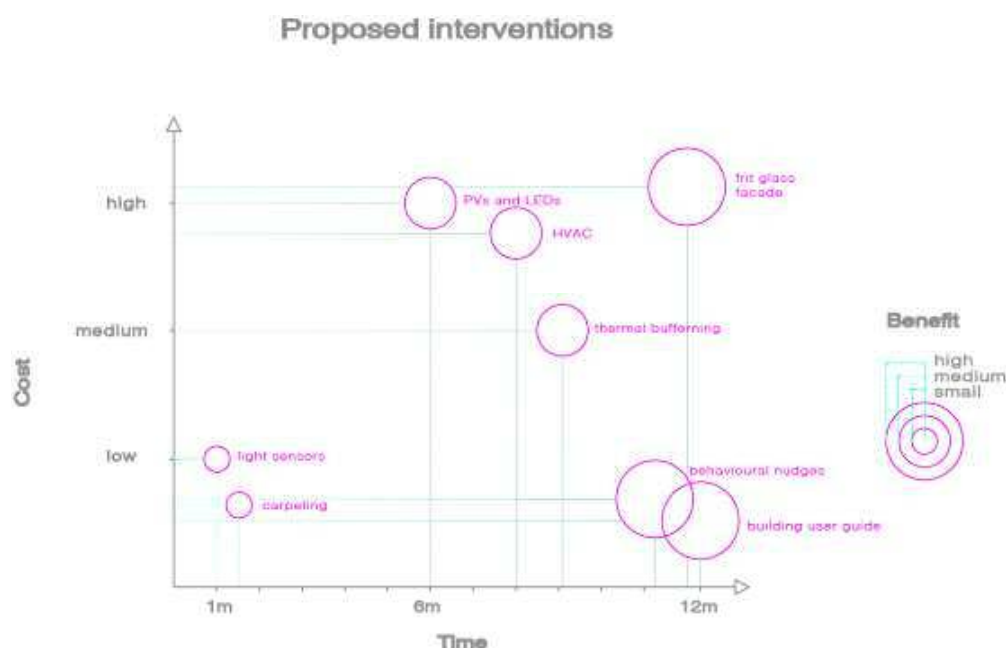
Figure 12: Proposed interventions for the refurbishment of the History Faculty at the University of Cambridge based on the cost, implementation timeframe and benefit

The practical aspects related to the implementation of the proposed interventions (cost, benefit, timeframe) were presented in a comparative graph. The different measures were plotted based on their cost (high, medium, low), the timeframe of their implementation and their impact on energy efficiency and comfort (small, medium, high) (Figure 9).

In terms of comfort and energy efficiency, the replacement of the outer layer of the building's glass envelope with fritted glass and the behavioural nudges were the interventions with a higher expected impact. The new façade intends to give a creative and delicate aesthetic touch, enhancing the identity and popularity of the building however, this is anticipated to be a costly intervention. The interactive 'building wizard' would be less costly but needs constant update and monitoring. The case where the two measures are combined is seen as the optimal intervention in the existing context.
