ASHKELON 8

The Islamic and Crusader Periods

17. THE FORTIFICATIONS: GRID 20 FORTIFICATION TOWER

by Hannah Buckingham and Denys Pringle

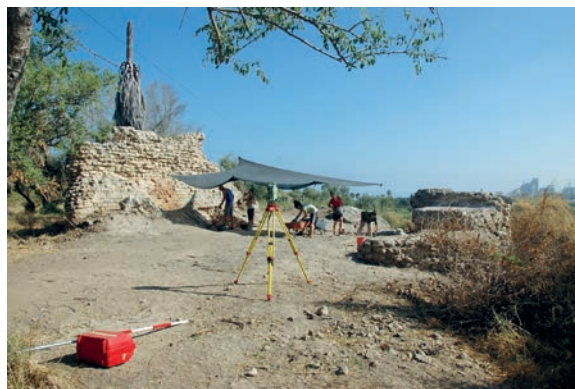
Figure 17.1. View of the site under excavation from the south, with remains of the Phase 3 Fatimid town Wall and Tower 3–4 to the right and the leaning wall of the Phase 4 Fatimid Building 8 to the left (photo DP 2014)

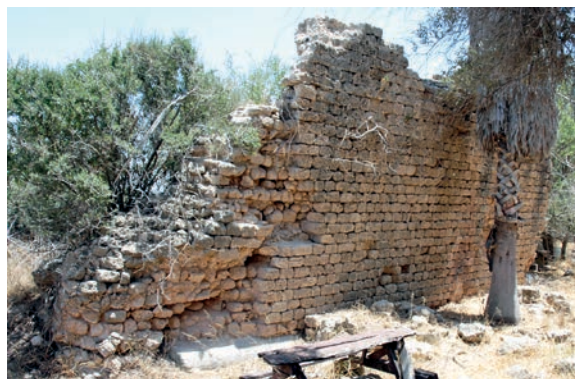
Figure 17.2. Leaning Wall 8 from the northwest (photo DP 2008)

The wall is 10.40 m long, 1.44 m wide, and survives to a height of 4.40 m above a 7-cm-wide foundation plinth (figure 17.5–6). At present it is leaning at an angle of 10° toward the west. It appears to have been built on a raft of granite column drums, laid mostly longitudinally rather than transversely to the line of the wall. Their purpose was evidently to provide a solid base on what was probably recognized to be unstable ground. A similar, though less consistent, reuse of Herodian and Byzantine columns has been noted in the foundations of the Umayyad palatial buildings lying south of the Haram al-Sharif in Jerusalem (Prag 2008:130–31, figs. 115–16, 118.). In the case of **Wall 8**, however, the laying of the columns longitudinally and so close together may actually have made the wall less stable than would otherwise have been the case and have contributed to its lean. In addition, the central part has sunk somewhat, leaving diagonal cracks in the wall and the columns at the ends sticking up at an angle.

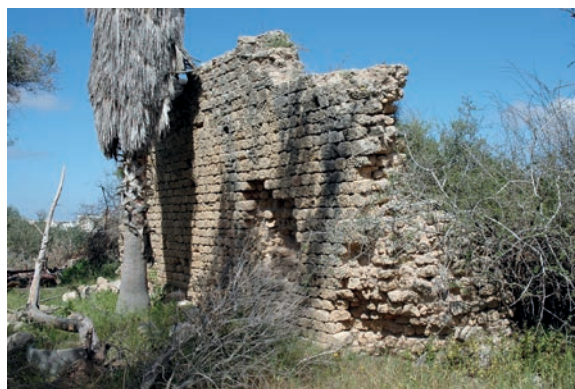
Figure 17.3. Leaning Wall 8 from the southwest (photo DP 2009)

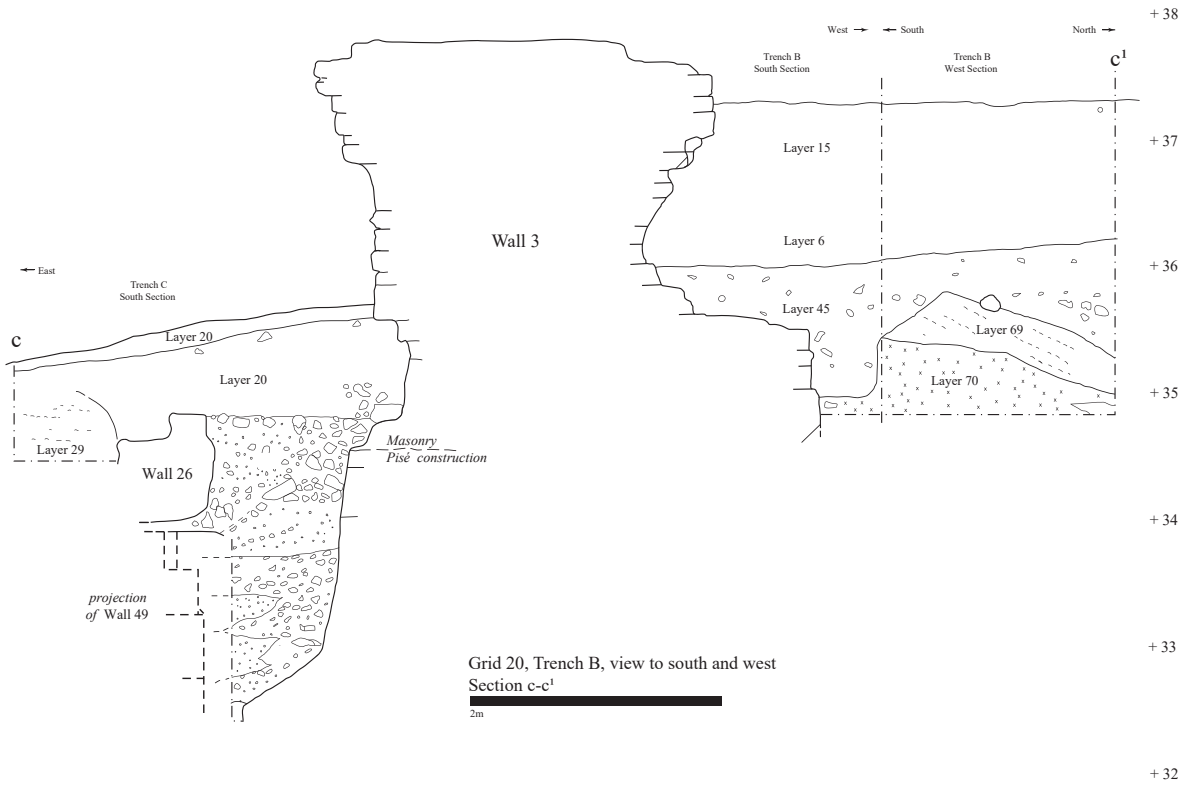
Figure 17.7. Above: Trenches B and C, section e-f-g (looking south and west). Below: Trench E, section d, looking west

Inside the wall to the west, a layer of burnt material containing large amounts of vitrified wasters of Byzantine coarse ware (**Layer 70**) that had been redeposited against the inside face of the later Phase 3 **Wall 3** (see Figure 17.7 and below) suggests that there may have been a kiln in this area in the Byzantine period.

The standing **Wall 8** appears to be the west wall of a building that once extended eastward toward the Phase 6 town wall. The position of the building's north wall is indicated by traces of its stub end, at least 0.90 m thick, surviving in the standing masonry at the north end of **Wall 8**, though no trace of its foundations was found by excavation in **Trench F**. At the south end of **Wall 8**, however, not only was the stub end of the south wall more clearly expressed in the standing masonry, but it was also possible to excavate its **Foundation 63** in **Trench E** (figures 17.7, 12–13).

The next structural event to be recorded in this area was the complete rebuilding of the town wall (figures 17.5–7). This entailed the demolition of the earlier Phase 6 (Byzantine/Early Fatimid) wall and the partial destruction of the building erected in Phase 4. At this point the medieval town wall, after following the edge of the scarp from the Jerusalem Gate on a course of roughly $\text{N}20^{\circ}\text{E}$, made a dogleg turn of some 15–20 m to the west before continuing on a course of around $\text{N}10^{\circ}\text{W}$. Although it is likely that already in the Hellenistic and Byzantine periods a tower or bastion would have marked the point at which the wall made its initial turn, we have little evidence to indicate what form such a structure would have taken. In the rebuilt wall of Phase 3, however, the exposed right-angled turn was marked by a massive quarter-round tower or bastion, built of a piece with the curtain wall to the south of it (figures 17.5, 14–17). Only the southern part of this tower still survives in situ (**Tower 3–4**), the northern part and the wall that would have run west from it having been undermined and destroyed, though several large **Fragments 5–7** still lie on the downhill slope. The masonry that survives extends some 11.5 m north–south and is some 2.5 m thick. An irregular **Foundation 23, 48**, 1.4 m thick and 3.5 m long, which runs west at right angles to the southern end of **Wall 3**, albeit separated from it by a gap of some 60 cm to the depth excavated, also appears to belong to the same construction, though it was not fully excavated and its purpose remains unclear.

On the outside (east side) (figure 17.7), the outer edge of the foundation trench was represented by the west (inside) face of the foundation of the Phase 6 (Byzantine/Early Fatimid) wall (part of which [Wall 26] was even undermined in the process, though remaining suspended in situ) and possibly the Phase 7 Wall 49 beneath it (though this was not fully investigated for fear of collapse). In the southern part of Trench C, Wall 3 was investigated to a depth of 32.42 m ASD. If we assume that its inside face continued down vertically to the same depth, the wall's

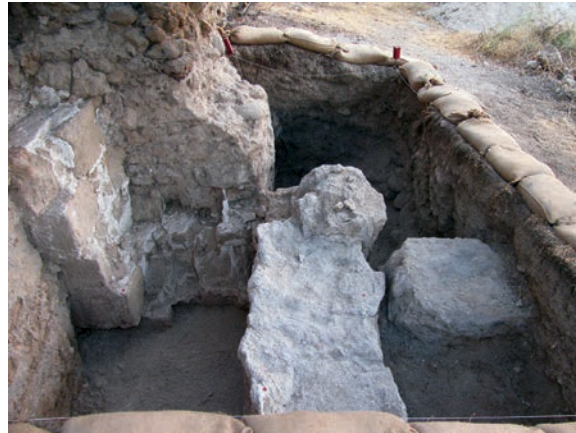
Figure 17.8. Trench C, Hellenistic Wall 44 running (left–right) through the Phase 3 (Fatimid) (3–4) and Phase 6 (Byzantine–Fatimid) (26, 28) town walls (photo DP 2014)

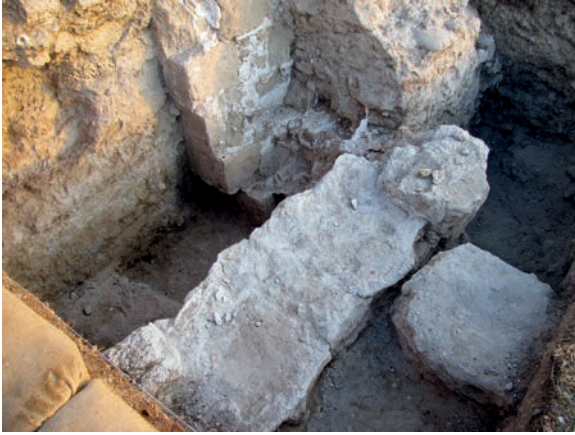
Figure 17.9. Trench C, Hellenistic Wall 44 running (obliquely left–right) through the Phase 3 (Fatimid) (3–4) and Phase 6 (Byzantine–Fatimid) (26, 28) town walls, with the top of the Fatimid pisé wall visible below the masonry wall to the left (photo DP 2014)

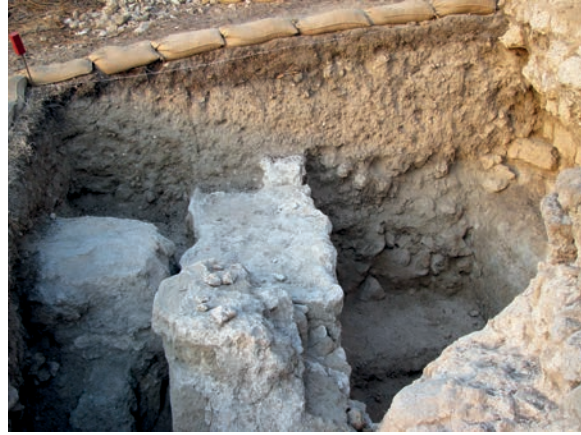
Figure 17.10. Trench C, section e–f looking south, showing Phase 6 (Byzantine–Fatimid) Wall 26, 28 (center, left) and Phase 3 (Fatimid) Wall 3 (right) (photo DP 2014)

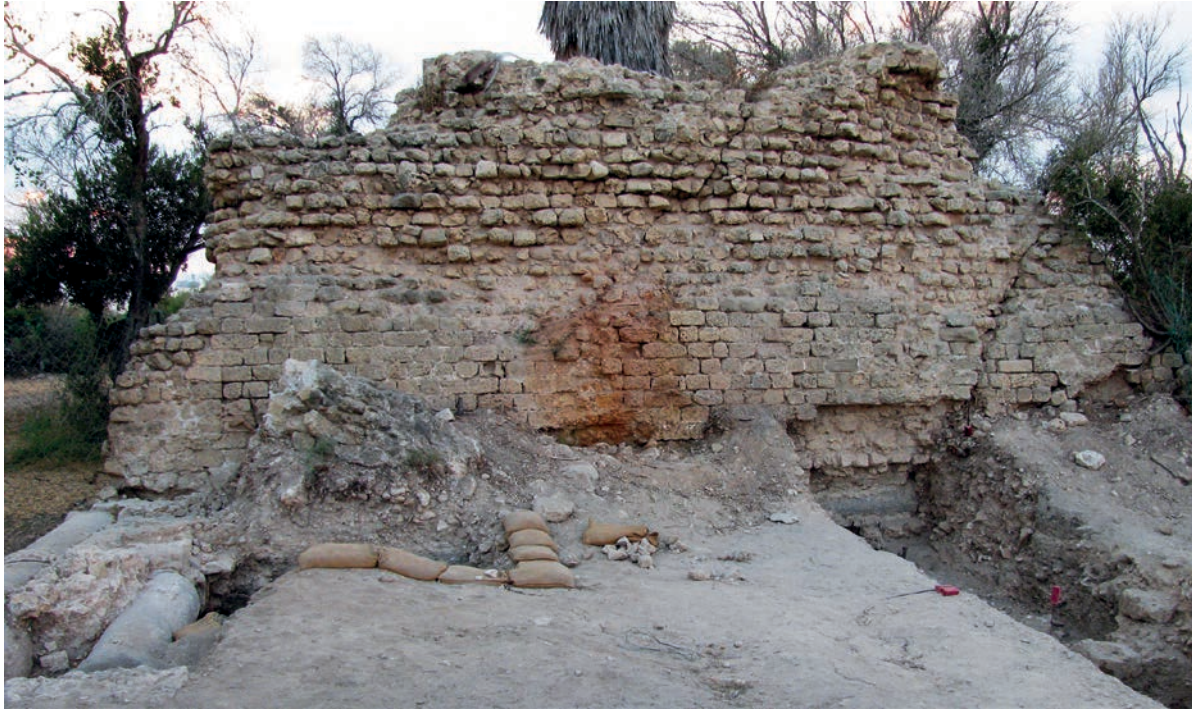
Figure 17.11. West Wall 8 of Phase 4 Fatimid building, from the east (photo DP 2014)

Despite its unstable foundation, the wall was well built with two facings of *kurkar* ashlar enclosing a rubble concrete core, laid *pari passu* with the facing in courses 13–19 cm high (mostly 14–15 cm, averaging 14.65 cm). The mortar used varies from creamy buff to creamy pink in those places where it contains a lot

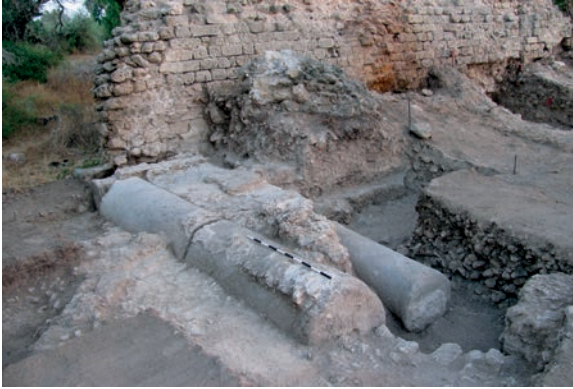
Figure 17.12. South Wall 63 of Phase 4 Fatimid building, from the southeast, with Wall 8 behind (photo DP 2014)

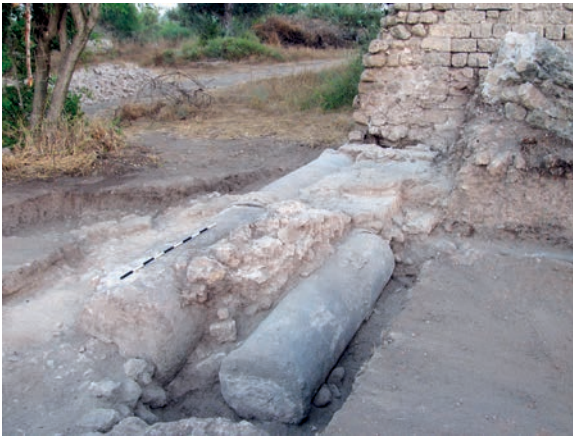
Figure 17.13. South Wall 63 of Phase 4 Fatimid building, from the northeast (photo DP 2014)

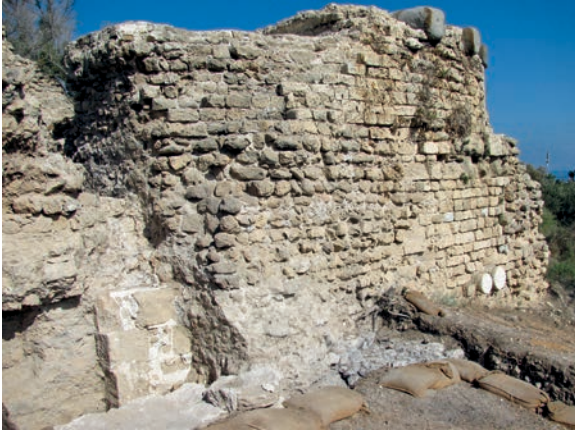
Figure 17.14. Exterior of the Phase 3 Fatimid town wall and tower (3–4) from the southeast, showing the large blocks and ghost of the Phase 7 Hellenistic Wall 44 running through it and, in the foreground, the foundation of the Phase 6 Byzantine–Fatimid wall (26, 28, 90) against which it was built; also visible are the Phase 2 (Crusader?) triangular spurs added to the Phase 3 tower (photo DP 2014)

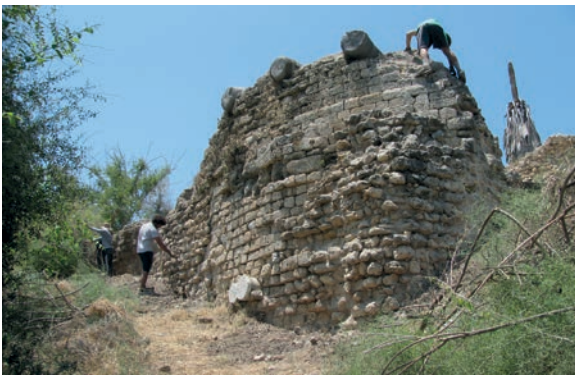
Figure 17.15. Phase 3 Fatimid rounded Tower 4 from the northeast, showing the Phase 2 triangular spurs added to square off the foundation. The original Fatimid-period ground level is indicated by the polygonal courses and plinth just above the top of the spurs (photo DP 2014)

It appears that the rounded tower was undermined and slighted while Ashkelon still retained a military significance, for an attempt was subsequently made to refortify it. The main evidence for the attempted rebuilding consists of two triangular masonry “Spurs” **64–65** that were added to the southeast and northeast sides of its foundation with the evident intention of producing a rectangular base enclosing the rounded tower (figures 17.5, 14–15). The north end of **Wall 4**, already perhaps damaged or fallen, was also squared off in line with the northern “spur” (figure 17.17). In some places an attempt was made to bond the “spurs” into the rough facing of the foundation, but elsewhere—including on the plinth of the rounded tower itself—rubble was simply applied to the earlier facing. The mortar used for the spurs is medium hard, creamy gray, and sandy, containing grits (< 3 mm) and finely graded crushed shell; in places it also includes potsherds, but they seem to have been used more as pinnings than as part of the mortar mix. Some small *kurkar* ashlar still adhering to the lower part of the foundation indicate that the whole squared base would have been faced, though apart from these few survivals all the ashlar have now been robbed out. Given that the northern part of the rounded tower no longer existed, it may be doubted whether much of its superstructure remained standing at all. Indeed, the facing up of the foundation suggests that the external ground level was deliberately lowered in order to present something resembling more a low rectangular bastion than a standing tower. It also seems to have been at this point that a section of **Blocking 59** was added to bridge the gap in the wall where the remains of the Phase 7 (Hellenistic) **Wall 44** had been partly eroded.

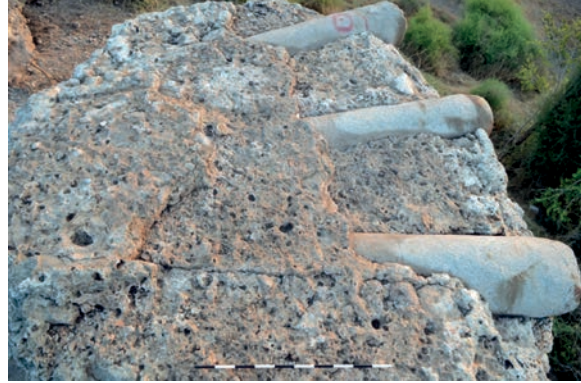
Figure 17.16. The surviving top of the Phase 3 Fatimid rounded Tower 4, showing granite through-columns (photo A14–26213)

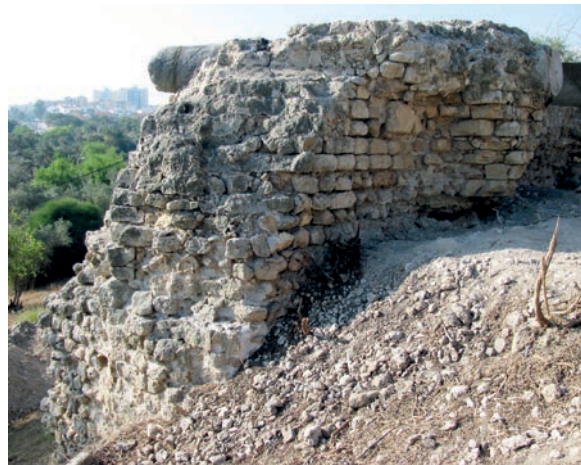
Figure 17.17. Phase 3 Fatimid rounded Tower 4 from the north, showing the Phase 2 squaring off of the truncated wall in line with the added spur. Inside the tower (right) the Fatimid floor level would have been higher than the present surviving height of the tower (photo DP 2014)
