## **Energy Retrofit Infill Panels for Historic Timber-Framed Buildings in the UK: Physical test panel monitoring versus hygrothermal simulation**

Christopher J. Whitman<sup>1</sup>, Oriel Prizeman<sup>1</sup>, Julie Gwilliam<sup>1</sup>, Andy Shea<sup>2</sup>,  
Pete Walker<sup>2</sup>

<sup>1</sup>*Welsh School of Architecture, Cardiff University, Cardiff, UK. [WhitmanCJ@Cardiff.ac.uk](mailto:WhitmanCJ@Cardiff.ac.uk)*

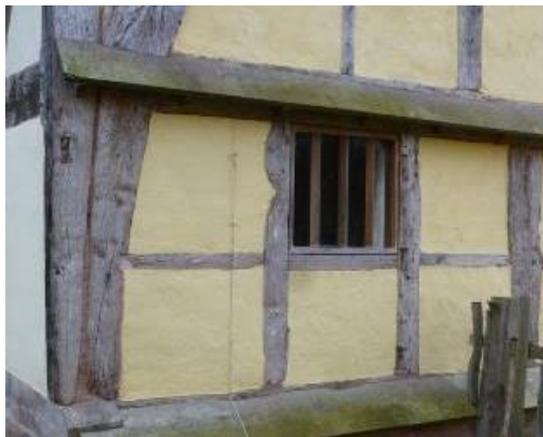
Figure 1. Externally exposed frame.  
(Whitman, 2015)

Historic timber-framed buildings in the UK consist of a structural timber frame with a solid infill. This is traditionally wattle-and-daub, a framework of thin timber members (wattlework) covered by an earthen render (daub). Other historic infills include lath and plaster and brick nogging (Harris 2010). Whilst some of these buildings are over-clad with tiles, weatherboarding or continuous plaster, in many cases the timber frame is exposed both internally and externally (Figure 1 & Figure 2).

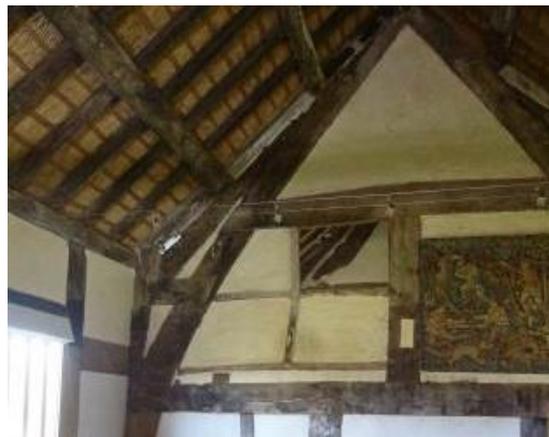
Figure 2. Internally exposed frame.  
(Whitman, 2015)

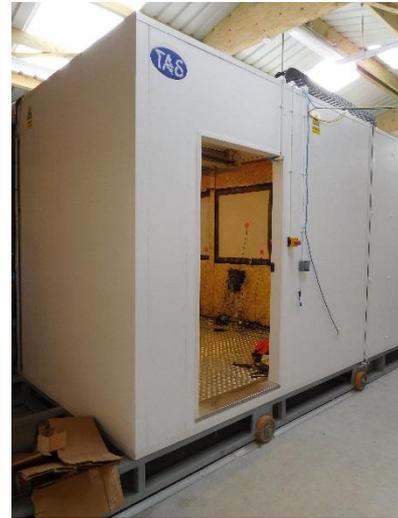
Figure 8. Dual climate chamber

The three panels, each measuring 1120 by 1120 mm, were mounted as part of a dividing wall between the two climate-controlled chambers (Figure 7 & Figure 8).
