The Restoration of the Oratory of the Partal Palace and the House of Astasio de Bracamonte in the Alhambra of Granada Granada, Spain

Dr. Federico Wulff Barreiro Lecturer of Architecture and Urban Design Welsh School of Architecture, Cardiff University

RESEARCH STATEMENT

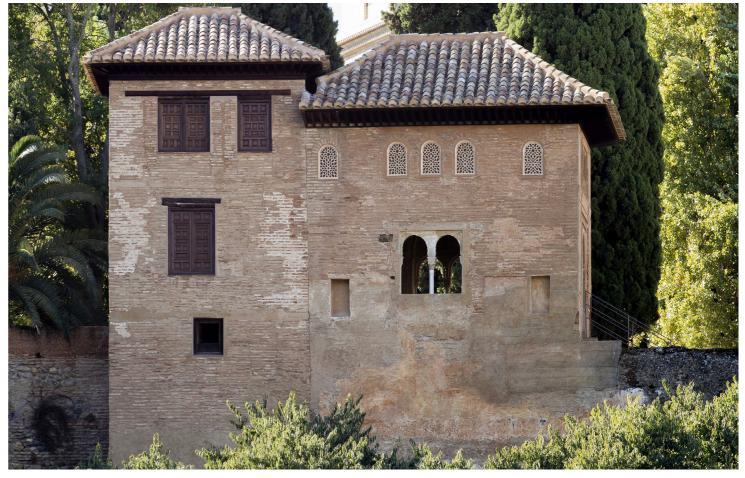
Fig. 1 North-east elevation of the Oratory and the House of Astasio de Bracamonte (Alhambra Council 2015)

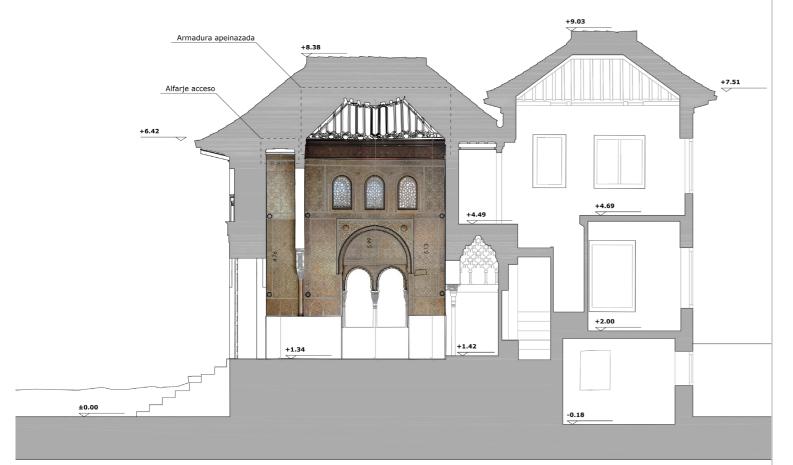
Fig.2 Longitudinal section of the Oratory and the House of Astasio de Bracamonte, condition before the 2013-2017 restoration. From left to right: access staircase, entrance, previous narrow space, main prayer space covered by the Nasrid timber framework, *mihrab*, House of Astasio with the upper space over the *mihrab*, internal staircase and the three storeys of the House of Astasio (Wulff 2012).

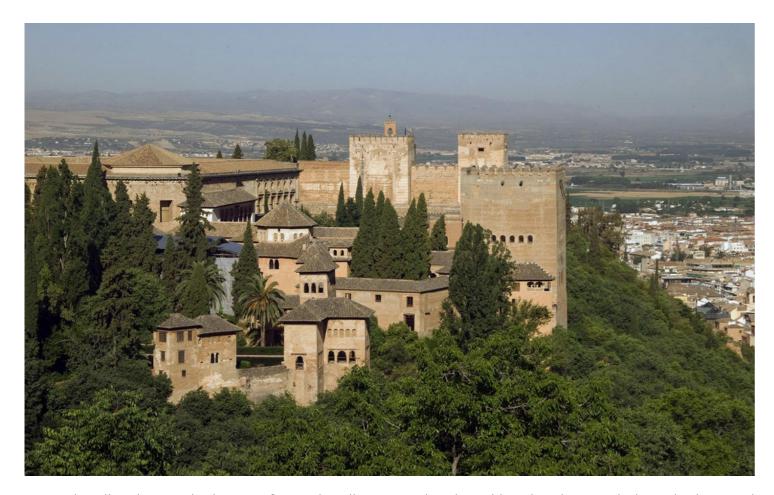
Fig. 3 The Alhambra north elevation facing the Albaycin medieval neighbourhood. Granada (Spain). The Partal Palace is on the left end.

The Oratory has a rectangular plan of 4.20m x 3m surmounting an earlier tower of 15m high that forms part of the north defensive walls of the Alhambra complex (Fig. 3 & 5) (Orihuela Uzal 1996). Its entrance door opens to a narrow space which leads onto the prayer space covered by an original and richly-decorated timber framework. The *mihrab* of the mosque decorated with a *muqqarnas* vault that retains part of its original polychromy, is located on the other end of this space facing the entrance (Fig.7).

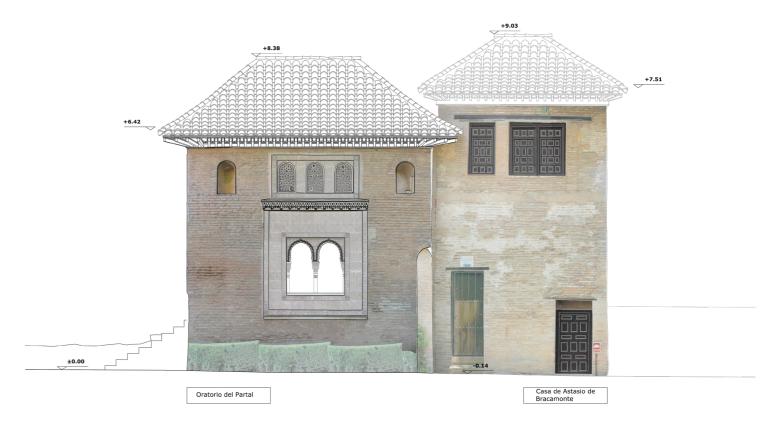
Fig.4 Photogrammetric analysis of the south-west elevation of the Oratory (*left*) and the House of Astasio de Bracamonte (*right*).

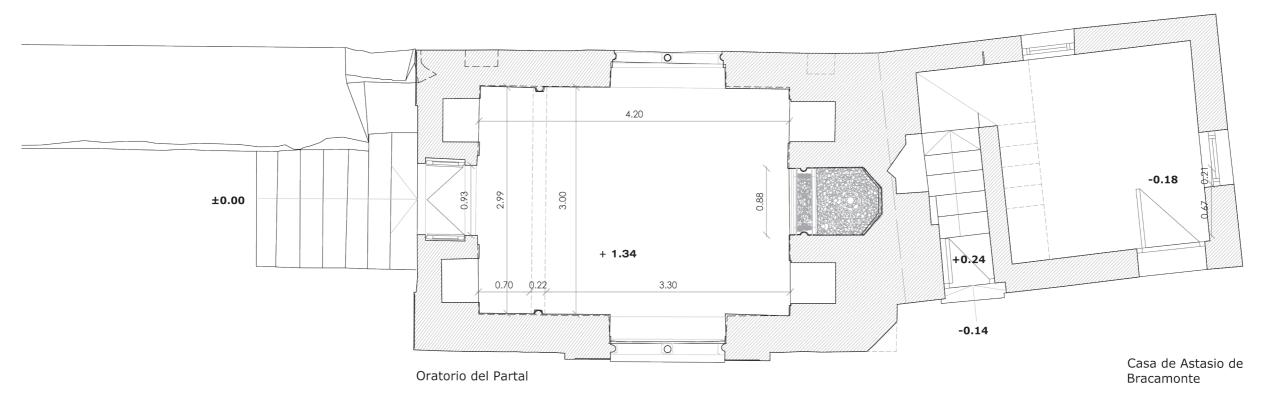
Fig. 5 Plan layout of the Oratory (*left*) and the House of Astasio de Bracamonte (*right*) (Wulff 2012).

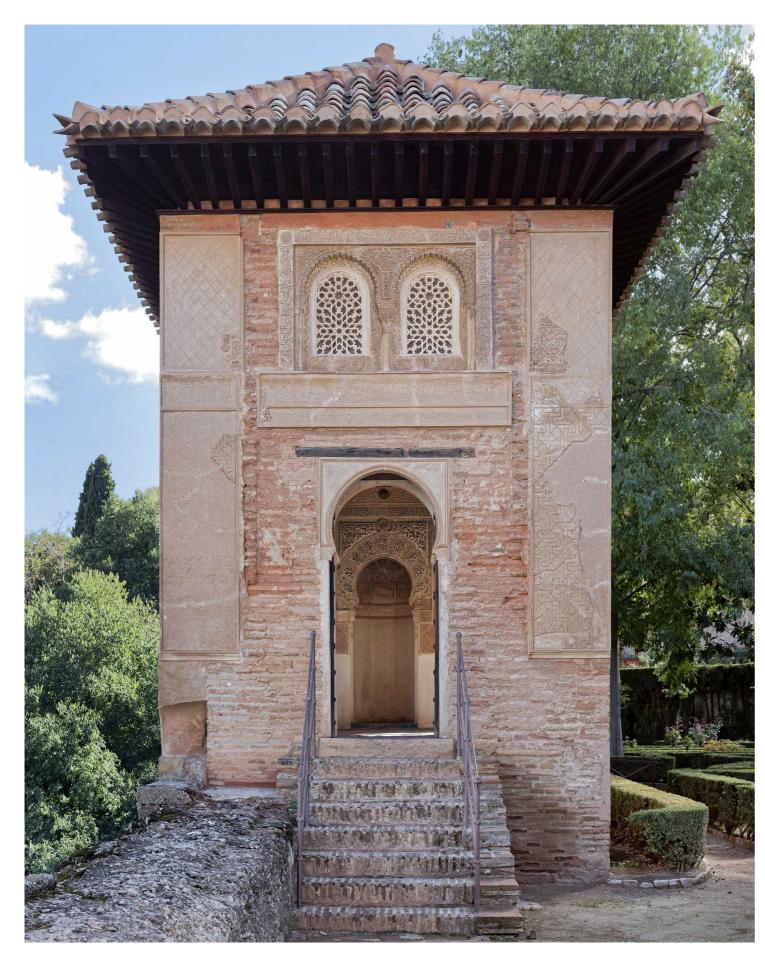
Fig.6 The Oratory's entrance on the north-west façade. The Oratory was built over the earlier defensive north-east walls of the Alhambra, see bottom left. (Alhambra Council 2015)

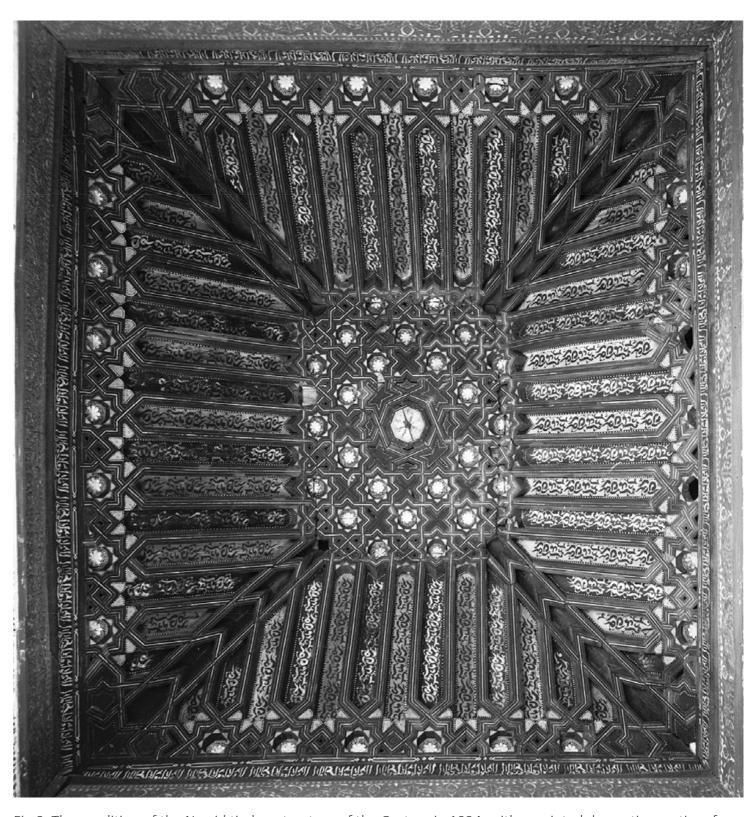
Fig.8. The condition of the Nasrid timber structure of the Oratory in 1924, with repainted decorative motives from the 1846 restoration (© 2014 Institut Amatller d'Art Hispanic. Foto Mas, ref.n. C-42674 (1924), detail; Artyco 2015, I, 18)

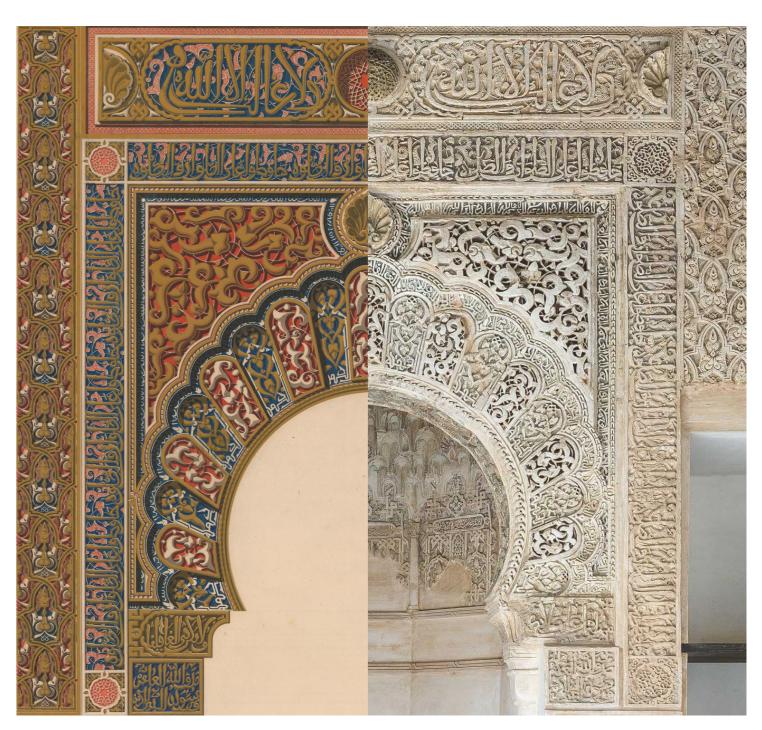
Fig. 9&10. The *mihrab* of the Oratory. Elevation from 1846 Rafael Contreras' restoration (Alhambra Council Archive-APAG, left) and the actual condition after the 1930 and 2013-2017 restorations (Alhambra Council 2015, right).

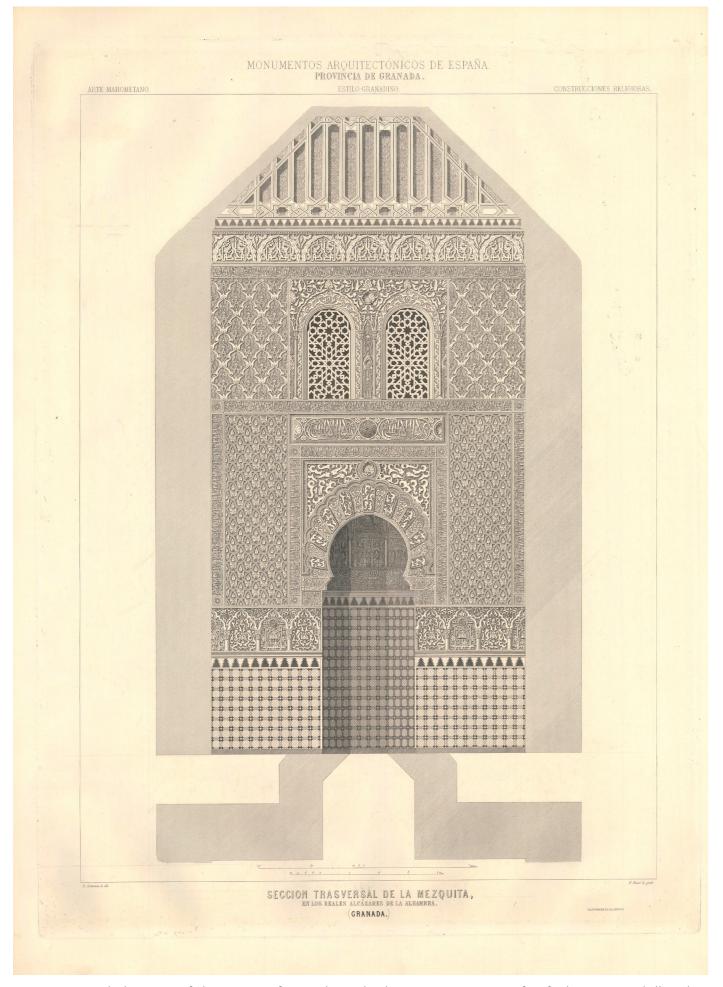
Fig. 11 Internal elevation of the Oratory facing the *mihrab*. 1846 restoration of Rafael Contreras (Alhambra Council Archive-APAG)

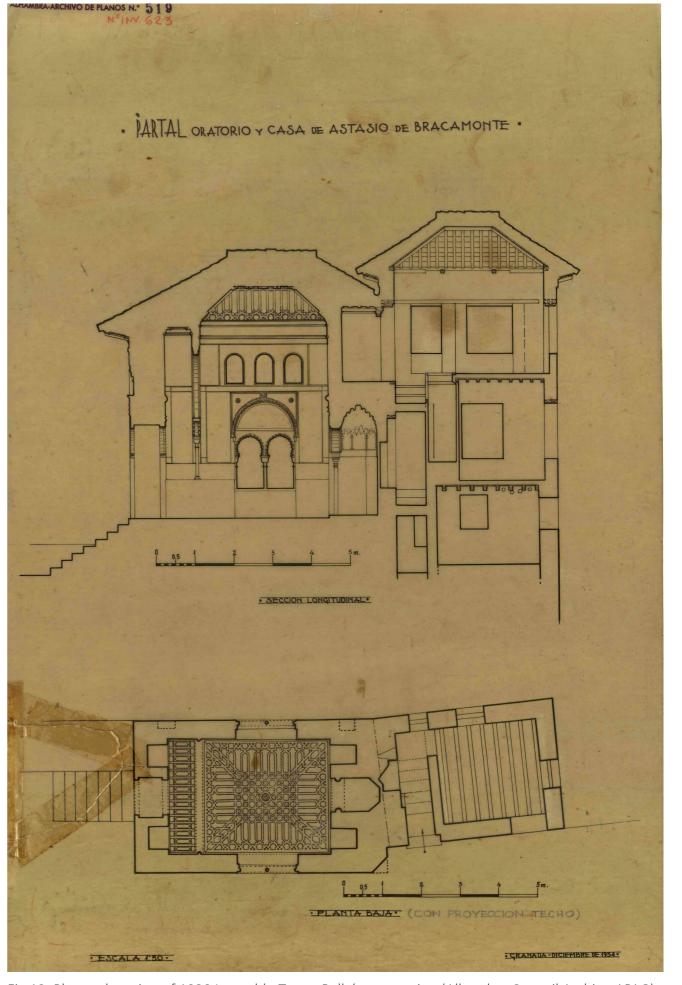
Fig.12. Plan and section of 1930 Leopoldo Torres Balbás restoration (Alhambra Council Archive-APAG)

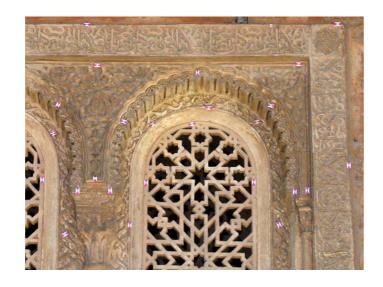
Fig.13. (above)Detail of the twin windows of the north-west elevation, covered by lattices added in 1846 restoration.

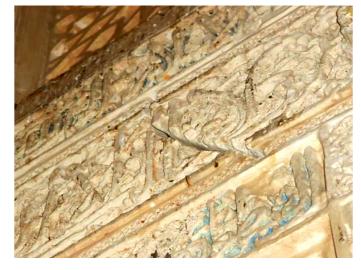
Fig.14. (below)Crack in the epigraph motives of the upper part of the north-west inner wall plasterwork.

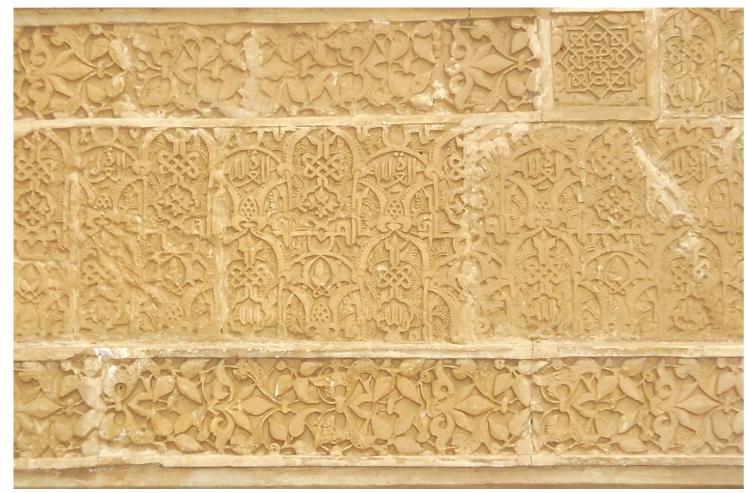
Fig. 15 Restored plaster panels from the 1846 intervention, including epigraphs and vegetal decorations that frame the windows of the south-west elevation, kept by Torres Balbás in his 1930 intervention (Wulff 2012)

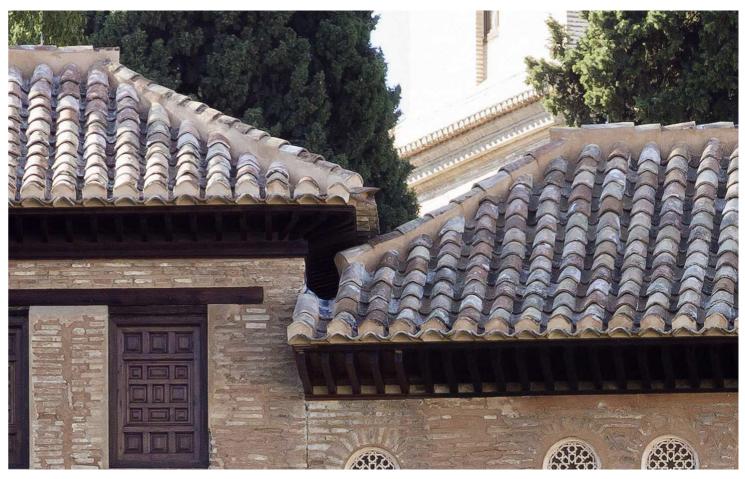
With the aim of enhancing the external legibility of both buildings, the 1930 restoration conceived an inadequate design for their roofs, with the Oratory's hipped roof, slightly higher than the wall of the House of Astasio, pouring the rainwater off its south-east side against the north-west side of the latter. A similar hipped roof covering the House pours the rainfall to the same valley gutter. Since then, it has generated damp issues in the northwest wall of the House and rainwater penetration into the inner spaces, resulting in the decay of both the wooden ceiling and the structure that covers the overlapping space between both buildings. Similar damp issues have affected the inner decorated timber framework, causing the decay of the north-east timber plate, the failure of its rafters' support and their disintegration with the collar ties from the upper horizontal plane of the timber framework.

Fig. 17 The Oratory and the House of Astasio's hipped roofs encounter, pouring the rainwater off the north-west wall of the House of Astasio. (Alhambra Council 2015)

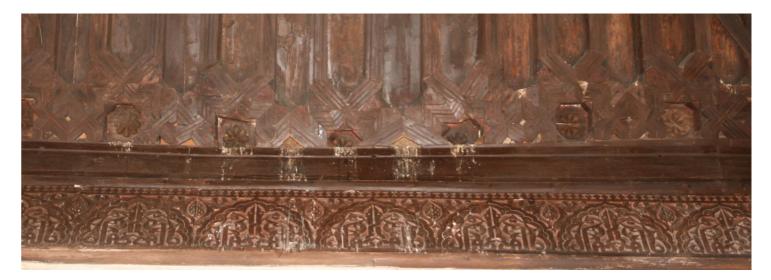
Fig. 18 North-east slope of the inner timber frame that covers the mosque's praying space. The eight-point stars at the lower end of the central rafters evidence a profound deformation due to their support's failure at the level of the wall plate. (Wulff 2012)

The reconstruction process of the rafters' support of the north-east slope of the inner decorated timber framework, seriously degraded by the penetration of rainfall, moisture and the xylophagous action, has shown another interesting evidence of the particularities of the Nasrid carpentry compared to the *mudéjar*-Christian ones.

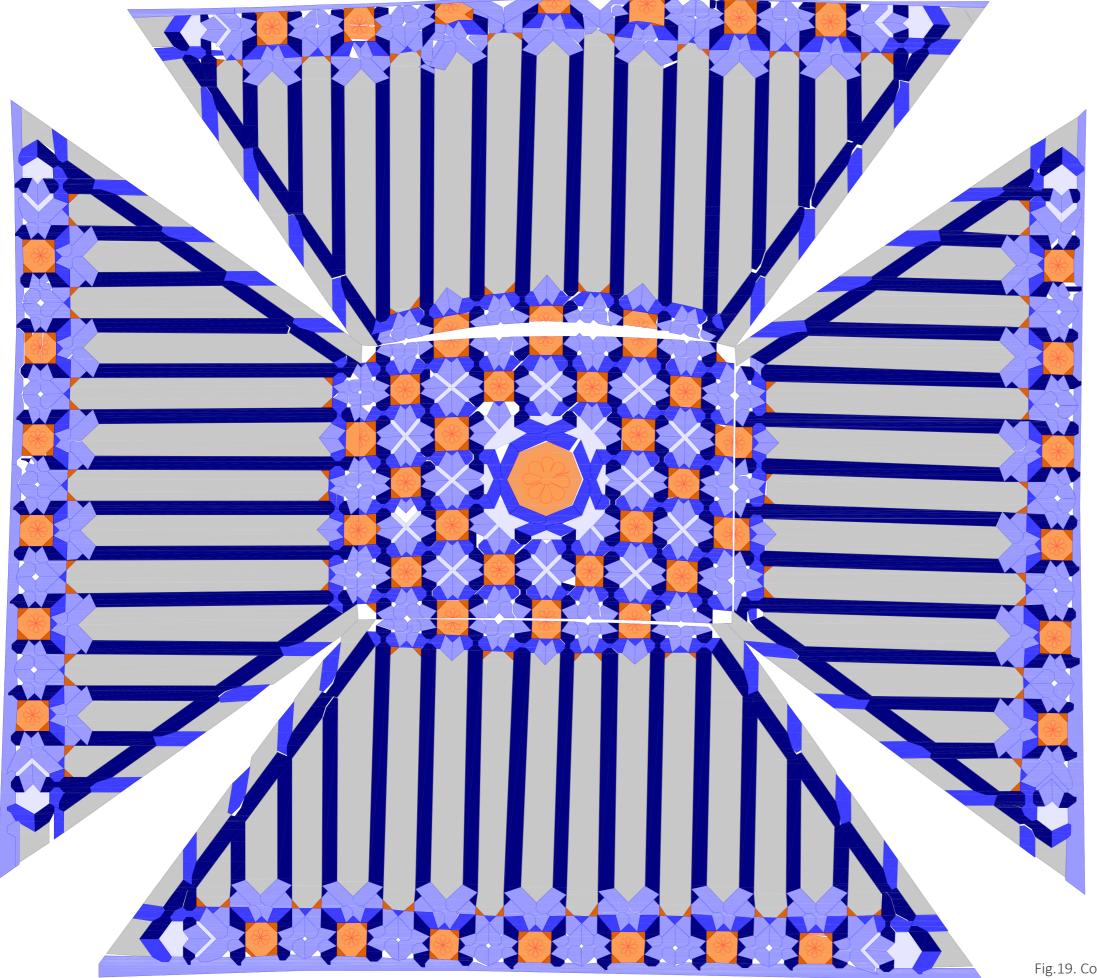
Fig.19. Constructive elements of the Nasrid decorated timber framework covering the prayer space

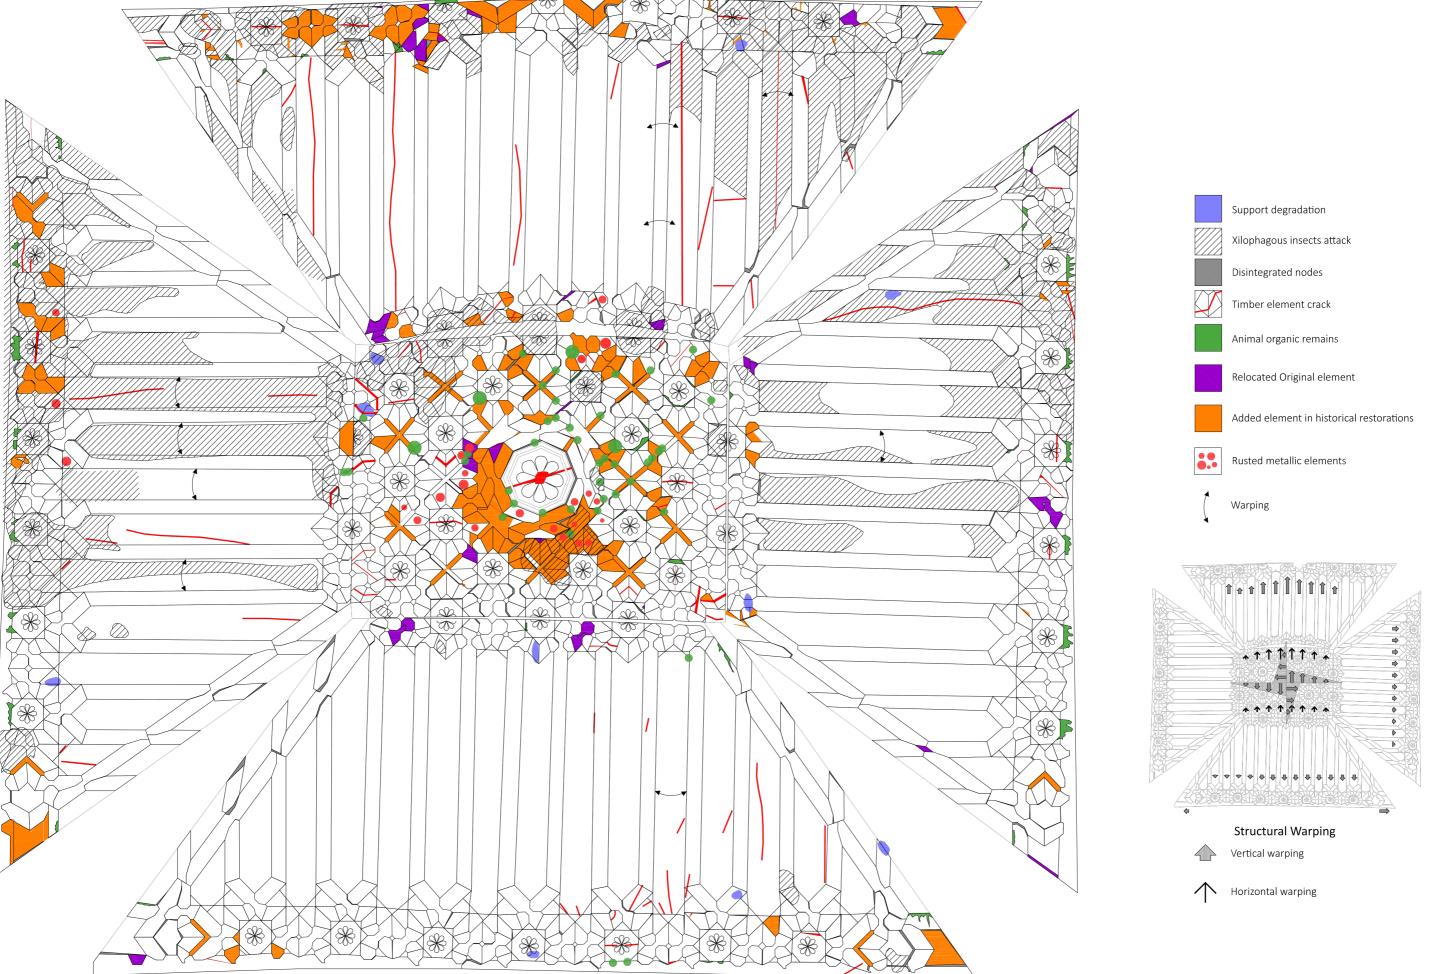
Fig.20. Timber framework pathologies mapping

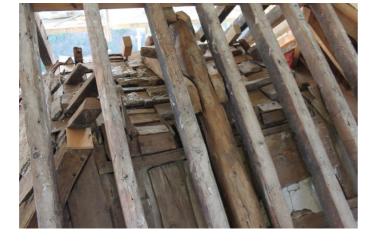
Fig. 22 Phase 1. Nasrid remains in the confined space

Dismantling of the pre-existing roof of the Oratory for the access to the external side of the Nasrid timber framework. This upper roof structure proceeded from 1930 Torres Balbás' restoration and included some reused elements from other historic structures. Discovery of the timber elements forming part of the original Nasrid roof structure, that were located in the confined space between the modern roof and the inner Nasrid timber framework. These remains, consistently dated by Carbon-14 tests, were formed by fragments of two rafters, a false collar tie and a fragment of their wall plate. Their constructive study and position in regards to the inner timber framework has allowed the restitution of the original design of this Nasrid structural typology, distinctive in its structural conception and in its details from the contemporary roof's structures of the Christian-mudéjar context.

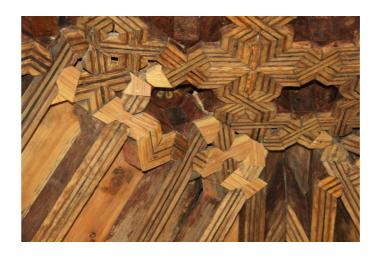
Fig. 23 Phase 2. New additions and Nasrid elements

Structural and constructive analysis and restoration of the original decorated timber framework that covers the main prayer space of the Oratory, together with the original decorated flat ceiling covering its entrance space. Discovery of several Nasrid carpentry solutions, decorative and epigraphic motives that were interpreted, consolidated and restored as important contributions to a deeper knowledge of Nasrid architecture and its associated techniques, in relation but also distinctive to the contemporary Christian-*mudéjar*.

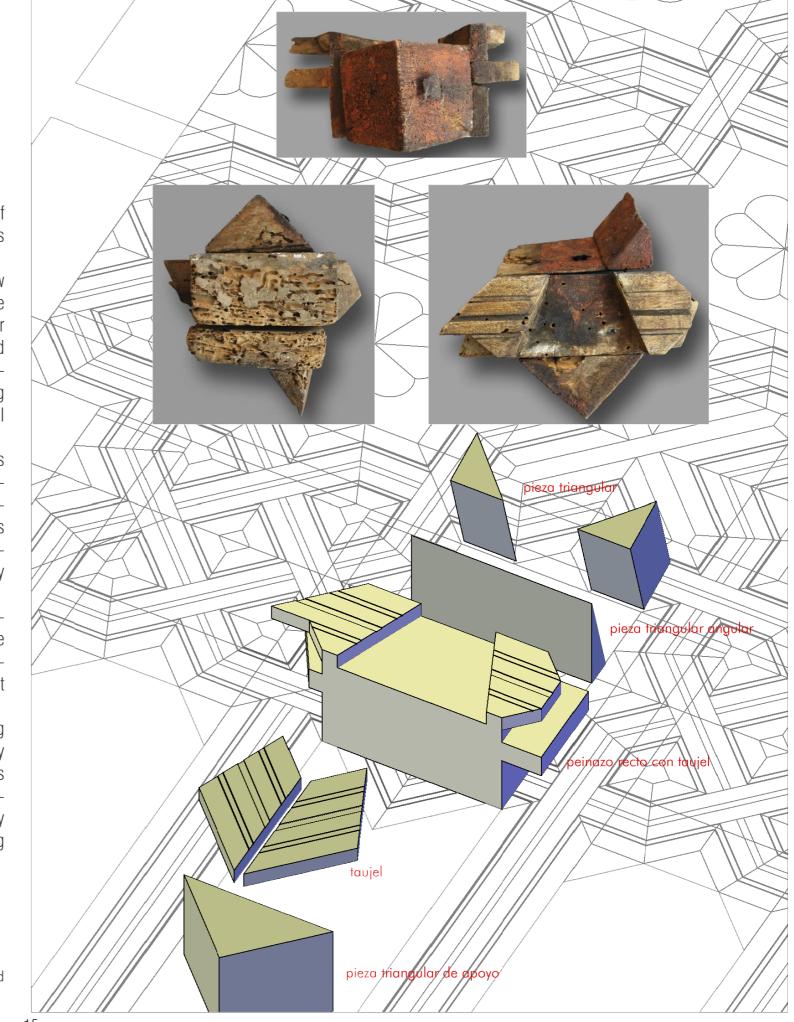
Fig. 24 Constructive analysis of the timber framework components and their assembling process

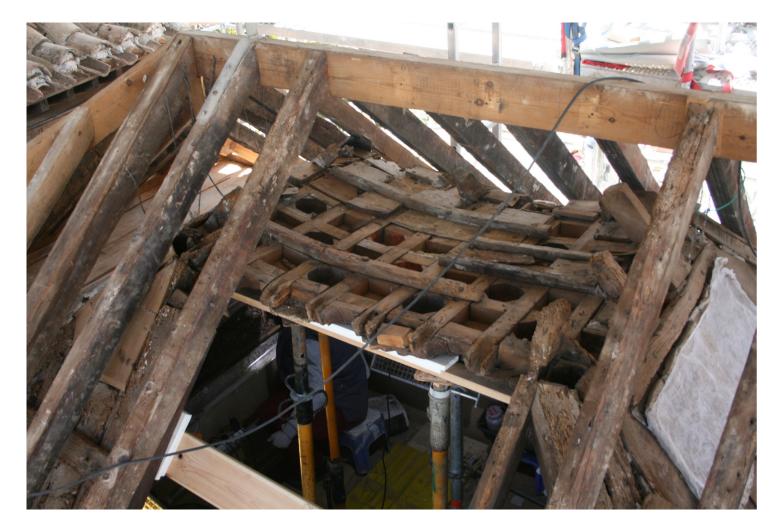
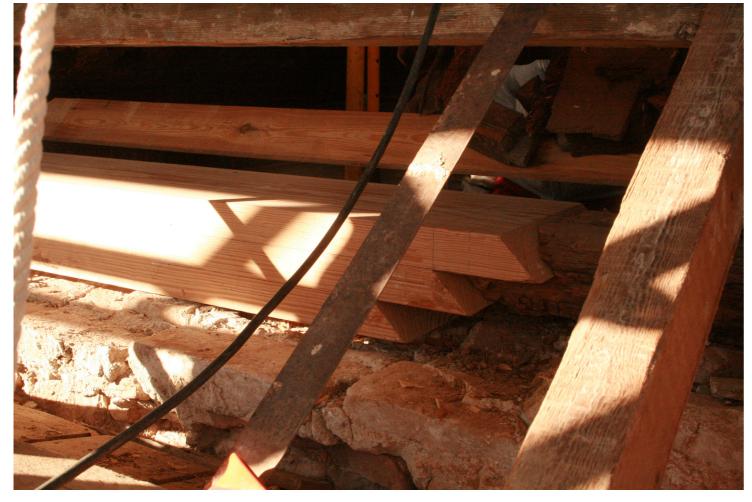
Fig.25 (*left*) & Fig.26 (*below*) Restoration and recovery of the original shape of the upper horizontal plane of the timber framework, formed by collar ties and noggings.

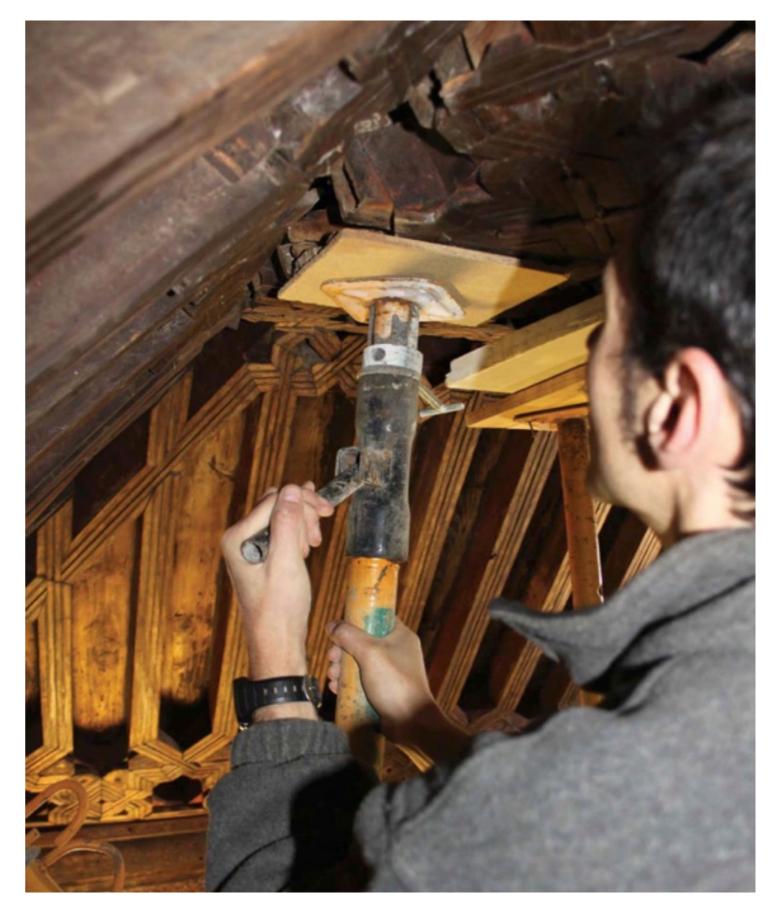
Fig.27 (*left*) Replacement of a section of the original Nasrid timber wall plate

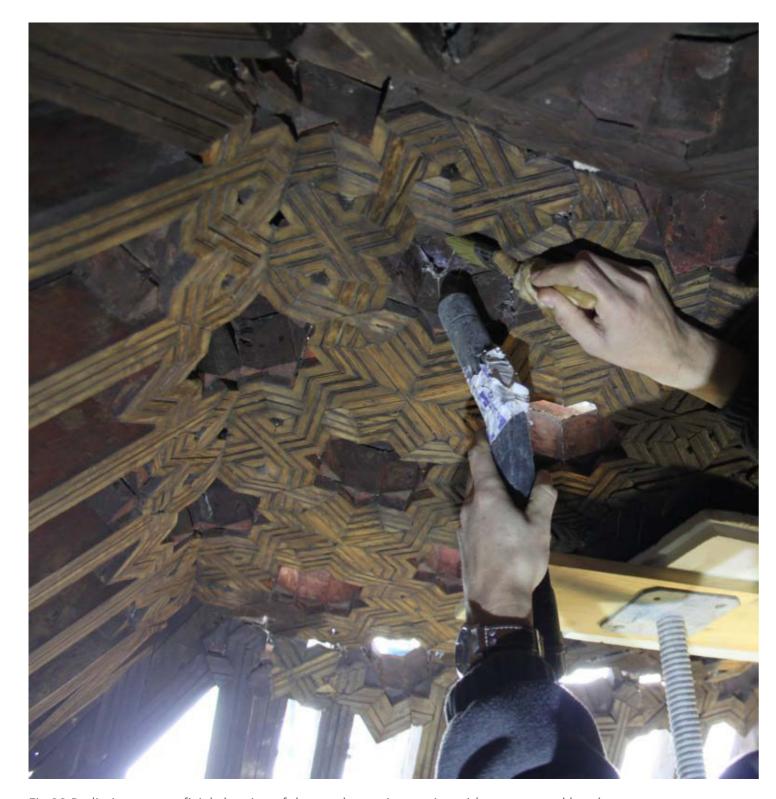
Fig.28 Preliminary superficial cleaning of dust and organic remains with vacuum and brush.

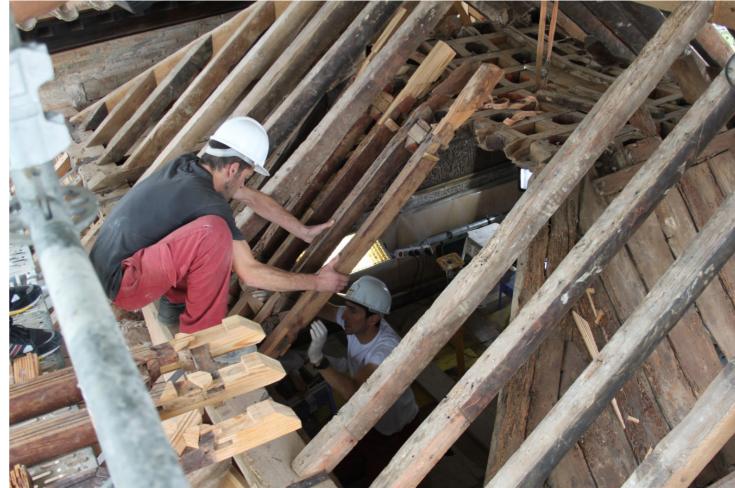
Fig. 30 Assembling of the rafters of the inner timber framework to the collar ties and the wall plate. Their new added prostheses are apparent on their upper end.

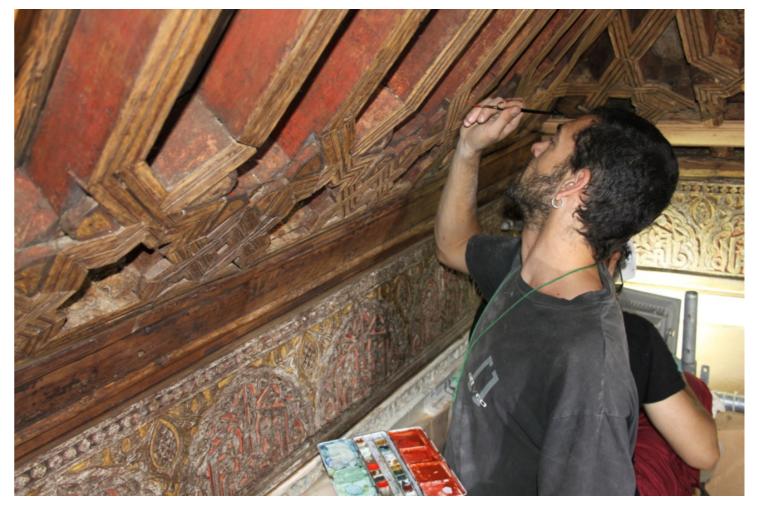
Fig.29 (right) Chromatic reintegration of the original pigments and their primer.

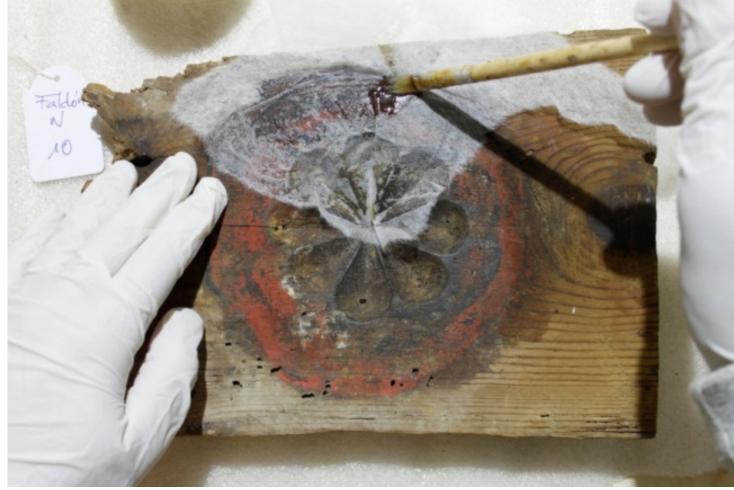
Fig.31 Fixation and consolidation of pigments with Japanese paper and synthetic adhesive

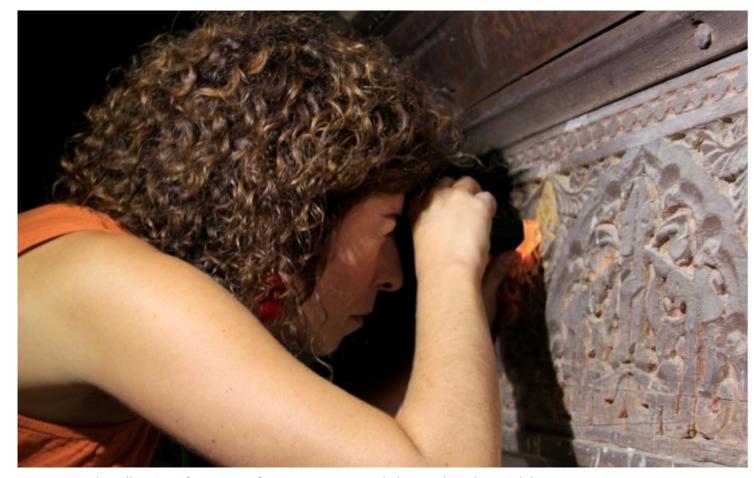
Fig.32 Sample collection of pigments for microscopic and chemical analysis in laboratory

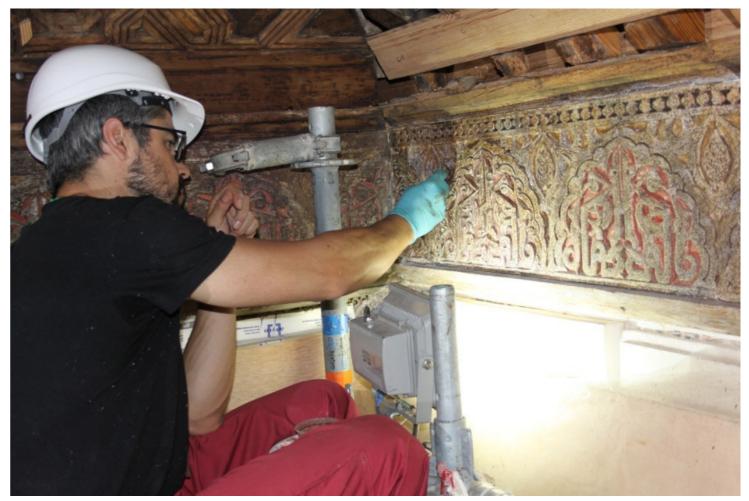
Fig.33 1846 restored plaster frieze chromatic reintegration with the other three Nasrid wooden friezes

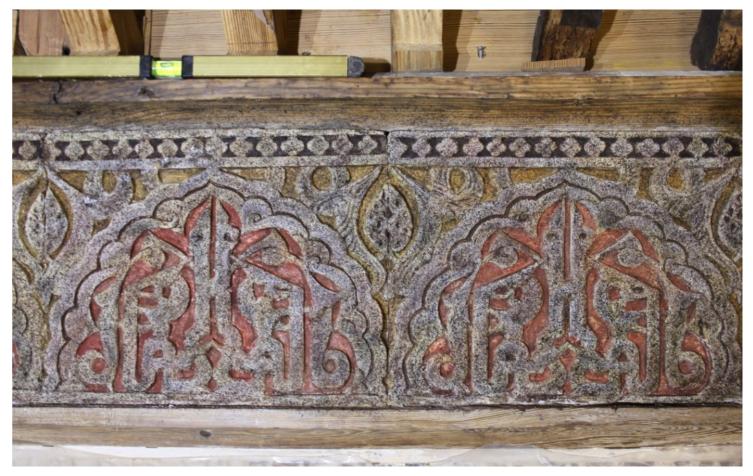
Fig.34 Cleaning of the last coating on the wooden frieze applied by the 1930 intervention with a laser of 1064 nm wavelength

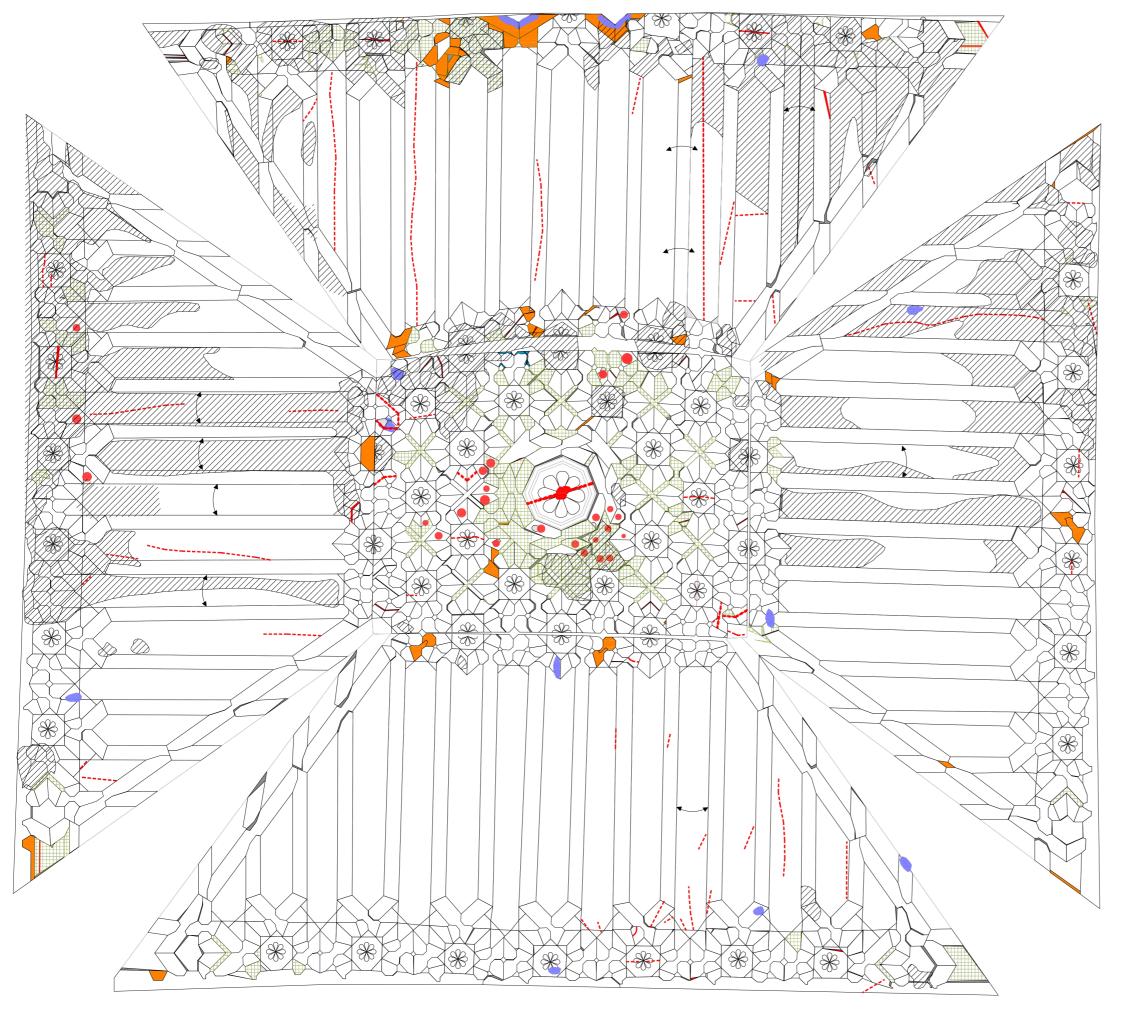
Relocation of non-structural elements on their original position Cracks and breaks repair Finishing differentiation of newly added elements Elimination of former inadequate repairs Biocid treatment and support consolidation Cleaning and treatment of rusted elements (nails) Warped elements morphological recovery Wooden support replacement 1 * + 1 1 1 1 1 1 1 + Analysis of the original shape recovery Vertical shape recovery Horizontal shape recovery

Fig.35 Timber framework restoration interventions mapping

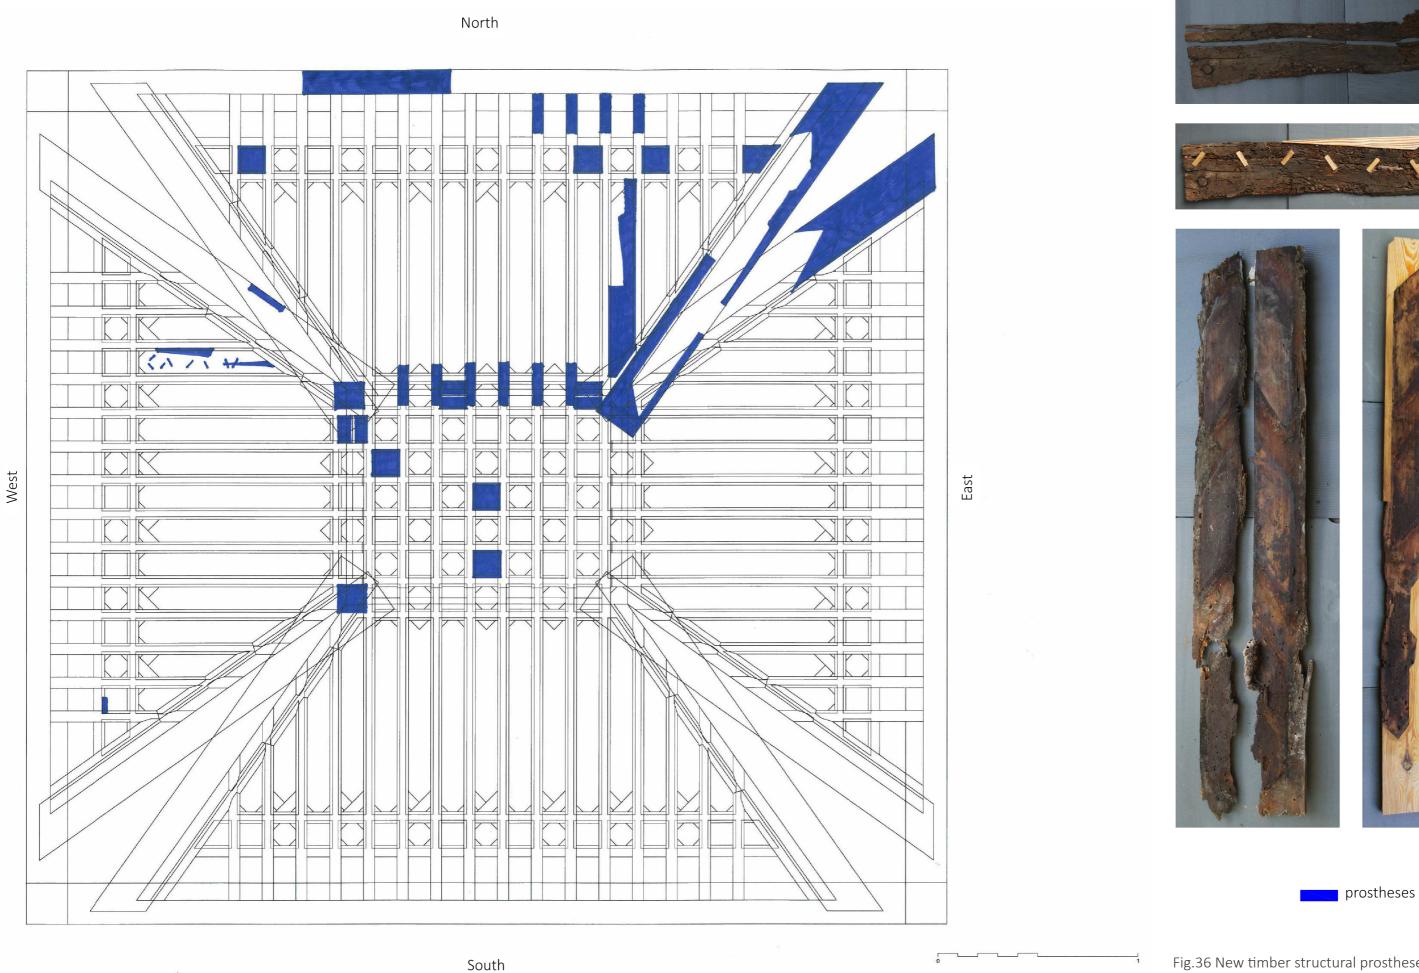
Fig.36 New timber structural prostheses mapping

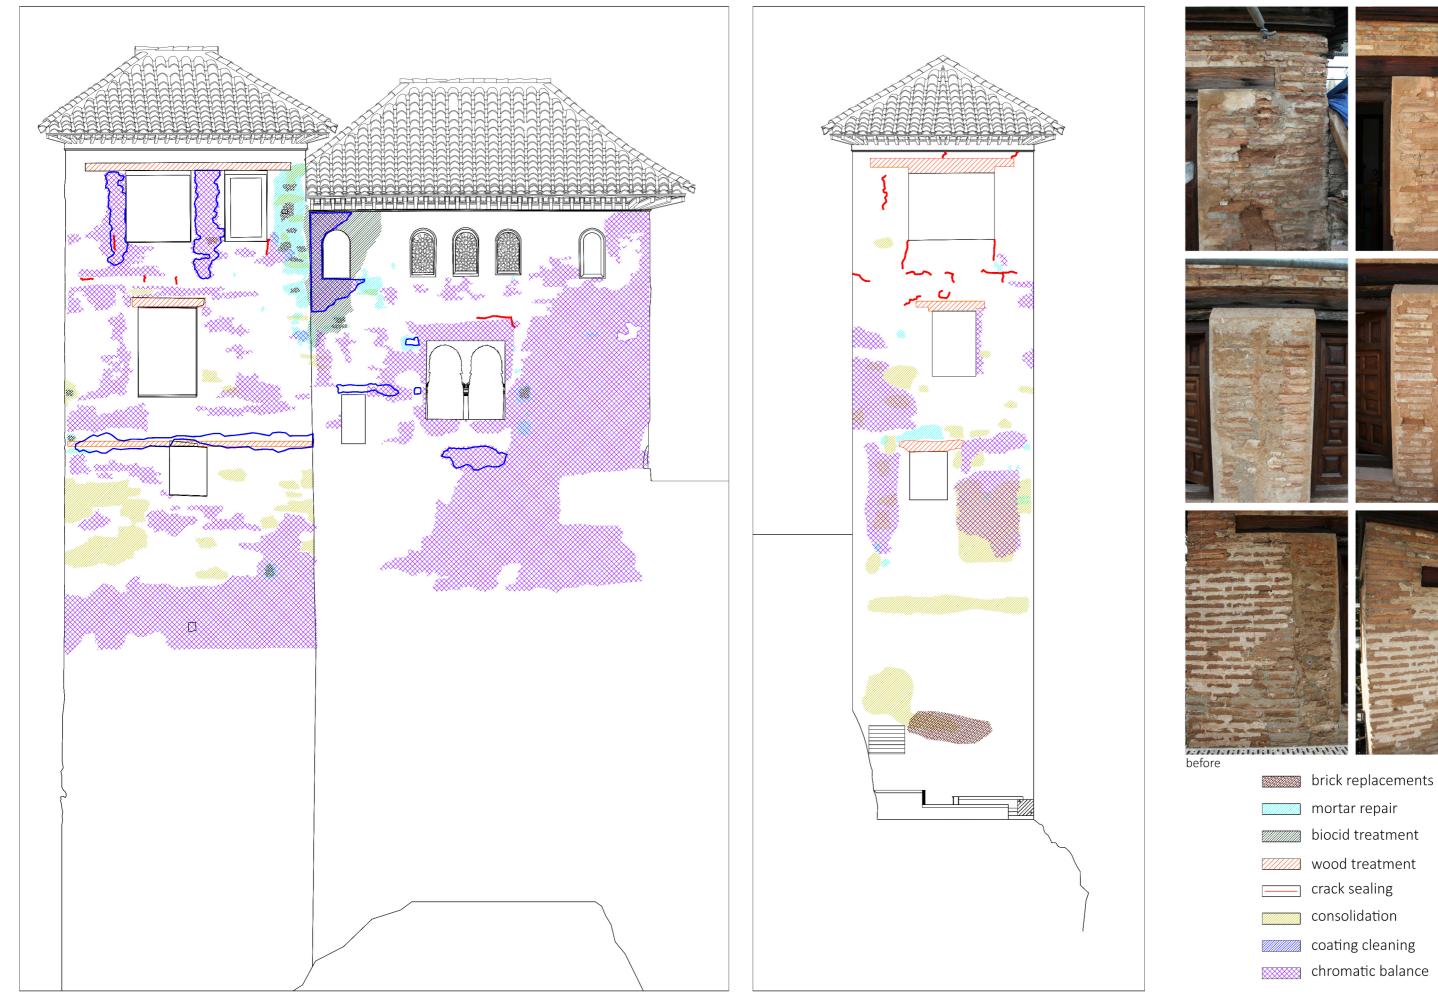
Fig.38 Interventions of the external brickwork walls. North-east and south-east elevations

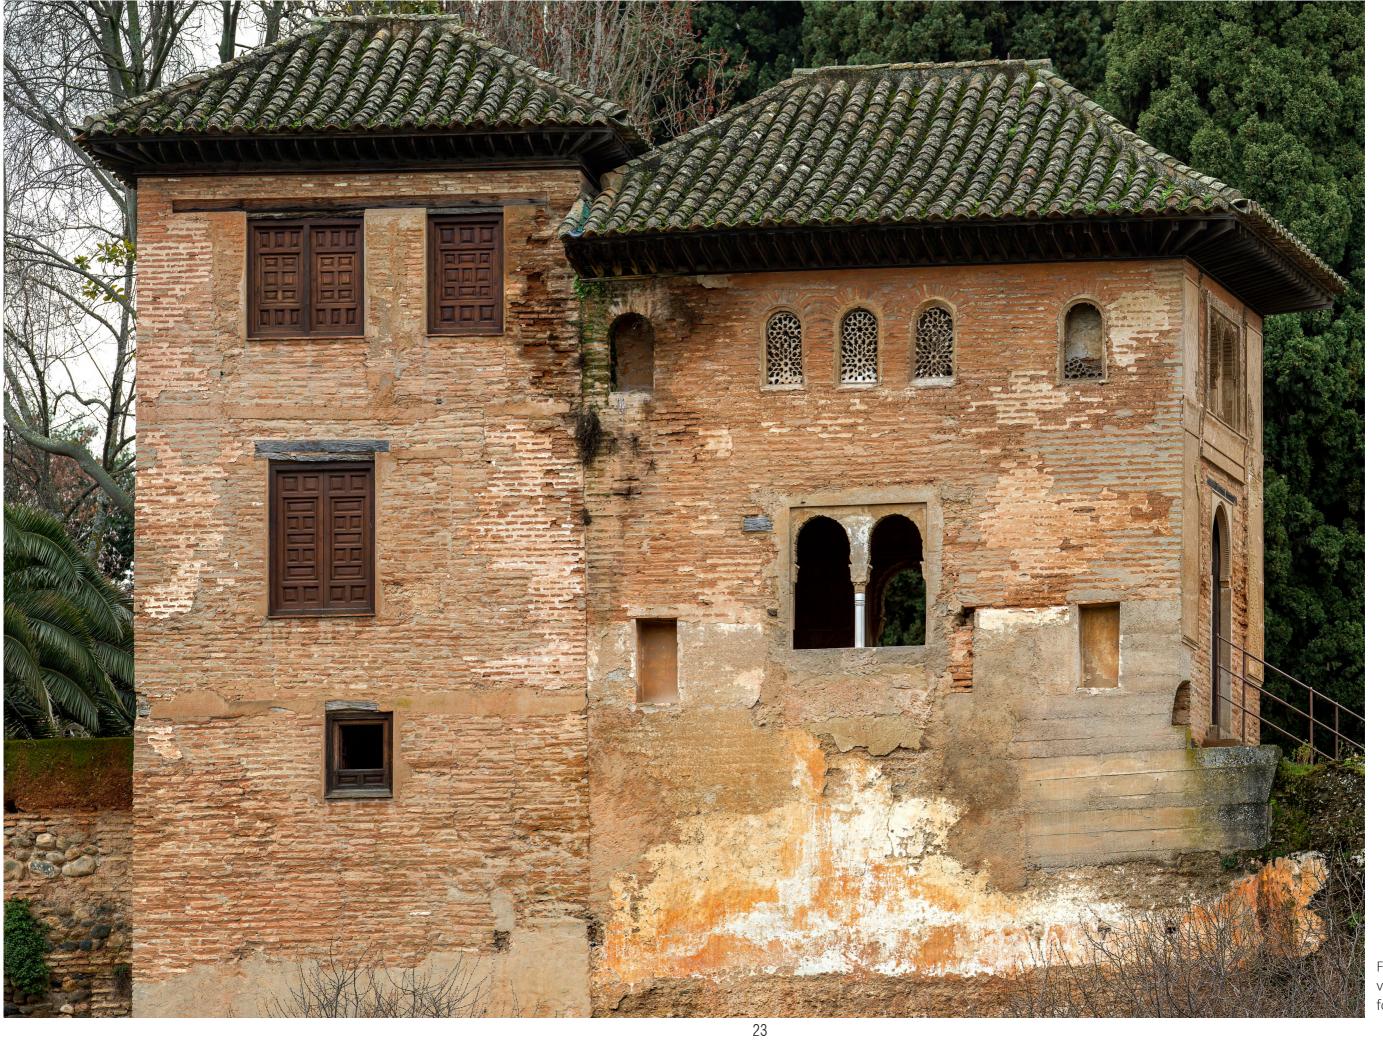
Fig.39 North-east elevation. Condition before restoration.

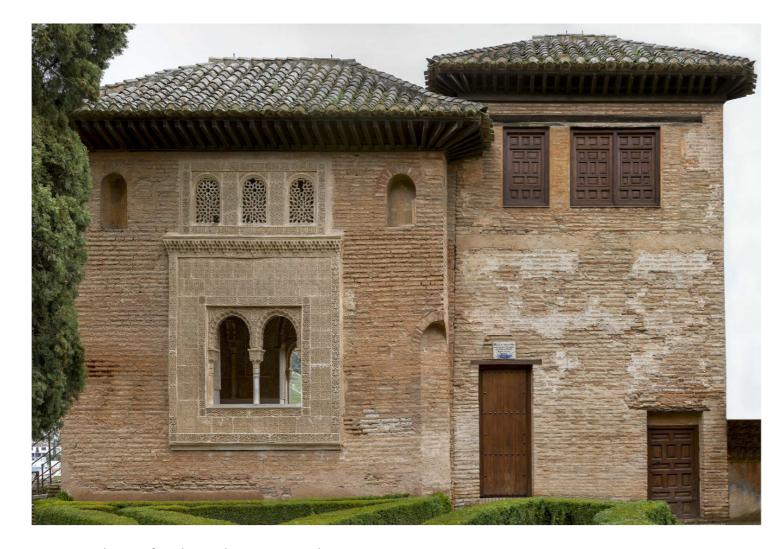
Fig.40 South-west façade condition prior to the restoration

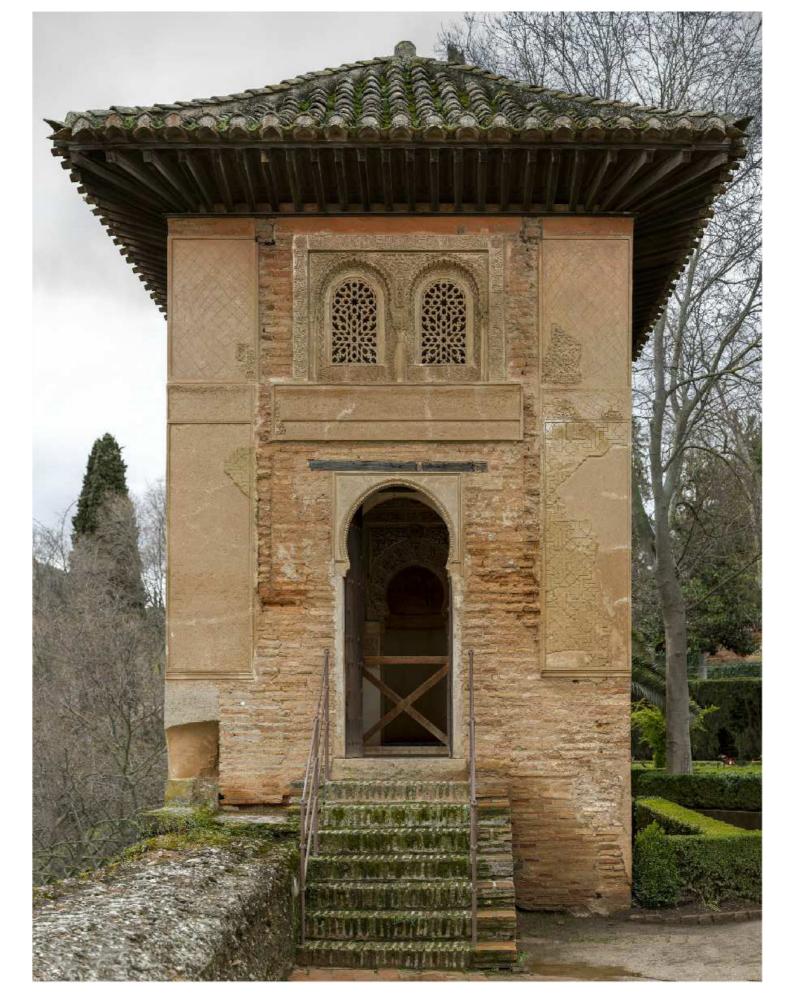
Fig.41 North-west façade condition prior to the restoration
