The Restoration of the Oratory of the Partal Palace and the House of Astasio de Bracamonte in the Alhambra of Granada Granada, Spain

Dr. Federico Wulff Barreiro Lecturer of Architecture and Urban Design Welsh School of Architecture, Cardiff University

RESEARCH STATEMENT

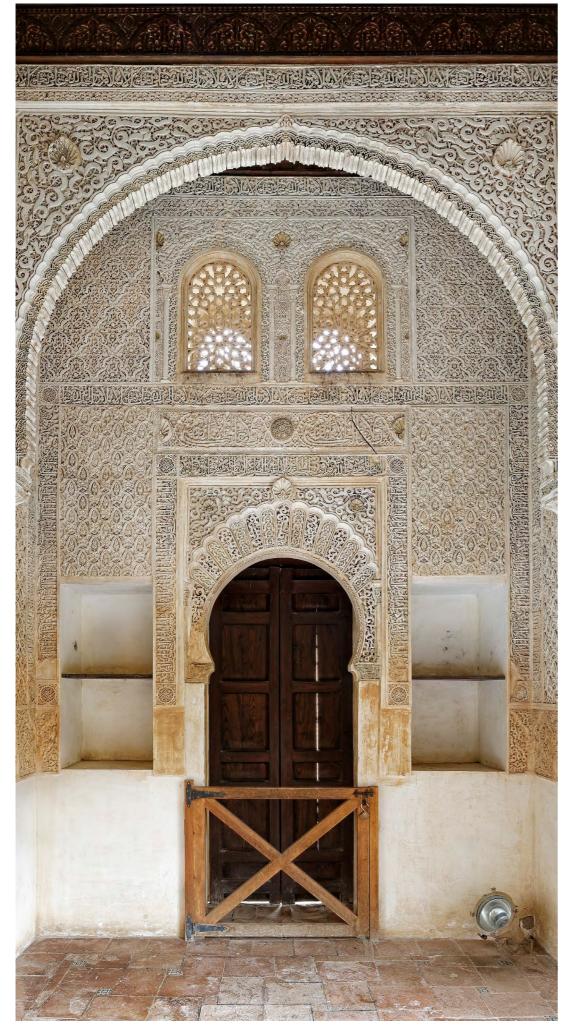
Fig.42 North-west internal elevation. Condition prior to the restoration

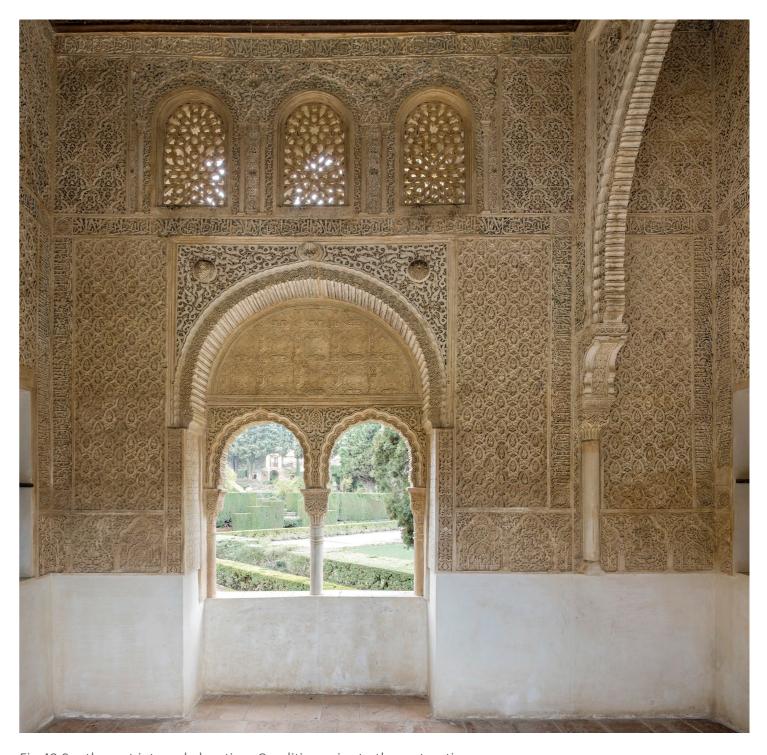
Fig.43 South-west internal elevation. Condition prior to the restoration

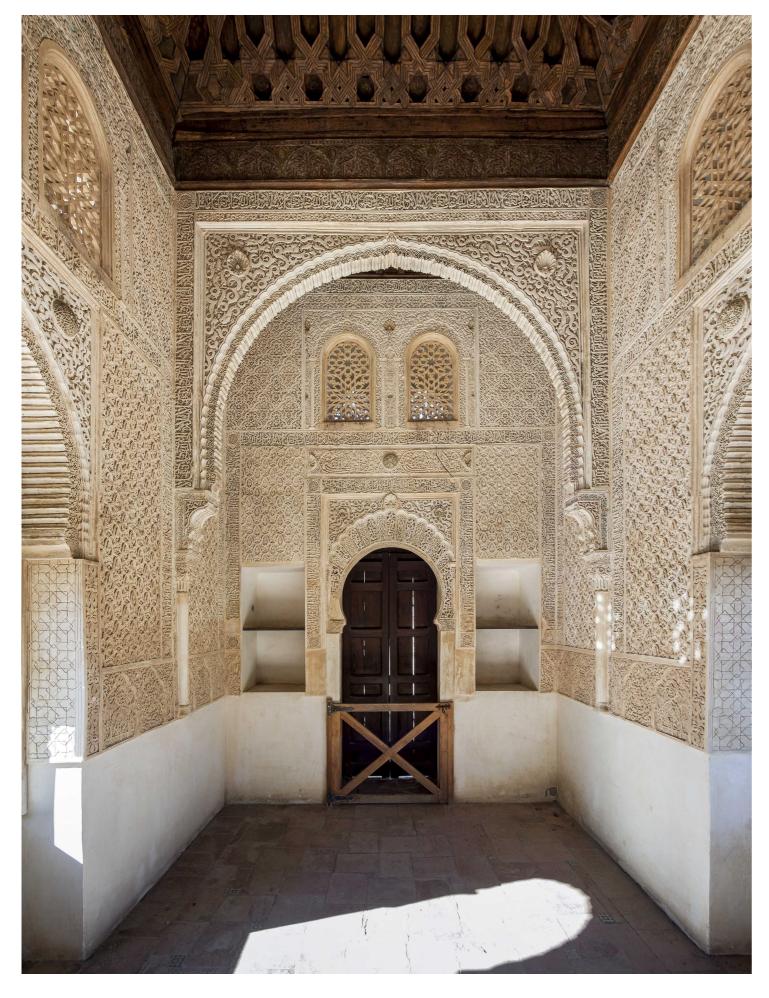
Fig. 44 (*above*) South-west inner elevation facing the Partal Palace gardens after the restoration

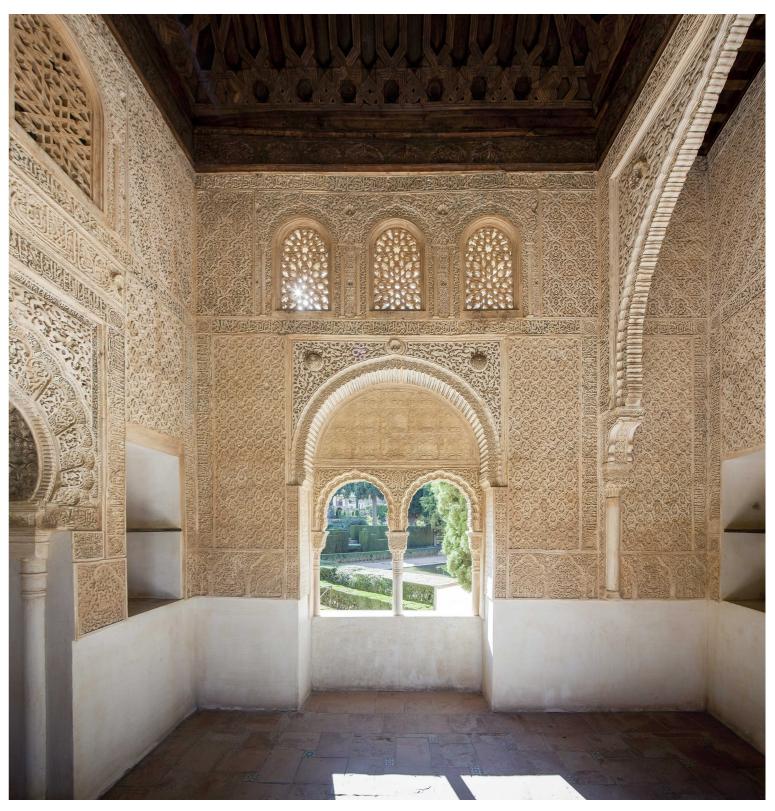
Fig. 45 (*left*) North-west access inner elevation after the plasterwork restoration

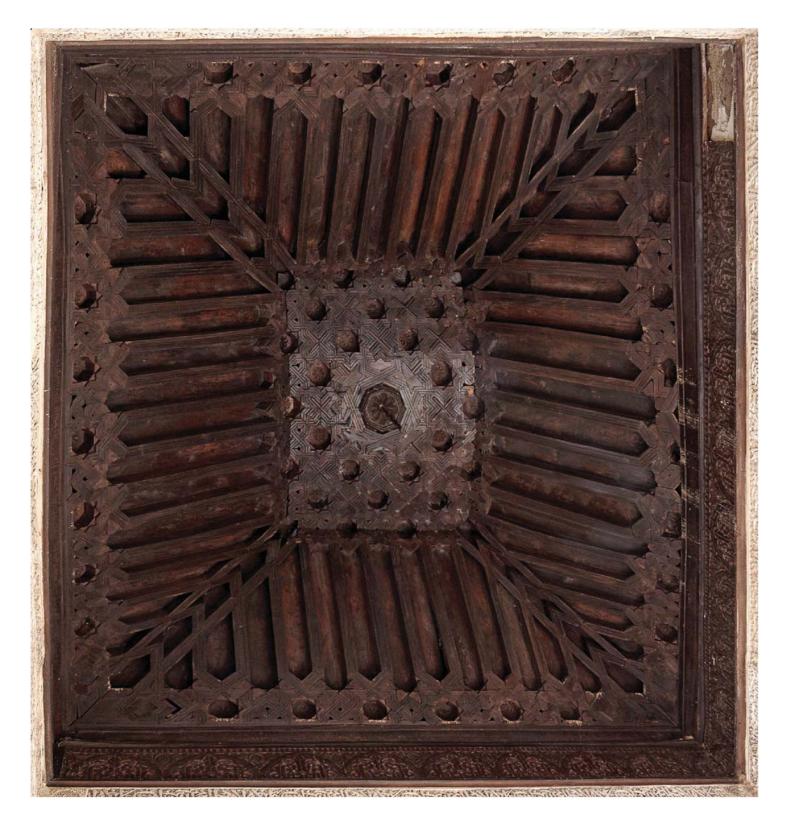
Fig. 46 The original Nasrid decorated timber frame (*almizate apeinazado*) that covers the main praying space of the Oratory before the 2013-2015 restoration. (Alhambra Council 2015)

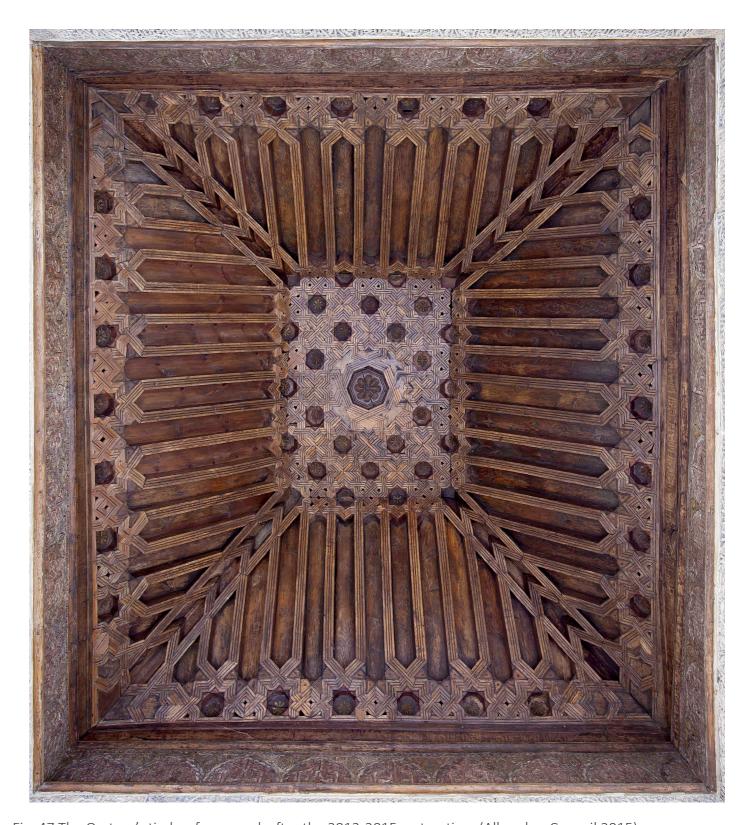
Fig. 47 The Oratory's timber framework after the 2013-2015 restoration. (Alhambra Council 2015)

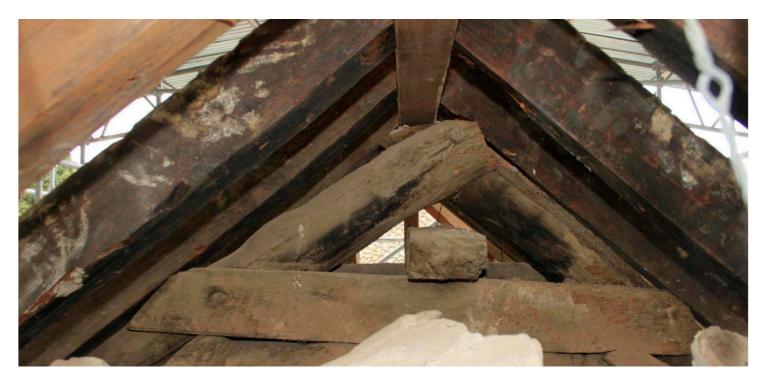
were found within the confined space between the external roof's structure and the internal decorated timber framework, and consisted in the remains of a couple of rafters of white poplar wood (Populus Alba) formed by logs and by a double false collar tie embracing them. They have been consistently dated by carbon-14 with a 95,4% probability in 1280 AD - 1400 AD, with an additional 68.2% probability dating distributed into 1290 AD - 1320 AD (26.5%) and 1350 AD - 1390 AD (41.7%), (The Angström Laboratory / Tamdem Laboratory, Uppsala University 2014, 3). This dating indicates that these structural elements were most probably part of the original Nasrid elements of this roof structure. Roof structures formed by very simple rafters made of logs similar to these remains were a common solution in the Nasrid carpentry, as it has been evidenced in the Palace of Genil (Alcázar Genil) in Granada, built in 1218 during the Almohad rule (Malpica Cuello 2005, 140) and in the Nasrid roof structure of the Royal Hall of St. Dominic (Cuarto Real de Santo Domingo), also in Granada (Rodríguez Trobajo 2014, 2).

Fig. 48 Remains of the original Nasrid upper roof's structure: two rafters and a false double collar tie (Artyco 2015). These have been dated by a Carbon-14 test between 1290 and 1400 with a 95.4% probability (Upsalla Universitet 2014)

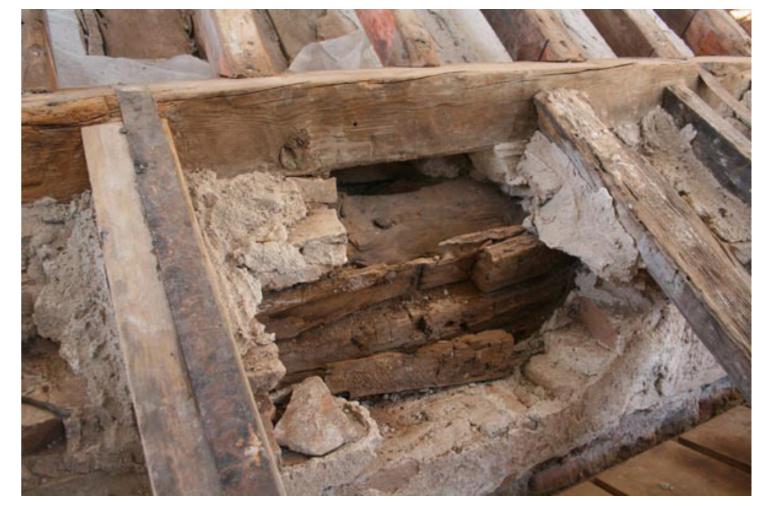
Fig. 49 Remains of the original Nasrid timber wall plate, with an unusual shape compared to its *mudéjar* equivalents (Artyco 2015)

As evidenced in the hypothetical restitution of this original Nasrid structure, the upper roof structure could have shared its support on this referred wall plate with the inner timber framework (Rodríguez Trobajo 2014, 2; Nuere 2014, 13). The cut found on the external side of the lower end of the best conserved Nasrid rafter could have been the support of a disappeared shorter rafter that might have formed the original roofs' eaves. The interpretation of this constructive solution is not only grounded on the interpretation of the cut on the upper side of this Nasrid rafter, but also on the particular shape of the referred original wall plate.

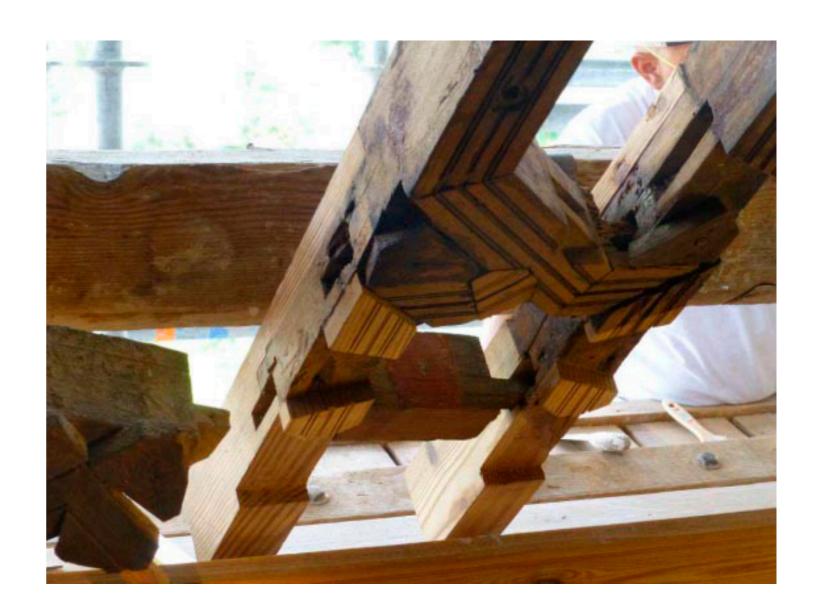
Fig. 50 Discovery of new fourteenth century Nasrid carpentry techniques, distinctive in their sophisticated solutions from their contemporary Christian-*mudéjar* carpentry (Artyco 2015)

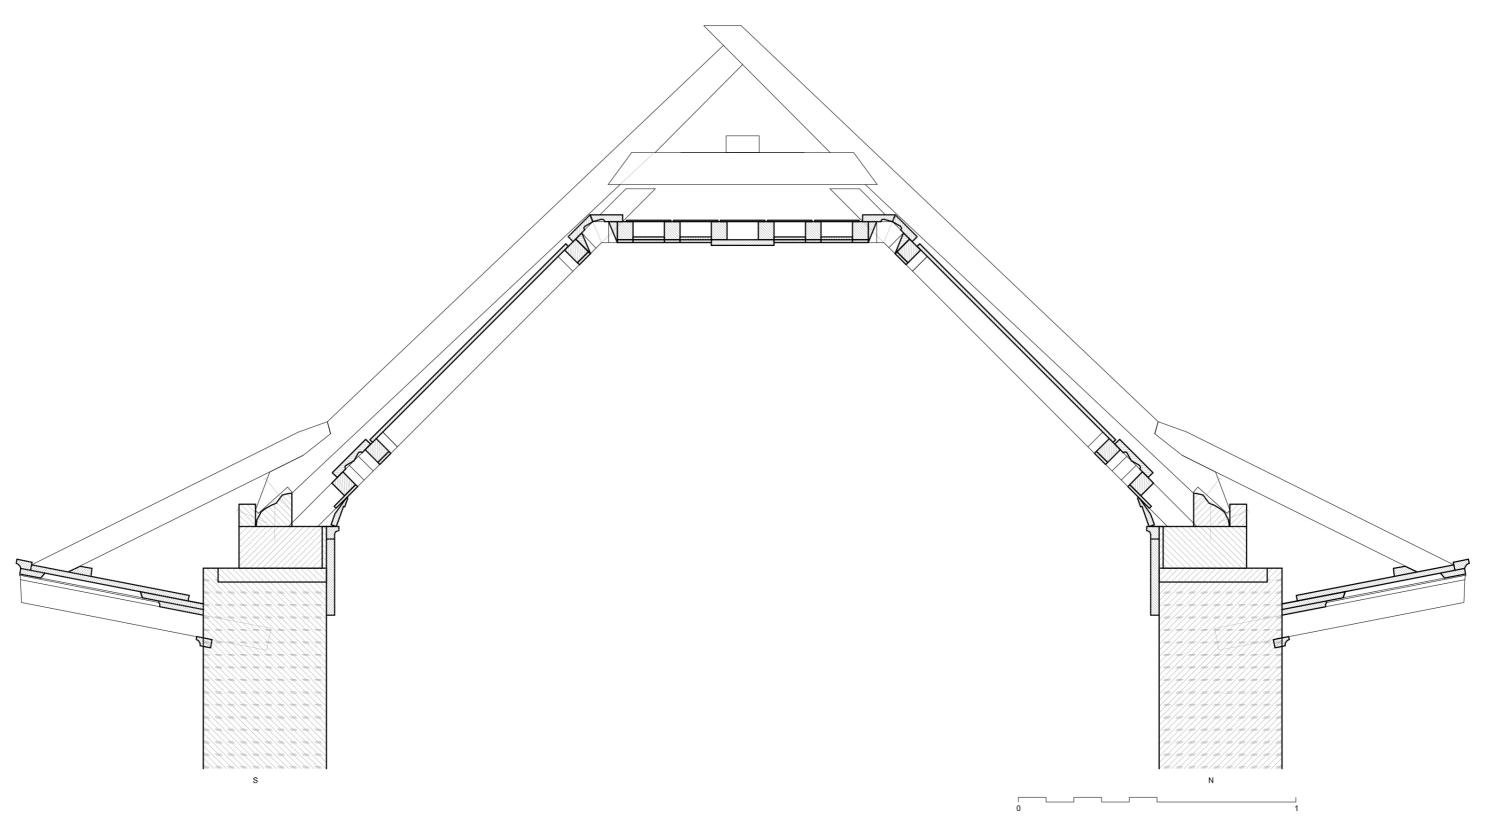
Fig. 51 Hypothetical restitution of the original Nasrid structure of the roof, based on the site survey of the restoration company Artyco. The hypothesis was that the three elements found between the inner timber framework and the upper roof's structure would have belonged to the original Nasrid roof structure. The cut found on the lower end of the best conserved Nasrid rafter might have been the support of a disappeared shorter rafter that would have formed the original roofs' eaves (Artyco 2015)

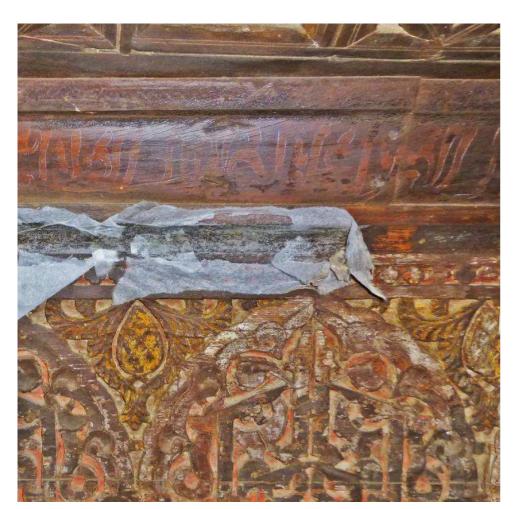
This inscription only conserves the marks of its primer coat, but unfortunately has not retained its original pigments. This repetitive epigraph runs along all the perimeter of the upper board (alicer) of this wooden frieze. The arabist of the University of Granada (UGR) José Miguel Puerta Vílchez has studied and transcribed this epigraphic inscription and has revealed that is a Surah, a Quran's versicle (Puerta Vílchez 2011).

Fig. 52 Previously unknown epigraphic inscription was discovered on the upper board (alicer) of the wooden frieze (arrocabe). The interior carved part of the timber frieze also preserved original pigment remains.

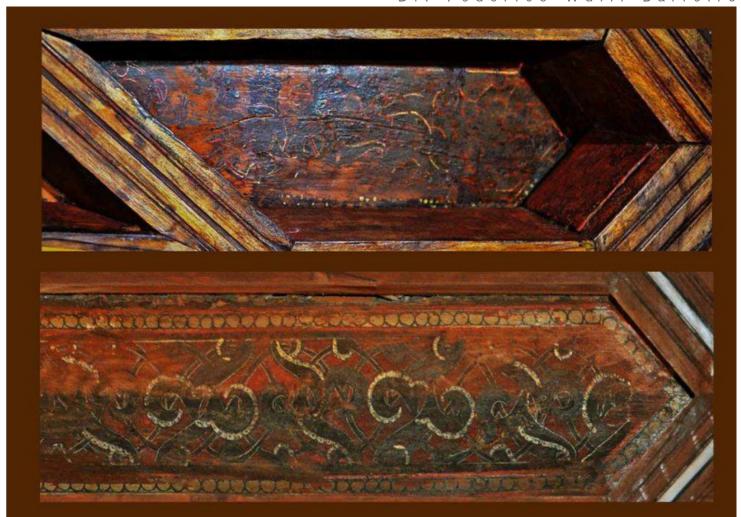
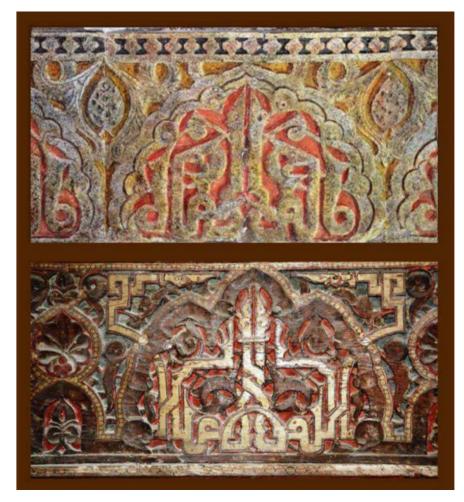
Fig. 53 (above) The picture above shows the Nasrid painted decoration on a timber plank covering the space between two rafters on the north-west slope. The picture below corresponds to the ceiling of the Plasterwork Hall (Salon del Yeso) of the Royal Palaces of Seville, contemporary to the Oratory. The commonalities between these two decorative motives are striking (Nuere 2014).

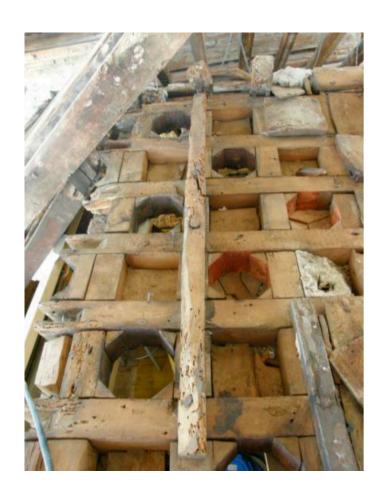
Fig. 55 The external side of the upper horizontal plane of the timber framework (*almizate*) has revealed how its central space was initially conceived as a regular pattern of small octagons supporting the eight-point stars apparent on the internal side.

The current second Nasrid design version of this area with the large central octagon is visible in this picture by looking through this pattern of octagonal spaces. The nogging from the central octagonal motive is visible behind the squared space (2nd row from below, 2nd column from the left) (Rodríguez Trobajo, 2014, 3)

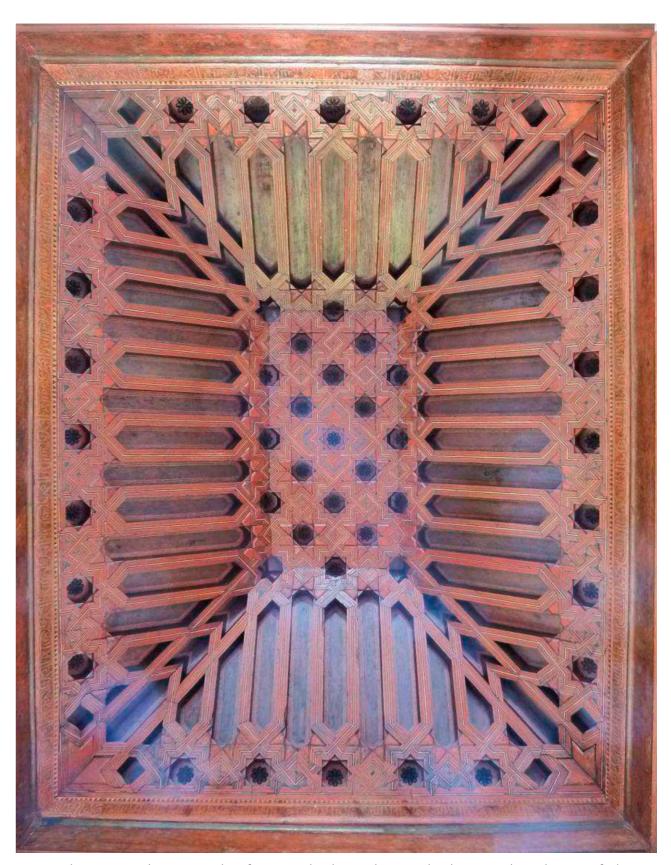
Fig. 56 The Paintings' House timber framework, also in the Partal Palace, attributed to Yusuf I (1333-1354). The regular eight-point star decorative pattern of its upper horizontal plane (*almizate*) is almost identical to the first version of the Oratory's timber framework, as shown in Fig. 55 (Wulff 2012).

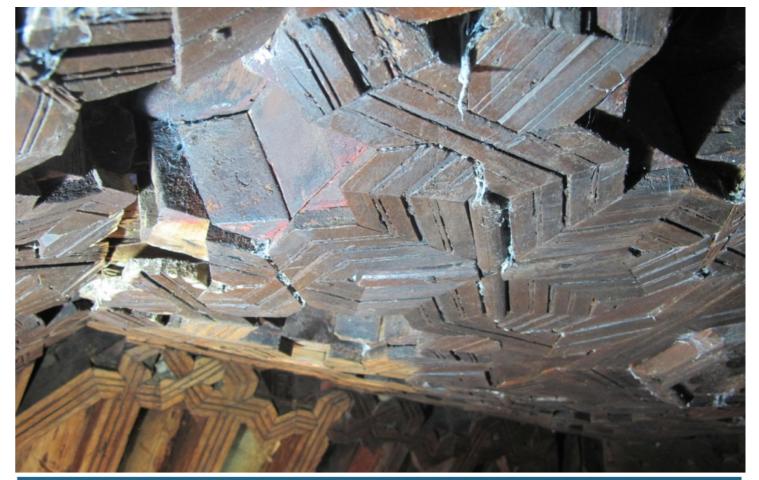
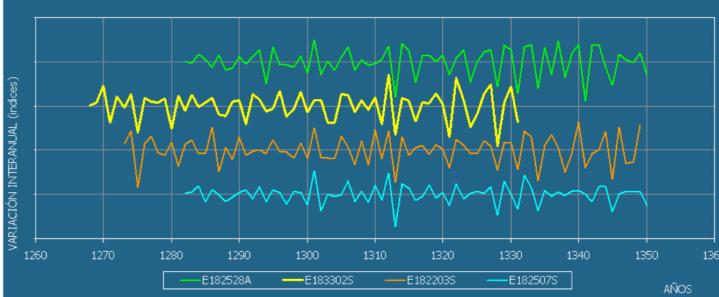
Fig. 57 & 58 New dendrochronology and 14C dating Timber cut in Autumn / Winter of 1332 (Rodríguez Trobajo, INIA 2014), conceived and initiated under sultan Ismai'l I (1314-1325) and not under sultan Yusuf I (1333-1354), who finalised the works.

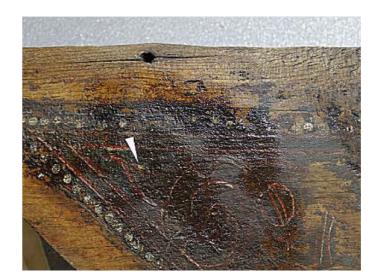
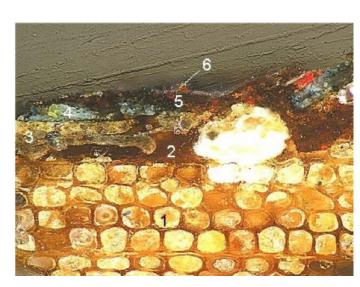
The AOA-9 sample, although very degraded by successive cleaning processes and varnish treatments, evidences a very thin tin glaze (3) over which a vermilion decoration was applied (4), (Fig.59). In the case of AOA-12 sample (Fig.60), the application of a similar tin coat is more apparent. It has been implemented in two layers; the wooden support still conserves part of these metallic remains (3). The blue decoration is rich in indigo, with some orpiment additions (4). The painting technique of this Nasrid decoration is tempera-based, applied to the wooden support after a coating preparation based on shellac and organic glue.

Fig.59 AOA-9 sample location (left) and the 300x microscopic analysis (right) (Parra Crego 2014; Artyco 2015)

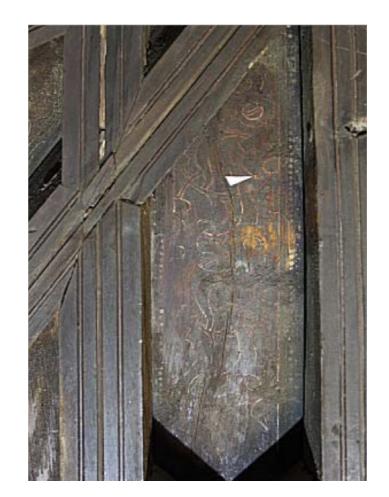
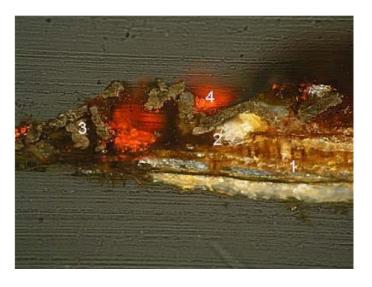
Fig. 60 AOA-12 sample location (*left*) and a microscopic picture evidencing the different layers, 300X (*right*) (Parra Crego 2014; Artyco 2015)
