## Retrofitting the UK's half-timbered heritage

Retrofitting historic timber-framed buildings is a complex challenge, but one which must be addressed in order to ensure the future of a large part of the UK's housing stock

**Author:** Chris Whitman

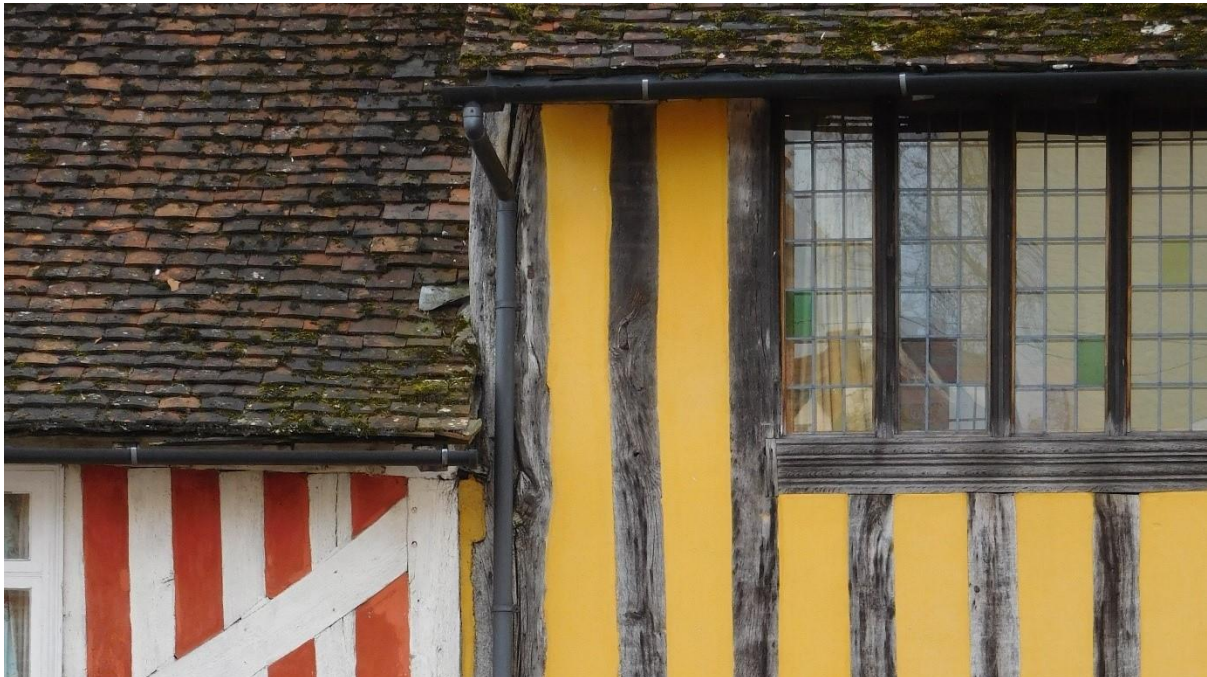
Figure 1. C15th timber framing, The Manor House (left) and 53 Church Street (right), Lavenham, Suffolk, © Whitman

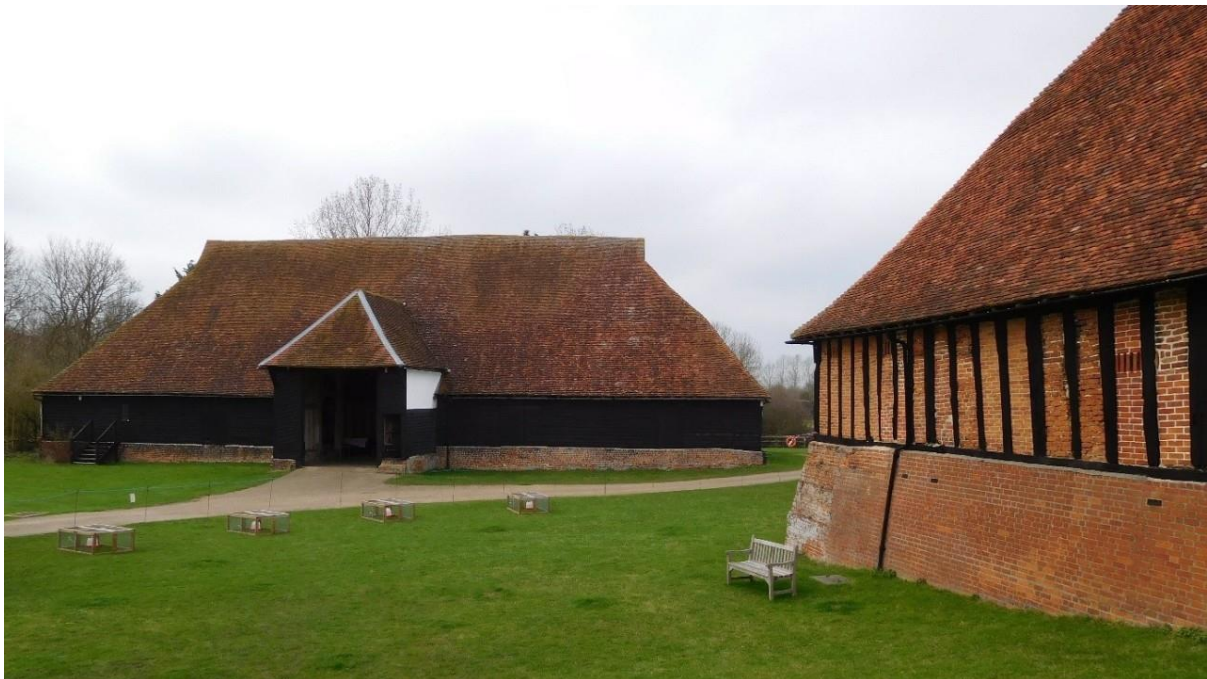
Crossing Temple Barns, Essex. Wheat Barn c.1220 (left) and Barley Barn c.1280 (right), © Whitman

Timber-framed construction as we recognise it today appears to have emerged around the late 12<sup>th</sup> century, with the barns at Cressing Temple being two fine early examples. Two separate construction techniques developed in Britain simultaneously;

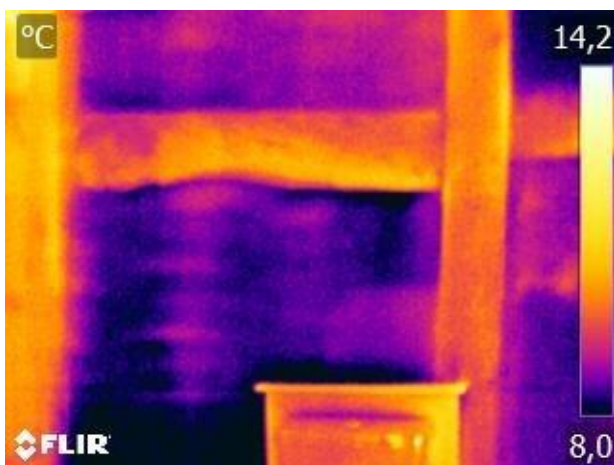
Thermographic image showing wattlework infill panel, © Whitman

Traditionally the infill panels may comprise of wattle-and-daub, mud-and-stud, lath and plaster, brick nogging, stone, or flint. Often it is initially difficult to ascertain the material without opening up the wall construction. Here the use of thermal imaging can be of assistance, as this may show up the weave of wattle work or mortar joints between masonry. Reviewing the listing descriptions of all timber-framed buildings in the UK, many are simply described as plastered, 18% are described with brick nogging and only 2% are noted as having traditional earthen infills such as wattle-and-daub or mud-and-stud. The protection and retention of any surviving examples of earthen infill is therefore of great importance.

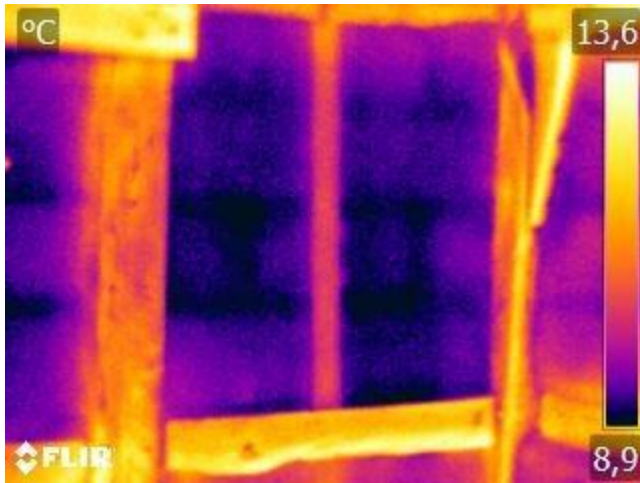
Thermographic image showing blockwork infill panel, © Whitman

Where the historic infill is beyond repair, has already been replaced with inappropriate modern materials, or is required to be removed to facilitate repairs to the timber frame, there is an opportunity to replace them with materials with a higher thermal performance. Modern infill materials can provide improved U-values, but only if well-detailed and properly installed. Again, the junction between infill material and historic timber frame is a critical detail and, if not well-designed and constructed, can negate any improvements brought by the insulation.
