**MONITORING RECOVERY AFTER EARTHQUAKES  
THROUGH THE INTEGRATION OF  
REMOTE SENSING, GIS AND GROUND OBSERVATIONS:  
THE CASE OF L'AQUILA (ITALY)**

**EEFIT RESEARCH GRANT 2013  
JANUARY, 2014**

**MSc. DIANA MARÍA CONTRERAS MOJICA**

**INTERFACULTY DEPARTMENT OF GEOINFORMATICS – Z\_GIS**

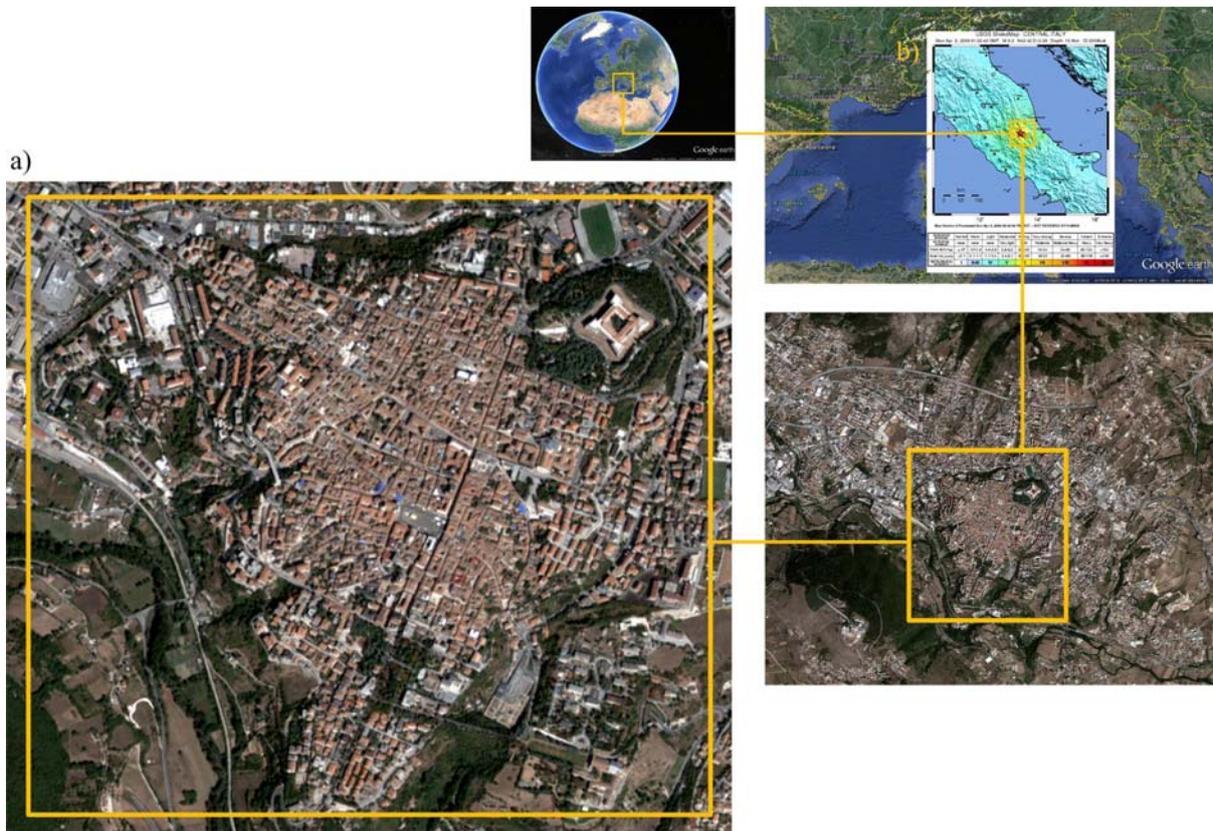
Figure 1-1 Case study area: L'Aquila (Italy).

a) Location. Source: *Google Earth – Quickbird/Digitalglobe*, distributed by *European Space Imaging* on 11 September 2011; and b) Map of the ground motion intensity during the earthquake in L'Aquila (Italy). Sources: USGS.

On April 6<sup>th</sup> of 2009, an earthquake with a magnitude of 6.3  $M_w$ , at a depth of 10 km and at an epicenter located 34 km to the Southwest of the city of L'Aquila in Italy struck the city (population 728.000). L'Aquila is the capital of the province by the same name, and a major center of the *Abruzzo* region. Its location, and the map of ground motion intensity during the earthquake are displayed in figure 1-1.

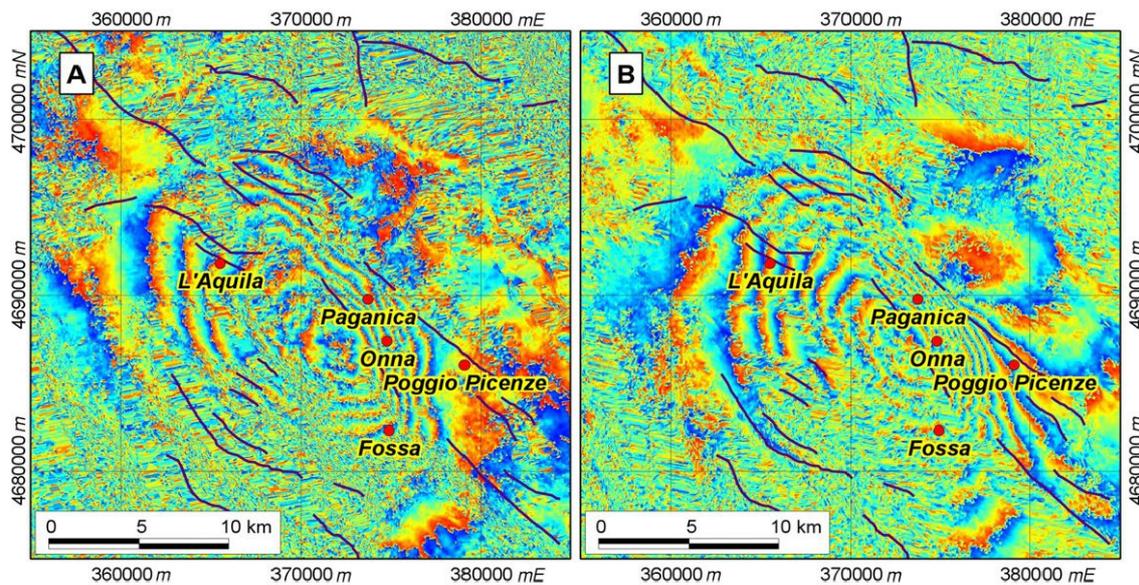
Figure 2-3 ENVISAT ASAR interferograms of the L'Aquila area.

(A) the ascending (2009/04/15-2009/03/11) and (B) descending (2009/04/12 - 2009/02/01) pairs in the UTM coordinate system (zone 33). Major faults are shown in black lines. Goudarzi, M. A., et al. (2011). "Surface deformation caused by April 6th 2009 earthquake in L'Aquila (Italy): A comparative analysis from ENVISAT ASAR, ALOS PALSAR and ASTER." *International Journal of Applied Earth Observation and Geoinformation* **13**(5): 801-81.[33].

separate pairs of *ENVISAT ASAR* and *ASTER* optical image data sets were used, and horizontal displacements un Range/Azimuth and in West-east/south-north directions were also studied. They found a maximum of 28.1 cm subsidence in LOS direction on the descending interferogram of the *ENVISAT ASAR* data set to the north-west of Onna village, figure 2-3 shows both, the ascending and the descending interferograms. The post-seismic relaxation occurred after April 7<sup>th</sup>, towards the South and South-east of the main epicentre. The horizontal displacement was not significant on the surface, as it was observed in the results from SCT [33].

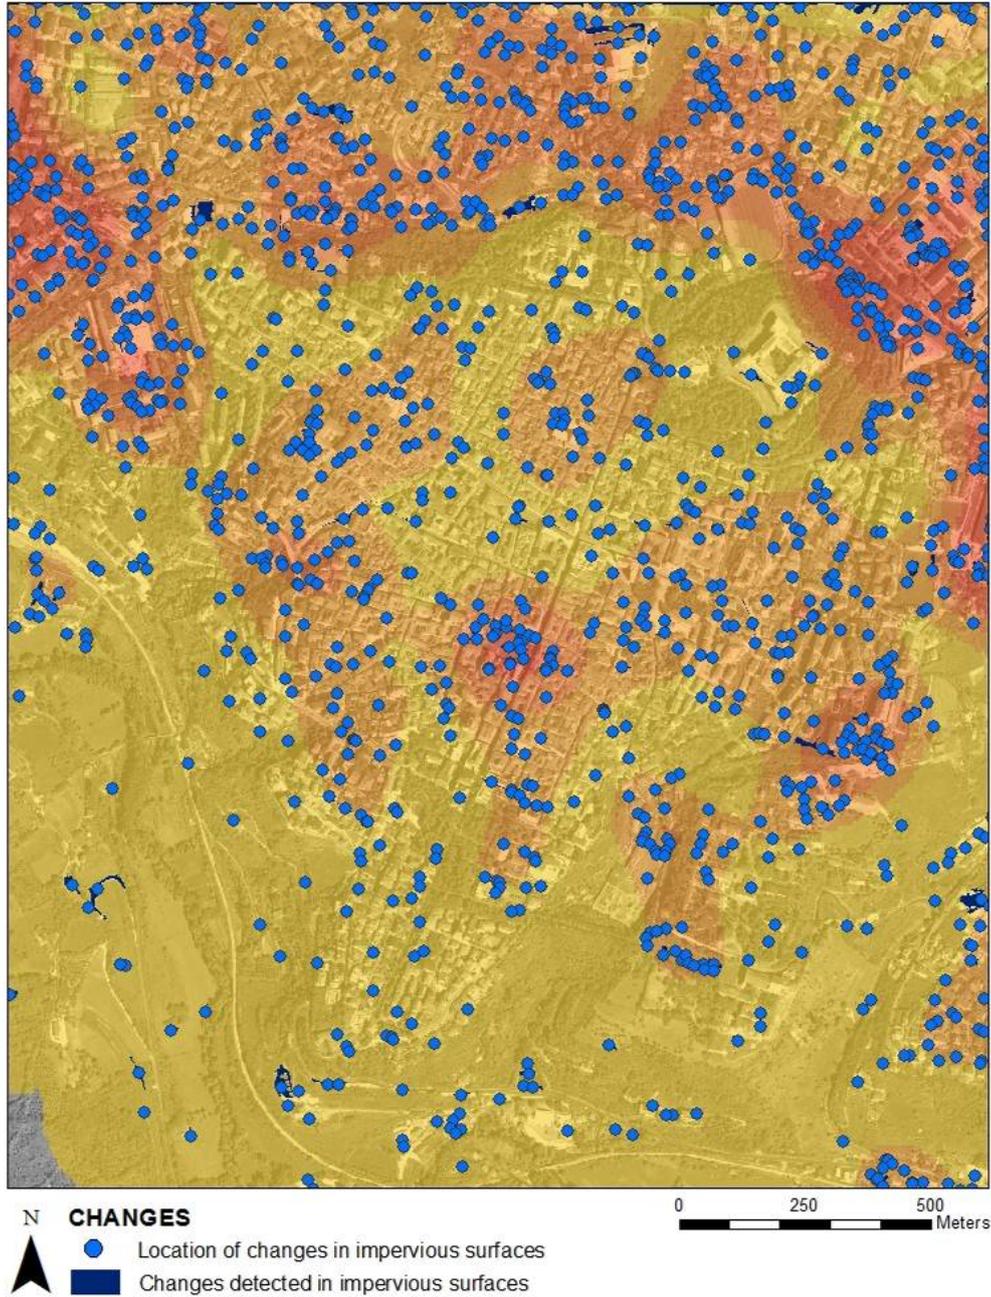
Figure 4-4 Heat-location map of changes in impervious surfaces after the earthquake in L'Aquila (Italy) between 2009 and 2011.

Moreover, 1775 changes in impervious surfaces were detected as it is displayed in figure 4-4. Changes consist of debris removed, temporary shelters removed, earthworks, parking areas removed, new pathways, and so on.

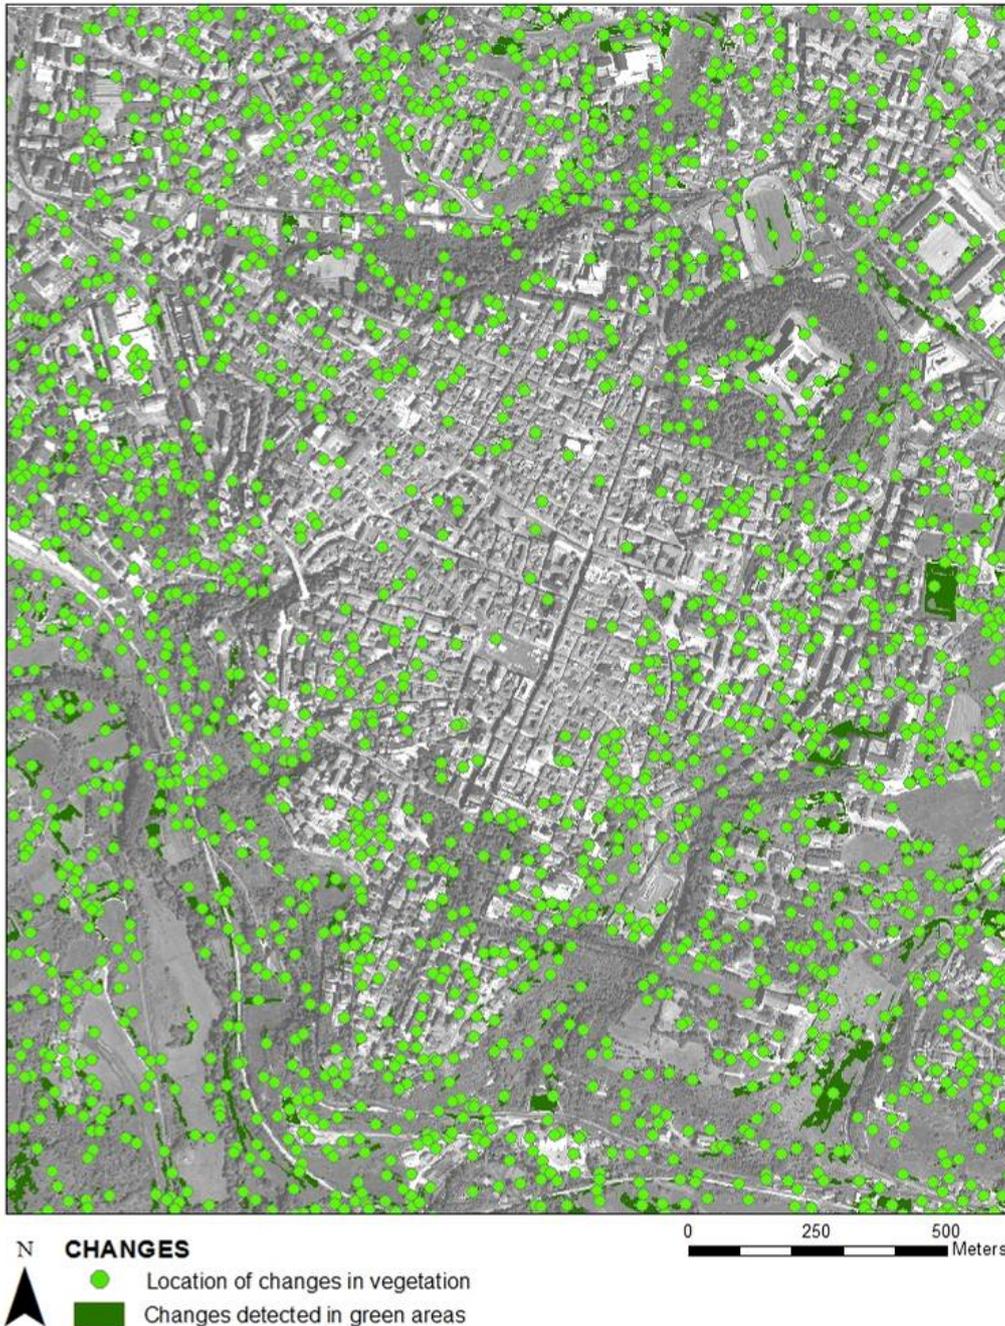
Figure 4-5 Map of changes of changes in vegetation after the earthquake in L'Aquila (Italy) between 2009 and 2011.

Regarding vegetation 3556 changes were identified, and depicted in figure 4-5. Changes in vegetation should not be mapped as a heat map since it is not single tree analysis or similar.

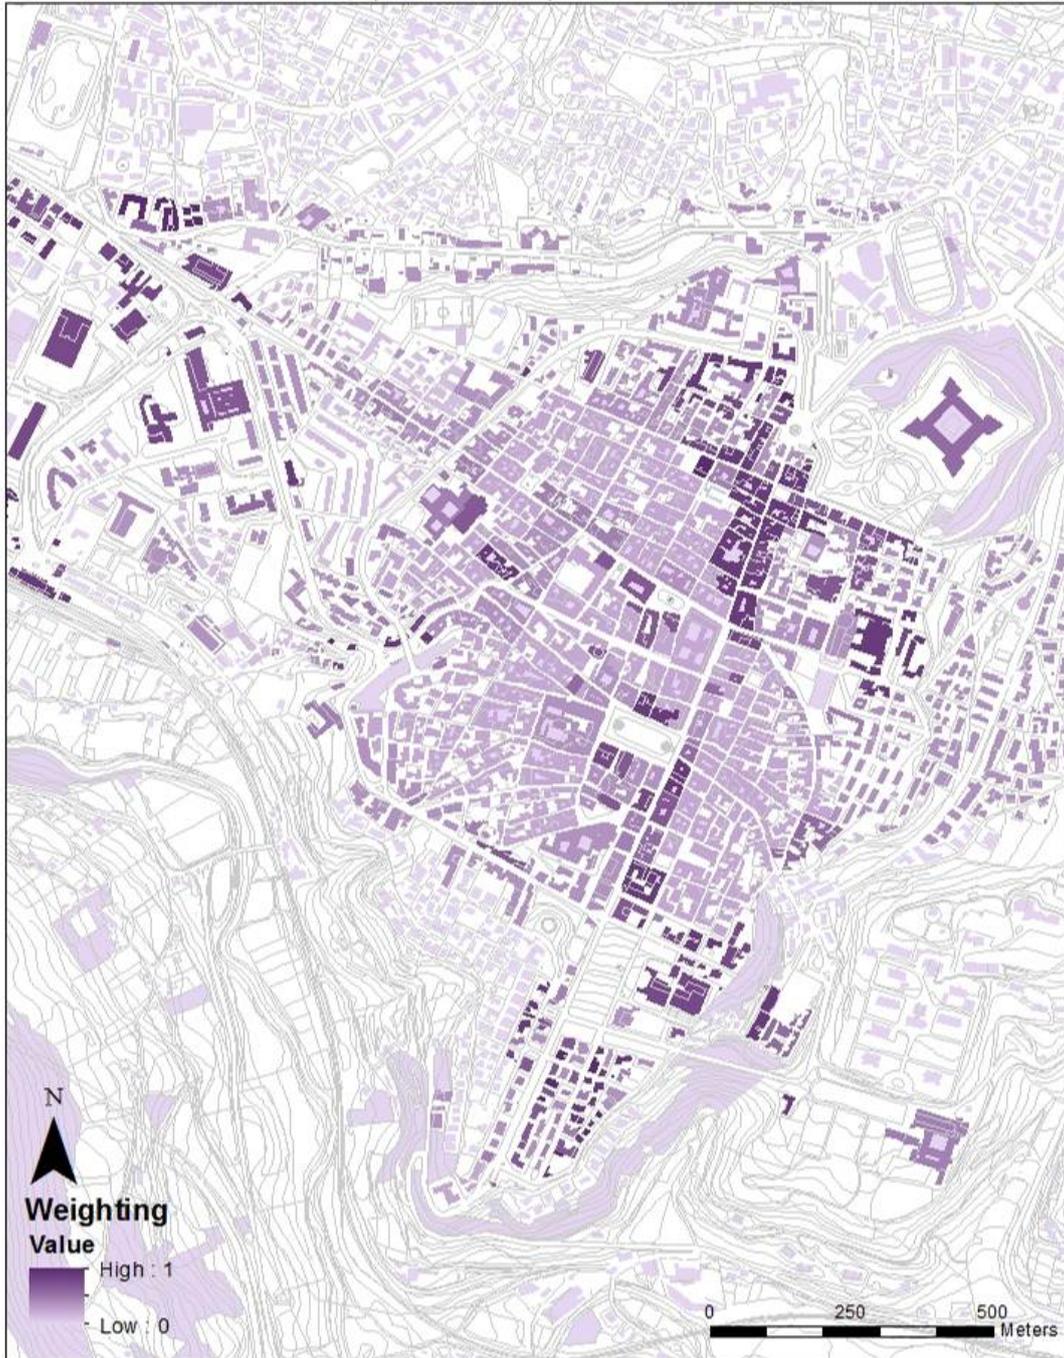
Figure 4-9 Hotspots of recovery identified by ground observations in the city center in L'Aquila (Italy) in 2012.

remote sensing tools, and techniques. In this case, the map was produced based on the data collected through ground observations done on fieldwork 2012.

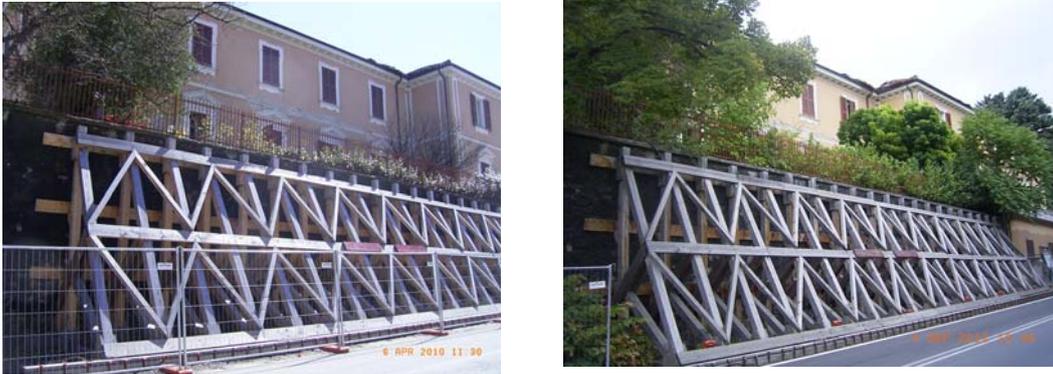
Figure 5-2 Foliage near to buildings on the road via XX Settembre in L'Aquila (Italy).  
A) April 2010, and b) September 2012.

Another problem lies in the season of the available image, which is an essential aspect regarding change detection in buildings and vegetation. Regarding buildings, the seasonal difference between the *Quickbird* data from 2006 (September) and the *Quickbird* data from 2009 (April) caused some problems in shadow change detection, to determine the location of collapsed buildings, using a semi-automated method [25] during the relief phase. The different foliation of the vegetation, as it is possible to observe in figure 5-2 a) and b), causes some problems in change detection of buildings, which could be tackled by introducing rules for the

detection of vegetation shadow (proximity and direction of vegetation and shadow objects), but still some false positives are wrongly detected [25].

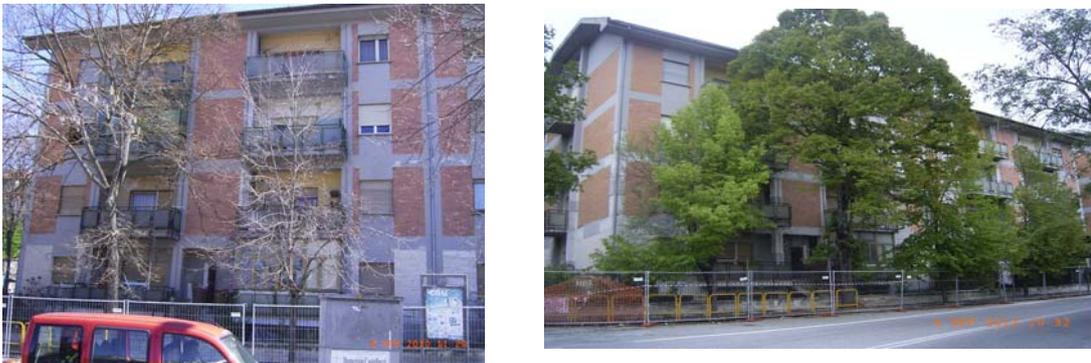
Figure 5-3 Difference in foliage on the road Via XX Settembre in L'Aquila (Italy).  
A) April 2010, and b) September 2012.

The same concern applies to change detection in vegetation. The *Quickbird* data from 2006 and 2011 was taken in September (late summer), while the *Quickbird* data from 2009 was taken in April (Spring), where the trees do not have foliage yet, as it is portrayed in figures 5-2 a) and 5-3 a). Therefore we considered that vegetation change detection is only meaningful for the images from September 2006 and 2011.
