Low Energy Retrofit of Historic Timber Framed Buildings in the UK

SBH2017 - RESEARCHER LINK workshop: Sustaining Built Heritage

Low Energy Retrofit of Historic Timber-Frame Buildings in the UK

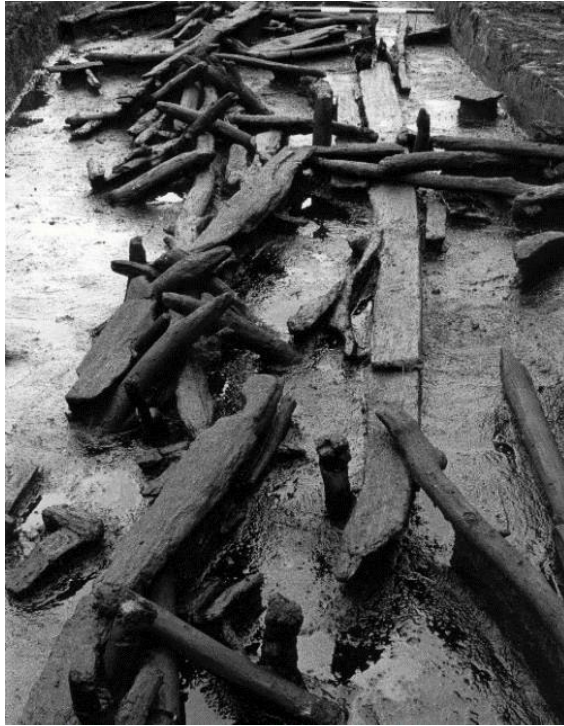
Sweet Track 3806 BC -Somerset Levels.
Source: Coles 2006

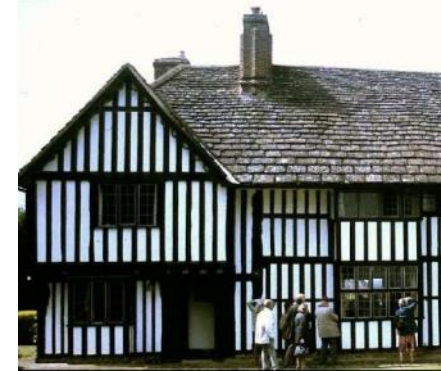
Close studding and Square framing
Sources: DBRG 2008, CAS 2010

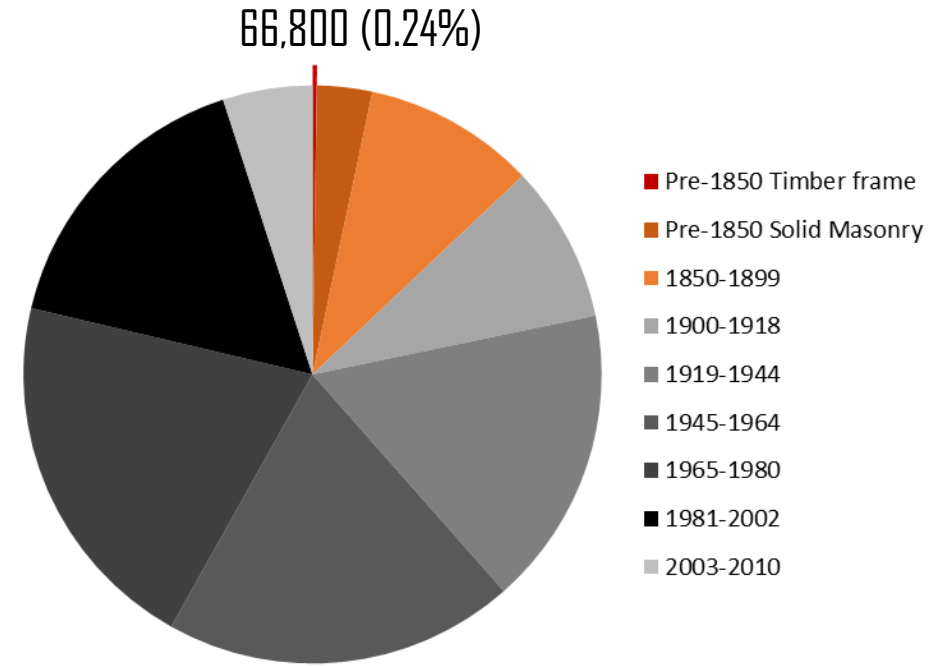
UK Domestic Building Stock

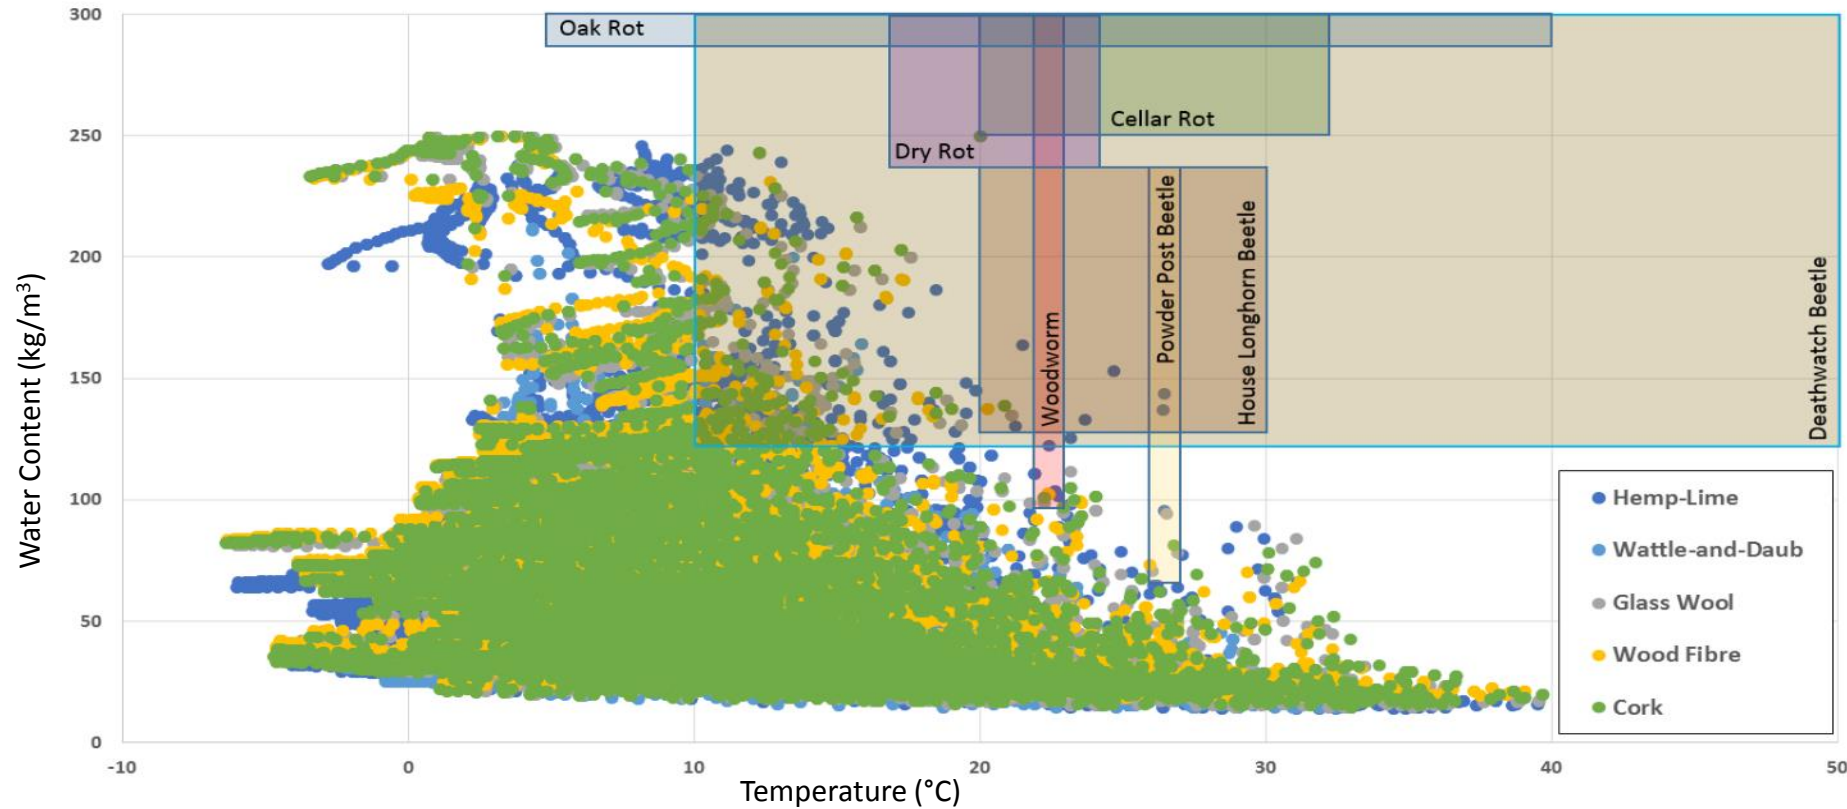
Simulation of Hygrothermal performance: WUFI (Wärme und Feuchte Instationär (WUFI) software Results of simulation for Hereford, UK *Source: (Author's own, 2015)*

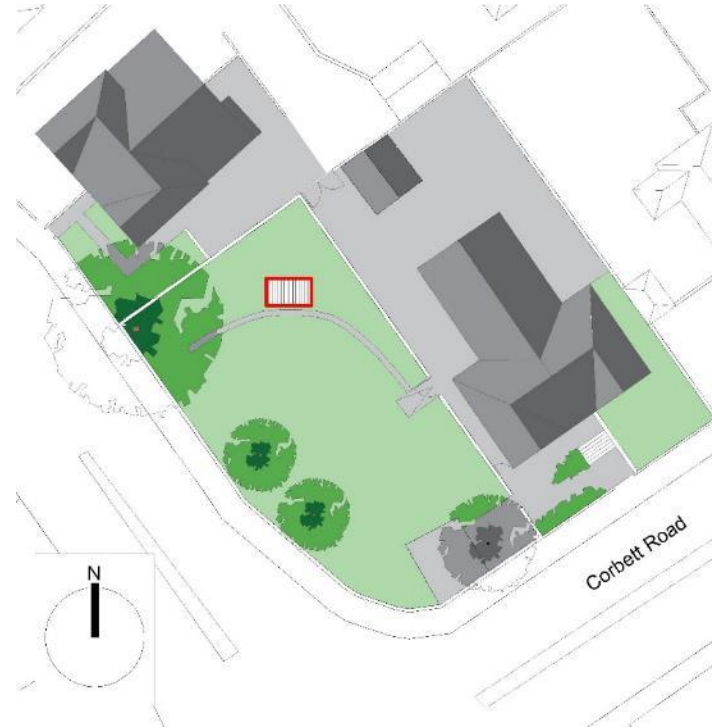
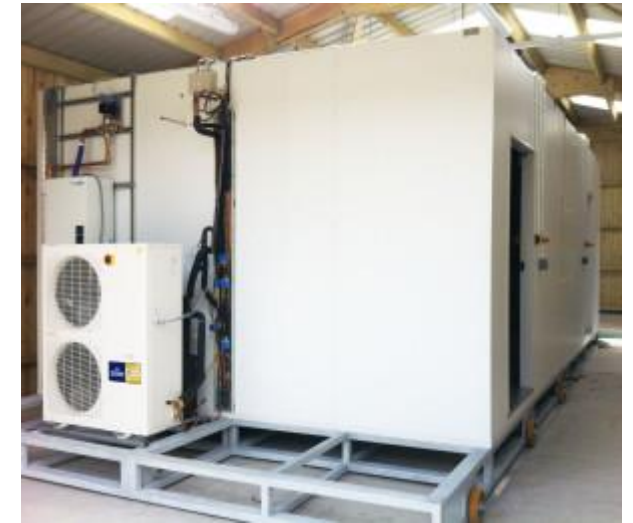
Proposed physical test cell for measurement of interstitial hygrothermal conditions of replacement infill panels *Source: (Author's own, 2015)*

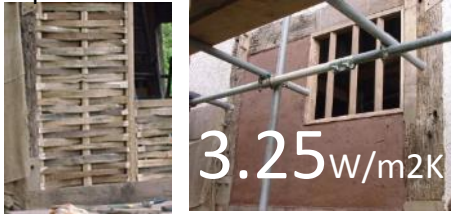
Replacement Wattle and Daub

3.25 W/m²K

In situ U-Value monitoring *Source: (Author's own, 2015)*

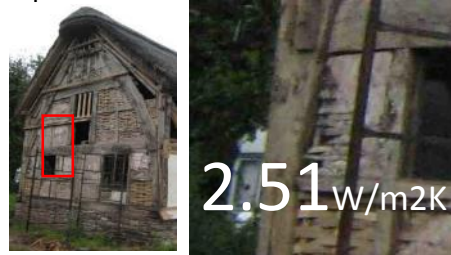
Repaired Lath and Plaster

2.51 W/m²K

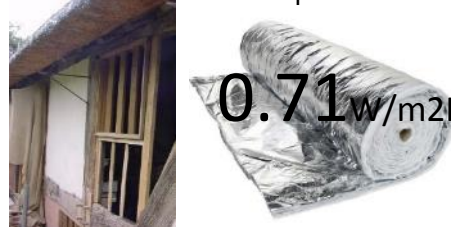
Triso-mur 25mm + Lime plaster

0.71 W/m²K

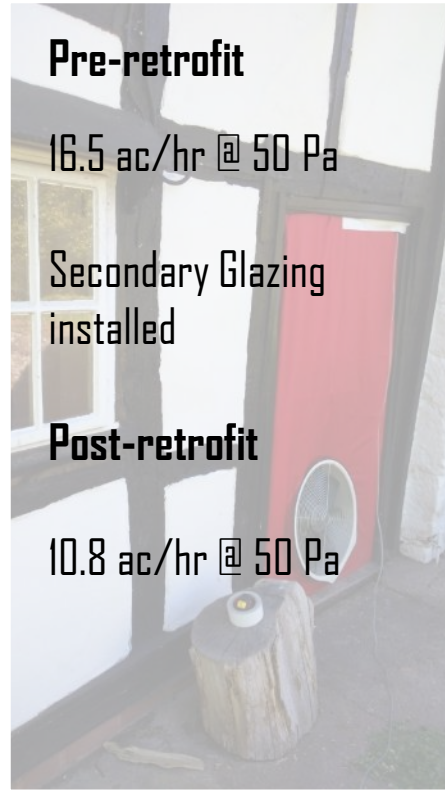
Pressure testing *(Author's own, 2016)*

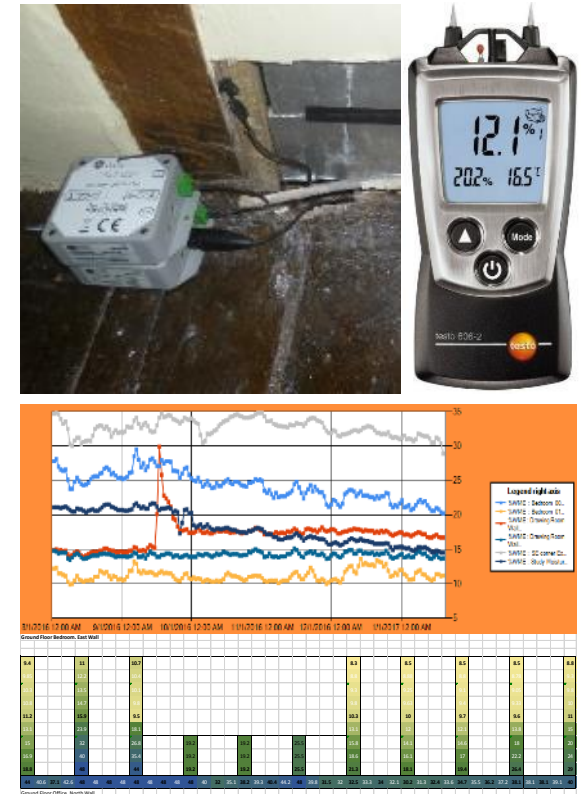
Moisture *Source: (Author's own, 2016)*

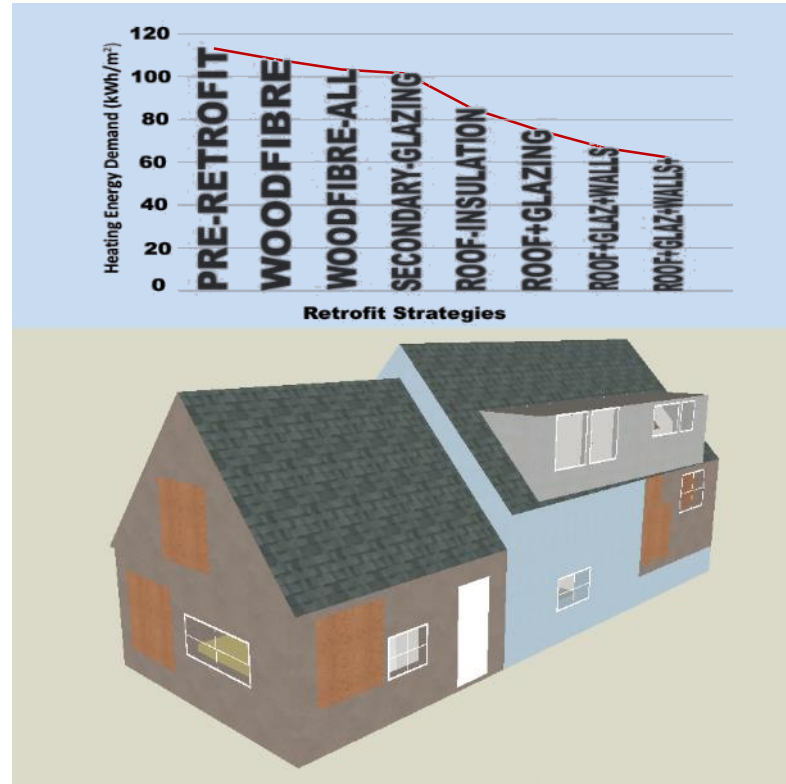
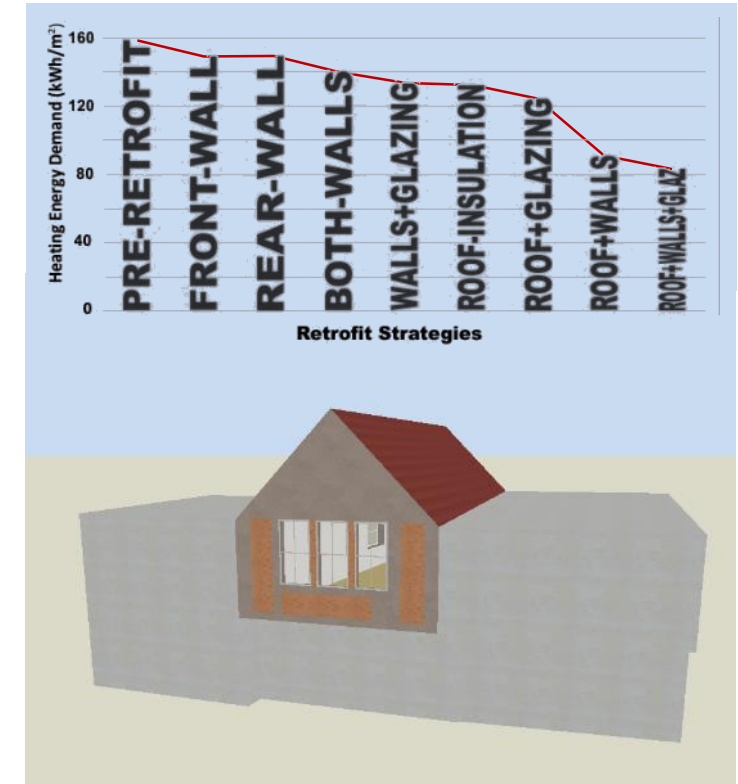
Energy simulation of case study buildings using DesignBuilder *Source: (Author's own, 2015)*
