Assessing the potential application of bacteria-based self-healing cementitious materials for enhancing durability of wastewater treatment infrastructure

Wastewater treatment plants (WWTPs) around the world are mainly built using concrete. The continuous exposure to wastewater affects the durability of concrete structures and requires costly maintenance or replacement. Concrete production and repair represents ~8% of the global anthropogenic CO₂ emissions due to the use of cement, thus contributing to climate change. Developing a more sustainable cementitious material is therefore required for this vital health infrastructure. In this study, the feasibility of using bacteria-based self-healing (BBSH) cementitious materials for WWTPs is assessed by exposing BBSH mortar prisms to a continuous municipal wastewater flow and comparing their self-healing capacity to equivalent mortar prisms exposed to tap water. Microscopy imaging, water-flow tests and micro-CT analyses were performed to evaluate the self-healing efficiency of the mortar prisms, while SEM-EDX and Raman spectroscopy were used to characterise the healing products. Our work represents the first systematic study of the heal

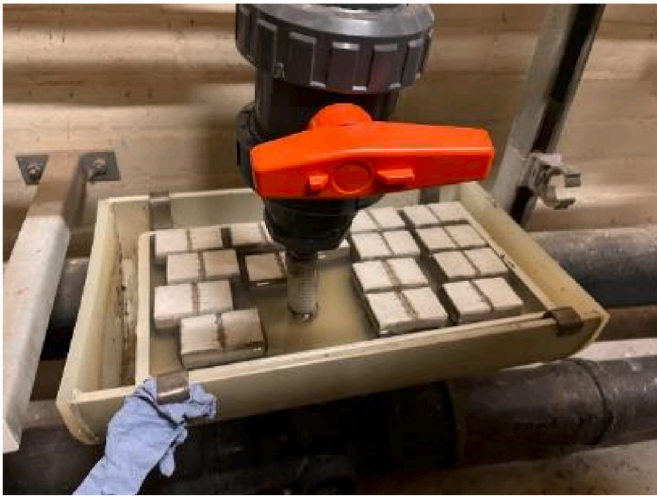
Fig. 1. Mortar prisms placement in the BEWISE pilot treatment plant. The inner tray of the hopper was subject to a continuous flow of municipal wastewater from the overhead tap. A small pipe extension was attached to the tap to prevent splashing. The inner tray, in which the samples were placed, had a height of 30 mm, allowing the top 10 mm of the mortar prisms to be exposed to air.

A duplicate set of mortar prisms (nominally identical to the ones kept in tap water) were tested at the BEWise pilot plant facility. The pilot plant is located inside the Northumbrian Water Ltd WWTP at Birtley (UK) which treats municipal wastewater (30,000 population equivalent). The mortar prisms were placed in a hopper within a tray of 30 mm height (Fig. 1), with the cracked side facing upwards. The hopper received a continuous flow of untreated municipal wastewater, identical to the one in the WWTP. The wastewater level was maintained 10 mm below the top of the mortar prisms, in a similar way to the tap-water-exposed mortar prisms. The mortar prisms were randomly distributed within the tray and their position was changed every week, to avoid any preferential healing due to the proximity of the prisms to the wastewater inlet.

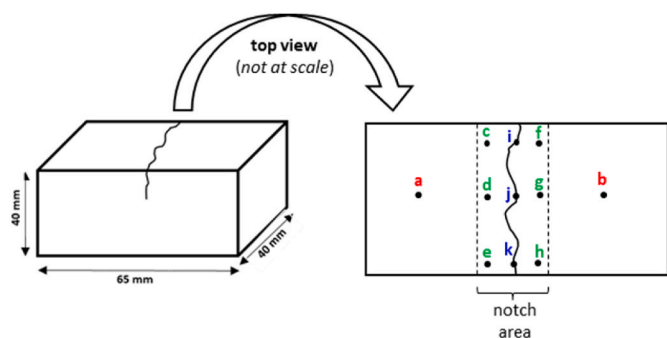
Fig. 2. Schematic of the SEM-EDX analysis. Images were taken at three points on the crack (i, j and k) to visualise the healing product, six points on both sides of the crack (c, d, and e on the left-hand side; and f, g and h on the right-hand side) and two points in the centre of the mortar prisms on both the side of the crack (a and b) to estimate the amount of calcium available in the mortar prism after 56 days of healing in tap water or wastewater conditions.

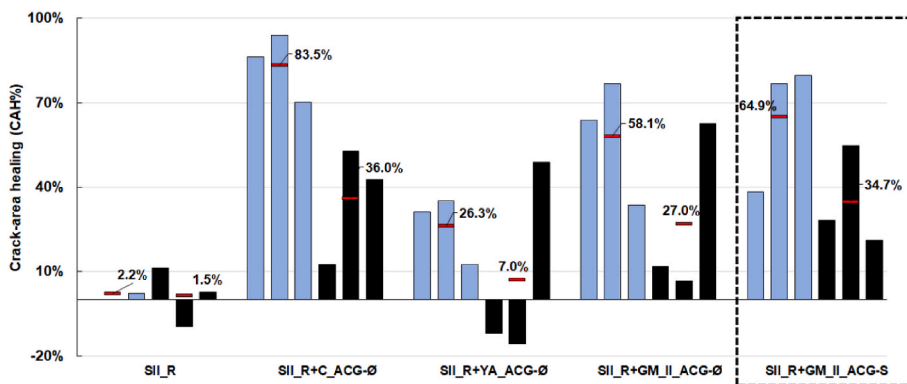
Fig. 6. Crack-area healing percentage (CAH%) for Set II mortar prisms after 56 days of healing. Bars represent the CAH% obtained as a function of crack-area reduction of the individual mortar prisms exposed during the healing period to: (■) tap water and (■) wastewater. The dotted box shows the mortar prisms containing bacterial spores encapsulated into aerated concrete granules (ACGs). Horizontal bars show the average values for each triplet of mortar prisms. The reference mortar mix (SII_R) exposed to tap water comprised only one mortar prism, as the other two prisms were damaged during cracking.

From the CAH% results (Fig. 6), except for the SII_R mortar mix, where the healing observed was negligible (2.2%), the rest of the mortar mixes presented some degree of healing. Moreover, the best healing performance was observed in the three mortar mixes where calcium nitrate was added (CAH% between 58.1% and 83.5%), regardless of whether or not bacterial spores were included. The addition of calcium nitrate results in a higher concentration of Ca^{2+} ions within the mortar matrix that could have resulted in the leaching and building up of these

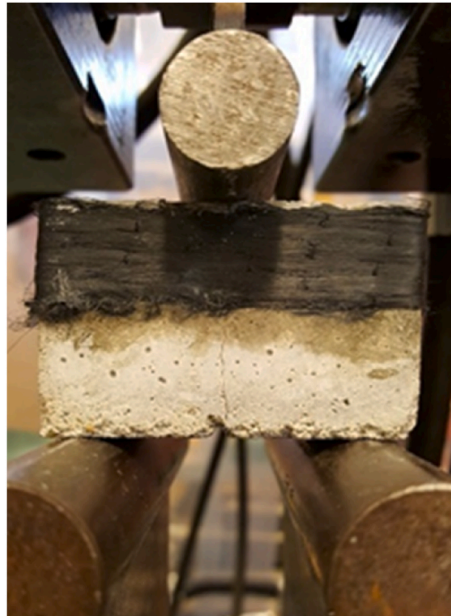
Cracking generation via three-point bending. Carbon fibre-reinforced polymer (CFRP) strips were affixed to guarantee the integrity of the mortar prisms after cracking.

After the curing period, all mortar prisms were dried at ambient laboratory conditions for 24 h. Following this, a notch of 1.5 mm depth was sawn at the centre of each mortar prism to induce crack formation. Then, carbon fibre-reinforced polymer (CFRP) strips were affixed to the top third of the mortar prisms using an EL2 epoxy laminating resin (Easy Composites, Stoke-on-Trent, UK) to guarantee the integrity of the samples after cracking (See Appendix A). Mortar prisms were cracked by

three-point bending using a 100 kN Dartec-Instron hydraulic loading frame. After the crack was formed and while maintaining the load, two 0.5 mm thick plastic spacers were placed at both ends of the formed crack, as fully described in Ref. [25]. Three selected crack locations (separated 10 mm from each other and the borders of the specimen) were marked with a permanent marker to enable monitoring of the crack at the same site. Immediately after cracking, the cracks were inspected using an optical microscope before placing the mortar prisms under healing conditions.
