Impacts of WWII bomb explosions on weathering damage of architectural heritage: Bath, England

Abstract

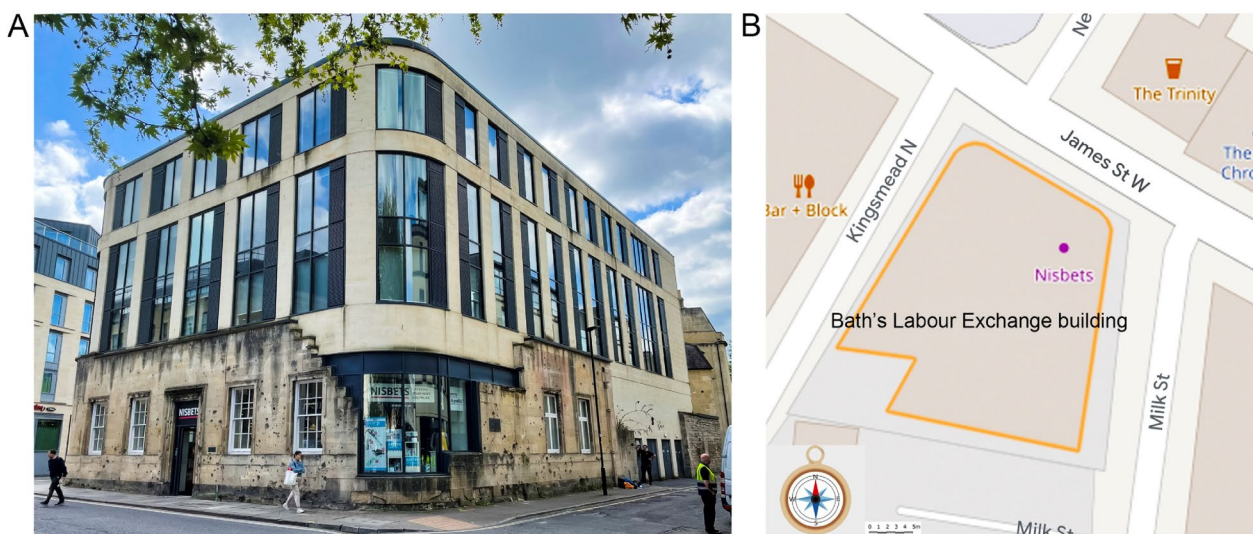
Fig. 2 A Labour Exchange building in Bath in 2022. B Geographical location of the building in Open Street Map [15]

Bath's Labour Exchange Building retains two explosive-damaged walls: the one facing James Street West and the other one facing Kingsmead North (Fig. 2). In April 1942 a bomb was dropped in the square directly adjacent to the Labour Exchange, which caused considerable cratering to both sides of the exposed building. While much of the building was demolished due to the extensive damage, these two outer walls were retained in a subsequent regeneration of the building. This provides the opportunity to study the effects of 80 years, almost to the day at time of measurement, of damage exposure to environmental stress, by a comparative study of impacted and non-impacted stonework.

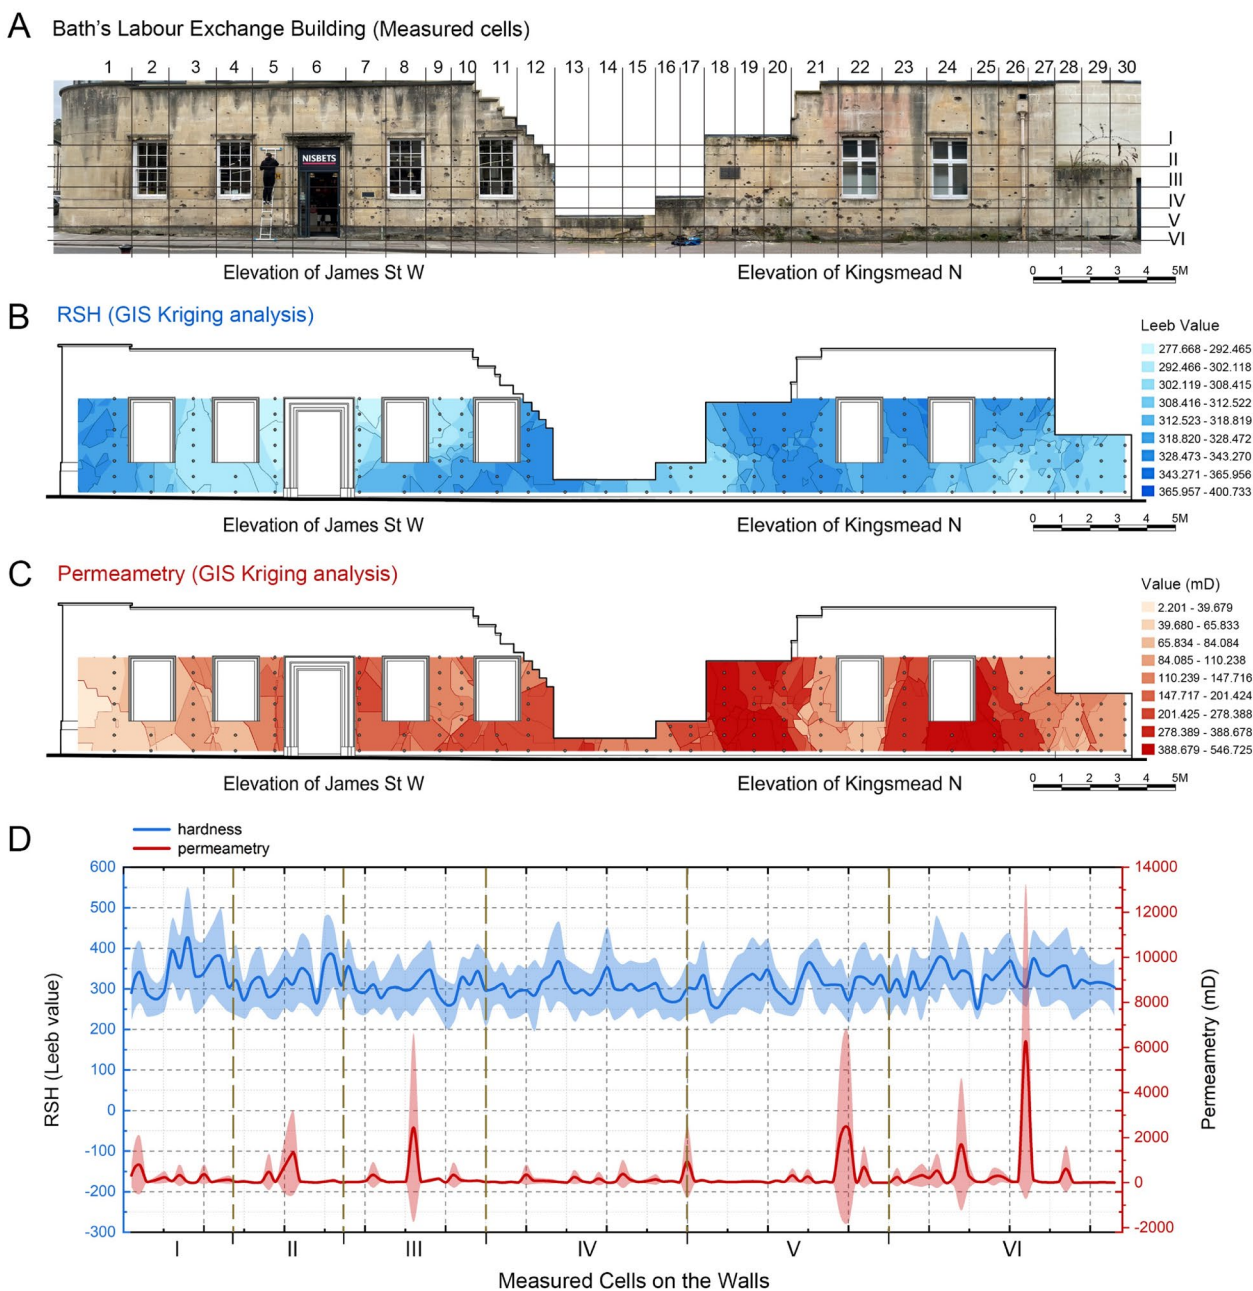
Fig.4 **A** 30 horizontal partitions and 6 vertical partitions on the two walls for measurements. **B** RSH (GIS Kriging) analysis. **C** Permeametry (GIS Kriging) analysis. **D** RSH and permeametry survey data of two walls

As shown in Figs. 4B, D associated with Fig. 5A, the RSH values of 123 cells of the two walls range from 200 to 592 L (Leeb values). The cells with low hardness values

are mainly located near doors and window openings, the cells near the ground floor, and the walls at the corners of the building. The cells with higher hardness values are mainly distributed on the upper part of the wall, far from the ground. The mean RSH values of the III, IV, V vertical partitions on the wall are about 20–30 L lower than other partitions. However, the standard deviation of I, II, VI vertical partitions are obviously larger than those of the III–V vertical partitions, and although the minimum RSH values of the three partitions are almost the same. The maximum RSH values range from 613 to 501. III–V vertical partitions are the areas where the windows and doors were missing due to direct exposure to the explosion and ensuing fire damage.

As shown in Figs. 4C, D associated with Fig. 6A, the permeametry values of 123 cells of the two walls range from 0.0024 to 13,800 mD. The cells with large permeability are mainly distributed in the partition VI which is closest to the ground, near the openings of doors and windows, and near the wall where the bomb exploded on the ground. The cells with low permeability are mainly distributed in the walls that are relatively continuous, without openings, and are higher from the ground. This indicates that the bomb explosion and the location of water penetration into the wall are the main factors affecting the permeability value. On the one hand, they are most affected by the bomb explosion; on the other hand, groundwater

For the purpose of understanding the spatial distribution regularities of the RSH and permeametry mean data, the kriging interpolation method of the geostatistical module in ArcGIS Pro was used to assess the RSH and permeametry concentrations on each cell of two walls. Based on this, a spatial distribution map of the RSH and permeametry concentrations on two walls was created. Figures 4B and C show an increasing or decreasing trend, and all these attributes have obvious high-value and low-value areas. There is an obvious large area of low-value RSH area at the openings of the door and windows of the wall facing James St W, and two high-value RSH areas at both corners of the wall. The two low-value RSH areas on the wall facing Kingsmead N are near where two walls were badly damaged in the war, and the high-value RSH area is on the upper wall (Fig. 4B). In general, the permeability of the wall facing Kingsmead N is greater than that of James Street W, and the permeability of the lower walls is greater than that of the upper walls (Fig. 4C).

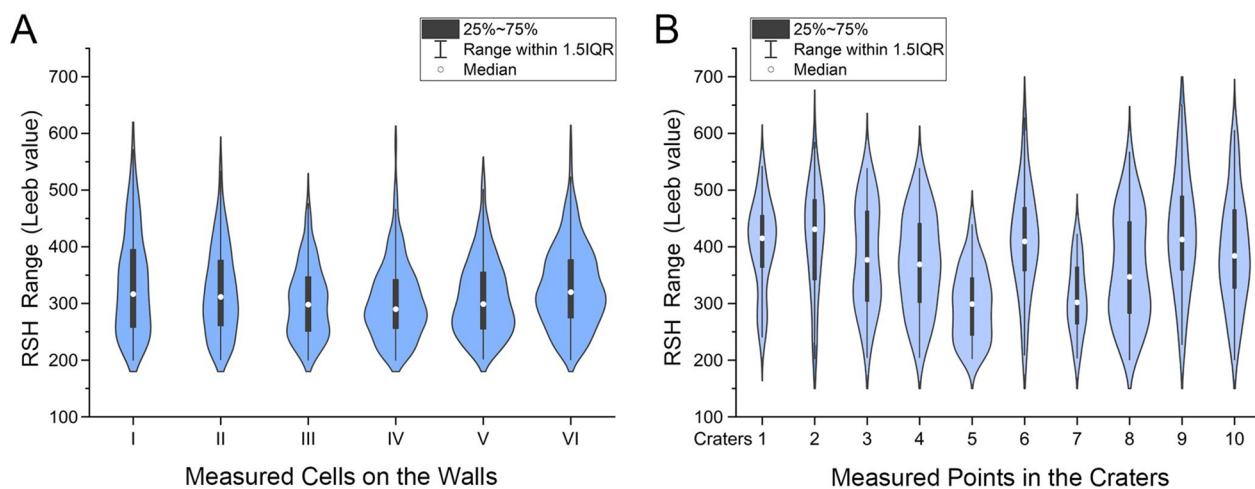
Fig. 5 **A** The density and distribution of RSH data of the two walls. **B** The density and distribution of RSH data of ten craters

As shown in Figs. 7, 8 associated with Fig. 5B, the RSH values of ten craters range from 201 to 650 L. Craters 3, 4, 5, 7, 8, and 10 all gave lower hardness values, and each crater presents a comparison of hardness values. Except crater 5, the mean RSH value of other craters is greater than the mean RSH value of each cell of two walls.

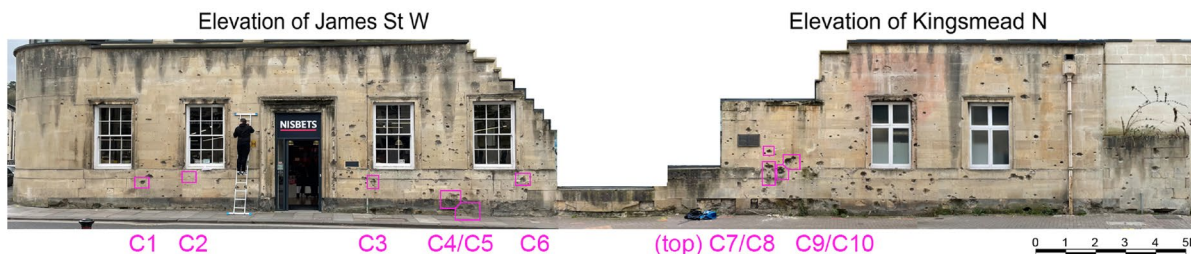
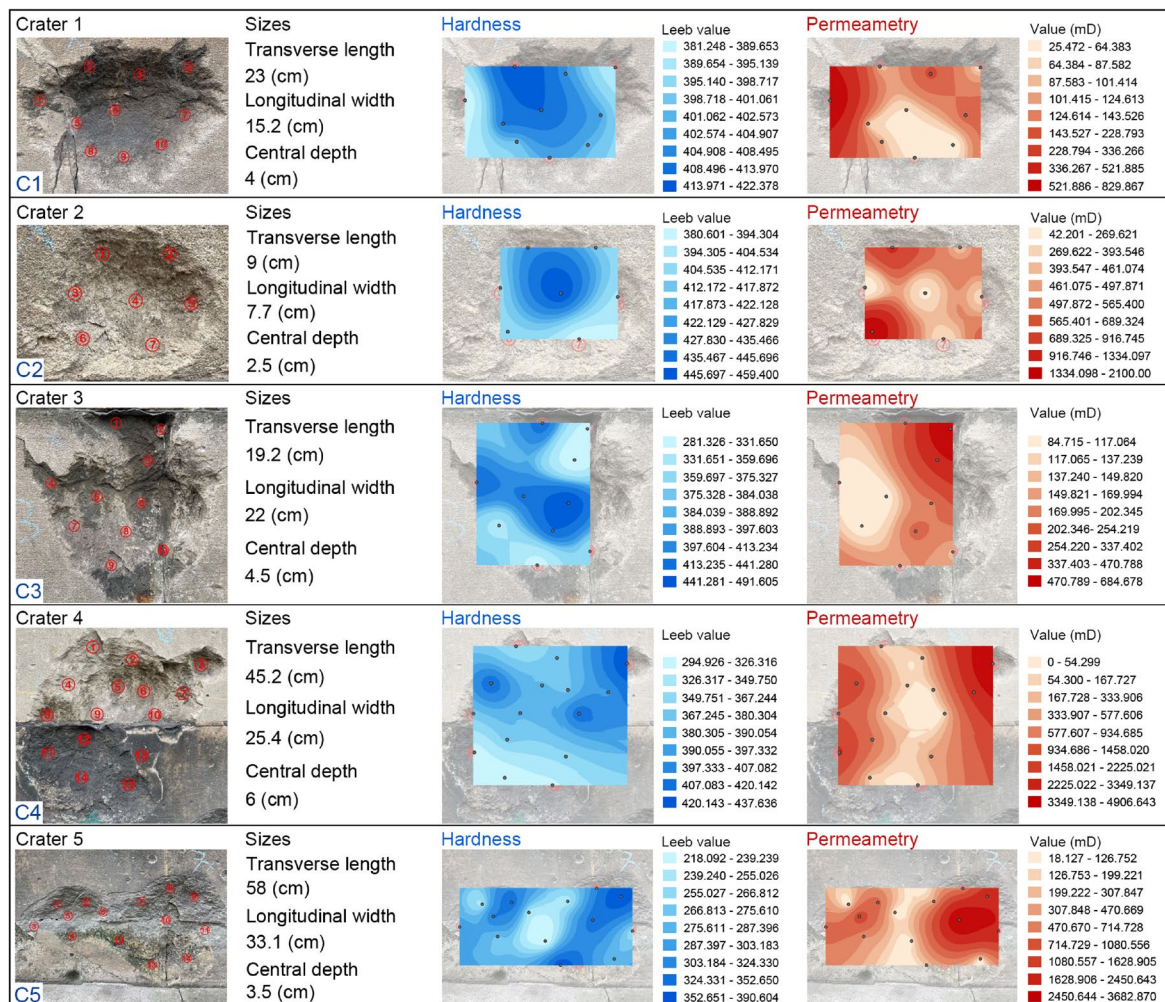
A Measured craters in the wall

Fig.7 a Ten craters for measurements. b RSH and permeametry (GIS Kriging) analysis for crater1 to crater5

As shown in Figs. 7, 8 associated with Fig. 6B, the permeametry values of ten craters range from 2 to 13,300 mD. Craters 2, 4, 5, 7, 8, and 10 show very large permeability values, and each crater presents a comparison of permeametry values. The mean permeability values of craters 2, 4, 5, 7, 8, 10 are also greater than the mean permeability value of each cell of two walls.

As shown in Figs. 7B and 8B, The RSH and permeability values do not seem to be consistently distributed within the craters. But in some craters, the RSH value of the middle of a crater is greater than that of the edge. The permeability value of the edge of a crater is greater than that of the middle. If the crater is cracked or spalling, the permeability can be very high.

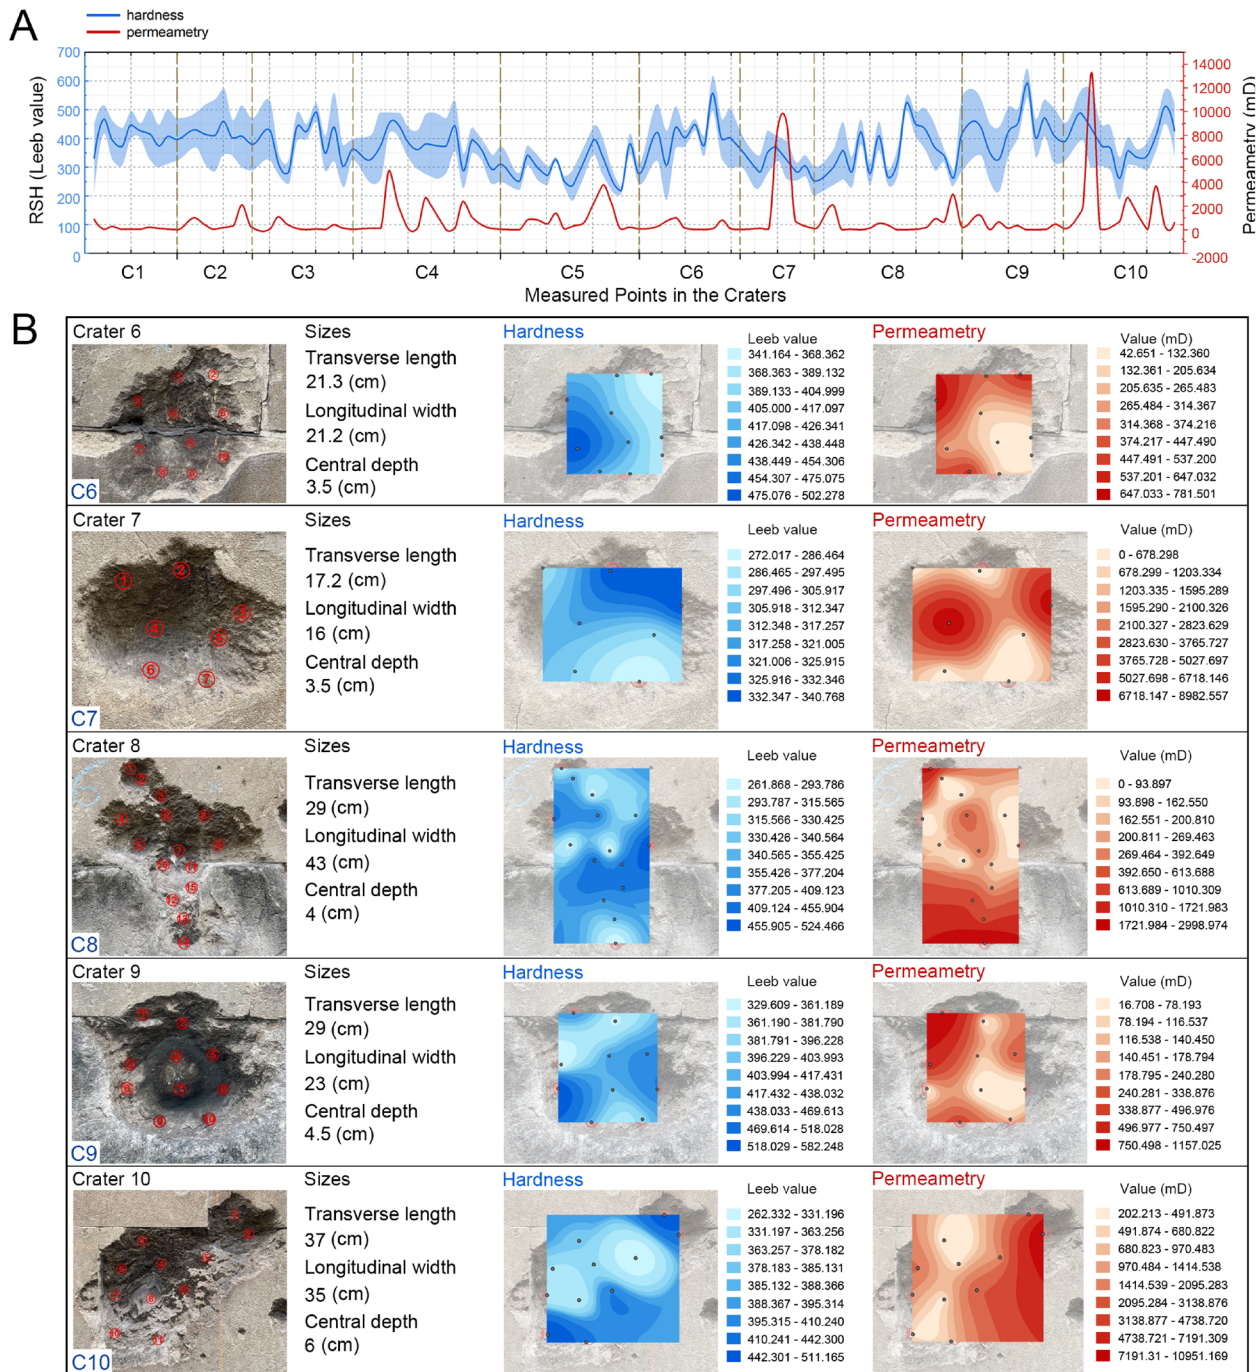
Fig. 8 a RSH and permeametry survey data of the craters. b RSH and permeametry (GIS Kriging) analysis for crater6 to crater10

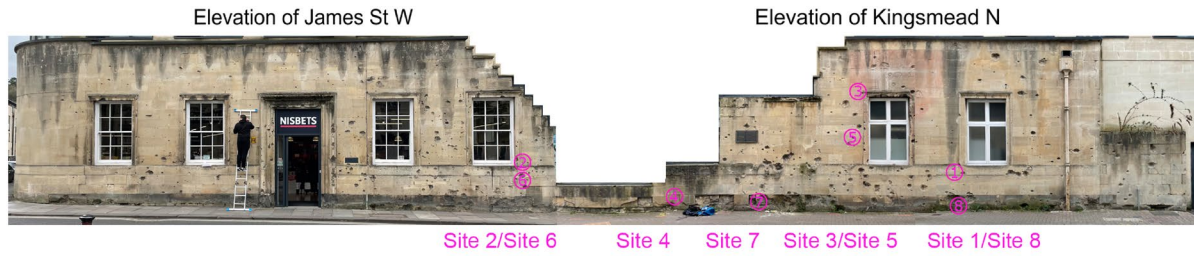
A Microscope observation positions

Fig.9 a The position of the microscope observations. **b** Microscopic observations of different areas of the building

Figure 9B shows the eight areas observed. Site 1 is a freshly exposed surface of stone unaffected by impacts; ooids are clearly visible with no signs of etching or pitting; it looks a fresh, unweathered surface. There is little microporosity; the limestone is tight. A few likely microbial filaments (dead) occur on the surface. Site 2

is outside of the craters, with well-preserved grains, no porosity, and some etching of the ooids. Site 3 is a fire-damaged window frame, with a pink-red staining of some grains wherein the iron would be located. Some etching of grains. Site 4 is from a discoloured stone on the front corner and shows a surface with a pale encrustation with

fine black particles and some faint pink colouration from fire damage. Site 5 is the inside of a small crater, where few ooid grains are visible, and there is a cream-coloured crust/coating with dark areas, probably from weathering and microbial encrustation. Site 6 is inside a large impact crater, where the surface has been weathered and coated so few grains are visible. Site 7 from the bottom of the

wall near the right edge of the information plaque shows the effects of long-term exposure to weathering, with a flakey appearance and dark particles, probably from air pollution and microbial encrustation. The two left images look like comminuted rock with microclasts on the surface, possibly powdered rock from an impact. Site 8

shows a rock surface with a green colour from a biofilm of cyanobacteria–algae.
