Al-Azzawi, Ahmad S. M., McCrory, John, Kawashita, Luiz F., Featherston, Carol A., Pullin, Rhys and Holford, Karen M. 2017. Buckling and postbuckling behaviour of glare laminates containing splices and doublers. Part 1: instrumented tests. Composite Structures 176, pp. 1158-1169.

Buckling and Postbuckling Behaviour of Glare Laminates Containing Splices and Doublers. Part 1: Instrumented Tests

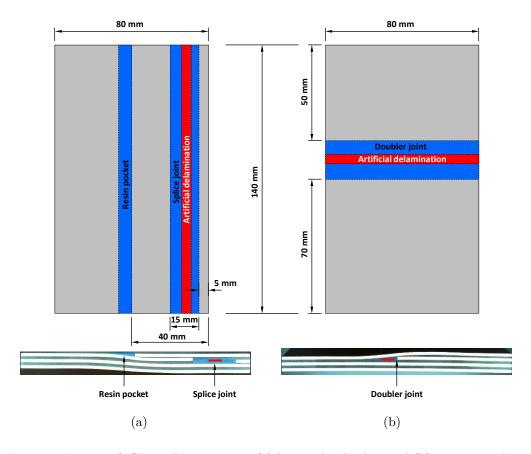
Figure 2: Layout of 'Glare 4B' specimens, (a) longitudinal splice and (b) transverse doubler.

Specimens measuring 140 mm \times 80 mm (unsupported dimensions; when clamped 100 mm \times 80 mm) were manufactured incorporating longitudinal splice and transverse doubler features as shown in Figure 2. These specimens were made by Airbus Germany GmbH from 0.4 mm thick sheets of aluminium alloy 2024-T3 and Hexcel S2-glass/FM94 glass fibre reinforced polymer (GFRP) unidirectional prepreg. Each GFRP 'layer' has 3 plies with the layup [90°/0°/90°] and a cured ply thickness of 0.133 mm. The layup one

side of the joint was '3/2' (three layers of aluminium and two layers of GFRP prepreg) and on the other '4/3' (four layers of aluminium and three layers of prepreg), according to the standard designation of commercial 'Glare 4B' shown in Table 1. Artificial delaminations were introduced by embedding a 4 mm wide strip of fluoropolymer film of thickness 10 μ m. This artificial delamination is representative of those which could potentially be generated during manufacturing.

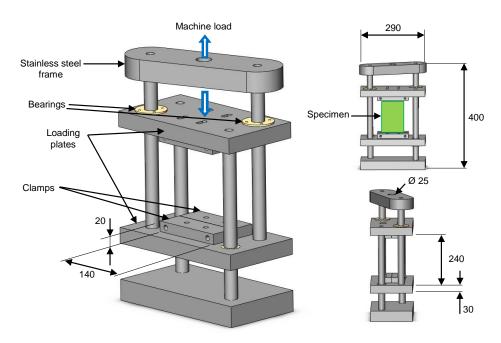
Figure 3: Buckling rig design (dimensions in mm).

The specially designed test rig seen in Figure 3, was manufactured from stainless steel 304. Specimens are held in place with four clamps. The frame was mounted in a Zwick[®] servo-hydraulic testing machine (fitted with a 500 kN load cell) as shown in Figure 4. The rig is designed such that when tension is applied the loading plates apply a compressive load to the specimen with axial movement of the rig being facilitated by four bronze journal bearings. The machine was operated under displacement control with a cross-head velocity of $0.1 \text{ mm} \cdot \text{min}^{-1}$. A total of four types of specimens were tested, namely splice and doubler specimens with and without artificial delaminations, with two repeats each, totalling 8 specimens.

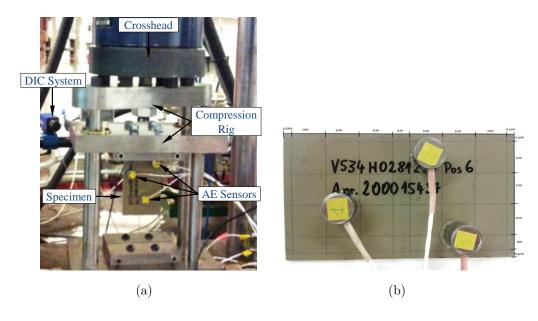
Figure 4: Experimental setup (a) and position of AE sensors on the specimen (b).

Three Acoustic Emission (AE) sensors were mounted on the specimens to monitor damage events during the buckling and postbuckling regimes. The wideband sensors used in this work were supplied by MistrasTM Group and had a frequency range of 100-1000 kHz. These were chosen because they cover a wide range of waveform frequencies which enable them to detect the different types of energy produced from different materials incorporated into the Glare[®] laminate. These were bonded to the specimens using multipurpose silicone sealant LoctiteTM 595. The sensors were connected to a Mistras GroupTM PCI2 acquisition unit with a 45 dB threshold (as recommended by previous work, including [34, 35, 36], for a wideband differential transducer) and a sampling rate of 5 MHz, recording over 1.2 ms to capture full waveforms, through pre-amplifiers with a 40 dB gain and a built-in band pass filter of 20-1200 kHz.

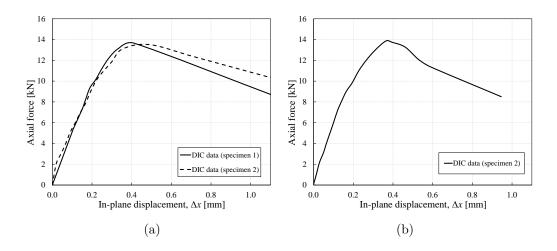
Figure 5: Axial force *versus* in-plane displacement for splice specimens; (a) pristine and (b) with an artificial defect.

Figures 5 and 6 show the load-displacement curves and section stress vs. normalised cross-head displacement curves for the splice specimens, respectively (Specimen 1 of the laminates with defects suffered from slippage in the rig and has therefore not been considered). The section stress is defined as the load divided by the cross-sectional area of the specimen, while the normalised displacement is the ratio between cross-head displacement and initial specimen length, i.e. $\Delta x/l_0$, where $l_0 = 100$ mm for all specimens. It should be noted that 'section stresses' are global measures and may not reflect the local stress states in each of the material constituents. Approximate 'lamina stresses' can be recovered during the initial elastic regime via the assumption of uniformity of in-plane strains. This will be discussed later in this paper, based on the material strengths provided by the accompanying paper [37].

The in-plane displacements were obtained from DIC data instead of the machine cross-head displacement as the former is believed to be more accurate (since it is not affected by the compliance of the machine). In terms of the ultimate compressive loads for the splice coupons the experimental values

are 13.66 kN and 13.72 kN (corresponding to section stresses of 77.86 MPa and 78.20 MPa) with and without defects respectively. The effect of the inserted delamination on both pre and postbuckling stiffness and ultimate strength therefore appears to be negligible. This could be due to the relatively small delamination size relative to the specimen size, or the fact once global buckling has started to occur the deformation of the specimen tends to close any delamination initiated by the insertion of this localised defect which is in front of the specimens neutral axis and therefore sits between plies which are under tension during bending, which consequently has little effect on the performance of the joint under compression.

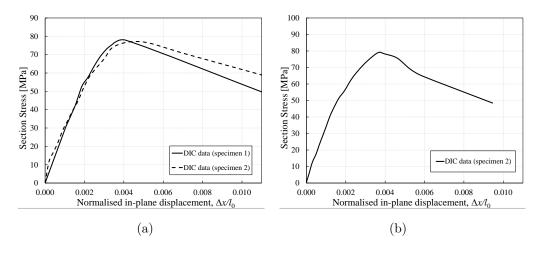
Figure 6: Section stress versus normalised in-plane displacement for splice specimens; (a) pristine and (b) with an artificial defect.

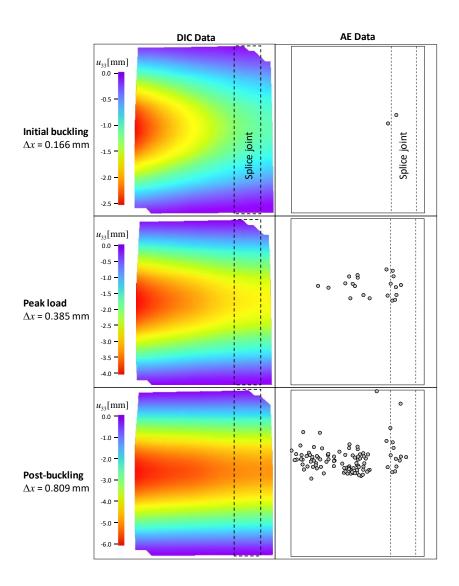
Figure 7: Contours of out-of-plane displacement (left) against location of AE events (right) for the *splice* specimen (with an artificial defect) at different in-plane displacements Δx (dashed lines indicate position of splice).

Figure 7 shows the contours of the out-of-plane displacement at initial buckling (in-plane displacement $\Delta x = 0.166$ mm), peak load ($\Delta x = 0.385$ mm) and postbuckling ($\Delta x = 0.809$ mm), obtained from DIC data. These are compared with AE location data using the Delta-T algorithm described earlier. The results presented are for splice specimens incorporating an artificial defect, but the pristine specimens presented very similar behaviour indicating that the effect of the damage introduced on the mode shape and the amplitude of out-of-plane deformations is negligible. The plate is seen to buckle with a single half wave length in the loading direction as expected for a plate with free longitudinal edges under compression. Deformations to the left of the joint in the thinner region of the specimen are higher than those to the right again as would be expected.

With respect to the AE location data in Figure 7 and cumulative AE energy in Figure 8, at approximately $\Delta x = 0.166$ mm initially low-energy AE events are detected along the horizontal centreline in an area which coincides

with the location of the embedded defect. This due to matrix cracking at the initial buckling load, as illustrated later by SEM micrographs (Figure 11). Then, at approximately $\Delta x = 0.385$ mm, a large number of high-energy AE

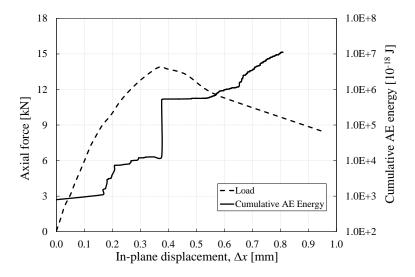
Figure 8: Load and cumulative AE energy *versus* in-plane displacement for the *splice* specimen with defect.

Figure 8 shows the cumulative energy of events occurring throughout the test period, against applied load. The first significant increase in the logarithmic cumulative energy occurs at an in-plane displacement of around $\Delta x = 0.166$ mm corresponding to matrix damage which accompanies initial buckling of the panel, indicating that AE can be used to predict the onset of buckling. A further large jump is observed when the load reaches the ultimate compressive load at $\Delta x = 0.385$ mm indicating a high level of damage activity (potentially matrix cracking and matrix shear damage, as suggested by the SEM micrographs) plus the initiation of macroscopic delamination, due to high levels of deformation and curvature at this point, as would be expected. This is followed by a gradual increase in energy which corresponds to delamination initiation and growth along the splice feature during post-buckling. Again, this interpretation is backed by the analysis of detailed nonlinear Finite Element models in [37].

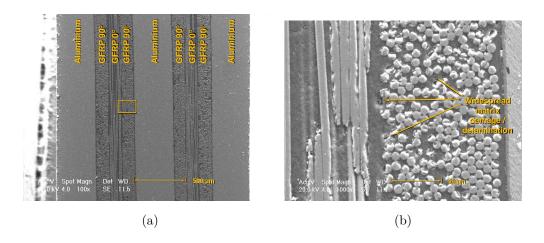
Figure 10: SEM of *splice* specimens along section 1 (side of specimen), with magnifications of (a) $100\times$ and (b) $1000\times$.

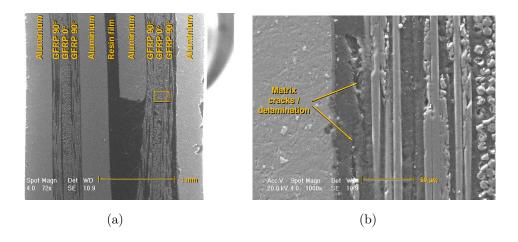
Figure 11: SEM of splice specimens along section 2 (across splice), with magnifications of (a) $72\times$ and (b) $1000\times$.

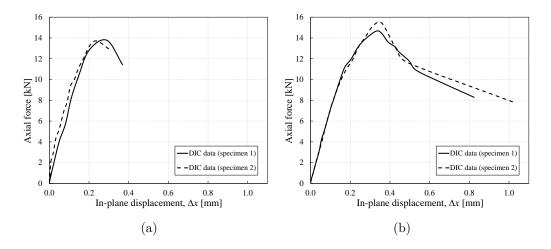
Figure 12: Axial force *versus* in-plane displacement for doubler specimens; (a) pristine and (b) with an artificial defect.

The load *versus* in-plane displacement curves and section stress *versus* normalised displacement curves of doubler specimens with and without artificial defects are shown in Figures 12 and 13. As before, in-plane displacements were extracted from DIC data. The ultimate compressive loads for the specimens without defects are 13.78 kN and 13.69 kN (corresponding to section stresses of 85.27 MPa and 84.72 MPa) and for those with artificial defects are 14.65 kN and 15.49 kN (corresponding to stresses of 90.66 MPa and 95.85 MPa). Clearly the presence of the defect is not having any significant impact on the buckling load of the doubler specimens, and this is believed to be for the same reasons as for the splice specimens.

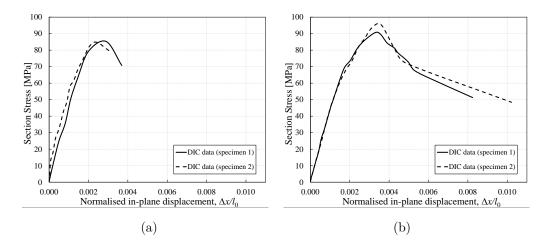
Figure 13: Section stress *versus* normalised in-plane displacement for doubler specimens; (a) pristine and (b) with an artificial defect.

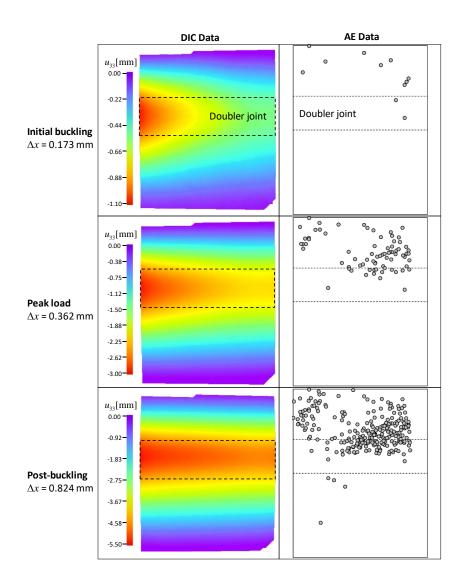
Figure 14: Contours of out-of-plane displacement (left) against location of AE events (right) for the *doubler* specimen (with an artificial defect) at different in-plane displacements Δx (dashed lines indicate position of doubler).

Figure 14 shows the contours of the out-of-plane displacement for initial buckling (in-plane displacement $\Delta x = 0.173$ mm), ultimate load ($\Delta x = 0.362$ mm) and postbuckling ($\Delta x = 0.824$ mm), obtained from DIC data, which are again compared with AE event location data and AE cumulative energy (Figure 15). The results shown correspond to one of the specimens with a defect but the pristine specimens give similar results. Out-of-plane displacements can be seen to be greatest along the doubler joint, which corresponds to the panel buckling with one half wavelength along the length of the panel. It is also where a change in panel thickness occurs, with the thinner portion being above the joint. Examining the results from the acoustic

emission monitoring, Figure 14, shows initial low-energy AE events detected in the upper portion of the panel just above the doubler joint, as well as at the point of highest curvature at around $\Delta x = 0.16$ mm corresponding to the onset of buckling. This is mostly due to matrix cracking as illustrated by the SEM micrographs (Figure 18). Then, at approximately $\Delta x = 0.36$ mm when the peak load is reached, a large number of high-energy AE events are seen (Figures 14 and 15). These again correspond to the joint and the thinner section of the specimen where the out-of-plane displacements and curvatures are increasing significantly leading to matrix cracking in the resin layers as confirmed again by SEM micrographs (Figure 17). Following this point activity levels continue to increase as loading continues into postbuckling (Figure 14) particularly at the boundary of the joint with the thinner section, with the results of the SEM indicating this damage to be in the form of matrix cracking and shear damage as seen in Figure 17. In terms of AE energy the results in Figure 15 show that there is a sharp increase in cumulative energy between $0.16 \text{ mm} < \Delta x < 0.23 \text{ mm}$ corresponding to widespread matrix cracking. A further large jump in energy can be seen at $\Delta x = 0.36$ mm due to the large out-of-plane displacements and high curvature seen at ultimate load causing further matrix cracking. This is followed by a more gradual increase in energy up to the end of the tests at approximately $\Delta x = 0.85$ mm caused by a number of different damage mechanisms including matrix cracking and shear damage, as confirmed by SEM micrographs at the doubler joint region in Figure 18. No delamination initiation or propagation from the embedded defect was noticed in the SEM results. Again this can be explained by the fact that as the specimen begins to buckle globally, deformations act to close

As also shown in Figure 14, initial low-energy AE events were detected in the upper portion of the panel just above the doubler joint, as well as at the point of highest curvature which shows great levels of AE activity at around $\Delta x = 0.16$ mm which corresponds to the onset of buckling. Then at approximately $\Delta x = 0.36$ mm a large number of high-energy AE events are seen in the same region, corresponding to the peak load when out-of-plane displacements and curvatures increase significantly.

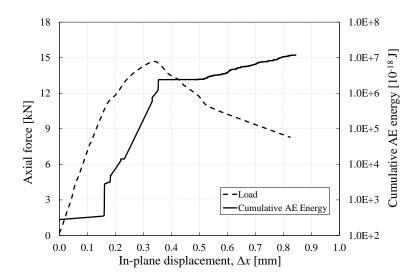
Figure 15: Load and cumulative AE energy versus in-plane displacement for the doubler specimen with defect.

The AE energy results shown in Figure 15 show a sharp increase in cumulative energy between 0.16 mm $< \Delta x < 0.23$ mm corresponding to widespread matrix cracking. A further large jump in energy can be seen at $\Delta x = 0.36$ mm due again to the large out-of-plane displacements and high curvature seen at ultimate load. This is followed by a more gradual increase in energy up to the end of the tests at approximately $\Delta x = 0.85$ mm. The increase in cumulative energy is more gradual for the doubler specimen than for the splice specimen. This suggests that the transverse doubler joint investigated here does not promote large scale delaminations as observed for the longitudinal splice joint. This is supported by the detailed Finite Element analysis presented in [37].

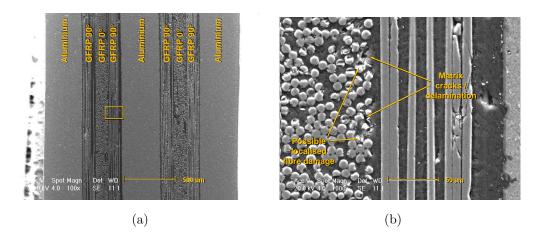
Figure 17: SEM of doubler specimens along section 1 (near the top grip), with magnifications of (a) $100\times$ and (b) $1000\times$.

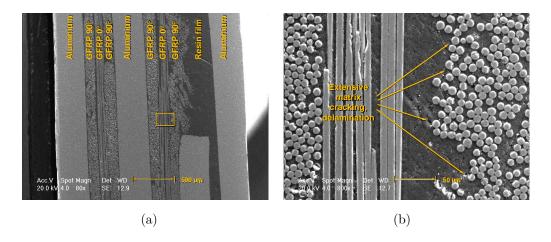
Figure 18: SEM of doubler specimens along section 2 (across doubler), with magnifications of (a) $80 \times$ and (b) $800 \times$.
