Liu, Simeng, Pearson, Matthew R. , Eaton, Mark and Pullin, Rhys 2017. Correlation between acoustic emission distribution and stress variation through the depth of RC beam cross sections. *Construction and Building Materials* 150 , pp. 634-645. 10.1016/j.conbuildmat.2017.06.001

1 Correlation between acoustic emission distribution and stress 2 variation through the depth of RC beam cross sections

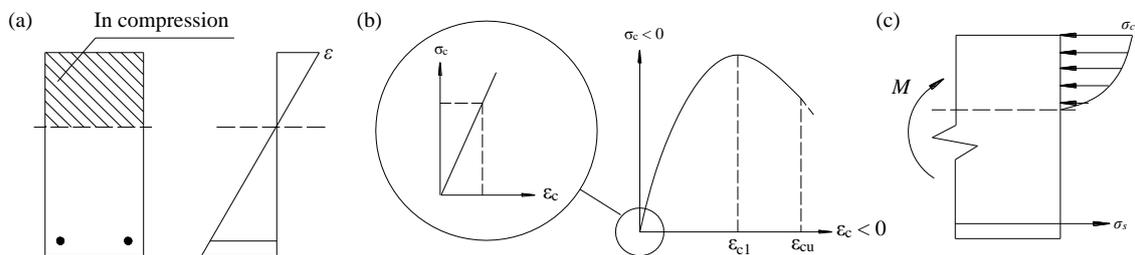
106 **Figure 1.** (a) A typical theoretical distribution of strain on an RC beam cross section; (b)

107 a stress-strain curve of the concrete material [34]; (c) the corresponding stress diagram
108 across the section.

92 The Mechanics of Materials shows that strain develops linearly through the cross
93 sections of a structure under loading (e.g. Figure 1(a)). In addition, according to the
94 stress-strain relation of concrete (Figure 1(b)), different strain values correspond to
95 different stress magnitudes (Figure 1(c)), meaning that the pattern of the stress
96 distribution on the sections is deterministic and changes with load magnitudes. If the
97 magnitude of the load is sufficient, cracking occurs. Finally, well established research
98 [21, 28-33] has revealed that events, such as cracking, cause the release of energy in
99 materials, forming elastic waves, i.e. AE. Therefore, the following two questions are
100 considerably interesting in science and engineering:

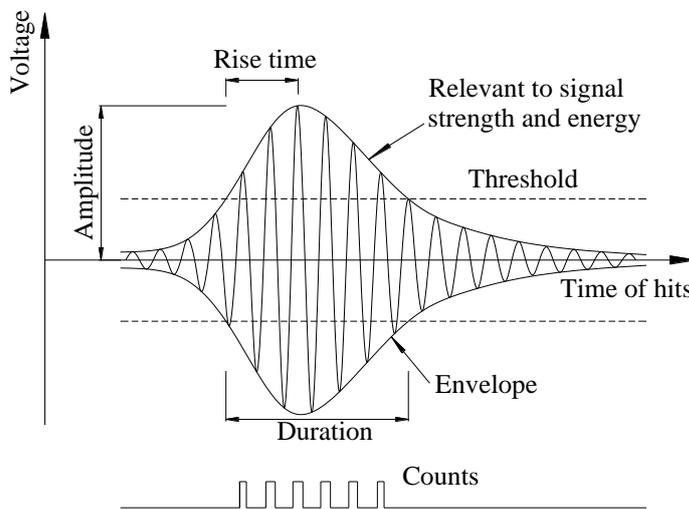
119 **Figure 2.** Important AE-related concepts discussed in this paper.

113 through a RC beam cross section. Figure 2 presents the classic AE parameters used to

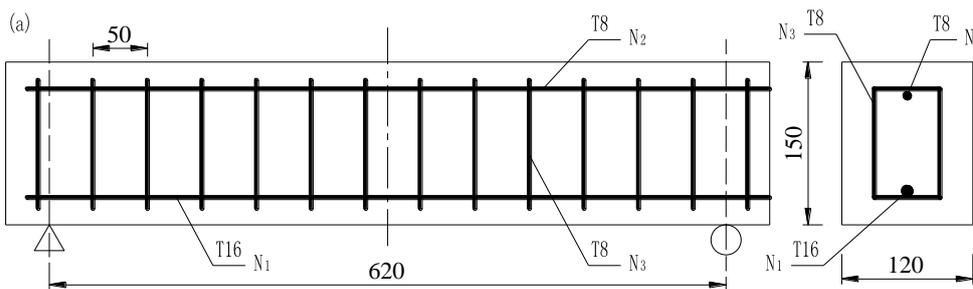
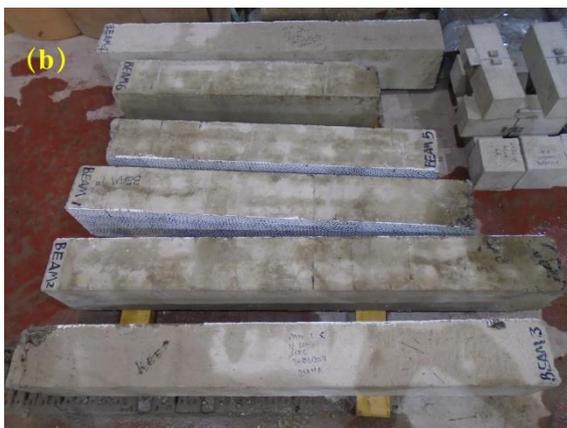
146 **Figure 3.** (a) The design details of the simply supported RC beams tested in the study

147 (Units in mm), (b) a photo of all specimens.

126 The details of these specimens are shown in Figure 3 and Table 1. The sections of
127 all beams are rectangular, 120mm wide and 150mm or 155mm deep, with a clear span
128 of 620 mm (Table 1). In every specimen, one steel bar (N1), 12 mm in diameter, is
129 provided as tensile reinforcement, and another bar (N2), 6 mm in diameter, is used as
130 compressive reinforcement. Stirrups (N3), 6 mm in diameter, are placed at 50 mm c/c
131 distance to avoid shear failure. The beams were designed in accordance with British
132 Standard for grade C40, and the mixture proportion of the concrete was that cement :
133 fine aggregate : coarse aggregate : water = 1:2:3:0.5, by weight. Steel fibres, 30mm or
134 60mm long, were mixed in the concrete, with a ratio of 1% or 2% (by weight), to obtain
135 the Steel Fibre Concrete (SFC). The specimens were cast in a specially made wooden
136 mould and a standard steel mould, and compacted using a needle vibrator.

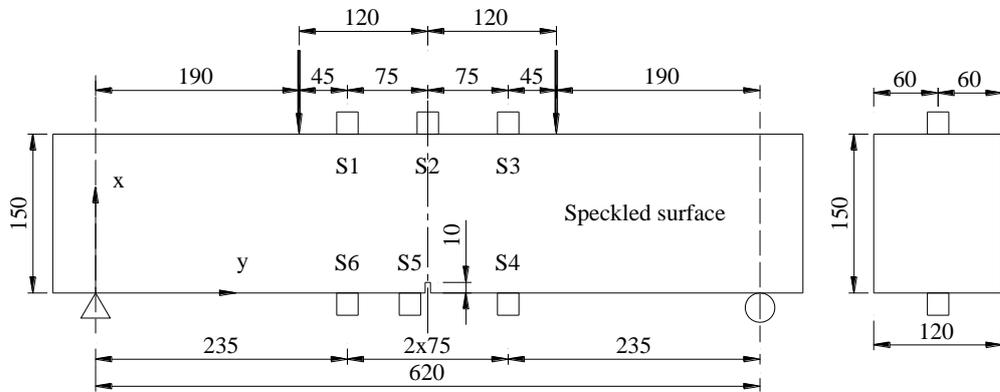
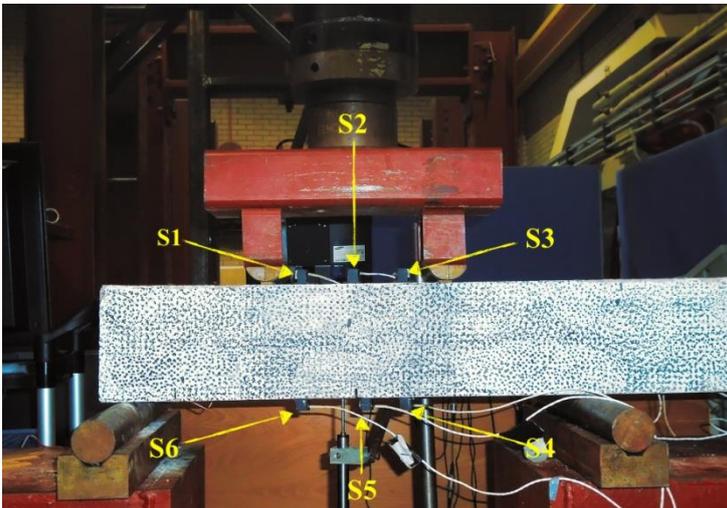
S1 ~ S6 : Acoustic Emission Sensor 1 to 6.

Figure 4. The layout of all six AE sensors employed in tests (Units in mm).

157 As stated by Swit [35], since AE signals are mainly registered by sensors that are
158 close enough to the sources of AE events, all sensors were therefore placed around the
159 most probable site of damage – the notch and the pure bending region. Hence, as shown
160 in Figure 4, six sensors (S1 through S6) are mounted on the top and the bottom of every
161 beam. Brown grease was used as an acoustic couplant. Sensor S5 is placed adjacent to
162 each pre-cut notch. In order to make sure all sensors were mounted correctly, a
163 Pencil-Lead Breaks (PLBs) [36] test was completed prior to testing.

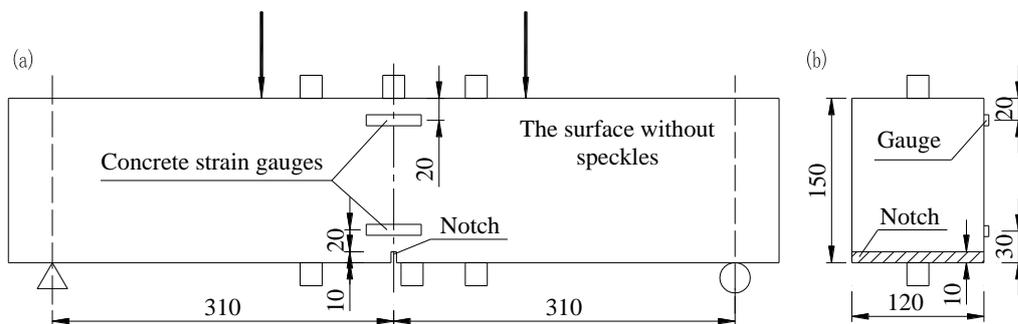
180 **Figure 5.** The layout of two concrete strain gauges on each beam: (a) Elevation, (b) The
 181 mid-span cross-section diagram (Units in mm).

174 resistance wire concrete strain gauges were affixed to measure point strain. As shown in
 175 Figure 5, one gauge is 20mm away from the top of the beam, and the other is 20mm
 176 away from the top of the notch. In addition, a displacement transducer was arranged
 177 beneath the mid-span of each specimen.

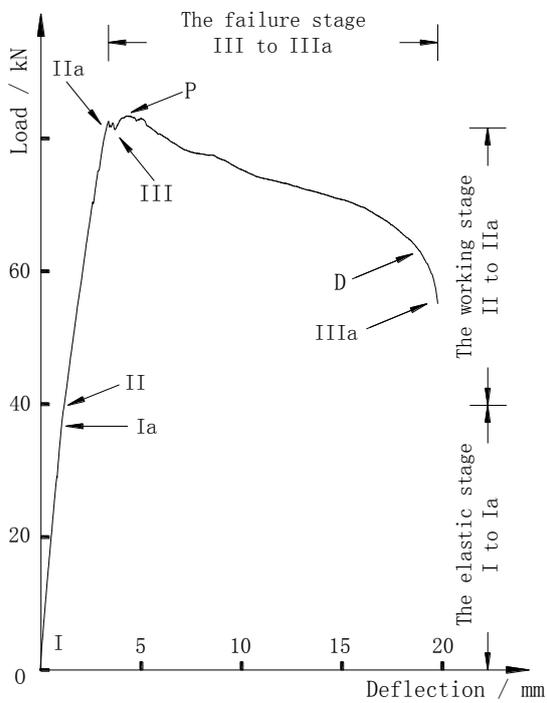
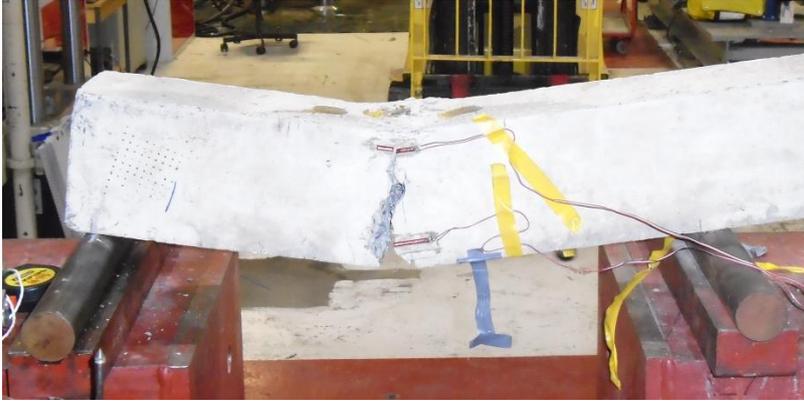
232
 233 **Figure 6** The load-deflection curve (Upper) and the failure shape (Lower) of Beam 1.
 234

215 The failure of Beam 1, i.e. a three-stage loading process, is detailed as follows. In the
216 first stage, no cracks were observed, and the stiffness of the beam was of the greatest
217 magnitude. Theoretically, all parts of each cross section are effective in resisting
218 external moment, and concrete stress is proportional to strain. The stage corresponds to
219 *I-Ia* in the first panel of Figure 6. In the second stage, cracks appeared in the tensile
220 zone very close to the notch, and the deflection of the beam increased significantly,
221 meaning its stiffness also appreciably declined. In theory, the stress increases with strain
222 nonlinearly, and to a cracked section, only a part of the section provides resistance to the
223 bending moment. The second stage corresponds to *II-IIa* in Figure 6. In the third stage,
224 many cracks appeared in both the tensile and compressive regions; and strain increased

226 reinforcement yielded. More importantly, the stiffness dramatically reduced. Finally, a
227 part of the concrete in the compressive region was crushed, and then the beam
228 completely failed (See the lower panel of the figure). The last stage corresponds to
229 *III-IIIa* in Figure 6.
230

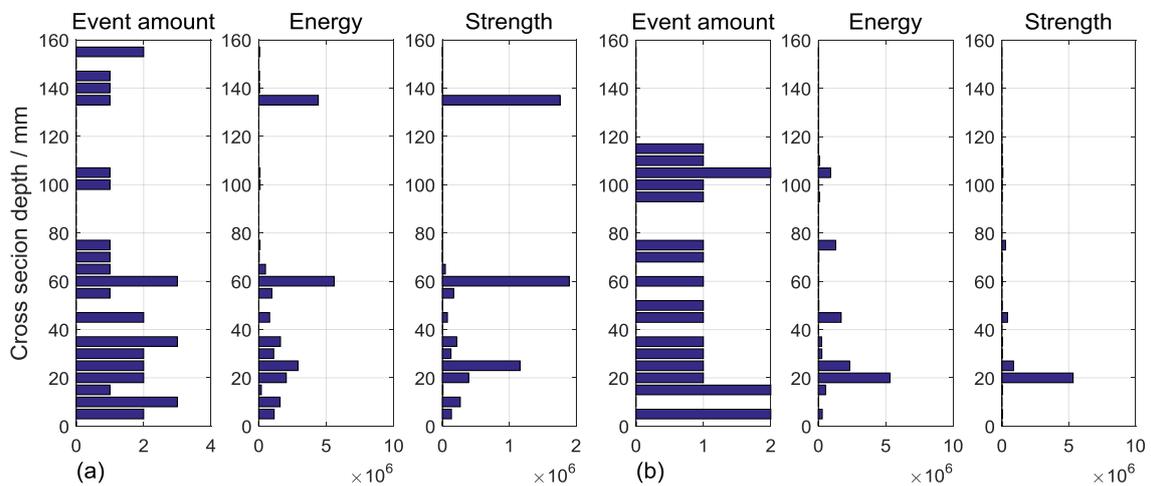
262 **Figure 7** The distributions of the acoustic emissions acquired (a) in the elastic stage and
263 (b) during the onset of the first crack in the tensile area, across the depth of Beam 1
264 (Energy refers to the AE Absolute Energy, in aJ (attojoules); Strength is short for the
265 Signal Strength, in pVs (picovolt-seconds)).

250 Figure 7 shows the AE data of Beam 1 obtained in the elastic stage and during the
 251 period from *Ia* to *II*. Note that the y-axis of all figures is the depth of RC beam section.
 252 The cross-sectional height (155mm) is divided into 31 intervals, and three variables, i.e.
 253 the AE events, absolute energy and signal strength, are related to each interval (5mm
 254 high). When an event is located in an interval, the AE event amount variable increases
 255 by one, and the quantities of the energy and the signal strength are added to the other
 256 two variables, respectively. The x-coordinate is the amount of AE events (proportion to
 257 the intensity), absolute energy or signal strength. Note that the total number of events
 258 identified is 3,649, and the order of magnitude of the AE absolute energy and the signal
 259 strength in the failure state of Beam 1 is 10^8 .

267 As shown in the left panel of Figure 7, there are 31 AE events acquired within the
268 elastic stage of loading. The number is less than 1% of the total event amount (3,649),
269 demonstrating AE activity is very low. Furthermore, structural responses of the beam
270 can give deep insight into the characteristic of showing low AE activity at this stage.
271 Since the maximum tensile stress in the concrete is smaller than the modulus of rupture
272 at this stage, all parts of a concrete section are effective in resisting stress which is
273 proportional to strain[34, 37-39]. Namely, the beam is behaving elastically.
274 Theoretically, it is therefore, generally assumed that no damage has occurred [40].
275 Consequently, the AE activity inside the beam is very low. In conclusion, the structural

277 The first crack appeared during the period from *Ia* to *II* in Figure 6, and Figure 7
278 shows the corresponding AE measurements. The second panel of Figure 7 reveals that
279 19 AE events were recorded, similar to what happened in the previous stage. Therefore,
280 the AE activity in this period is also considered to be considerably low. However, as
281 shown in the load vs. deflection curve (Figure 6), the slope of the curve in the
282 post-elastic stage decreases slightly, meaning that the stiffness has reduced. For
283 comparison, the data from the same stage of testing in Beam 3 is shown in Figure 8 and
284 support the the above conclusions.

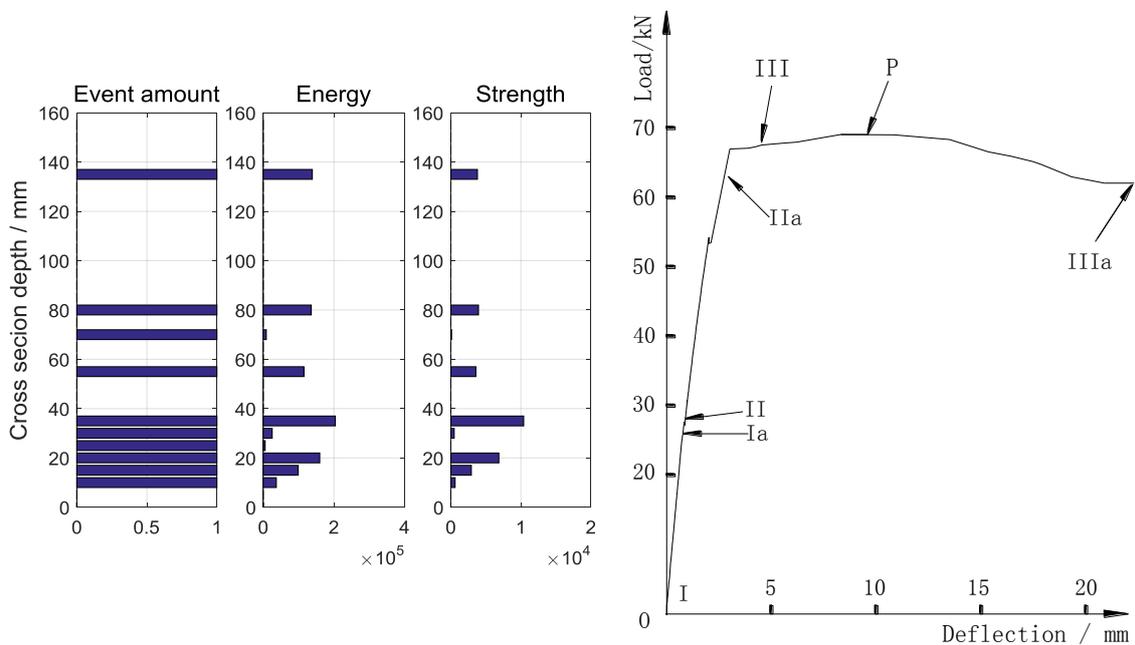
287 **Figure 8** The distributions of the acoustic emissions acquired in the elastic stage
288 through the depth (Left) and the load-deflection curve (Right) of Beam 3

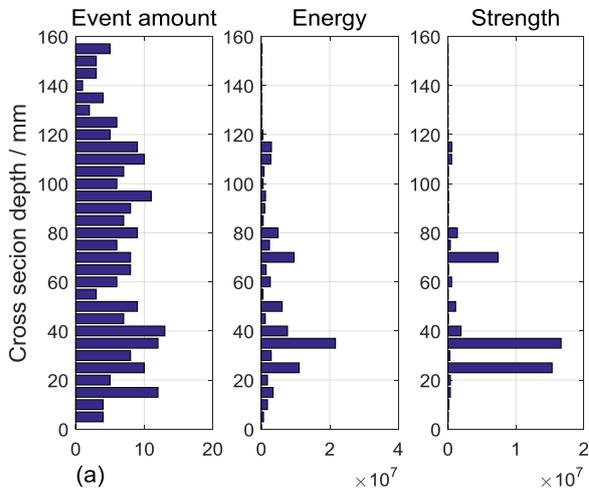
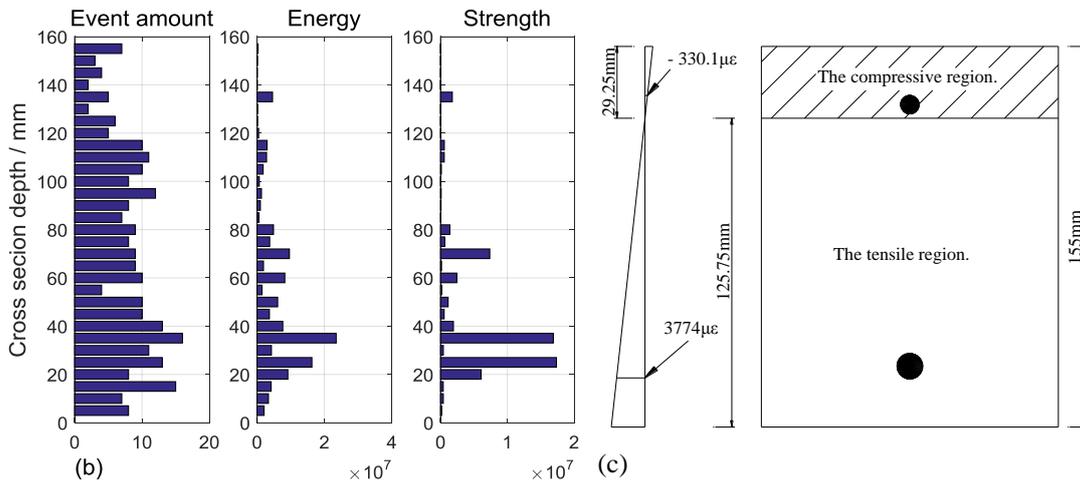
304 **Figure 9** The distributions of the acoustic emissions acquired (a) in the working stage,
 305 (b) until the end of the stage and (c) the corresponding total strain distribution through
 306 the depth of Beam 1.

291 As shown in Figure 9, two features are considerably obvious at this stage. Firstly, 211
292 events, 581% larger than the amount of emissions captured in the elastic stage, were
293 acquired on Beam 1, meaning that the AE activity significantly increased. However, the
294 activity is still low as it represents only 5.78% of the total number of the events captured
295 in the entire test. Secondly, most of the events took place in the tensile zone of the beam,
296 meaning the AE event distribution roughly matched with that of the tensile stress (the
297 right panel in Figure 9). Meanwhile, the intensity of AE events in the compressive
298 region also rose. In addition, analysing the data of the AE absolute energy came to
299 similar conclusions, and the same characteristics were also found on the other
300 specimens, which are not presented here to save space.

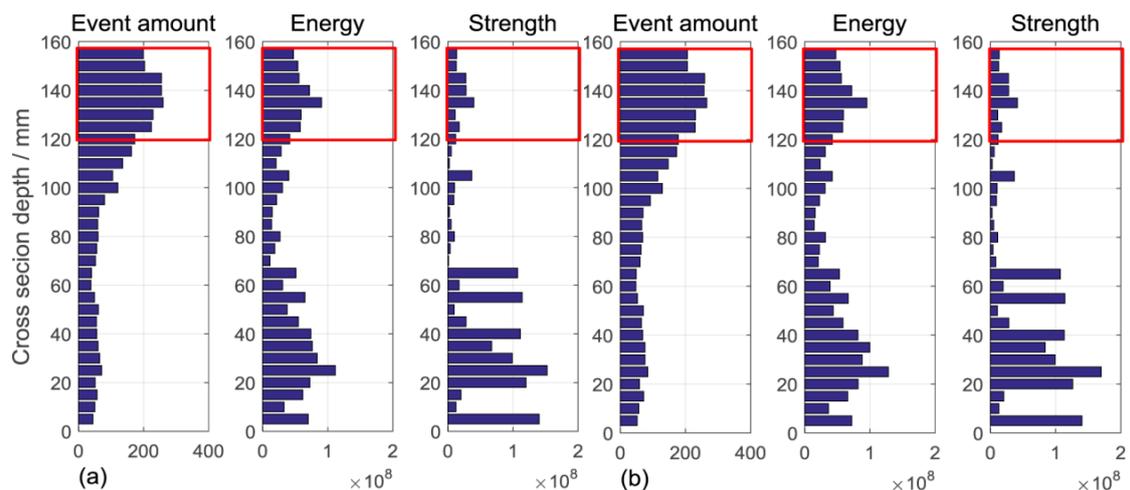
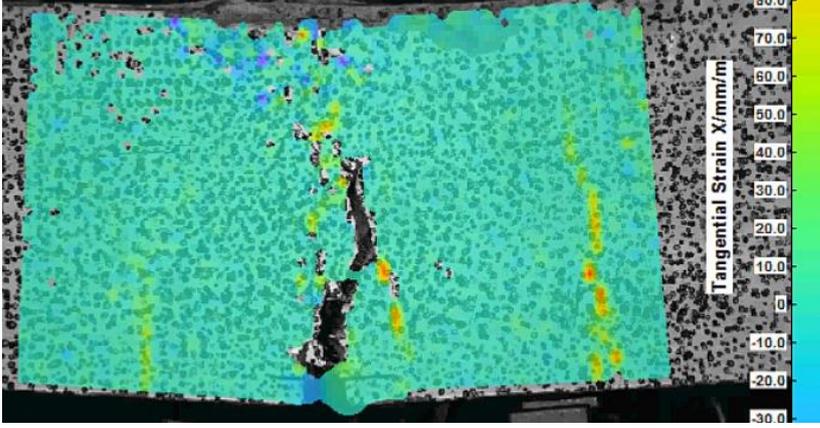
326 **Figure 10** The distributions of the acoustic emissions acquired (a) in the failure stage,
 327 (b) until the end of the test and (c) the corresponding total strain distribution through
 328 the depth of Beam 1(The compressive concrete zone is circled with red rectangles).
 329

313 In Figure 10, all AE and DIC data acquired in the failure stage (Panel (a)) and
314 throughout the test (Panels (b) and (c)) are presented, while further analysis on the
315 corresponding behaviour of Beam 1 is shown in Figure 11. On the whole, Figure 10
316 shows two features. Firstly, the AE activity dramatically rises in the stage. For example,
317 as shown in Panels (a) and (b), the order of magnitude of the AE absolute energy and
318 signal strength is 10^8 , while it is 10^7 in the previous stage. Secondly, the AE event
319 intensity in the compressive zone is far greater than that in the tensile region. Both
320 features are also observed on other specimens, such as Beam 4 (Figure 12). Additionally,
321 other researchers [19] also came to the same conclusion, namely overwhelming majority
322 of AE events appear during the final failure of structures.

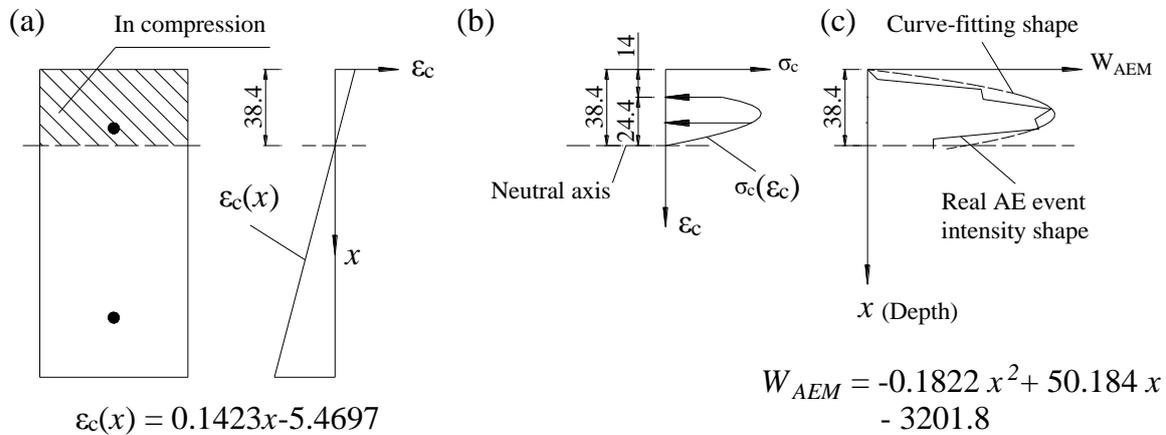
Figure 11 (a) The strain diagram on the mid-span section, (b) the corresponding stress distribution and (c) the AE event intensity distribution in the compressive region of Beam 1 (Length in mm, stress and strength in MPa).

As shown in Panels (b) and (c) of Figure 11, the distribution of the AE event intensity correlates very well with that of the compressive stress over the zone. Firstly, these two distributions are of very similar curve shapes. Secondly, the peak values of the AE event intensity and the stress occur at almost the same location. More specifically, the former appears 20mm away from the top, the latter 22mm. This was consistent in all beams and demonstrated by Figure 12 from Beam 4. In conclusion, the AE intensity variation pattern accurately correlates with the distribution of the compressive stress through the cross-sectional depth in the failure stage.

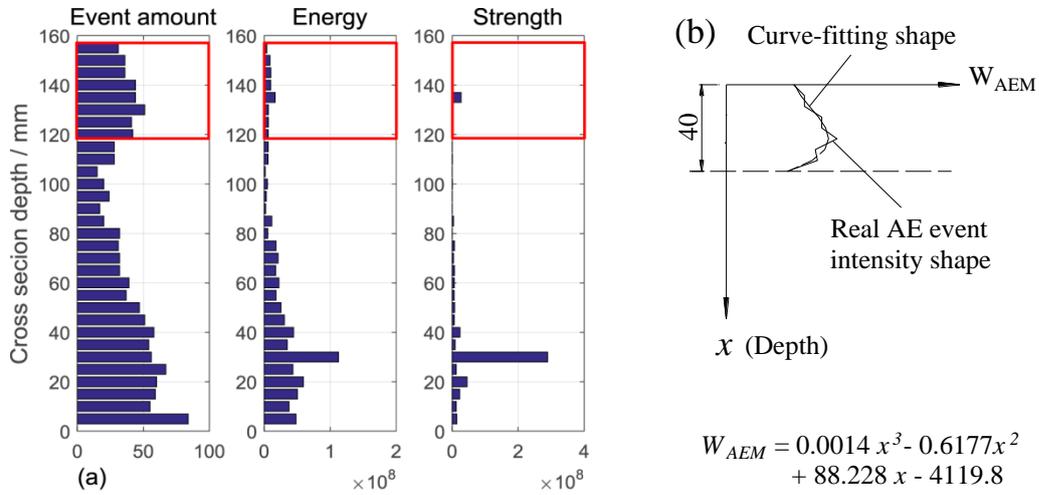
370 **Figure 12** (a) The distribution of the acoustic emissions acquired in the test on Beam 4
 371 through the depth and (b) the AE event intensity distribution over the compressive
 372 region circled with red rectangles (Length in mm).

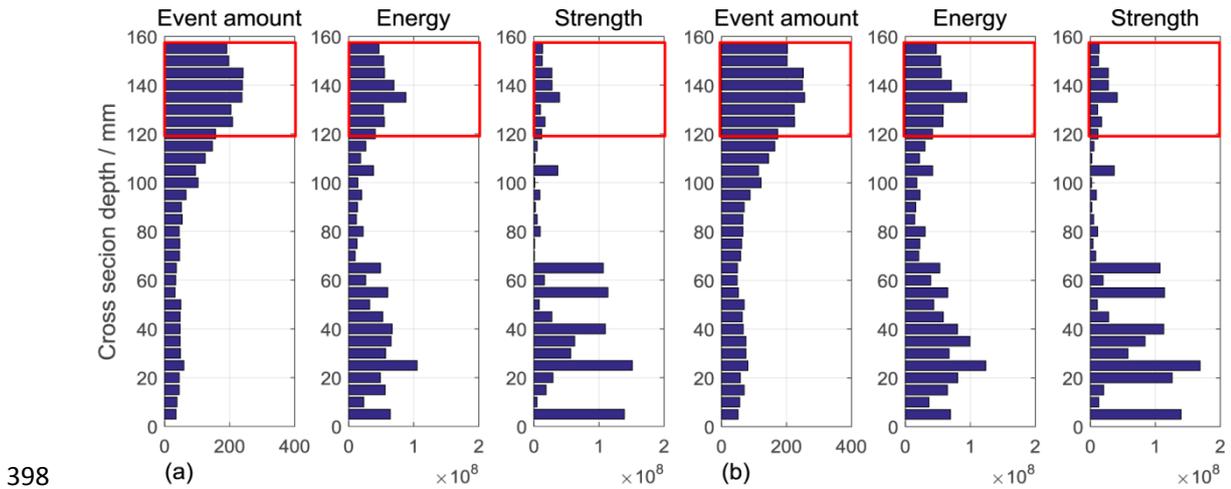
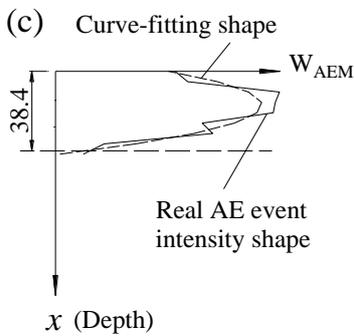
$$W_{AEM} = -0.171 x^2 + 47.474 x - 3062.3$$

399
 400 **Figure 14** The distributions of the acoustic emissions acquired (a) during the period
 401 from P to D, (b) until the Point D across the depth of Beam 1 and (c) the AE event
 402 intensity distribution over the compressive region circled with red rectangles (Length
 403 in mm).
 404

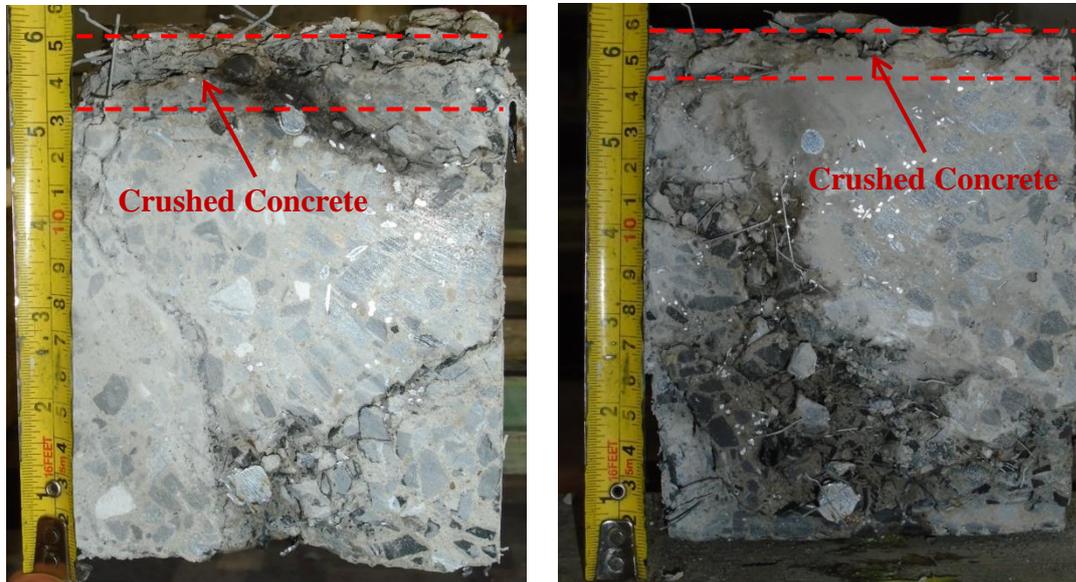
422 **Figure 15** The cut cross sections of Beams 5 (Left) and 6, respectively.

407 Beams 5 and 6 were cut at the failed sections after final failure. As shown in Figure 15,
408 two conclusions can be drawn based on observations from the cut sections. Firstly, the
409 thickness of the crushed concrete measured in Figure 15 matches with the estimation
410 (14mm high) in Figure 11(b). In the discussion regarding the zero-stress zone in Figure
411 11(b), it was theoretically concluded that the concrete on the top of the section was
412 crushed, which resulted in the 14mm-depth interval with zero stress. It is confirmed
413 here, and the thickness of the crushed concrete measured in Figure 15, ranging from
414 13mm to 20mm (the space in between the two pairs of red dashed lines), matches very
415 well with the estimation (14mm). Secondly, AE events occurred through the whole
416 depth. This conclusion is supported by the observation that cracks developed during
417 testing had penetrated through almost the entire cross section. This is very strong

418 evidence of the AE distributions shown in Figures 9, 10, 12, and 13. In conclusion,
419 these observations strongly support the outputs discussed previously.

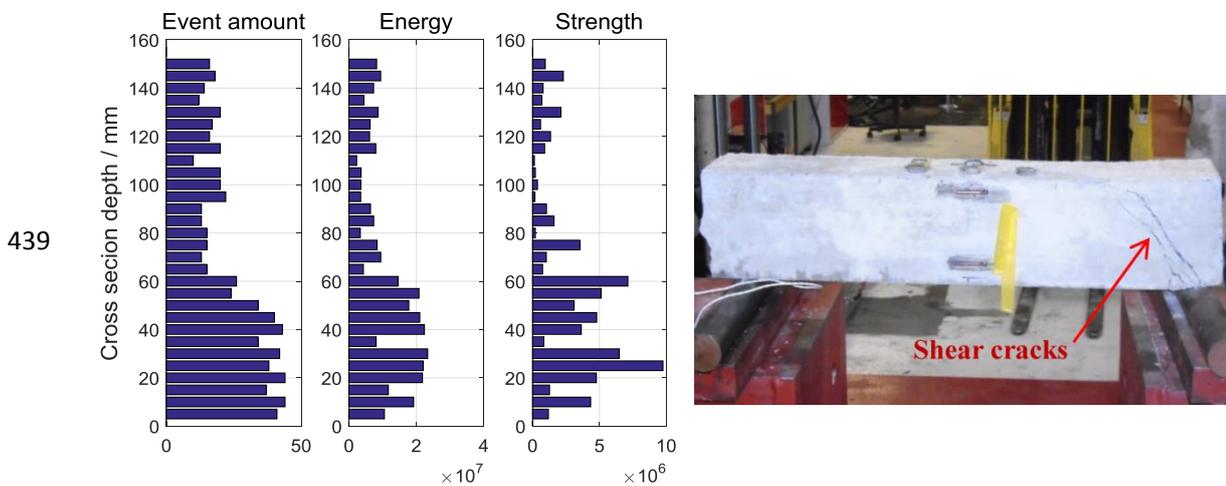
440 **Figure 16** The distribution of the AE acquired through the test on Beam 2 (Left) and the
 441 shape when it failed (Right).

425 Only Beam 2 failed in the shear mode (See Table 1 and Figure 16). The AE variation

426 across the depth of the beam is distinctively different from those that failed in the
