Shiyala Village Solar Electrification Project: 2014 Upgrade

30 August - 10 September 2014

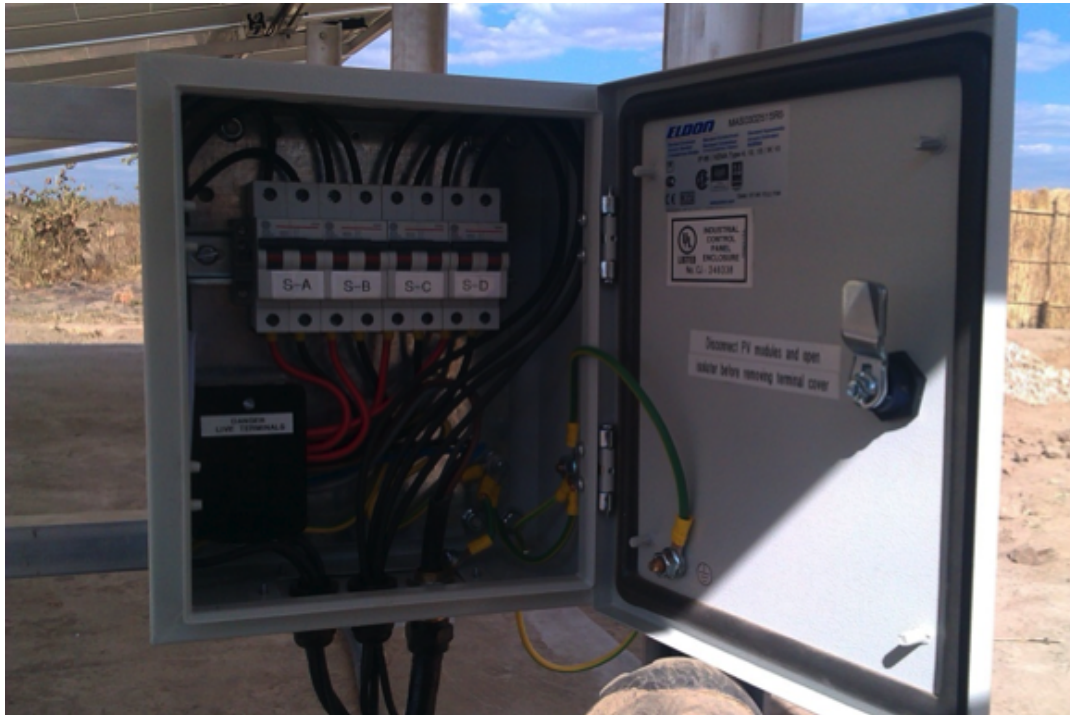
Figure 1: Inside the solar combiner box

The array is configured as 4 parallel strings of 3 series panels and produces a peak output of 3.4kW. Each string is protected with a double pole 10A MCB which also acts as a means of isolating individual faulty strings. In the event of a single string being damaged, it can be switched out leaving the remaining healthy strings in operation. To save time and avoid any potential problems the 'combiner box' which houses the MCBs and electrical connections, see Figure 1, was pre-built in a weatherproof enclosure before departing to Zambia. The combiner box was mounted on the panel frame assembly. As part of the preparation process, an electrical schematic was produced for the solar power supply which can be found in Appendix A.

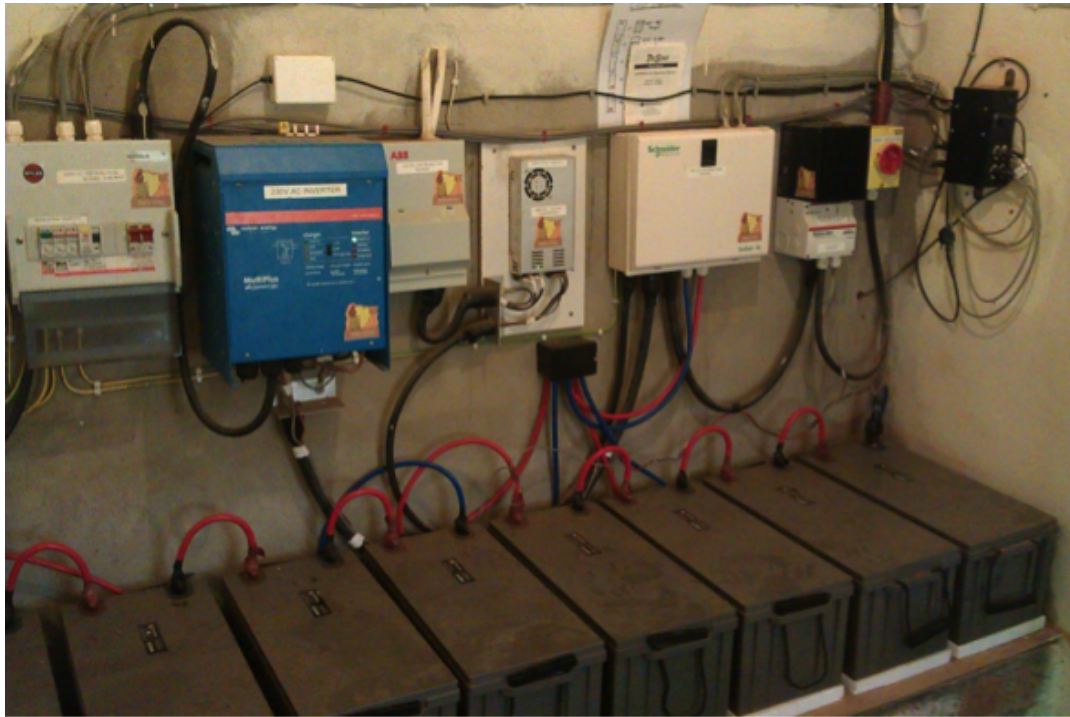
Figure 3: Eight new batteries in the battery room

Several potential solutions were considered for the battery storage method including long life flooded tubular plate, lithium and VRLA AGM batteries. It was concluded that 220 Ah, Deep Cycle AGM Batteries (Victron model number BAT412201080) would provide the most economical and maintenance free solution. The existing system voltage was 48V and therefore restricted the battery configuration to banks of four in series. Two such banks were connected in parallel to provide 21.12kWh of storage, effectively doubling that of the previous system. To accommodate the additional batteries the existing plinth was extended by local builders on the day of arrival. The existing schematics remain unchanged as the system was not modified beyond the rotary isolator located in the battery room.

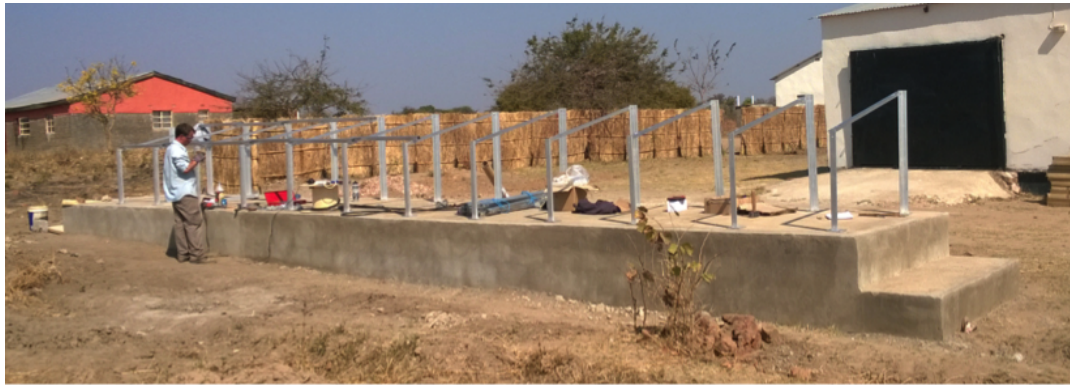
Upon initial inspection, the slab, shown in Figure 9, seemed to meet the design requirements. However, concerns were quickly raised about the construction technique when the first bolt-hole for the uprights was drilled.

It was found that the slab had a soft capping of mortar approximately 50mm thick above the remaining depth of slab containing concrete which was made up of very large aggregate. The aggregate used was found to be made

Figure 9: Overview photo of the slab

up of mainly broken up hand made clay bricks and quartz-based rocks. Usually concrete would be made up of 4 constituent parts which are; water, fine aggregate (sands), coarse aggregates (of varying diameter) and cement. Having coarse aggregates that can be compacted creating voids between them, which can be filled with a mixture of cement, and fines is what gives concrete its strength. Therefore, the mortar capping, containing only water, cement and fines, was indeed very soft and the below concrete, containing only very large aggregate, cement and water, relied on the strength of the aggregate and not the concrete as a whole. As discussed in Section 6.3, this resulted in the bolts the team had taken out to site failing to anchor the uprights effectively as the concrete was too weak to prevent pulling out of the bolts.

Should a concrete structure be required for future projects, the main purpose of the structure should be carefully assessed and compared to the knowledge and expertise of the construction team. The workers that constructed the slab created an adequate foundation like any other foundation in the area, primarily to be used to prevent the above structure sinking into the softer soil below. The purpose of the solar slab in preventing uplift and therefore, the construction techniques required, were unfamiliar to the workers and could not have been expected to be exactly what was required. However, through the sourcing of larger bolts, as discussed in the following section, the problem of the slab being too weak to prevent the pull out of the bolts was prevented.

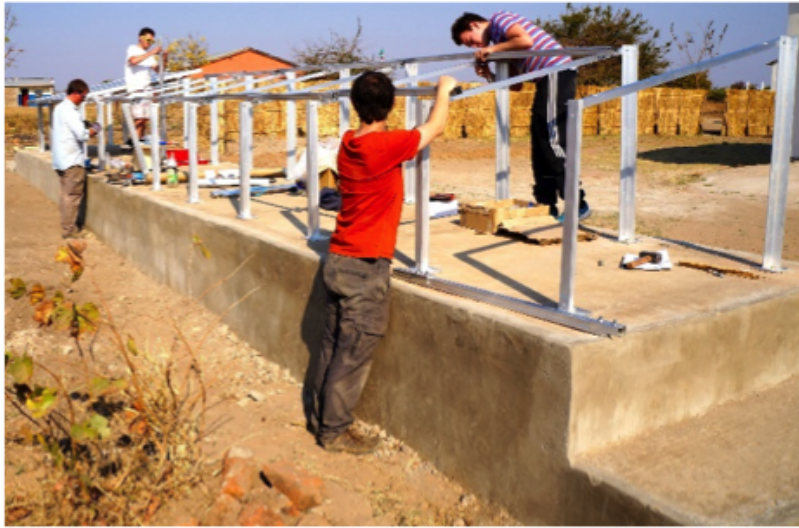
Figure 11: Frame assembly in full swing

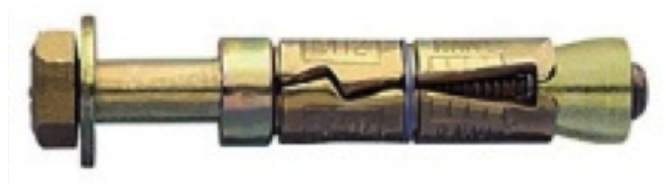
Figure 12: A rawl bolt similar in design to those used to attach the frame to the concrete slab

The next step involved marking out positions on the slab for each of the 13 rear legs. Once the position of a leg was marked, a hole was drilled into the slab in which a through bolt was to be placed. After drilling the first hole and attempting to attach a leg it became clear that the concrete was too soft to allow the through bolts to operate effectively. As a result, once the leg was attached it would sway significantly with even a gentle push. An alternative solution was found in the form of a rawl bolt, similar to the one shown in Figure 12, a small number of which were brought out with the team. The larger diameter and different operation of the rawl bolt provided a much more robust attachment in the soft concrete. As such, it was decided proceed with the assembly using rawl bolts that were purchased from the supermarket in Chongwe town.

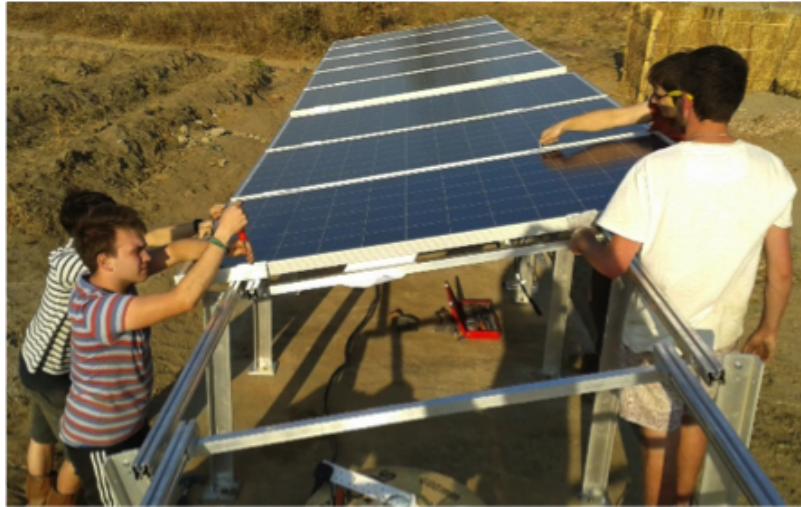
Figure 13: Attaching a solar panel using the excellent Schletter mounting system

The remainder of the frame assembly proceeded with no other unforeseen problems. The frame components fitted together easily and the Schletter mounting system proved to be a very easy and effective method of fixing the panels to the frame. It was decided not to attach the tensioning cables as the rigidity of the assembled frame proved to be more than satisfactory. The completed assembly can be seen in Figure 14.

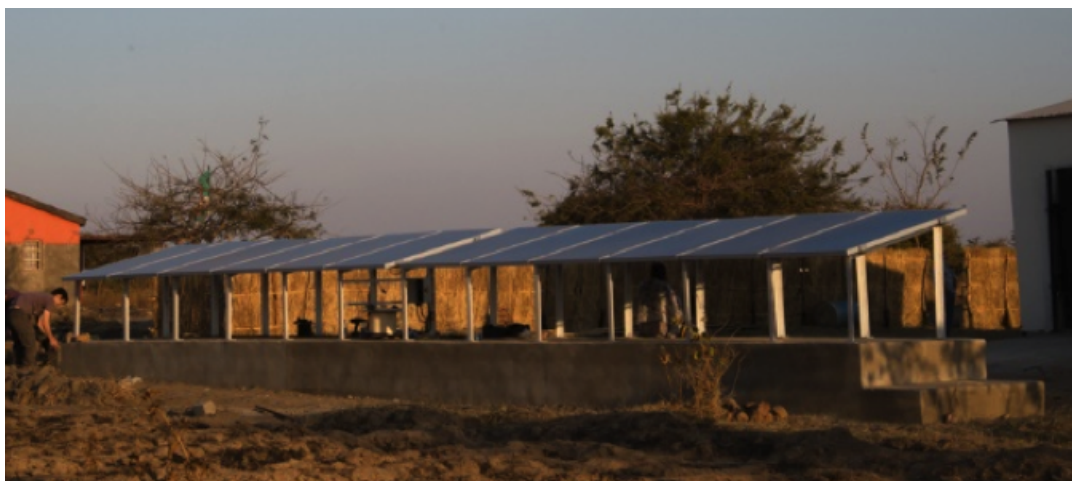
Figure 14: The completed frame with panels
