# Conservation Matters in Wales

## Challenging Buildings: the Search for Solutions

Post prints of a one-day conference held on  
Thursday 15 June 2006, at The Oakdale Institute,  
Museum of National History, St. Fagans, Cardiff.

# How to design a museum building that protects the collection without destroying itself

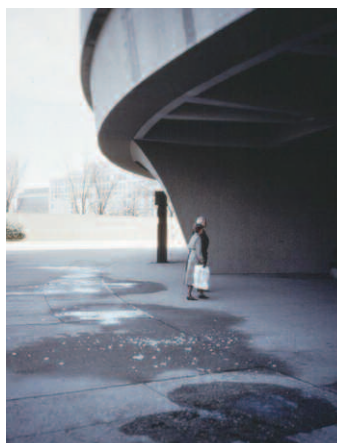
Figure 13: Office workers passing under the raised bulk of the Hirshhorn Museum in Washington DC are unaware of the danger from falling ice.

A similar process, but on a vertical plane, bombarded people passing under the Hirshhorn Art Gallery. The process is displayed in Figure 13 and explained in Figure 14. The warm air leaks out of this building not because of the stack effect but because the inside air is under pressure. This is to ensure that outside air does not enter by unauthorised routes to disturb the operation of the air conditioning.

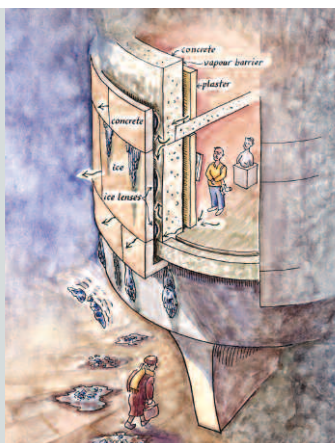
14

Figure 14: How the Hirshhorn makes ice. Warm, humidified air from the pressurised interior leaks out. Its water content freezes on the cold outer skin of the wall. The rising sun warms the concrete and melts the ice, which escapes through drain holes to the outside of the wall where it re-freezes because of evaporative cooling in the brisk wind of air of low relative humidity. Later, the growing solar radiation melts the ice where it touches the wall, sending slabs of ice to smash on the pavement below.

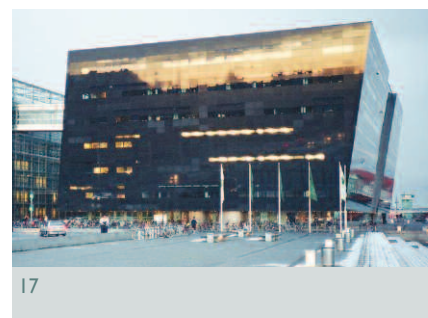
17

Figure 17: The Royal Library in Copenhagen, opened in 1999. Architects Schmidt, Hammer & Lassen. The outward sloping walls are covered with black Zimbabwe granite veneer and with large areas of glass.

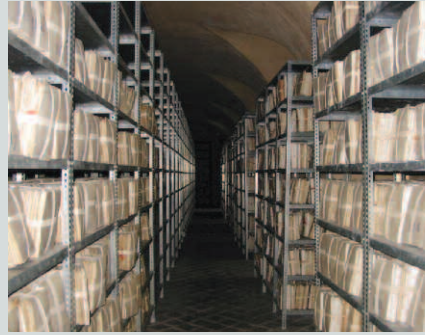
20

Figure 20: The military archive in the castle of Segovia. The room has massive temperature buffering from the approximately 13 metre thick limestone wall on the left. The room is lit by small windows in the thinner, but still massive wall on the right. (Photo by Victoria Smith).

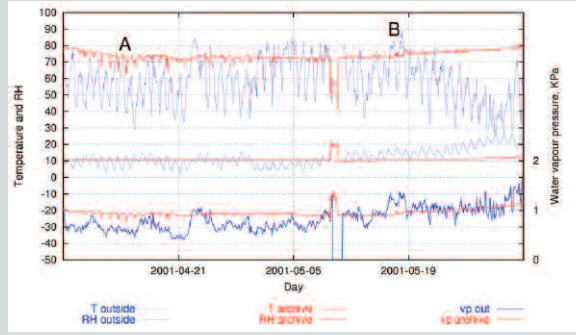
21

Figure 21: The climate in the archive over a three month period. Notice the daily dips in RH at point A, caused by the archivist opening the windows during the day. At point B, later in the year, the outside air contains more water vapour, so opening the windows now increases the interior RH. If a combination of sensors and computer could calculate exactly when to open the windows, a more even RH would be obtained, and also a lower average RH.

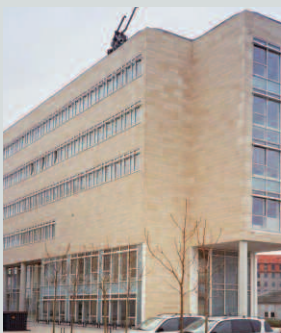
22

Figure 22: The Arnamagnæan archive of early Scandinavian manuscripts occupies the windowless volume behind the facade of this building in Copenhagen University. KHRAS Architects 2004.

An archive in Copenhagen (Figures 22-24) illustrates one strategy for reducing the RH without using air conditioning. In this archive heat is borrowed from the surrounding office areas and balanced against heat loss to the outside, so that the interior temperature lies about half way between inside and outside temperature.

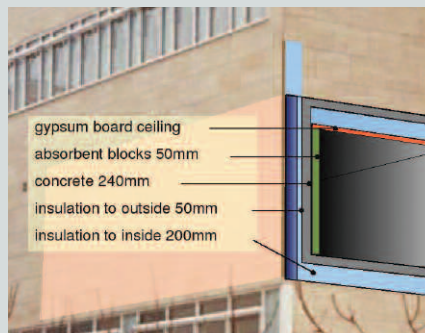
23

Figure 23: A cross section of the archive. On the inside there is a 50mm layer of moisture absorbing expanded cement covered with a single coat of porous silicate paint. The massive reinforced concrete box, designed to withstand a fall to the ground, functions as a temperature buffer. The insulation outside the concrete shell is, unusually, thicker towards the interior of the building and thinner towards the outside. This results in a temperature in the room which

hovers midway between the nearly constant temperature of the inhabited parts of the building and the annual cycle of outside temperature.

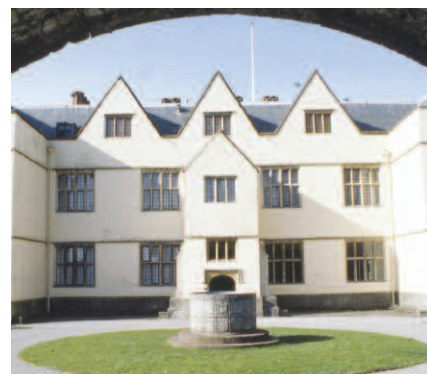
Exterior view of St Fagans Castle (built circa 1590). Electric under-floor heating was introduced into the kitchen in 1991.

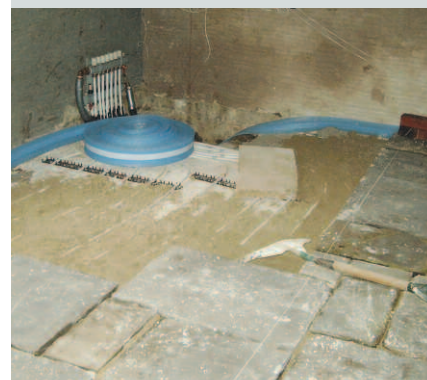
St Fagans Castle. Electric under-floor heating was introduced into the kitchen, the flagstone floor acting as a heat reservoir.

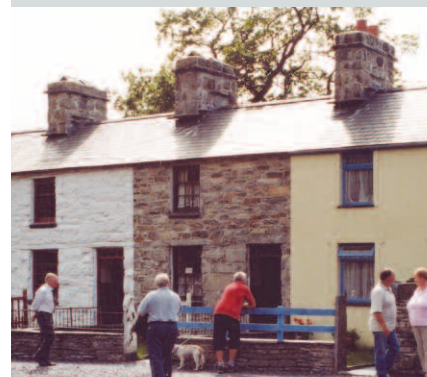
Fron Haul: a terrace of four houses moved from Tanygrisiau, Gwynedd, and re-erected at the National Slate Museum, Llanberis in 1998. Electric under-floor heating was incorporated in the houses, the slate-flag floors acting as heat reservoirs, enabling a constant background temperature to be maintained even at nights and in winter.

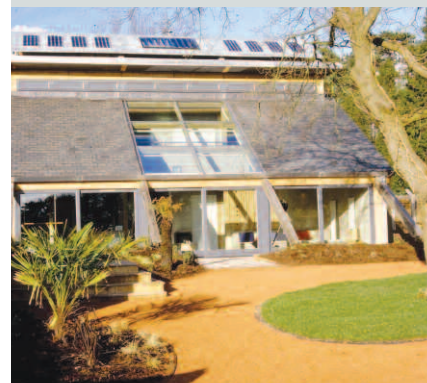
Y Tŷ Gwyrdd (a 'House for the Future') designed by Jesticoe & Whiles and built at the Museum in 2001. A ground source heat pump is one of four different systems available for heating the interior.

The building can be heated in several ways. Large areas of glazing on the south side mean that the interior can quickly be warmed by direct sunlight. A ground source heat pump linked to a 35m deep borehole circulates heated water via a compressor unit. A constant temperature of 10°C underground is raised three-fold in the heat pump and this is then fed under the floor, which acts as a giant heat reservoir.

There is also a small stove in the main living space downstairs which burns pellets made from recycled sawdust. However, the building is so efficient that the stove has only been used on very rare occasions.

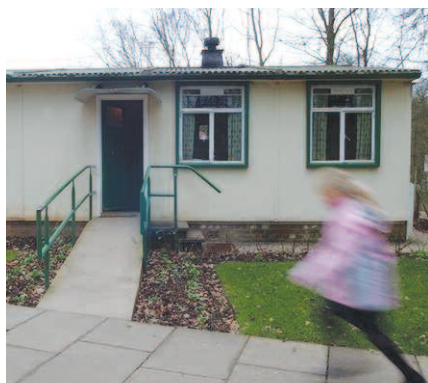
Aluminium prefab: moved to the Museum in 1998. An electric under-floor heating system was installed in order to maintain even temperatures throughout the building.

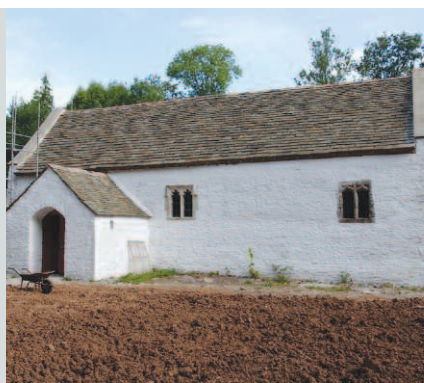
St Teilo's church: rebuilt at the Museum to its appearance circa 1520. A ground source heat pump has been incorporated to improve inside temperatures and humidity levels.

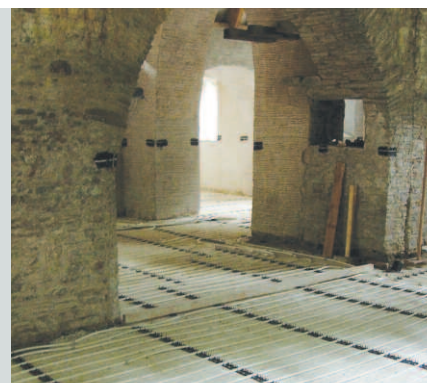
St Teilo's church: Under-floor pipework being laid inside the church on top of a limecrete base. The flagstone floor acts as a heat reservoir and the system is controlled by hydrostats located in the roof-space.
