U-value Monitoring of Infill Panels of a Fifteenth-century Dwelling in

Herefordshire, UK

Christopher J. Whitman and Oriel Prizeman

Published: APT International, Bulletin, Vol. XLVII No. 4 2016 <http://www.apti.org/>

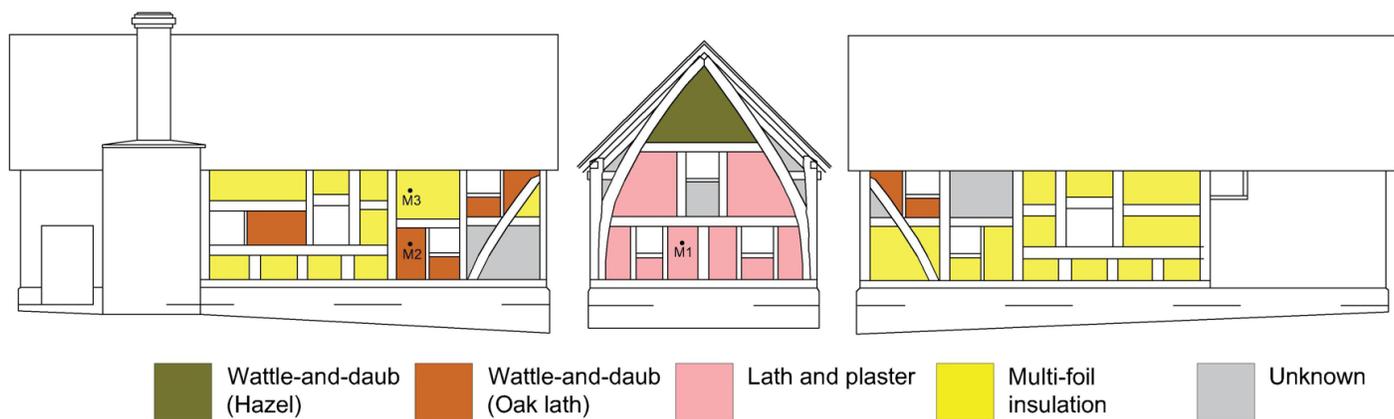
Fig. 1. Hacton Cruck Hall, east, north, and west elevations showing panel infill materials, 2015. All images by the authors, unless otherwise noted.

This paper presents the results of in situ U-value (thermal transmittance) monitoring of three infill panels of differing ages and material assemblies at a fifteenth-century cruck hall in the Wye Valley in Herefordshire in the English West Midlands. The property, once derelict, has been restored in stages over the past 15 years by its owner and now provides holiday accommodation (Fig. 1). Three types of panels were monitored: one original oak-lath and lime-plaster panel, one replacement wattle-and-daub panel (earth render on timber lath), and one new panel with modern multi-foil insulation consisting of reflective foils separated by polyester fleece. The multi-foil insulation is held in place between vertical timber staves within a void finished internally and externally with lime plaster on expanded metal lath. Figure 1 shows the location of each

panel type and the monitoring points M1, M2, and M3. Twenty-two percent of the infill panels are original oak lath and lime plaster; 18 percent are wattle and daub; 46 percent are insulated; and 14 percent are of unknown construction. All panels are visually identical and in good condition. Thermography and pressure testing were also conducted to complement the in situ U-value monitoring. This monitoring forms part of an ongoing PhD research project into the low-carbon retrofitting of historic timber-framed buildings in the UK.

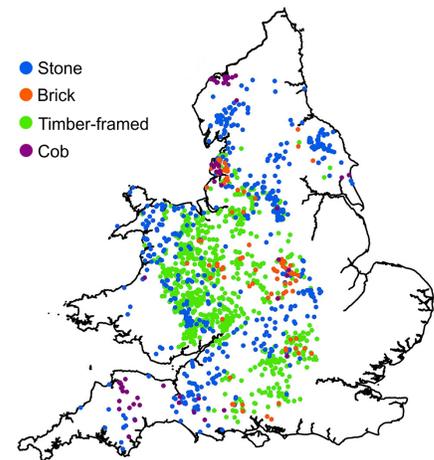
Fig. 2. Map of the UK showing distribution of surviving and demolished cruck-framed buildings according to N. W. Alcock, *Cruck Construction: An Introduction and Catalogue* (London: Council for British Archaeology, 1981). The map is by the authors based on the information of N.W. Alcock.

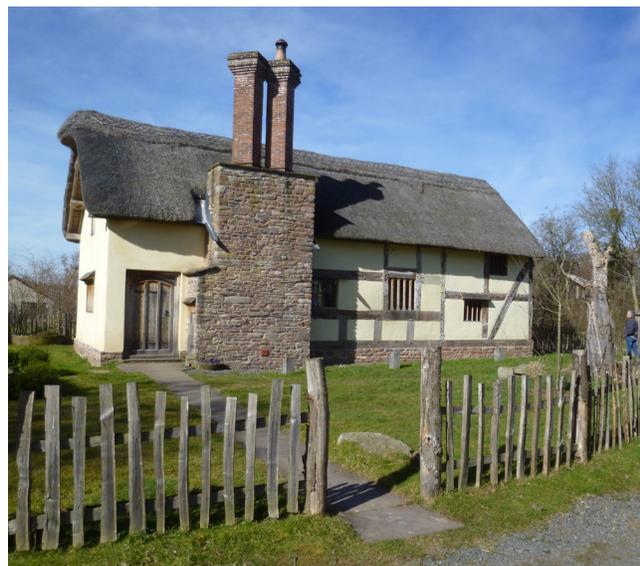
Fig. 3. Hacton Cruck Hall, Preston-on-Wye, Herefordshire, UK, built in the late-fourteenth or early-fifteenth century, east elevation looking northwest, 2015.

uninhabited and abandoned for much of the twentieth century. Prior to restoration, the south bay had collapsed, and much of the remaining fabric was in a poor state of repair. Over a period of 12 years, starting in 2000, the current owner undertook a process of restoration that resulted in the building that exists today (Fig. 3).

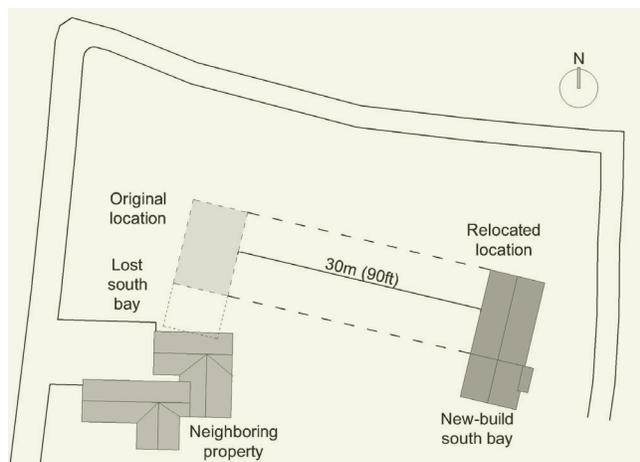
Fig. 4. Hacton Cruck Hall, site plan showing original and relocated site, 2015.

In order to reconstruct the lost south structural bay, it was necessary to relocate the building approximately 30 meters (90 feet) to the east (Fig. 4).

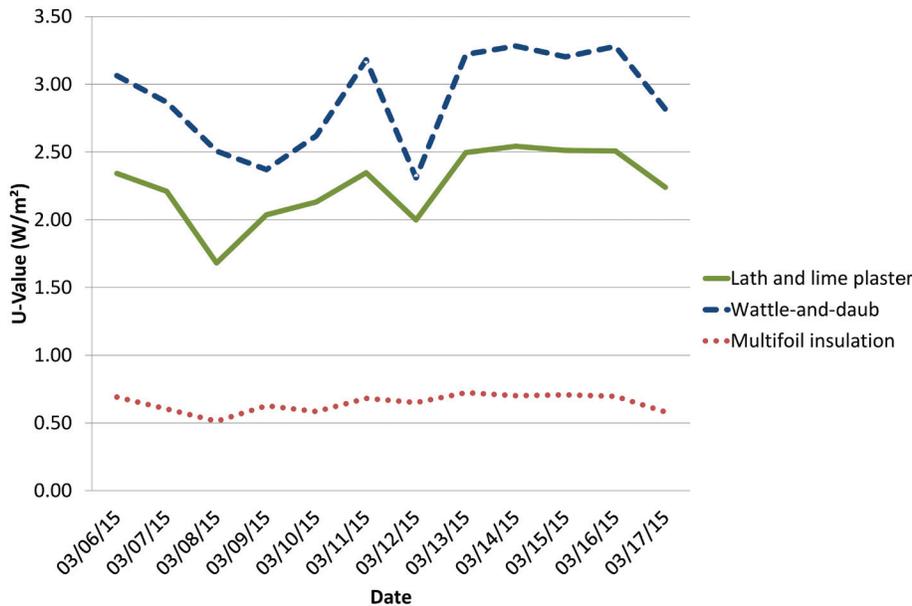
Fig. 5. Calculated U-values of three infill-wall panels measured on March 6–17, 2015.

In accordance with BS ISO 9869-1:2014, only nighttime readings (from one hour after sunset until sunrise) were included in order to remove the influence of any direct solar radiation. The thermal conductance was deemed to be that recorded over a period of three subsequent nights, where a variation of no more than ±5 percent was detected in the calculated U-value. This was observed on the nights of March 13 through 16, 2015. The results obtained are presented in Figure 5 and Table 1.

The results show that the original lath and lime-plaster panel performs remarkably well with a U-value equivalent to that of a historic solid brick wall.⁷ The new wattle-and-daub infill performs less well, with a U-value equivalent to that of a concrete wall 250 millimeters (10 inches) thick. The new panel with multi-foil insulation sandwiched between lime plaster on metal lath performs the best, with a U-value equivalent to that of a typical new stick-frame building insulated with 2 inches of mineral wool. The new insulated panel conducts only 28 percent of the heat when compared to the original lath-and-plaster panels.

Table 1. Thermal transmittance and thermal resistance of wall panels calculated from data (shown in Figure 5) measured March 13-16, 2015.

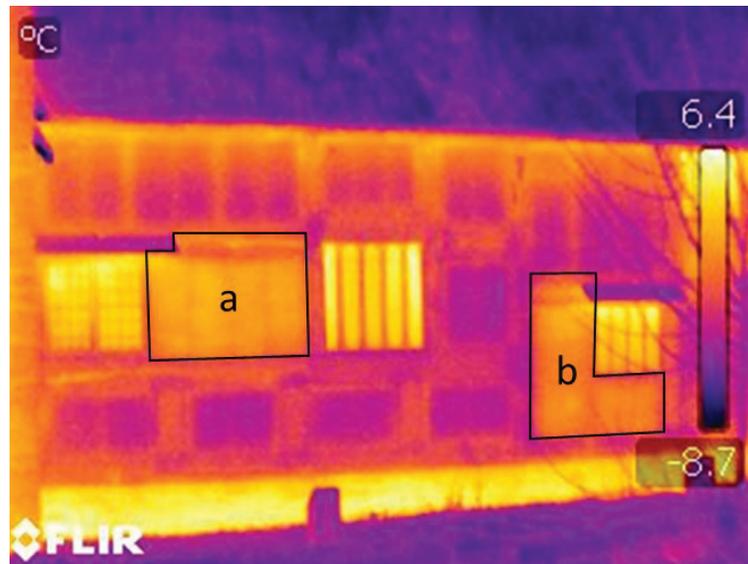
Fig. 6. Hacton Cruck Hall, thermographic image of exterior of east elevation, taken at 5:30 a.m. on March 25, 2015. Lighter colors indicate greater heat loss. New wattle-and-daub panels (a and b) show more heat transfer than surrounding panels insulated with multi-foil insulation.

The images clearly show the differing thermal performance of the various infill panels, with the lighter, warmer colors indicating areas of higher heat loss. In Figure 6 two new wattle-and-daub panels can be identified in paler orange (a and b), due to their higher surface temperature. One panel is located between the two windows on the left (a), and the other is L-shaped and adjacent to the right-hand window (b). Cold-bridging (increased localized thermal transmittance) formed by the upright timber staves within the panels appears as the lighter vertical lines in the middle of each panel. The image also indicates the lack of sufficient perimeter insulation to the edge of the concrete floor slab containing underfloor heating.

While the external thermography visibly demonstrates the differing thermal performance of the infill panels (Fig. 6),

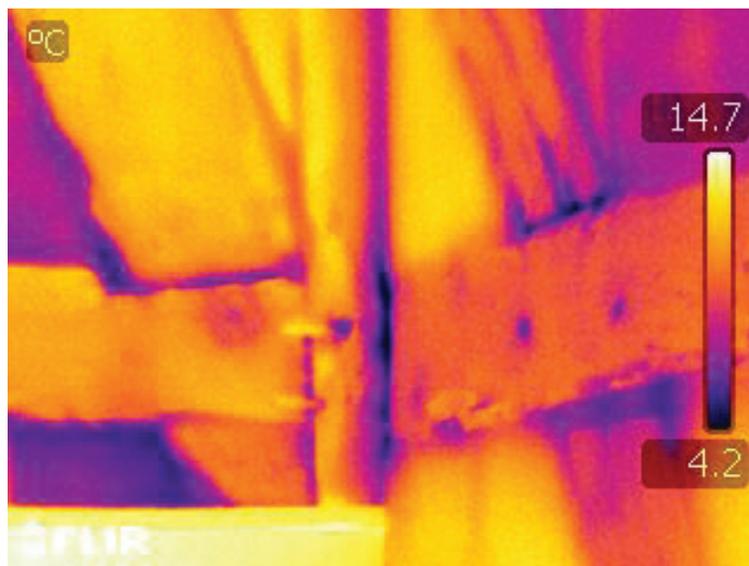
Fig. 7. Hacton Cruck Hall, thermographic image of internal northeast corner, taken at 5:45 a.m. on March 25, 2015.

the internal thermography made evident the heat loss via air infiltration through the perimeter joints between panel and frame, through the joints between timbers, and through peg holes within the timber members themselves (Fig. 7). The cold air being drawn into the depressurized building shows up as dark blue and purple in this image. Overall, the thermography begins to suggest that while the inclusion of multi-foil insulation within most of the new panels will improve their individual performance, there are other factors influencing the overall efficiency of the building as a whole. These factors became more evident in the results of the hygrothermal monitoring and pressure testing.

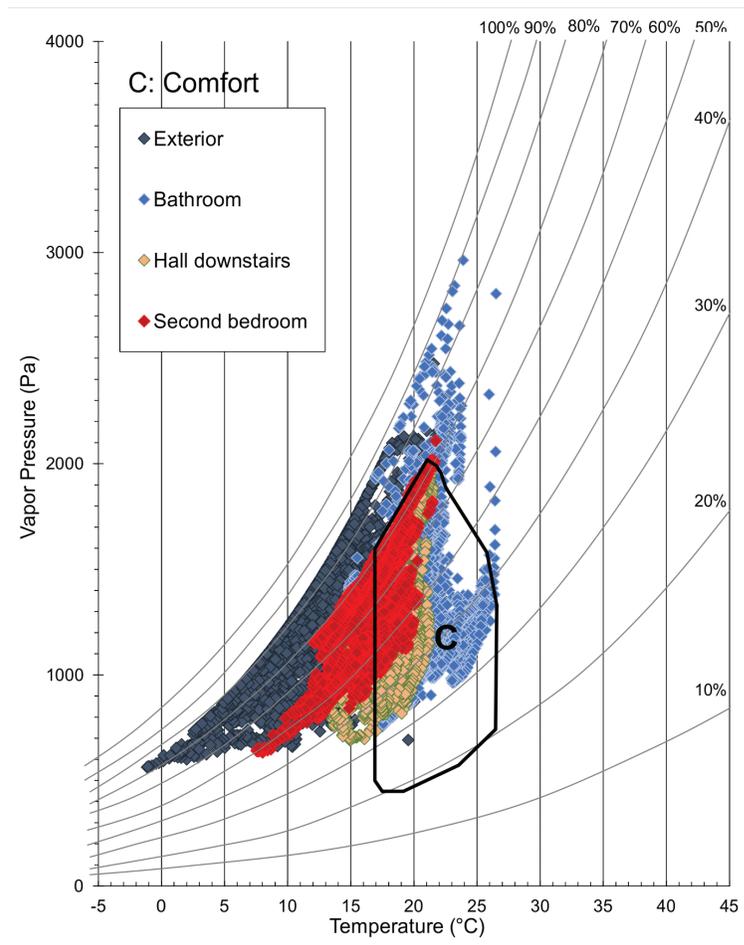
Fig. 8. Psychrometric chart created according to Baruch Givoni showing hygrothermal comfort at Hacton Cruck Hall during occupied days between March and November, 2015.

The results of this monitoring are presented in Figures 8 and 9. They show the hygrothermal comfort as defined by Baruch Givoni for those days when the house was occupied, according to the visitors' book.⁹ The results show that the warmest room in the house is the ground-floor bathroom, which has only one external wall, original lath-and-plaster infill, and underfloor heating. However, due to high relative humidity, this

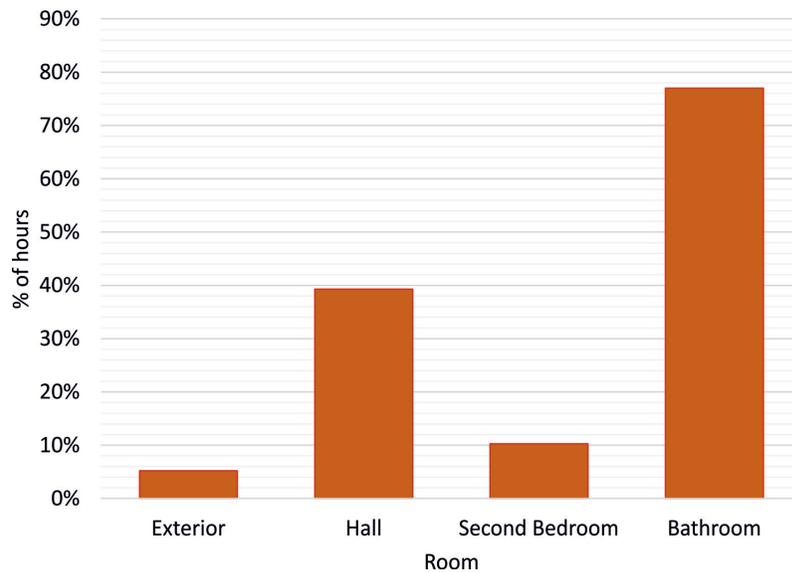
Fig. 9. Percentage of occupied hours where hygrothermal comfort was achieved at Hacton Cruck Hall between March and November, 2015.

room achieves acceptable comfort conditions only 77 percent of the time. The main, double-height hall achieves comfort conditions 39 percent of the time. In part this may be due to the volume of the space and the possible stratification of temperature, with heat rising. The infill panels of the exterior walls of this room are predominantly new insulated panels, with only 9 percent new wattle and daub. The measurements suggest that the least comfortable room is the second bedroom, located on the ground floor, which achieves comfort conditions a mere 10 percent of the time, even though 62 percent of its external infill panels are insulated and 38 percent are original lath and lime plaster. It should be noted that the effects of radiant temperature are not taken into account in these measurements.

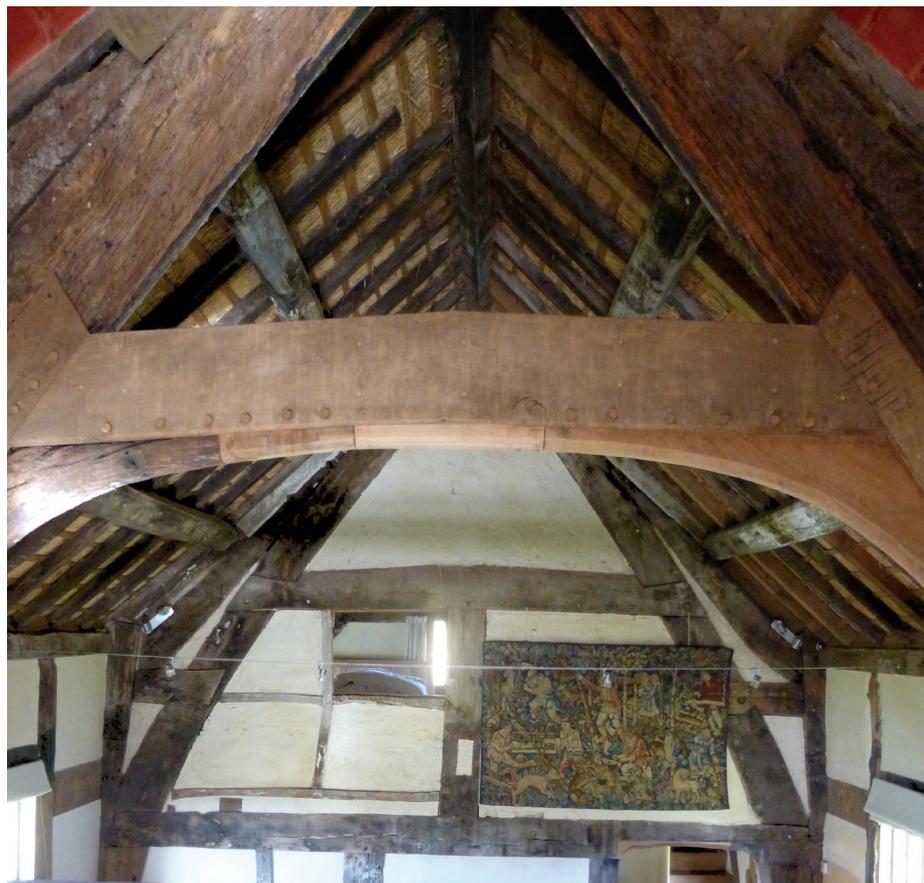
Fig. 10. Hacton Cruck Hall, interior view of central hall with bedroom beyond showing unlined thatch roof, 2015.

$\text{m}^3/\text{hr}/\text{m}^2$. One area responsible for these high infiltration rates has already been identified, that of the junctions between panels and timber and between those timbers themselves. However, a much more significant element contributing to this lack of air-tightness is the unlined thatched roof (Fig. 10). Thermography of this element clearly showed the difference between the unlined and the lime-plastered roofs at either end of the building.
