# **Use of Rate of Change of Torque to Detect Damage in Gear Systems**

A thesis submitted in partial fulfilment for  
the degree of Doctor of Philosophy

Tribology and Performance of Machines, Structures and Materials  
School of Engineering

2018

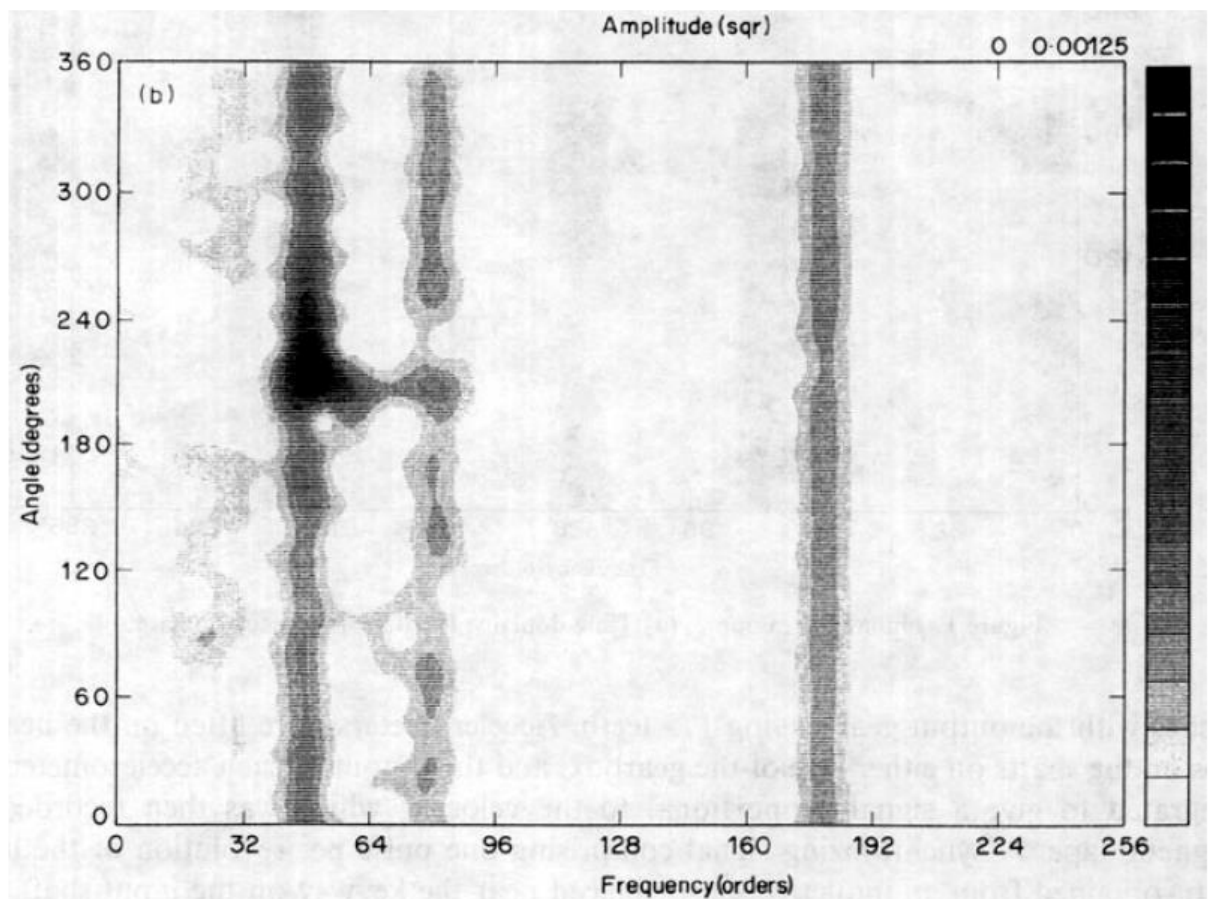
Figure 2-17 – Spectrogram of a gear with a small spall defect on a single tooth face located at approximately 210° (extracted from Wang and McFadden (1993a)).

Wang and McFadden (Wang and McFadden, 1993a) described the fundamentals of the Short Time Fourier Transform (STFT) and the spectrogram which is a visual indication of the STFT presenting a signal simultaneously in both the time and frequency domains, allowing the assessment of the change in frequency content of a signal with time. The spectrogram was found to be highly sensitive to changes of short duration in the signal, such as those caused by local damage to single gear teeth. The paper presents the results of the application of these techniques to the gearbox of a ball mill used for crushing coal in a power station. This can be seen in Figure 2-17 which shows the frequency content of the time signal captured, plotted against angular position of an idler gear.
