# Strength of materials and masonry structures in Malawi

## ABSTRACT:

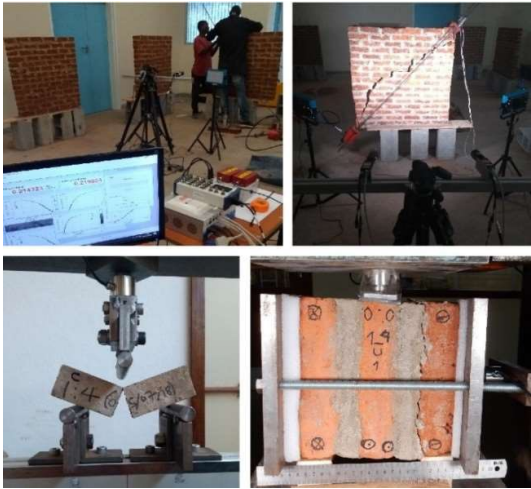
Figure 1. Typical testing configurations

The testing equipment consisted of a combination of conventional laboratory testing devices with some portable testing rigs mountable on the specimens directly and on the laboratory’s strong floor, and a high-precision video tracking system for measurement of displacements (Imetrum Video Gauge), with synchronised analogue load cell signals connected onto it. Some typical photos of the basic testing configurations are shown in Figure 1.

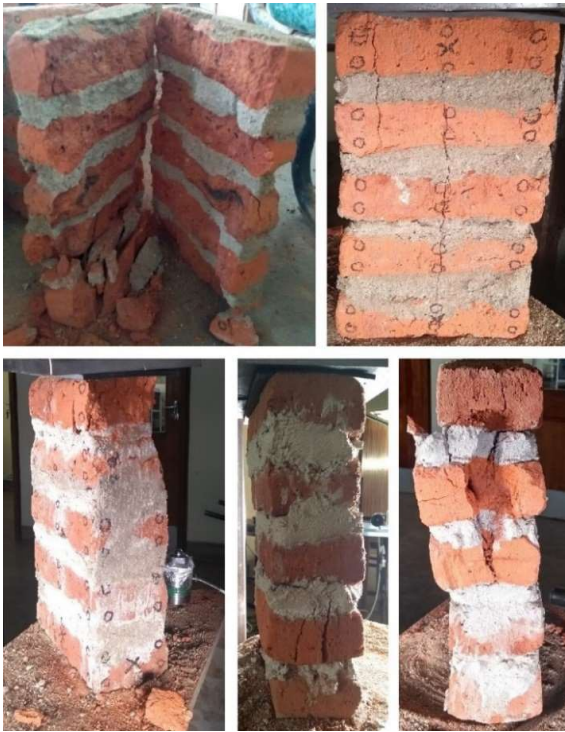
Figure 5. Failure modes of masonry prisms in compression; note the local brick crushing mechanism in the bottom pictures.

Results for compression test of masonry elements are shown in Figure 4 for the strongest and weakest combinations. It is known from the literature that the strength of the masonry composite is normally lower than the strength of the brick units, which are considered to be the strongest component, due to the lower strength and higher compressibility of the mortar (Kaushik et al., 2007). However, in this case study, the strength of the bricks is comparable and is in some cases even lower than the mortar strength. As a result, the compressive strength of all prisms falls within a narrow range. The failure mechanism was found to be characterised by local crushing of the weakest brick in the stack, according to the distribution shown in Figure 2. Typical photos of uniformly distributed and local crushing mechanisms are shown in Figure 5. The measured values are

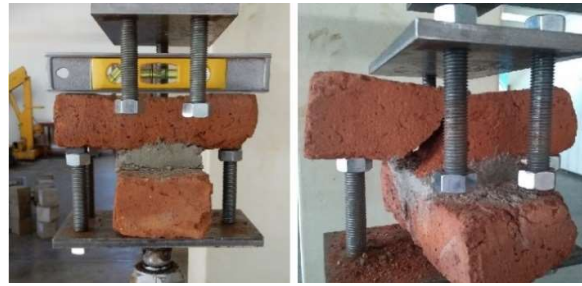
Figure 6. Crossed couplet method and associated problems due to very low strength bricks

Results from the crossed couplet tension tests are summarised in Table 2. The maximum tensile resistance for the strongest 1:4 and 1:6 configurations was not possible to be measured due to the failure of weak bricks before failure of the interfaces (Figure

6). Thus, a better method, such as the bond wrench (ASTM C1072, 2013; EN 1052-5, 2002) could be more applicable compared to the crossed couplet test. From these results, it is obvious that the mud mortar material performed much worse than the cement mortars in terms of interface adhesion. Practically, increasing cement ratios improves the interface adhesion, even though the results had significant scatter and were quite sensitive to the specimen's surface condition and workmanship.

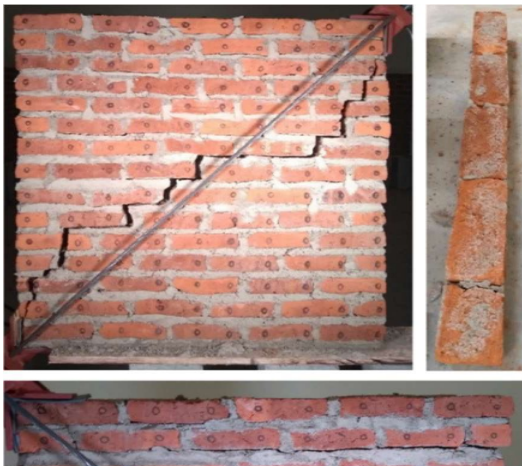
Figure 9. Typical failure modes in diagonal shears tests; note the bed joint failure mechanism and the associated “dry” joint

The results for the panel shear testing are shown in Figure 8, based on the more accurate RILEM method, over the simplified ASTM approach (Brignola et al., 2008). The results are consistent with the interface resistance measured from the triplet shear tests. The differences in strength and stiffness are obvious for the different configurations. Adobe masonry is around five times weaker compared to the weak 1:6U specimens, which is around three times weaker than the stronger 1:4F. From the stress-strain curves, premature failure of many specimens can be observed, corresponding to parallel sliding along a “weak” joint, rather than a diagonal crack (see typical failure modes in Figure 9).
