Fragility curves for non-engineered masonry buildings in developing countries derived from real data based on structural surveys and laboratory tests

Viviana Iris Novelli^{1,2} · Raffaele De Risi² · Ignasio Ngoma³ · Innocent Kafodya³ · Panos Kloukinas⁴ · John Macdonald² · Katsuichiro Goda⁵

Abstract

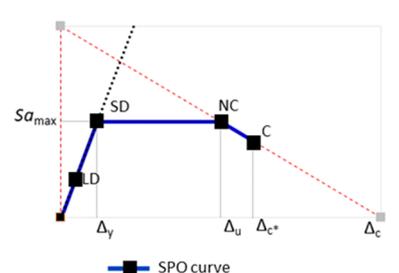
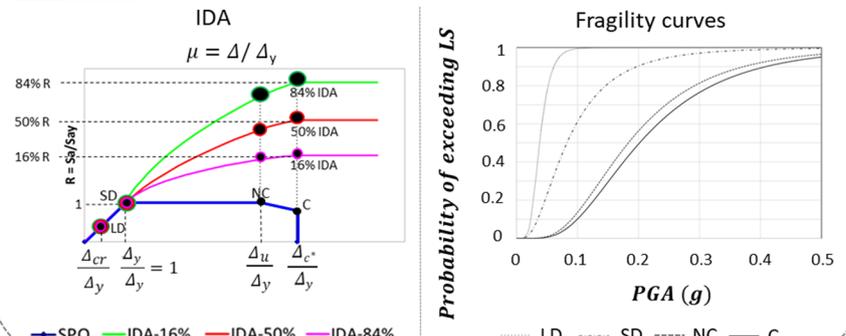
Fig. 2 Methodology for seismic performance assessment of Malawian masonry buildings

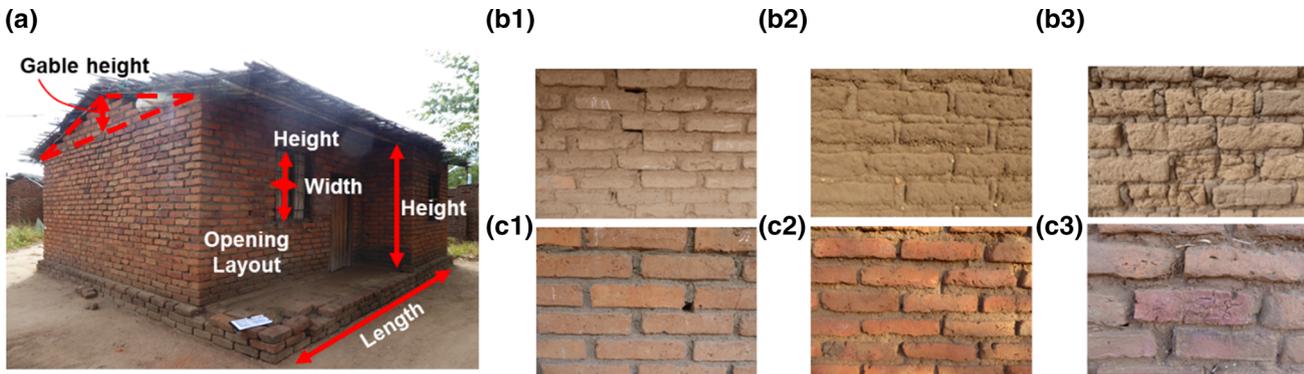
Fig. 3 a Geometrical measurements collected for each inspected façade, b1, c1 good; b2, c2 medium, b3, c3 poor fabric quality of unfired and fired bricks, respectively

1. Good fabric quality: bricks (unfired or fired) have regular shapes and regular average thickness of mortar layers. Bricks (Fig. 3b1, c1) have a homogeneous texture. Brick bonding is regular. Bricks have no apparent or hair-line cracks.
2. Medium fabric quality: bricks (unfired or fired) have partially regular shapes and mortar layers. Bricks (Fig. 3b2, c2) have a medium porosity. Brick bonding is partially regular. Bricks might have light cracks or small holes.
3. Poor fabric quality: bricks (unfired or fired) have irregular shapes and mortar layers. Bricks (Fig. 3b3, c3) have a high porosity. Overlapping of bricks is irregular. Bricks often have deep cracks, possibly from poor manufacturing methods or due to weathering.

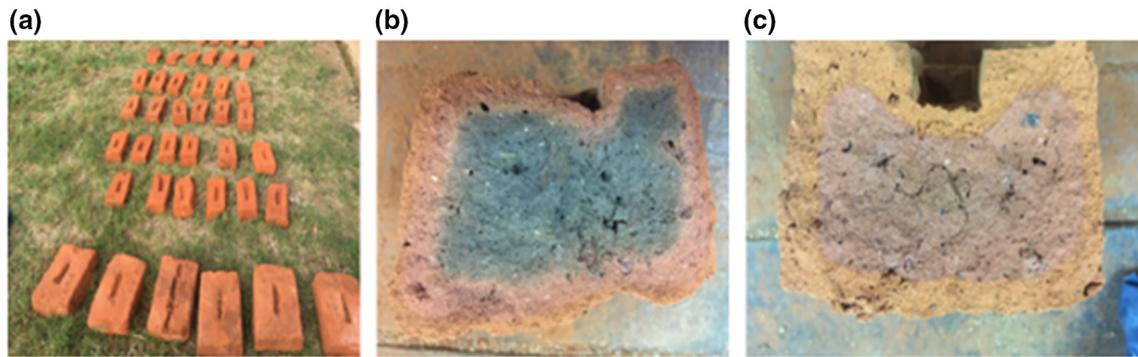
Fig. 4 Brick specimens that are used for the material tests

50 mm. These bricks, although sampled from the same batch, exhibited significant variation in fabric quality (i.e. colour, shape, and size, as illustrated in Fig. 4), but this was typical of bricks observed in the field.

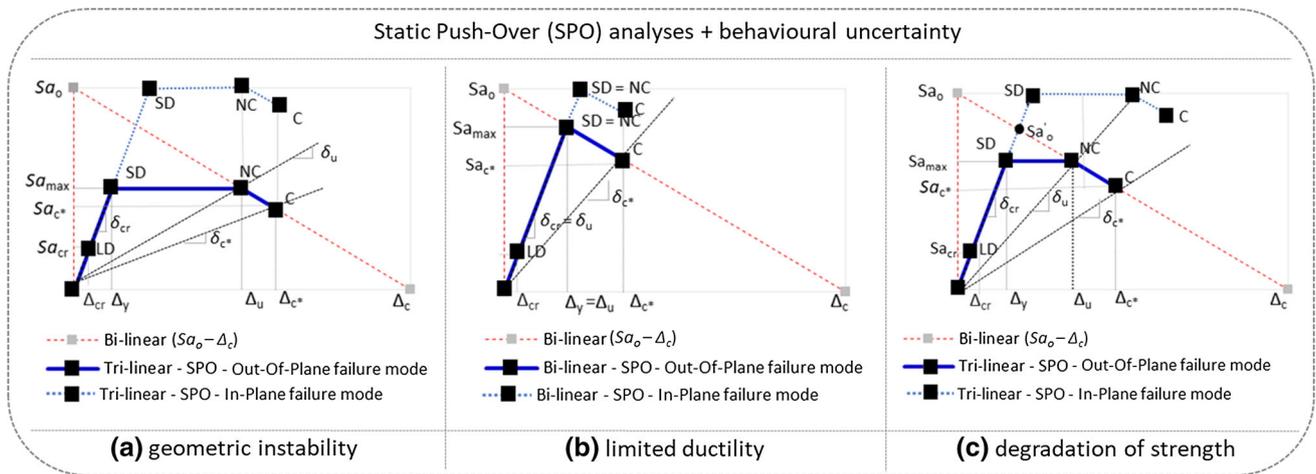
Fig. 5 Static pushover curves corresponding to the three different behaviours: **a** geometric instability, **b** limited ductility, **c** degradation of strength. Note $S_{a_{max}} = S_{a_y} = S_{a_u}$

three different ways: (a) geometric instability (D'Ayala and Paganoni 2011), (b) limited ductility (Lagomarsino 2015), and (c) degradation of strength (Tomažević 2007) (see Fig. 5).

Indicated in Fig. 5 by LD (Δ_{cr} , $S_{a_{\text{cr}}}$), this limit state is reached when the first crack occurs (Tomažević 2007). Based on the experimental results (Griffith et al. 2004) and numerical modelling (Doherty et al. 2002; Derakhshan et al. 2014; Lagomarsino 2015), the first crack defines the first branch of the SPO curve from the origin up to LD. This branch has a gradient of δ_{cr} equal to $(2\pi/T_{\text{eq}})^2$, resulting from the initial elastic behaviour of the equivalent SDOF oscillator in an ADRS (Acceleration Displacement Response Spectra) domain. The crack initiation point on the first branch of the simplified SPO curve is determined according to D'Ayala and Paganoni (2011) by the cracking displacement: $\Delta_{\text{cr}} = \frac{S_{a_{\text{cr}}}}{4\pi^2} T_{\text{eq}}^2$ and the corresponding cracking acceleration: $S_{a_{\text{cr}}} = tg/4H_{\text{tot}}$, where H_{tot} is the total height of the wall.

Indicated in Fig. 5 by $NC(\Delta_u, S_{a_u})$, this limit state corresponds to the attainment of the façade’s critical failure mode identified by FaMIVE. Different values of Δ_u are defined for each structural behaviour, while S_{a_u} is defined differently according to the critical failure mode. In particular, for In-Plane failure modes, the value of S_{a_u} coincides with the value of the spectral acceleration S_{a_0} at failure (see Sect. 2.4). This agrees with the existing literature related to In-Plane loaded unreinforced masonry walls (Portioli et al. 2013; Casapulla and Argiento 2018). For Out-of-Plane failure modes, S_{a_0} , which activates the rocking failure mode, is reduced to S_{a_u} , as proposed by the tri-linear models of Doherty et al. (2002) and Lagomarsino (2015). This reduction from S_{a_0} to S_{a_u} depends on three different types of structural behaviour as follows:

(c) *Degradation of strength* (Fig. 5c)

Indicated in Fig. 5 by C (Δ_{c^*} , Sa_{c^*}), this limit state is defined identically for all three considered types of structural behaviour. Specifically, Sa_{\max} is decreased by 20% to Sa_{c^*} . The additional degrading branch is defined to capture the extra safety ductility of the wall (Tomažević 2007). Δ_{c^*} represents the displacement related to 20% drop in spectral acceleration. This is directly defined from Sa_{c^*} , as it is located on the bi-linear $Sa_o-\Delta_c$ curve and linear system with a gradient of $\delta_{c^*} = Sa_{c^*}/\Delta_{c^*}$.

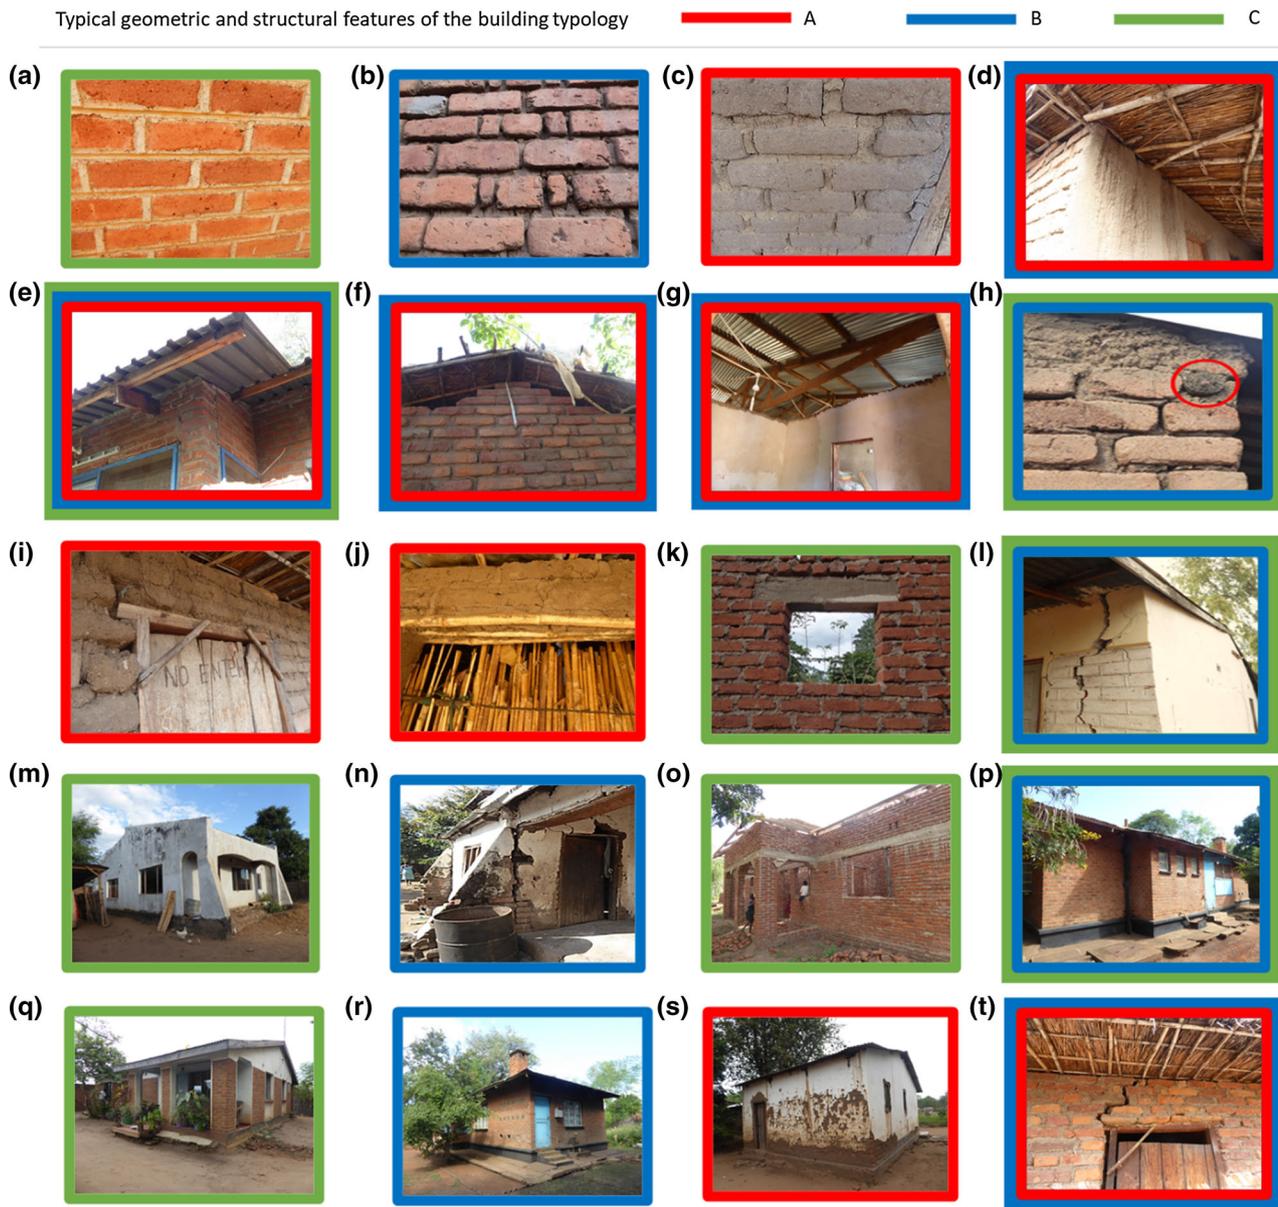
Fig. 6 Typical buildings in Malawi: **a** fired bricks with cement mortar; **b** fired bricks with mud mortar; **c** unfired bricks with mud mortar; **d** thatched roof; **e** light metallic sheets; **f** gable detached from the roof structure; **g** lack of connection between walls and roof system; **h** timber wall plates of circular section; **i** door frame showing absence of lintels; **j** bamboo lintel; **k** concrete lintel; **l** house with poor

connection between walls; **m** new constructions with buttresses; **n** lack of connection between buttress and wall; **o** concrete ring beam; **p** re-entrant corner; **q** portico; **r** chimney; **s** material erosion; **t** typical cracks. The red-blue-green tag on each picture is used to highlight the geometric/structural features of the building typologies A, B, and C, introduced in Sect. 3.1.1

On-site structural surveys were carried out on 323 non-engineered unreinforced masonry buildings located in formal and informal settlements in the townships of Salima and Balaka and informal settlements of the villages Lifidzi and Golomoti (see Fig. 1b). 86% of the inspected buildings are made of fired (clay) bricks (see Fig. 6a, b), since these materials are relatively cheap to source on-site and do not need specific construction skills. The remaining 14% of the inspected buildings are made of mud bricks (see Fig. 6c), a

corrugated sheets are observed for the remaining inspected buildings (Fig. 6e). Both roof types do not act as a rigid diaphragm during an earthquake. Furthermore, roofs generally are not connected to the bearing walls; therefore, they are not able to provide restraint against lateral movements due to winds or earthquakes (Fig. 6f, g). Only occasionally, timber wall plates are used on the top of the longest external walls to support the roof structures

the roof and openings. This is evident from the presence of cracks, material erosion, dry timber rot, damaged boards, and door jams (Fig. 6s, t).

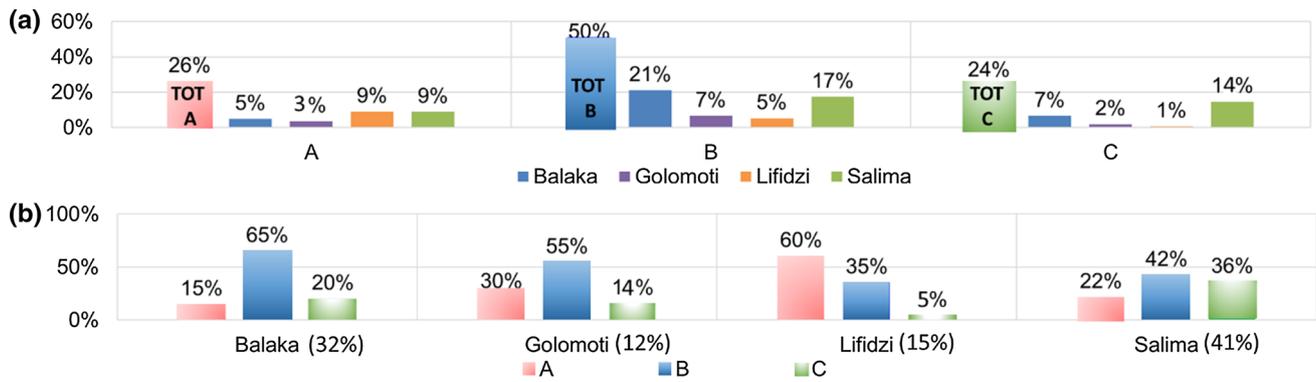
Fig. 7 **a** Total percentages of building typologies A, B, and C, **b** percentages of the building typologies A, B and C identified for each inspected settlement

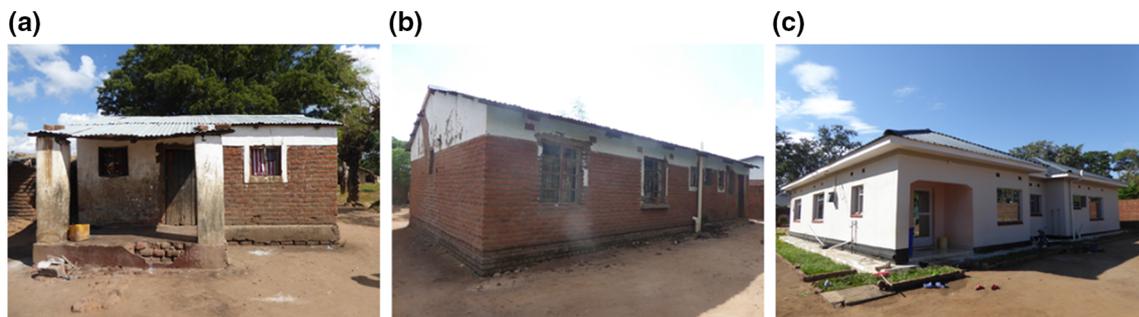
Fig. 8 Typical masonry buildings in Malawi: **a** typology A; **b** typology B; **c** typology C

unfired or fired bricks with mud mortar and are of poor fabric quality (Fig. 3b3). Generally, these houses have smaller building footprints than a typical floor plan of 8 m × 6 m. These houses have thatch or corrugated metallic sheet roofs supported by light timber elements. The structures are characterised by poor structural detailing (e.g. lack of connection between walls and between walls and roof).

- Typology B—This is the most common typology observed in Malawi, representing 50% of the buildings, and is rated as medium seismic vulnerability (Fig. 8b). These buildings are made of fired bricks with medium- to good-quality fabric (Fig. 3b1, b2). Due to the presence of mud mortar, bonding between bricks is considered poor; therefore, connections between walls are assumed weak. The construction details varied significantly as well as maintenance levels.

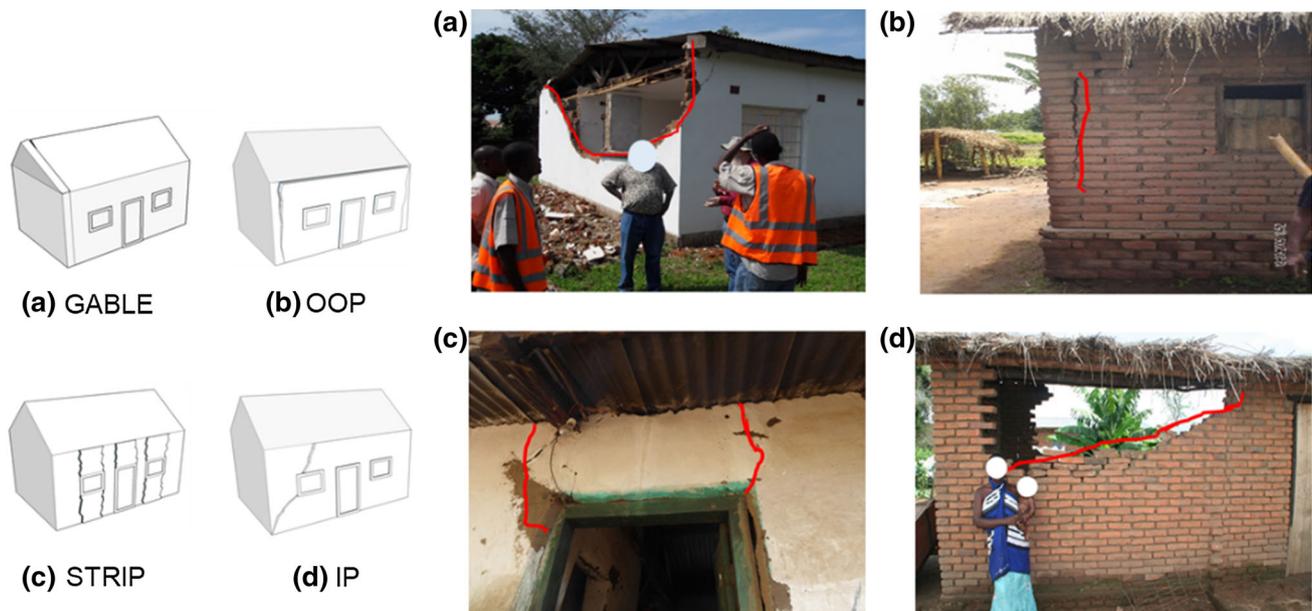
Fig. 9 Typical failure modes observed after the 2009 Karonga earthquake sequence. **a** OOP, **b** GABLE, **c** STRIP, **d** IP. Source of image for **a–c** are taken from the authors **d** (<http://www.aaronmoore.com.au/malawi-earthquake-relief#/i/1>) taken by Aaron Moore, used with permission

Possible failure modes for buildings in Malawi are identified based on the data from the post-earthquake surveys carried out after the 2009 Karonga earthquake sequence by the authors. Four failure modes are identified, as shown in Fig. 9:

- GABLE failure: according to post-earthquake field observations, this failure predominantly occurs on building typologies A and B in walls with gables which are not connected to roofs, and therefore fail in overturning. This failure mode is characterised by an inverted arch crack pattern on the gable wall.
- OOP (Out-of-Plane of the entire façade) failure: according to post-earthquake field observations, this failure mainly occurs on building typologies A and B made of single-skin walls with poor-quality materials and poor connections between walls and between walls and the roof, causing overturning of a single

façade. This failure mode is characterised by vertical cracks on the edges of the wall.

- (c) STRIP failure: according to post-earthquake field observations, this failure predominantly occurs on building typologies B and C made of single-/double-skin walls with medium-quality materials and good connections between walls and between walls and the roof, causing overturning of vertical strips of piers or spandrels. This failure mode is characterised by vertical cracks along the edges of piers or spandrels aligned vertically.

- (d) IP (In-Plane) failure: according to post-earthquake field observations, this failure predominantly occurs on building typology B and C made of double-skin walls with medium- to good-quality materials and good-quality connections between walls and between walls and the roof, causing shear failure of a single façade. This failure mode is characterised by a diagonal crack on the entire wall or diagonal or X-shape cracks on piers or spandrels. Buildings built according to the Safer House Construction Guidelines (Bureau TNM 2016) are likely to fail in this mode.

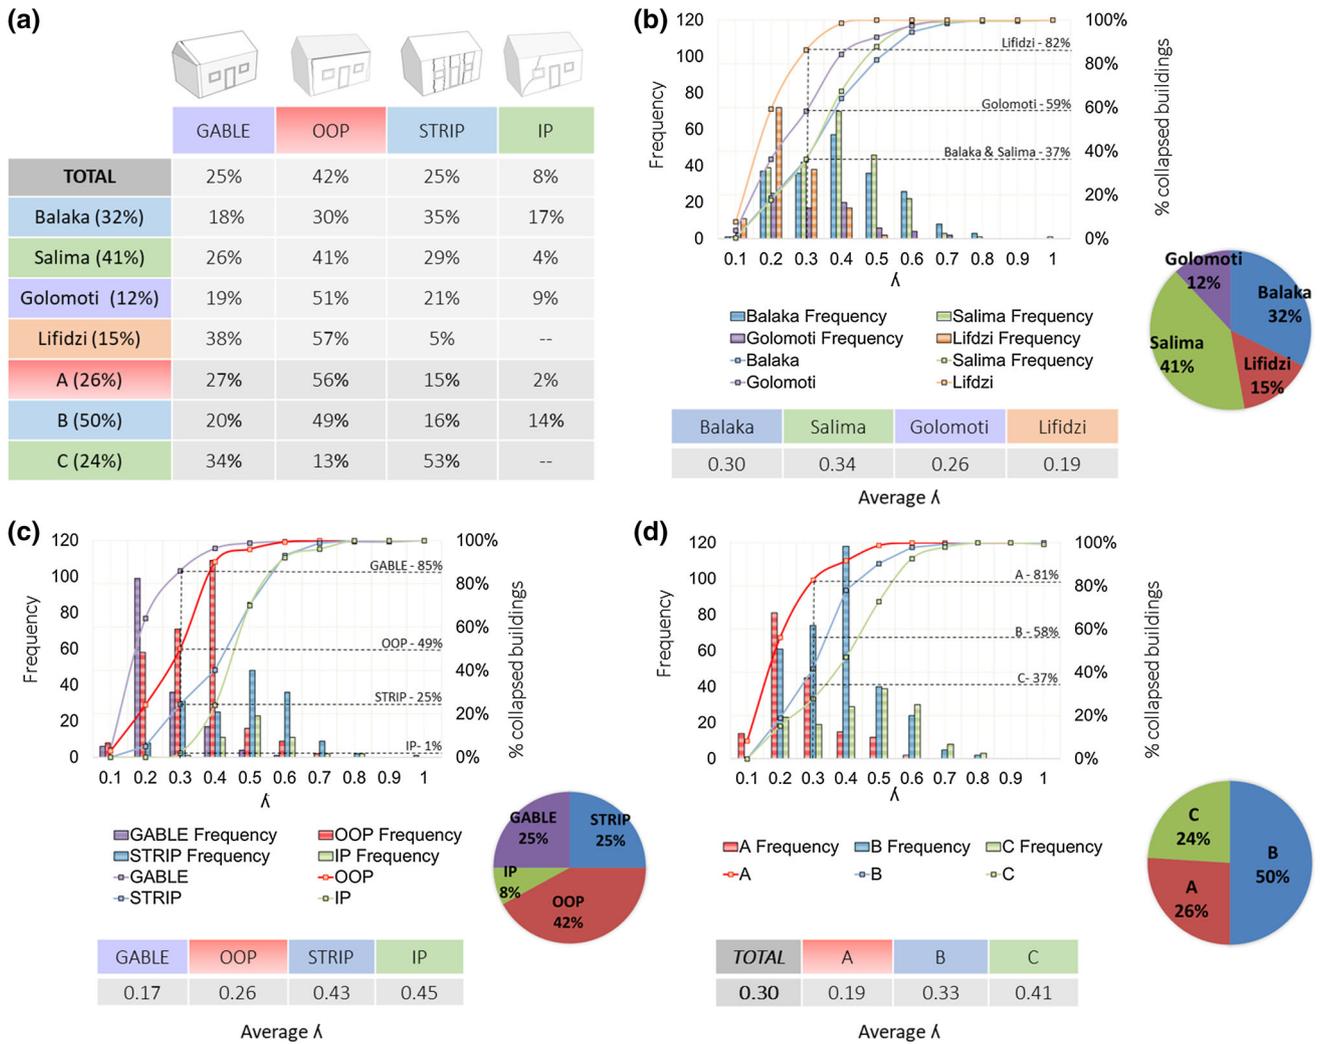
Fig. 10 a Proportions of buildings failing in each mode for the entire inspected building stock, in terms of overall total, locations and building typologies. Cumulative damage curves for b locations; c failure modes; d building typologies

The cumulative damage curves of Fig. 10b–d plot the values of the collapse load factor multiplier for each

analysed building against the number and percentage (on the left and right of each plot, respectively) of collapsed buildings. They provide the average of λ for the inspected locations, failure modes, and building typologies. In Fig. 10b, the slopes and relative positions of the curves underline that the rural settlements Golomoti and Lifidzi have weaker constructions than the urban settlements Balaka and Salima. These results are expected considering that Golomoti and Lifidzi have the highest percentages of buildings in typology A (30% and 60%, respectively, as illustrated in Fig. 7b), while Balaka and Salima have the highest percentages of buildings in typology C (20% and 36%, respectively, as illustrated in Fig. 7b). Figure 10c shows that GABLE and OOP are the most critical failure modes for most of the inspected buildings as highlighted by the failure mode percentages reported for $\lambda = 0.30$ each failure mode class. The results are also confirmed by the average values of λ which are higher for STRIP and IP than the others, since these failure modes mainly occur for buildings in typologies B and C of medium or high construction quality, as indicated in the failure mode proportions of Fig. 10a. As expected, the slopes of the cumulative damage curves in Fig. 10d highlight that building typology A, failing mainly in GABLE and OOP as illustrated in Fig. 10a, is the most vulnerable to seismic loading, followed by typologies B and C. This is consistent with the average values of λ (i.e. $\lambda = 0.19, 0.33,$ and 0.41 for A, B, and C, respectively) and the percentages of collapsed buildings for $\lambda = 0.30$.

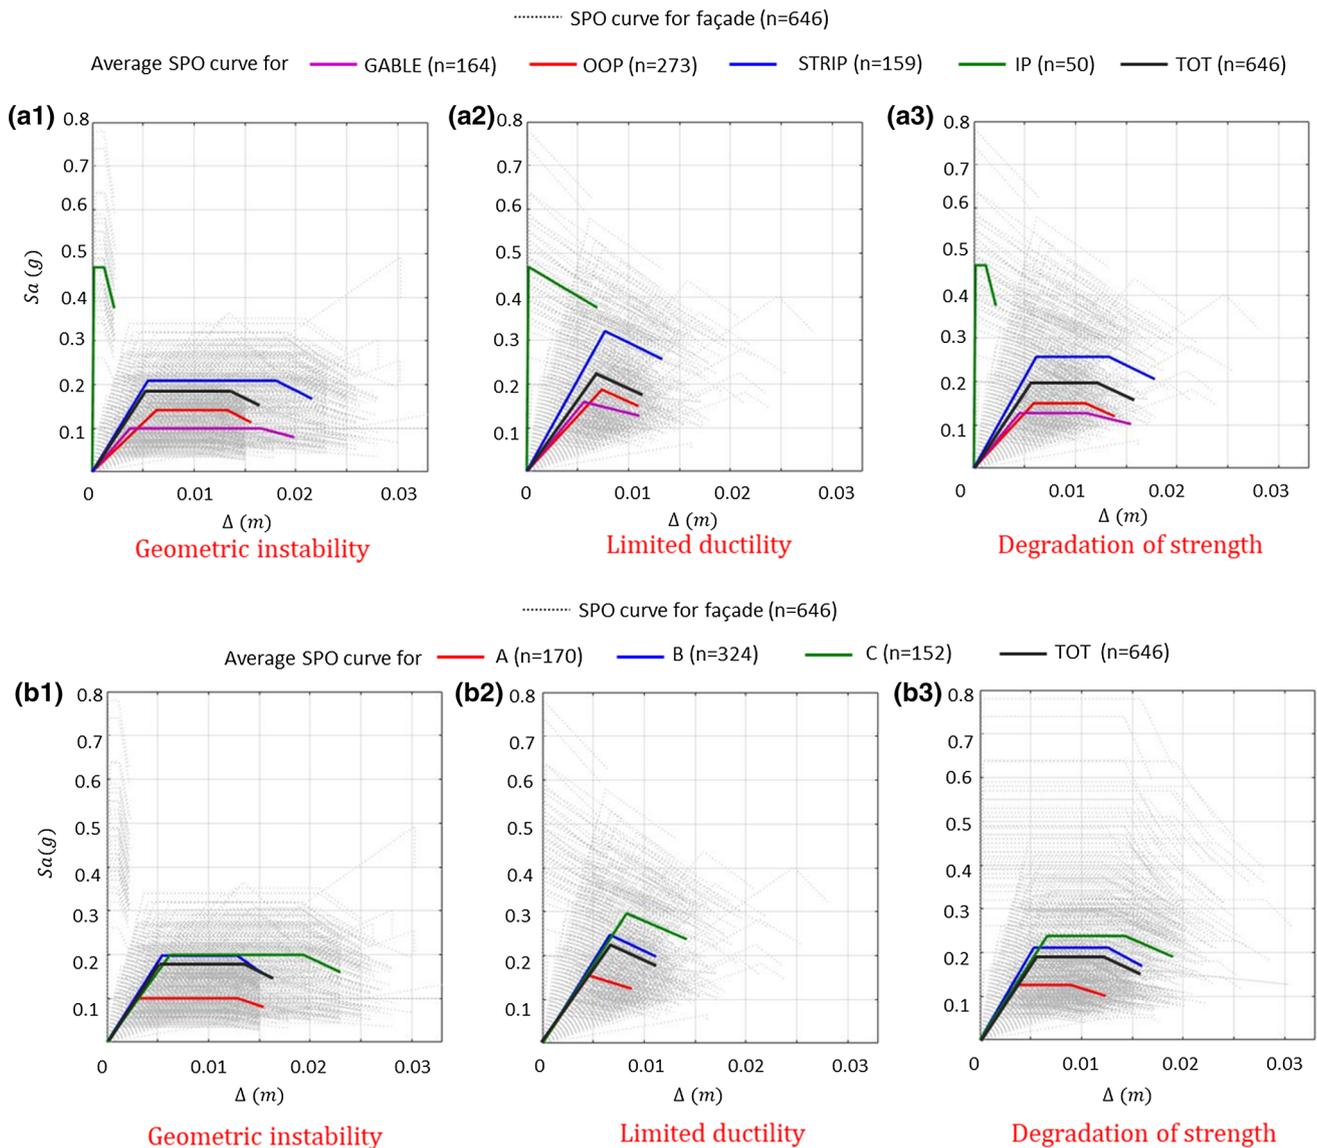
Fig. 11 SPO curves for each façade and average SPO curve over all inspected façades, **a** average SPO curves for failure modes: GABLE, OOP, STRIP and IP, **b** average SPO curves for building typologies A,

B, C, and total, for (1) geometric instability, (2) limited ductility, and (3) degradation of strength, respectively

The uncertainty regarding the three models of structural behaviour is highlighted in Fig. 11 by the three different sets of backbone SPO shapes. These differ in strength and ductility, demonstrating the impact of different definitions of the limit states described in Sect. 2.5 for each model. The highest strength is observed in the façades with limited ductility, as they have an average spectral acceleration ($S_{a_{\max}}$) which is 22% greater than the ones obtained in the

other two models. The median ductility ($\mu = \frac{\Delta_u}{\Delta_y}$) in the façades with degradation of strength results is 19% lower than the one obtained for façades with geometric instability, while the ductility is 1 for the façades with limited ductility by definition, as described in Sect. 2.5.

Furthermore, it can be observed that façades failing in IP, which are the ones with better construction quality, have the highest stiffness and the lowest ductility μ . Their SPO backbone curves depict brittle shear failure, which is related to their rigid construction. This is indicated by the value of their average fundamental period (T_{eq}), which is equal to 0.04 s (the shortest among the four), compared to T_{eq} of 0.38 s, 0.40 s, and 0.32 s calculated for GABLE, OOP, and STRIP, respectively. Façades failing in IP are only a small percentage (7%) of the total inspected façades (Sect. 4.1) and they do not have a significant influence on the average SPO curves derived for the building typologies in Fig. 11b. This is also confirmed by the similar average fundamental periods (T_{eq}) identified for the different building typologies: 0.34 s for A and 0.35 s for B and C.

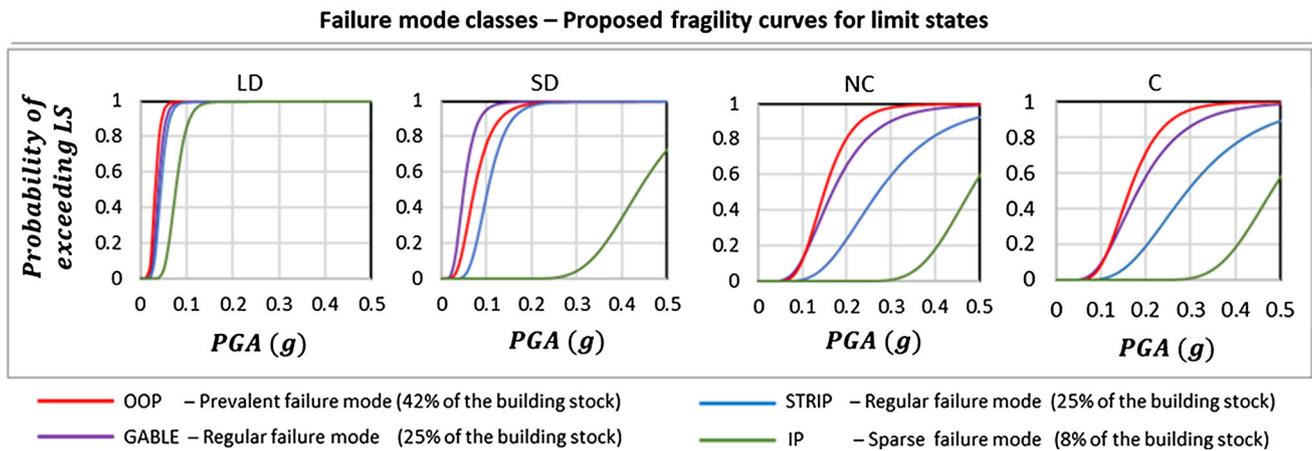
Fig. 12 Failure mode classes. Fragility curves for geometric instability

Firstly, the fragility curves are distinguished for the failure mode types (i.e. GABLE, OOP, STRIP, and IP) identified as a critical failure mode of the surveyed non-engineered masonry houses by the mechanical analysis discussed in Sect. 4.1. These fragility curves reported in Fig. 12, are obtained using the fragility parameters (i.e. η and β) of

Table 5a. As expected, the fragility curves show that houses failing for overturning of gables, entire façades and vertically alignment of piers or spandrels (i.e. GABLE, OOP, and STRIP) are the most vulnerable even for earthquakes of low intensity.

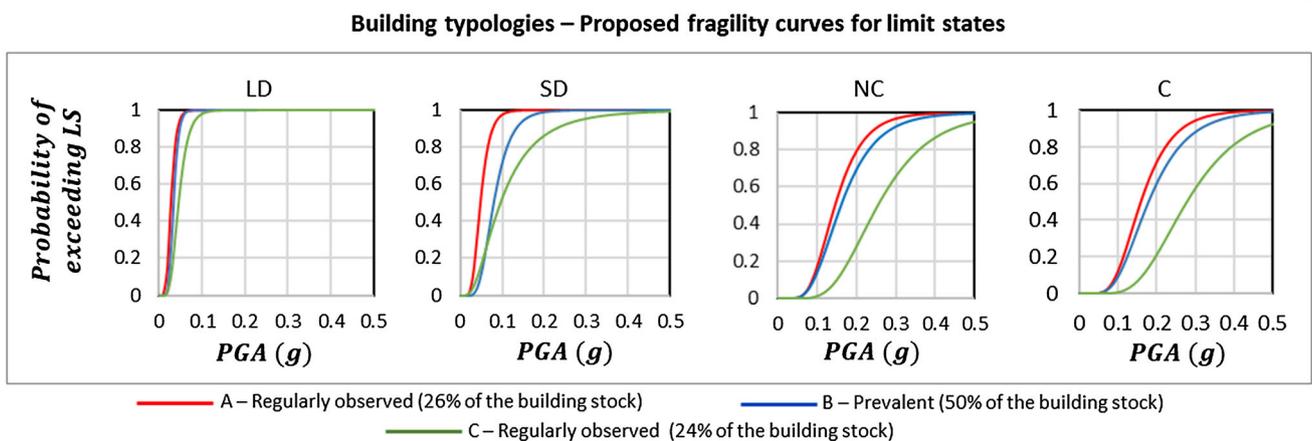
Fig. 13 Building typologies. Proposed fragility curves for geometric instability

Secondly, the fragility curves are distinguished by the building typologies (i.e. A, B, and C) identified as representative vulnerability classes of the surveyed non-engineered masonry houses according to construction materials, roof type and quality of constructions, defined in Sect. 3.1. The building classification uses parameters which are typically adopted in international databases to classify building in terms of seismic vulnerability. Fragility curves reported in Fig. 13 are obtained using the fragility parameters (i.e. η and β) reported in Table 6a. As expected, the fragility curves show that poor (A) and medium (B) construction quality buildings (which are also the ones mostly failing in overturning failure modes) are the most vulnerable compared to high (C) construction quality buildings, even for earthquakes of low shaking intensity. This is also evident in Table 3, where the probability of collapse for buildings in typologies A and B are already

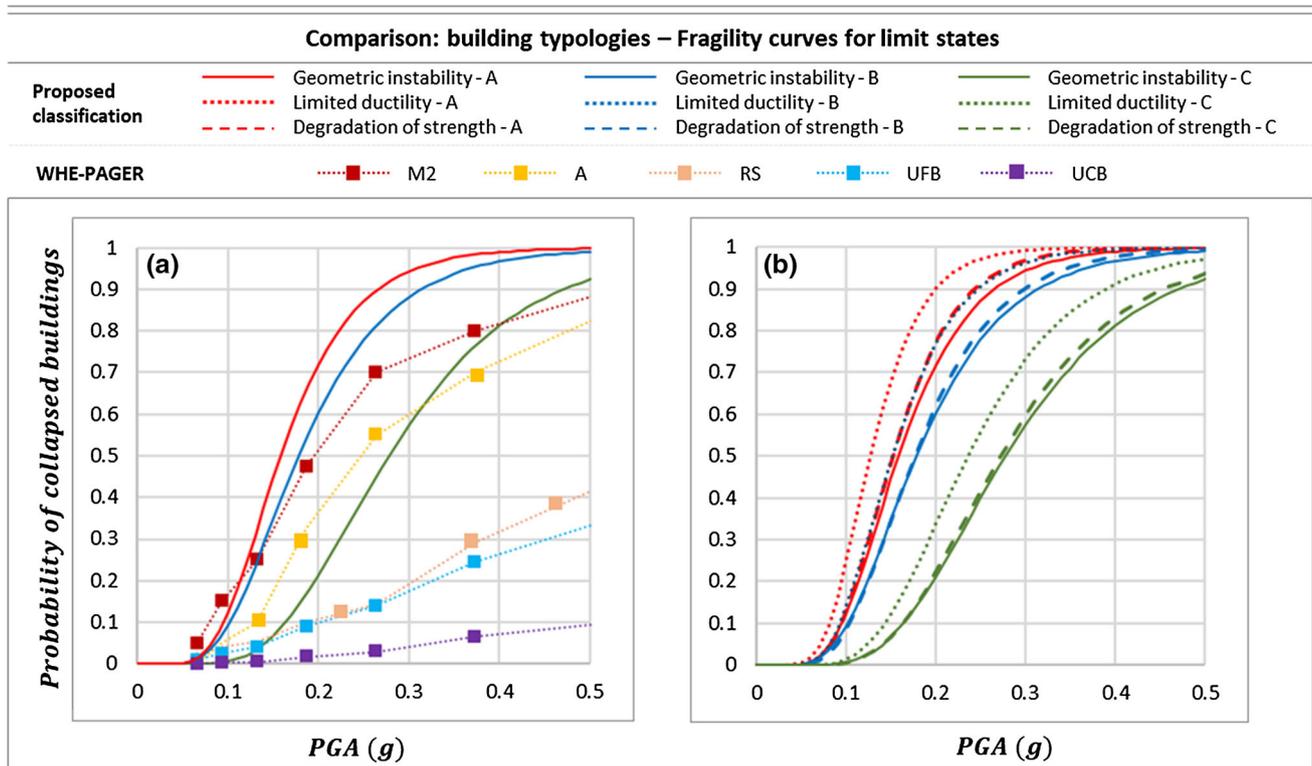
Fig. 14 Comparison: building typologies, **a** proposed fragility curves for geometric instability and fragility curves by WHE-PAGER classifications, **b** proposed fragility for geometric instability, limited

ductility, and degradation of strength. The comparison shows only the probability of collapsed buildings as this is the only limit state provided by the WHE-PAGER classifications

After a discussion on the proposed fragility curves, these fragility functions for building typologies and the weighted model are compared with previously available international reference data/models in Figs. 14 and 15. Note the comparison is only in terms of building typologies (not for failure mode types) as these are the only vulnerability classes provided by the international databases.

Apart from the noticeable differences in the identified building typologies, it can be observed that there is significant variability among the collapse rate functions between the vulnerability classes. In particular, it is important to note that the proposed fragility curves for poor (A) and medium (B) quality constructions in Malawi are more likely to collapse than according to the WHE-PAGER poorest quality classifications (M2 and A). Furthermore, even good (C) quality buildings in Malawi have similar performance to one of the poorest classifications from WHE-PAGER, and they are far more likely to collapse than the WHE-PAGER classification that appears to have the closest description of the building type (UFB). Therefore, unfortunately, buildings in Malawi are far more vulnerable to earthquakes than WHE-PAGER suggests.

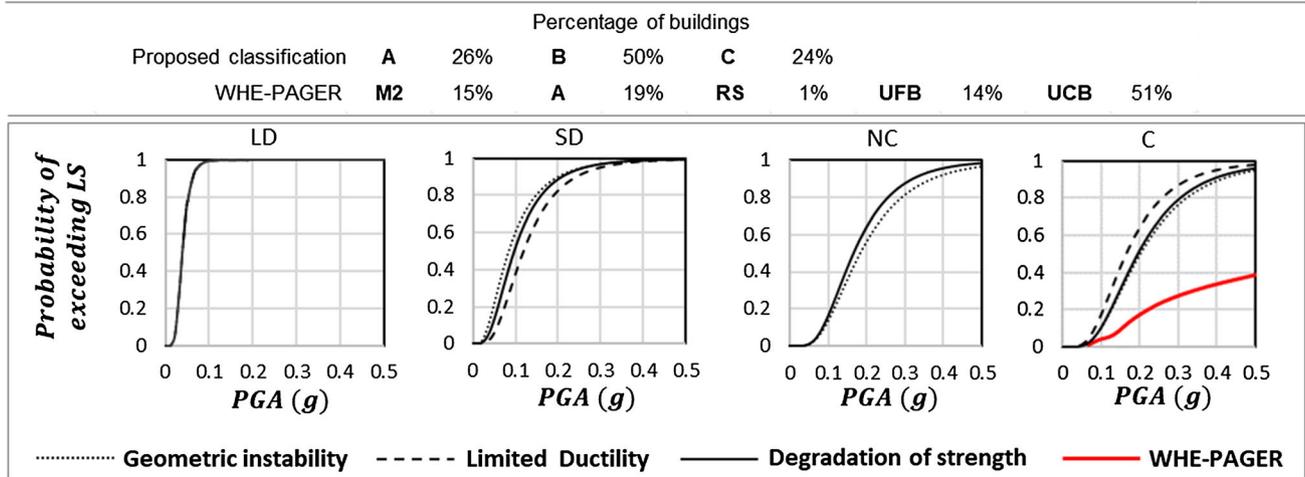
Fig. 15 Comparison: weighted model. Proposed fragility curves for geometric instability, limited ductility, and degradation of strength and fragility curves by WHE-PAGER classifications. Only the

probability of collapsed buildings is shown for WHE-PAGER as this is the only limit state provided by this classification

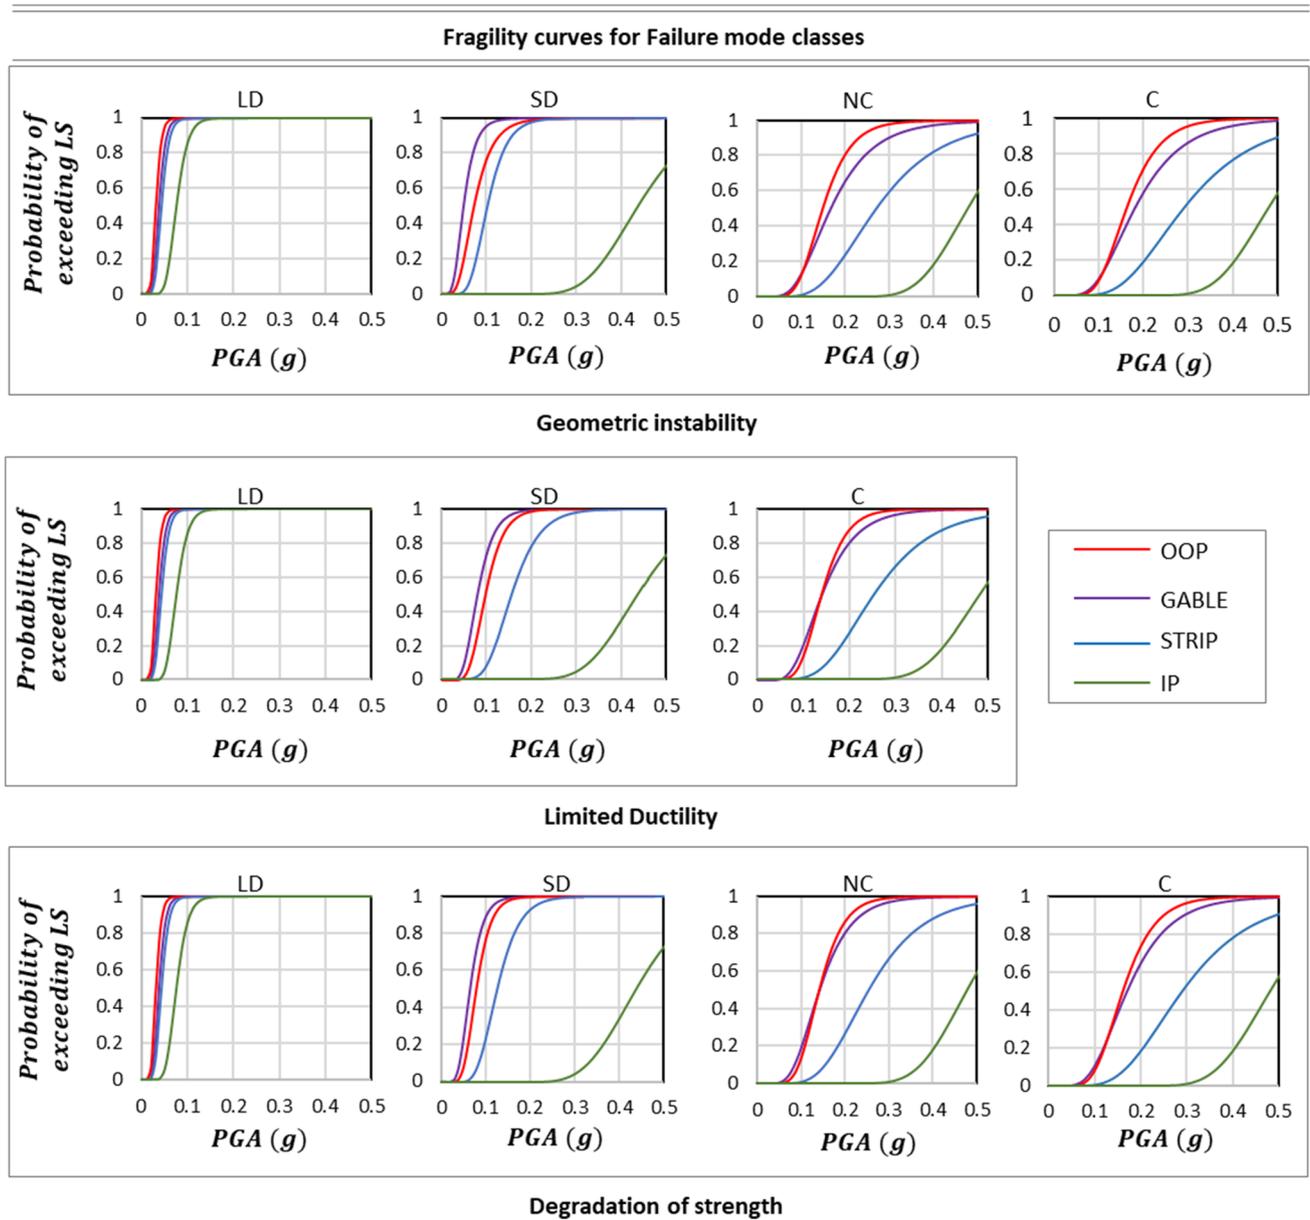
Fig. 16 Fragility curves for failure mode classes. Fragility curves are derived by Eq. 3 using η and β of Table 5

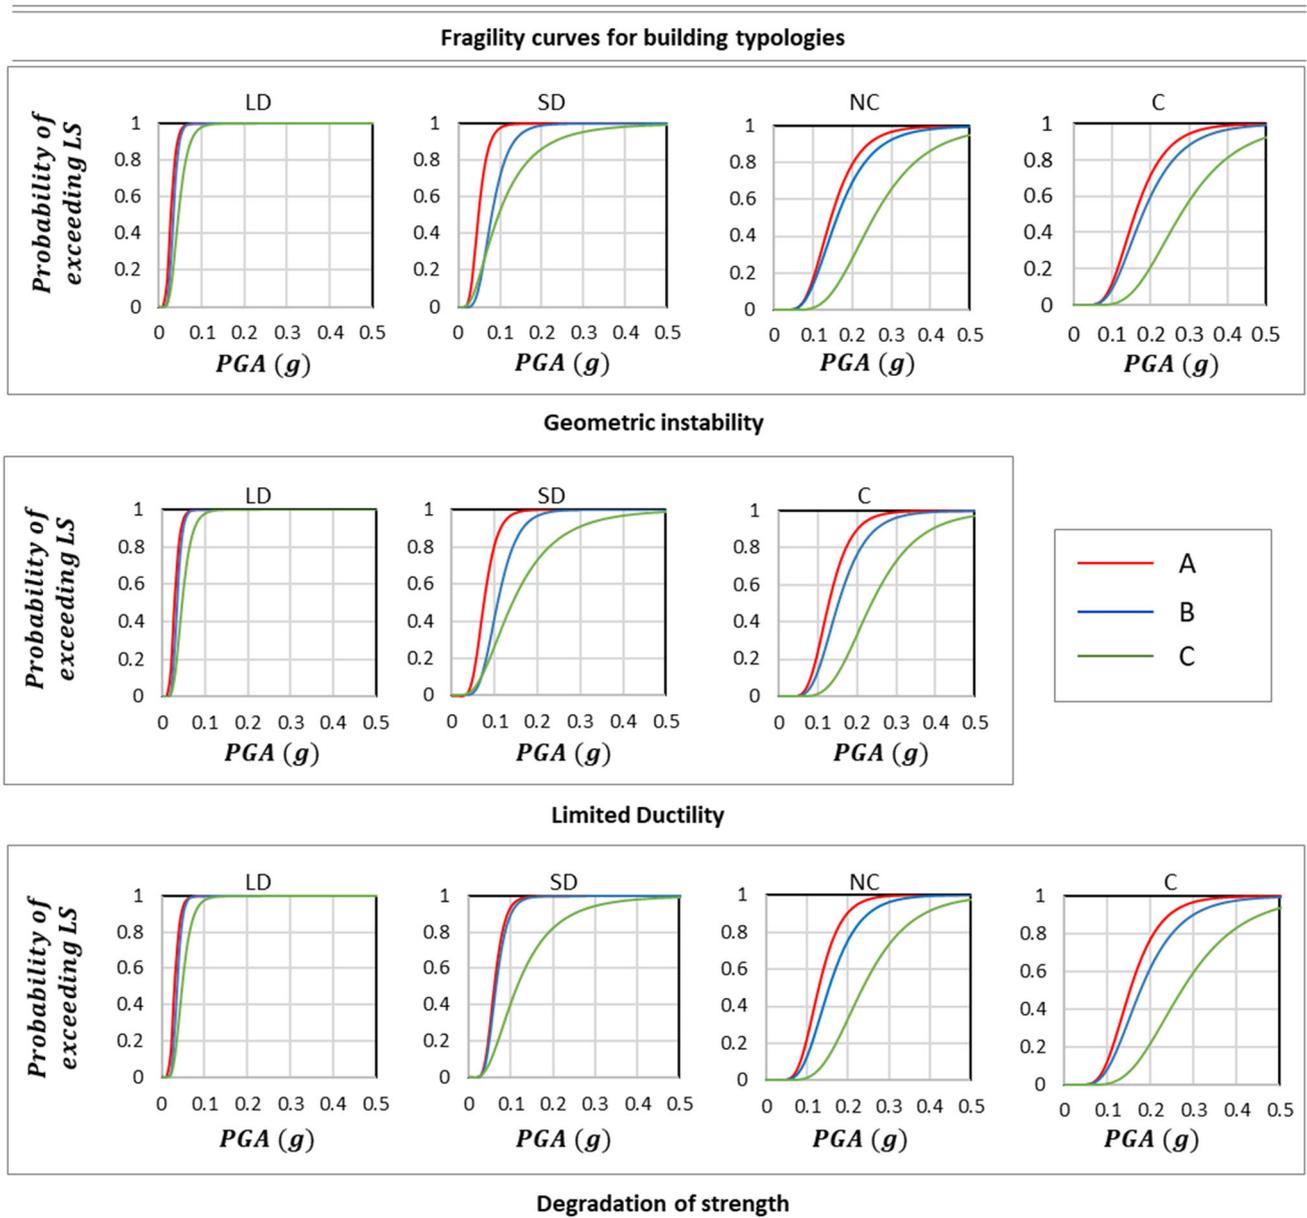
Fig. 17 Fragility curves for building typologies. Fragility curves are derived by Eq. 3 using η and β defined in Table 6

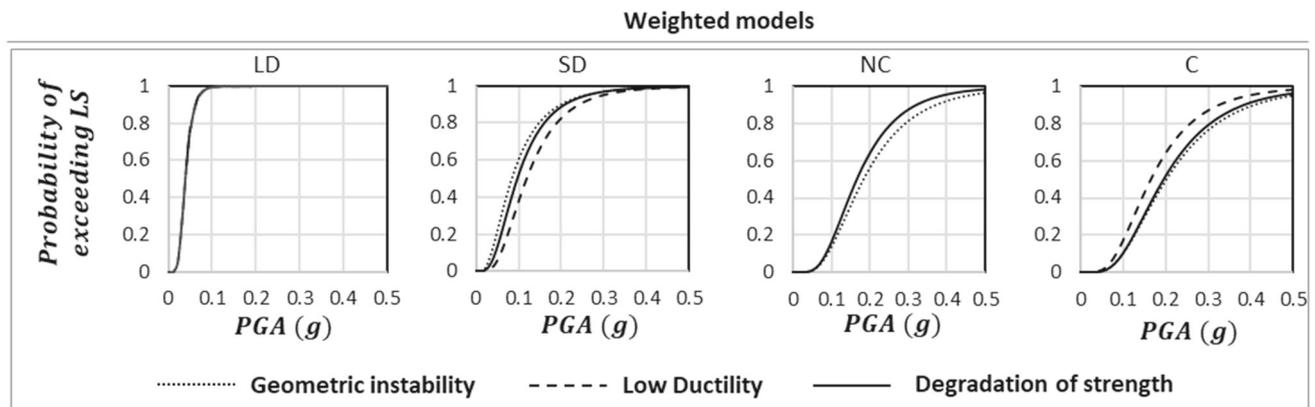
Fig. 18 Fragility curves for Non-engineering masonry buildings (weighted models). Fragility curves are derived by Eq. 3 η and β defined in Table 7
