# **Operational Aspects, Failures and Design of Radiant Tube Heater Systems in a Continuous Strip Annealing Furnace**

**W. Michael James**

Thesis submitted to Cardiff University  
in fulfilment of the requirements for the degree of  
Engineering Doctorate

The focus of this Engineering Doctorate Thesis is the investigation into how the radiant tubes installed in the Continuous Annealing Process Line (CAPL) at Port Talbot steel works were failing and what measures could be taken to improve tube life.

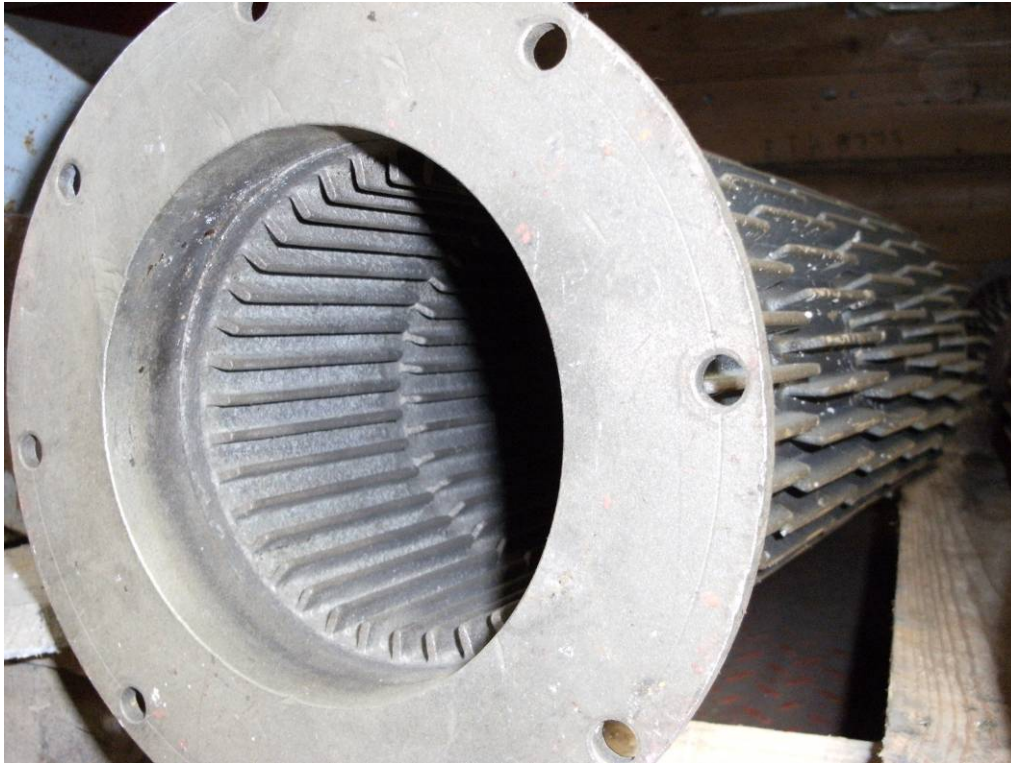
Hot exhaust gases are forced past the external fins and transfer energy through convection to the recuperator material. The heated recuperator material transfers energy via conduction to the inside surface, which in turn transfers energy to the incoming combustion air, Figure 2-3.

**Figure 2-3 - Recuperator heat exchanger recovering heat energy from the hot exhaust gases and transferring them to the incoming combustion air**

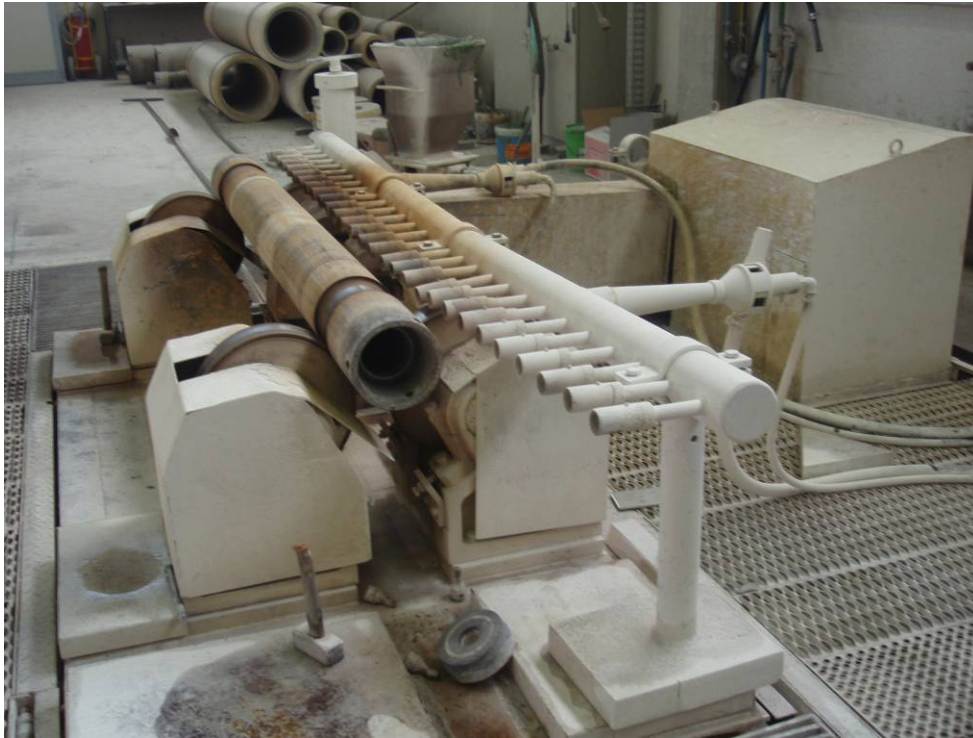
A cast radiant tube is manufactured from two common elements, a cylindrical tube and a return bend. The tube is spun-cast in a mould rotated on rollers as shown in Figure 2-11, while the bends are statically cast in sand moulds. After solidification and sufficient cooling the mating ends of the tubes and bends are chamfered as part of the weld preparation and then welded to form the main radiant tube structure. Subsequent quality control measures at the foundry ensure gas tightness and weld quality.

**Figure 2-11 - Image showing a spin-casting machine able to produce cast tubes. Note different size moulds in background to produce various diameters of tubes**

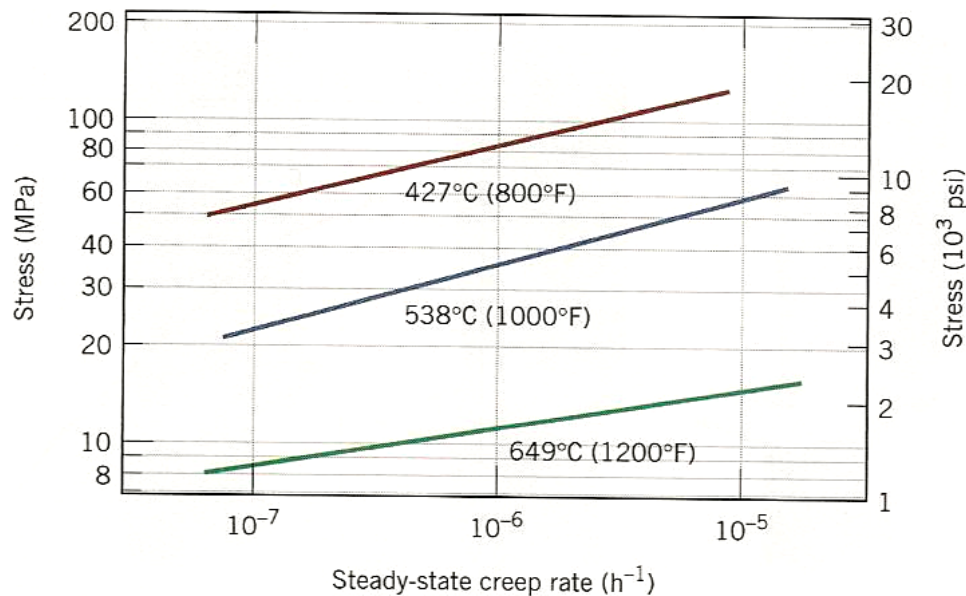
Figure 2-17 - Stress versus steady state creep rate at three different temperatures<sup>35</sup>

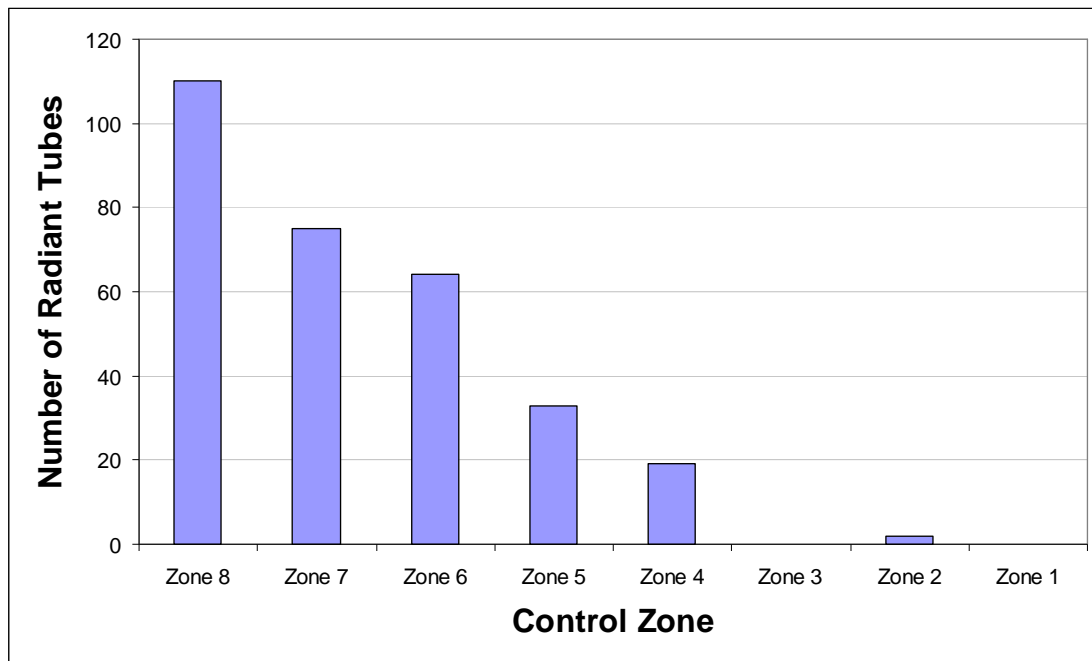
The replacement rate reduces from the final furnace zone, zone 8, to the entry of the furnace, zone 1. There have been no replacement tubes in zones 1 and 3; and only 2 tubes in zone 2. Therefore, by a simple manipulation of data, it is easy to see that the last half of the furnace, zones 5 to 8, has the highest failure rate.

**Figure 3-8 - Number of radiant tubes changed per furnace zone**

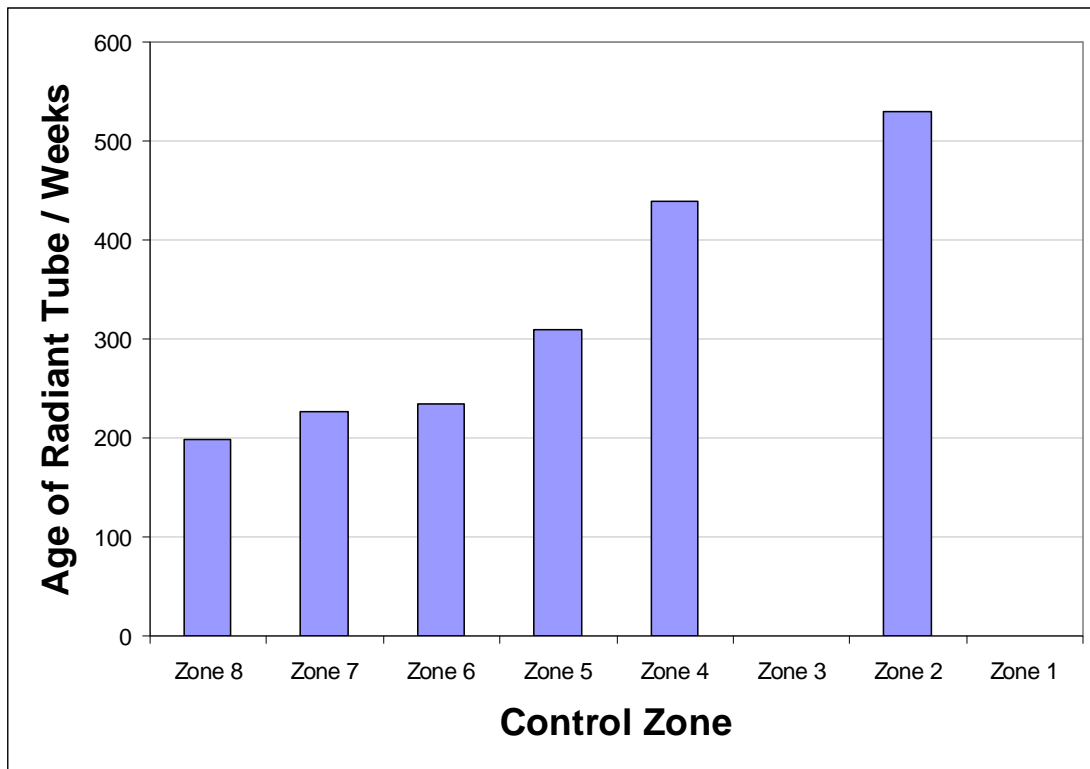
In contrast, zone 5 had an average tube life of approximately 6 years, while zone 4 had a tube life of approximately 8.5 years. Zones 1 and 3 have not had a tube replaced and as such they have been in operation since commissioning in 1998, which equates to 11 years. Zone 2 has had 2 tubes replaced in 2009, while this is not a significant number, it could be a sign that tubes are beginning to fail in the first zones of the furnace, which could need replacing in the next few years.

**Figure 3-9 - Average age of failed radiant tube when replaced per furnace zone**

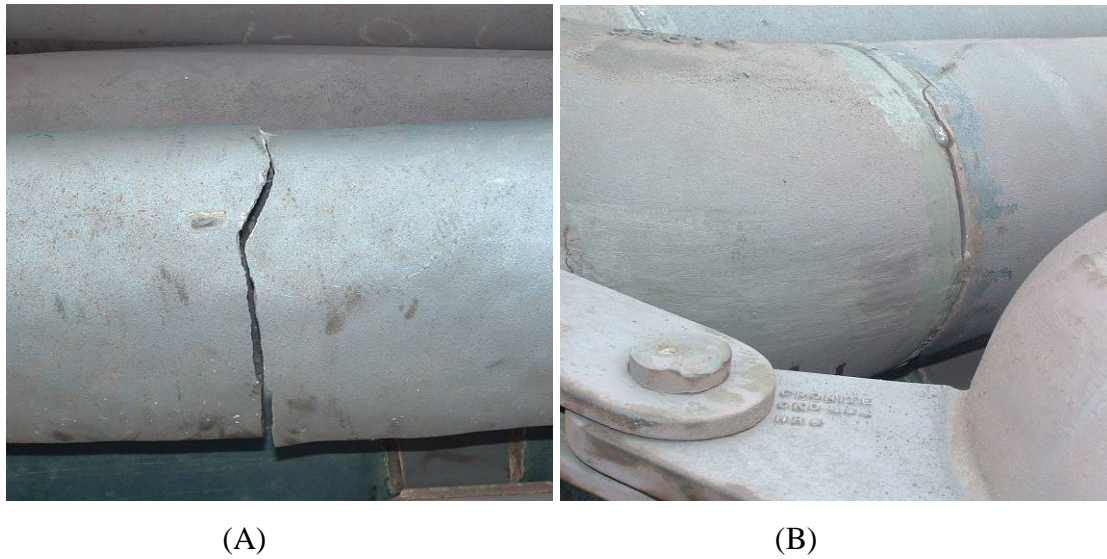
firing leg and the first bend, Figure 4-2. Other failures that occur are distortion, twisting and collapse.

**Figure 4-2 - Pictures indicating the common failures of tubes at Trostre; (A) cracking of the firing leg and (B) of the weld region of the 1st return bend**

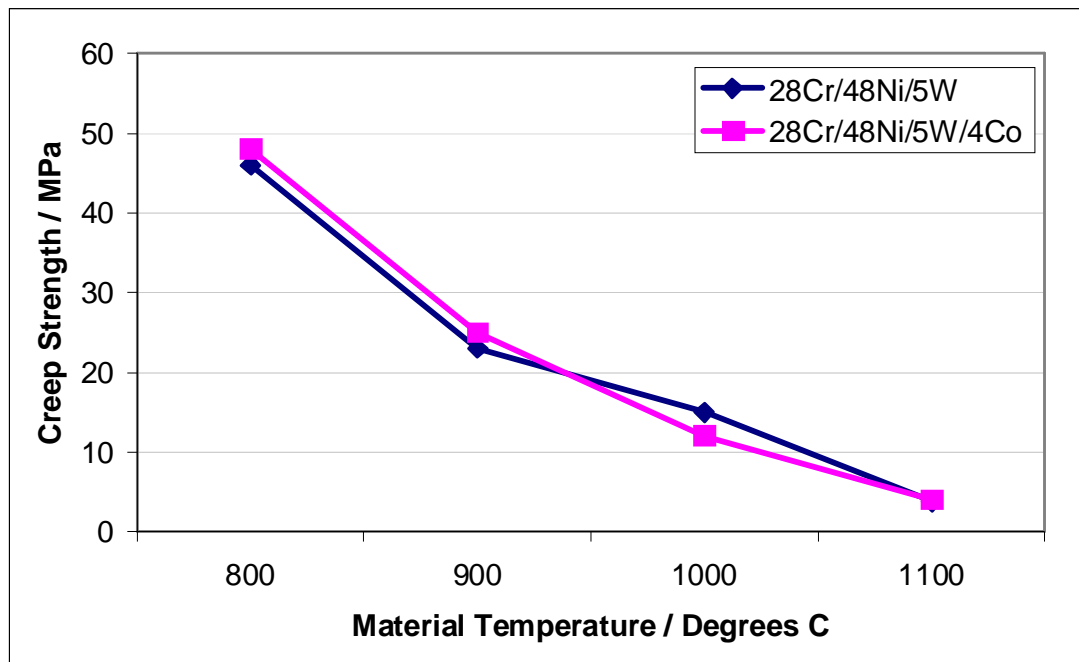
Figure 4-10 - Creep strength comparison of firing leg materials<sup>58</sup>

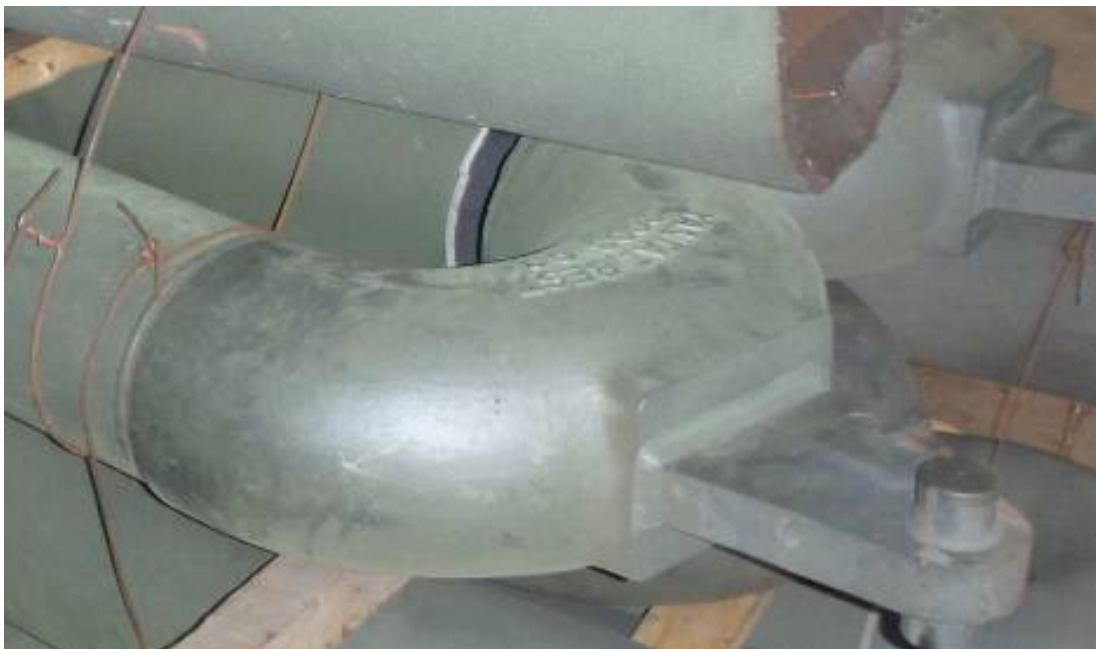
**Figure 4-18 - Cracked radiant tube where weld are has failed**

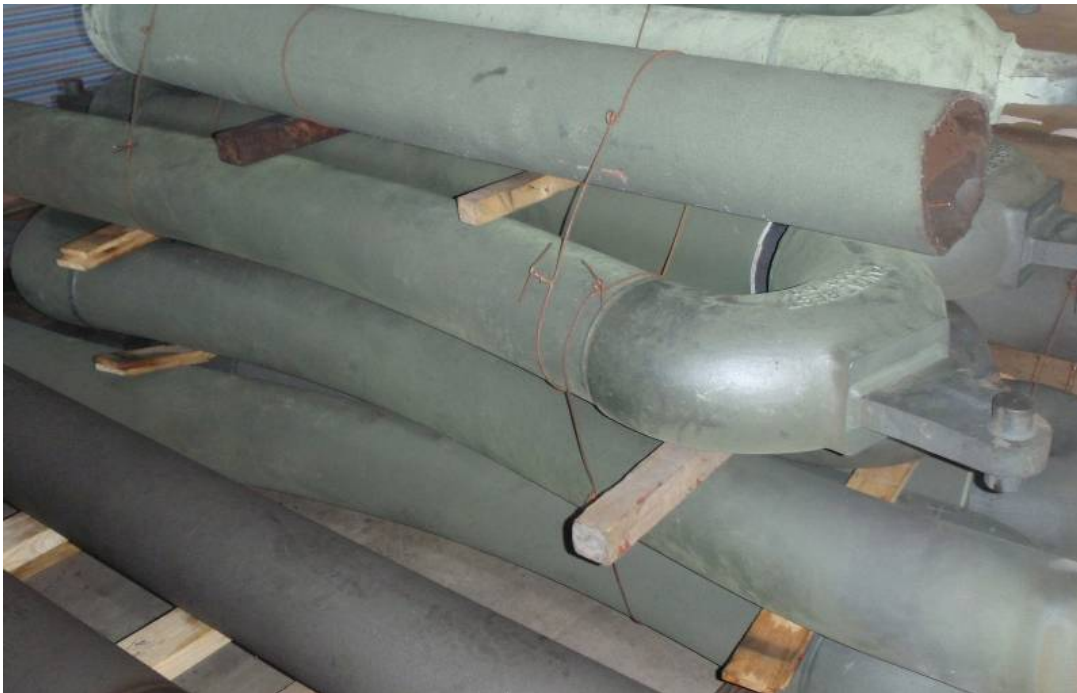
**Figure 4-19 - Failed radiant tubes showing signs of deformation in the firing and second leg**

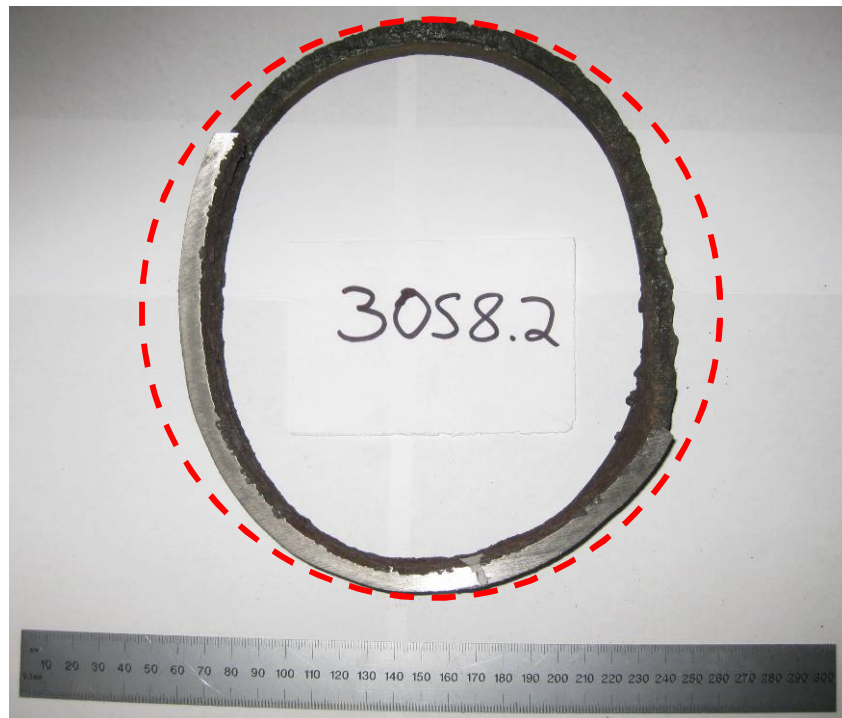
**Figure 6-4 - Very low levels of deformation visible in weld failure samples**

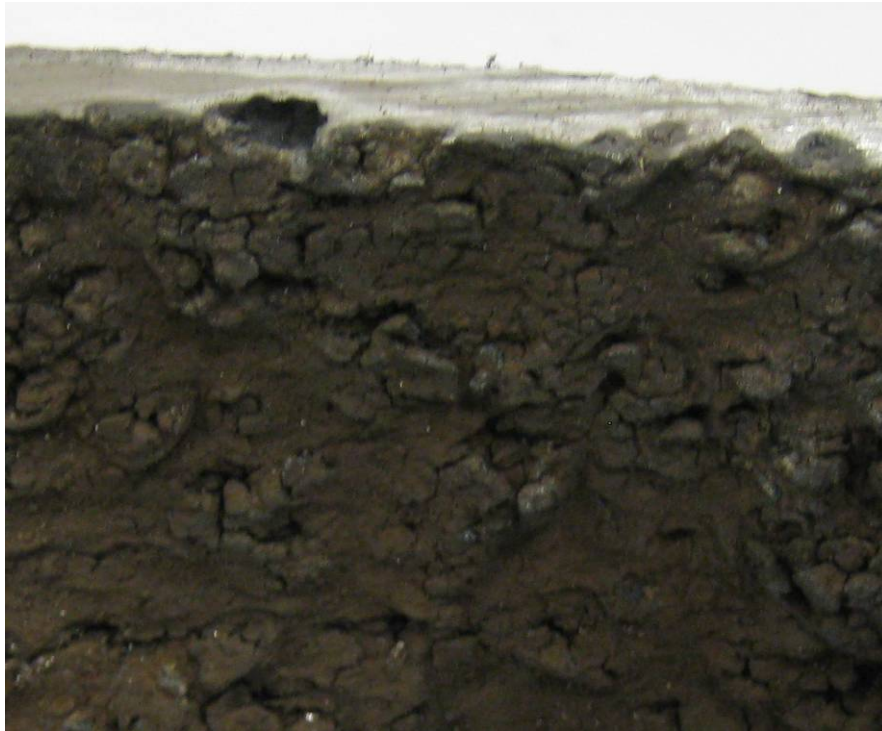
**Figure 6-16 - Example of how the oxide layer breaks up and cracks and eventually breaking off exposing fresh metal underneath to further oxidation**

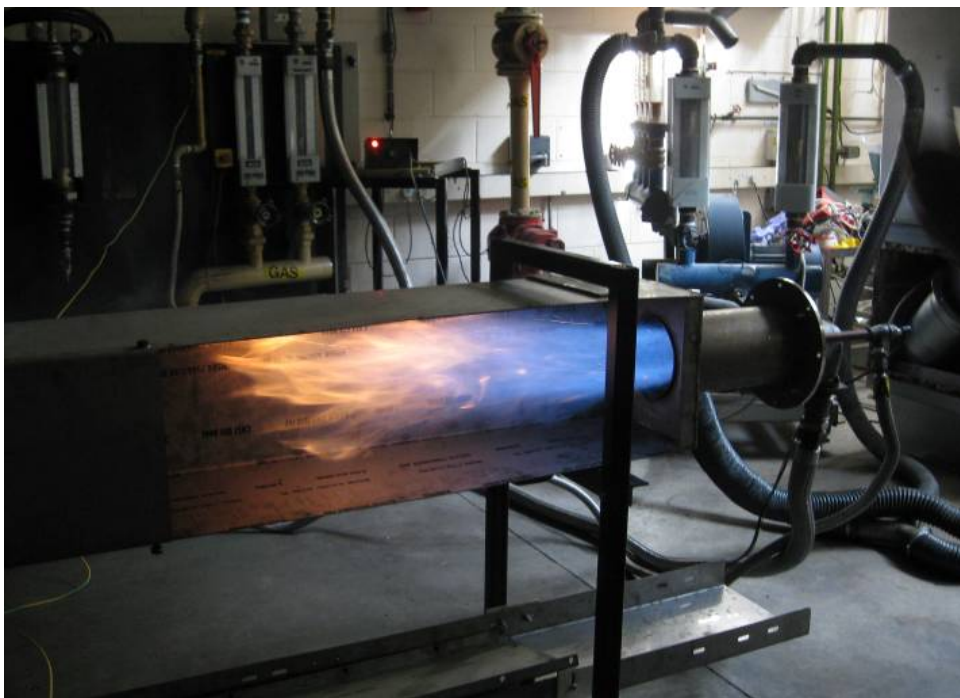
**Figure 8-8 - Problems with lighting the main burner were experienced during preliminary tests**

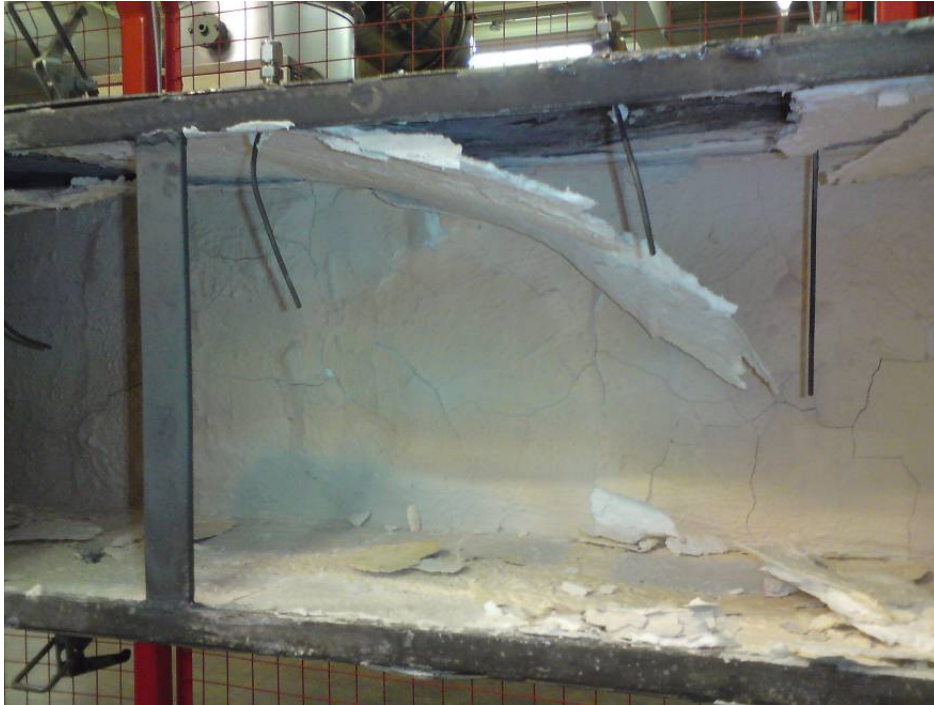
**Figure 8-9 - The thermal lining cracked, distorted and worked loose from the Inconel structure during thermal cycling experiments**
