Building Performance Evaluation of a 14th Century Pargetted House: Hygrothermal comfort and energy efficiency

Understanding operational performance and challenging preconceptions

Case Study: 14th Century Hall House with 17th Century Pargetting. Saffron Waldon, Essex, UK

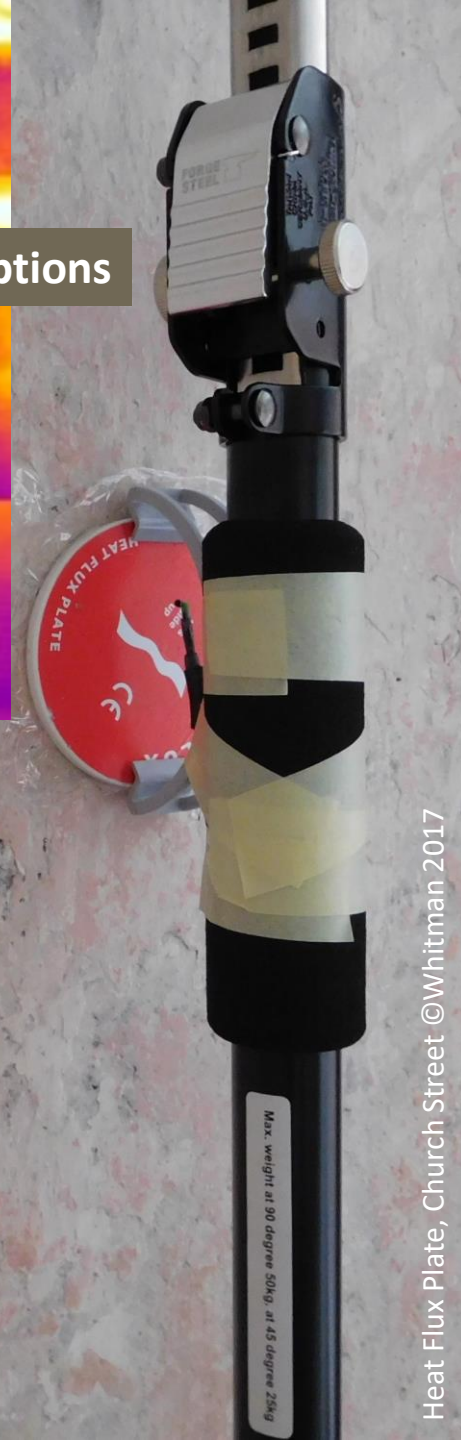
Heat Flux Plate, Church Street ©Whitman 2017

Huxeflux HFP01 heat flux plates, BS ISO 9869-1:2014
undertaken (12/03/17-02/04/17 and 15/12/19-22/01/20)

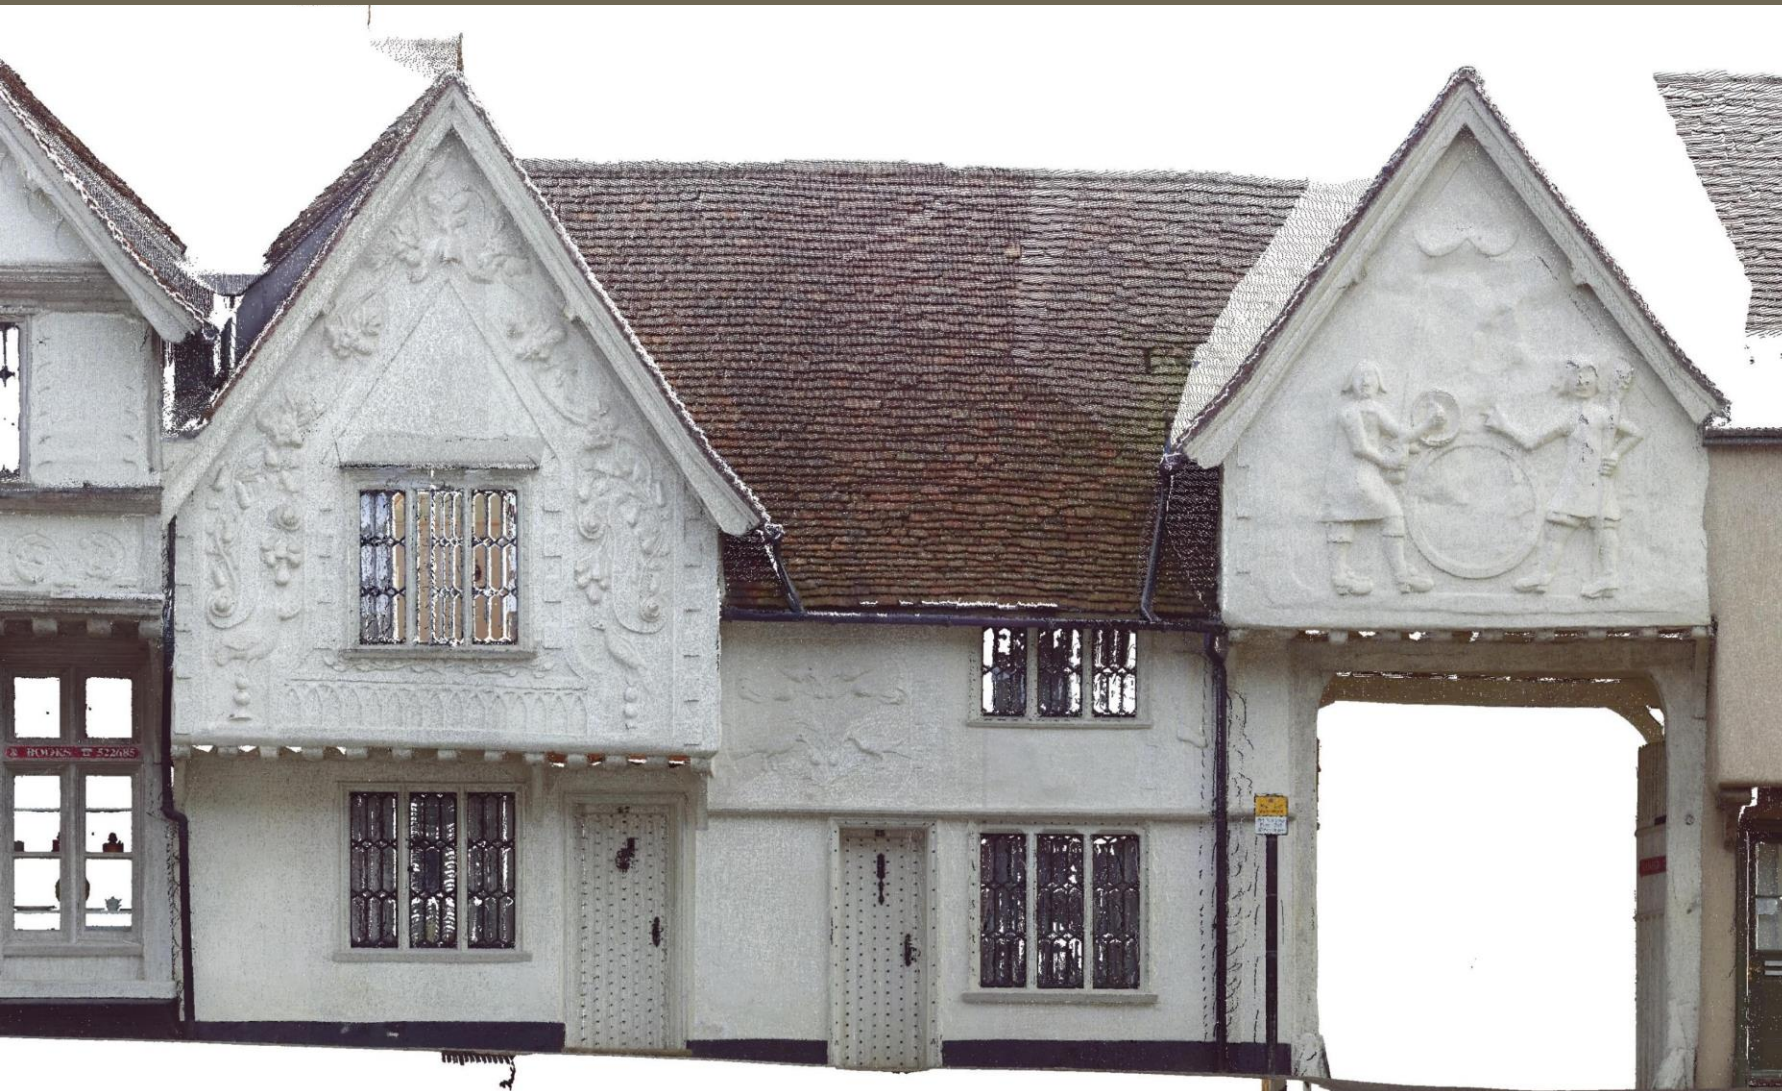
- Brick
- Plaster Infill
- Plastered/Pargetting
- Earthen
- Timber
- Tiled
- Mathematical tiles
- Slate
- Stone
- Flint
- C20th

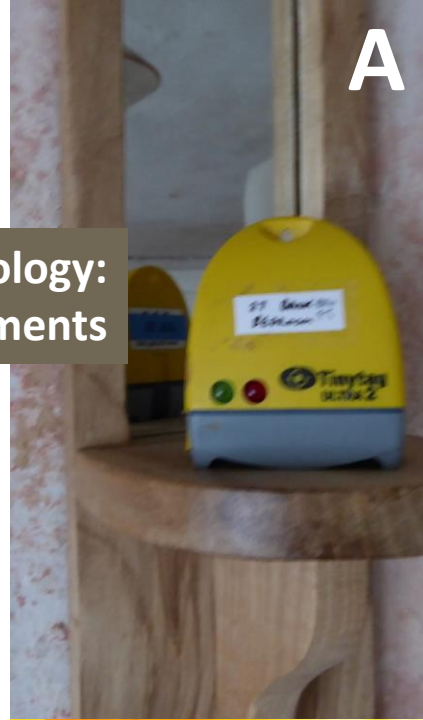
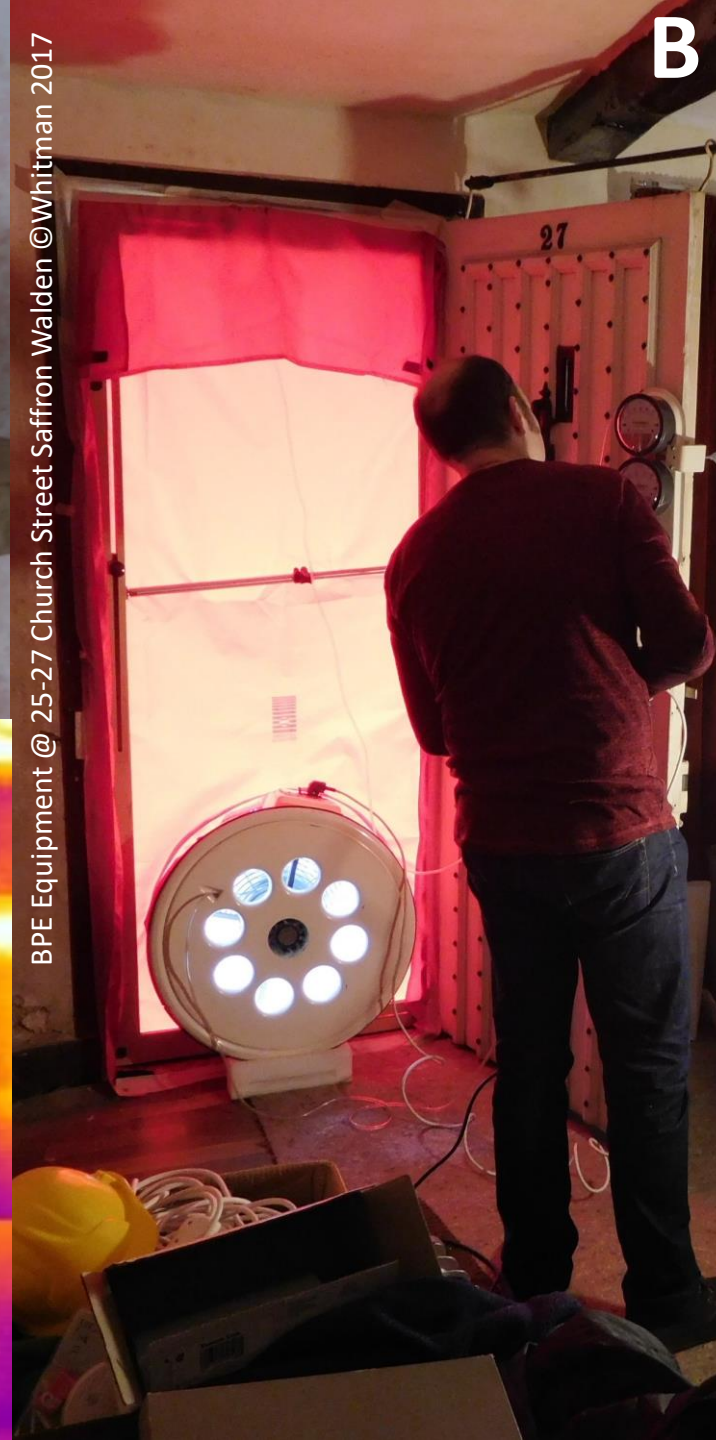
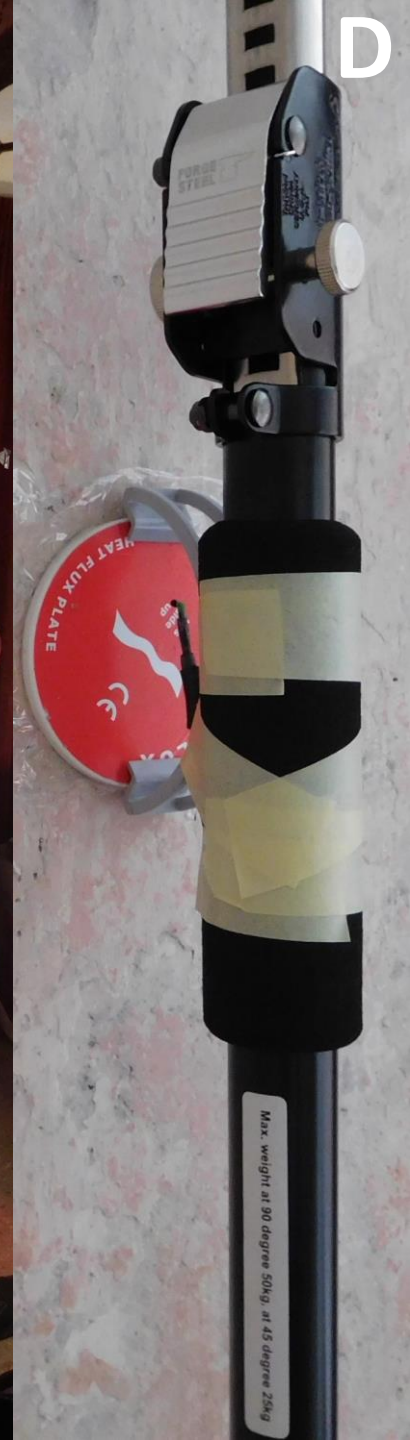
BPE Equipment @ 25-27 Church Street Saffron Walden ©Whitman 2017

TinyTag Ultra 2 TGU-4500 sensors
Lascar® EasyLog® EL-USB-2 sensors
located in seven internal locations and one external
measured at half hour intervals from 11/03/17-16/08/17.

Minneapolis® blower door with analogue Magnehelic
pressure gauges according to BS EN ISO 9972:2015
undertaken on 12/03/17

FLIR® B250 thermal imaging camera
Following Historic Environment Scotland guidance.
Undertaken 6:30am 12/03/17

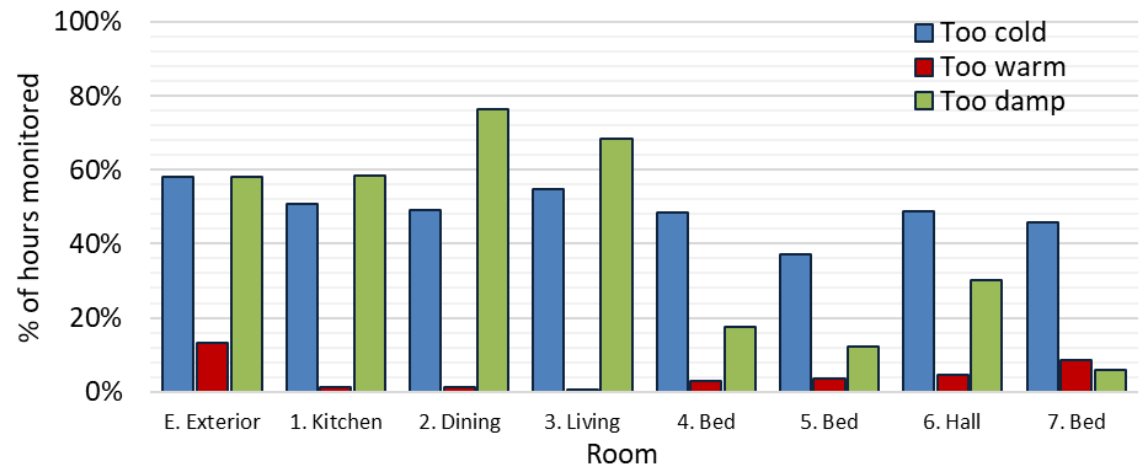
Percentage of time that hygrothermal comfort as defined by Givoni is not achieved due to low temperatures, high temperatures and high relative humidity. Source: (Author's own, 2017)

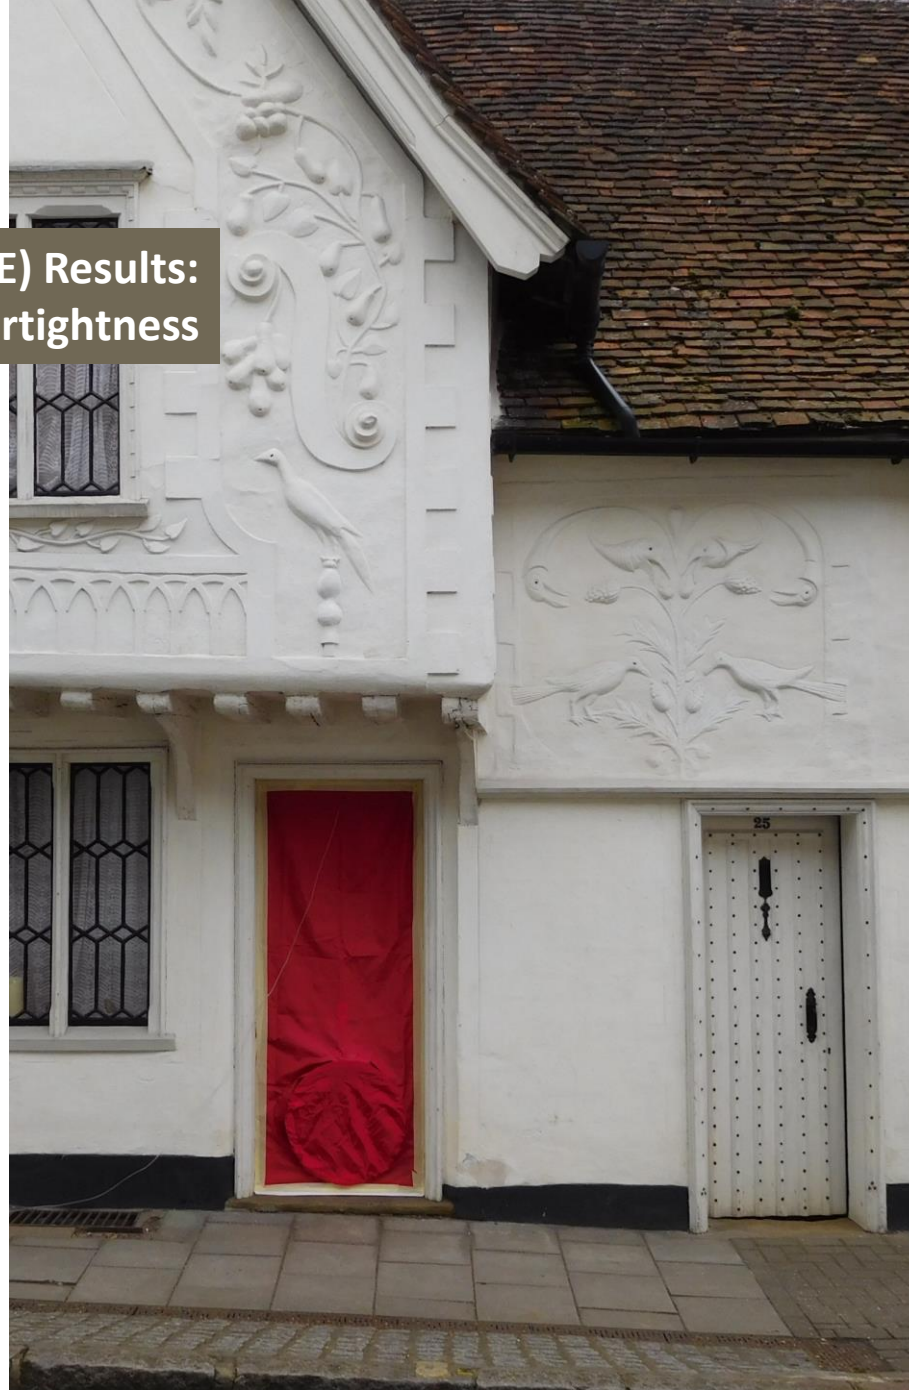
Property	API (m ³ /h.m ²)	ACR (/hr)
1*	7.3	10
1	14.2	18.8
1&2	58.6	56.6

API Air Permeability Index

ACR Air Change Rate @ 50 Pa

* Previous measurement undertaken in 2012

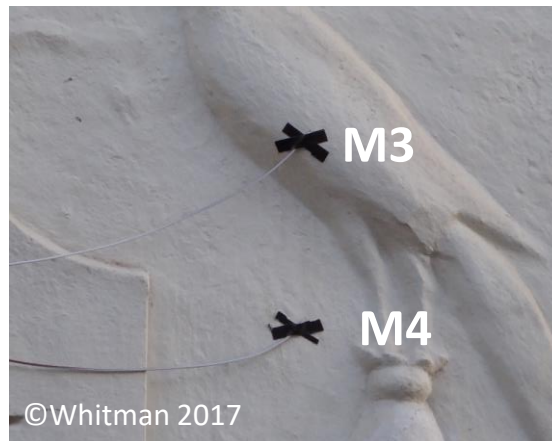
Monitored 15/12/19-22/01/20

Thermography of eastern cross wing showing location of monitoring positions. M1 & M2 monitored 12/03/17-02/04/17 and M3 & M4 monitored 15/12/19-22/01/20.
Source (Author's own, 2020)

Monitoring location	Wall thickness (m)	U-value (W/m ² K)
M1*	0.170	0.85
M2	0.130	0.64
M3	0.170	1.29
M4	0.130	1.33

* Only measured over 5 days and so high error factor

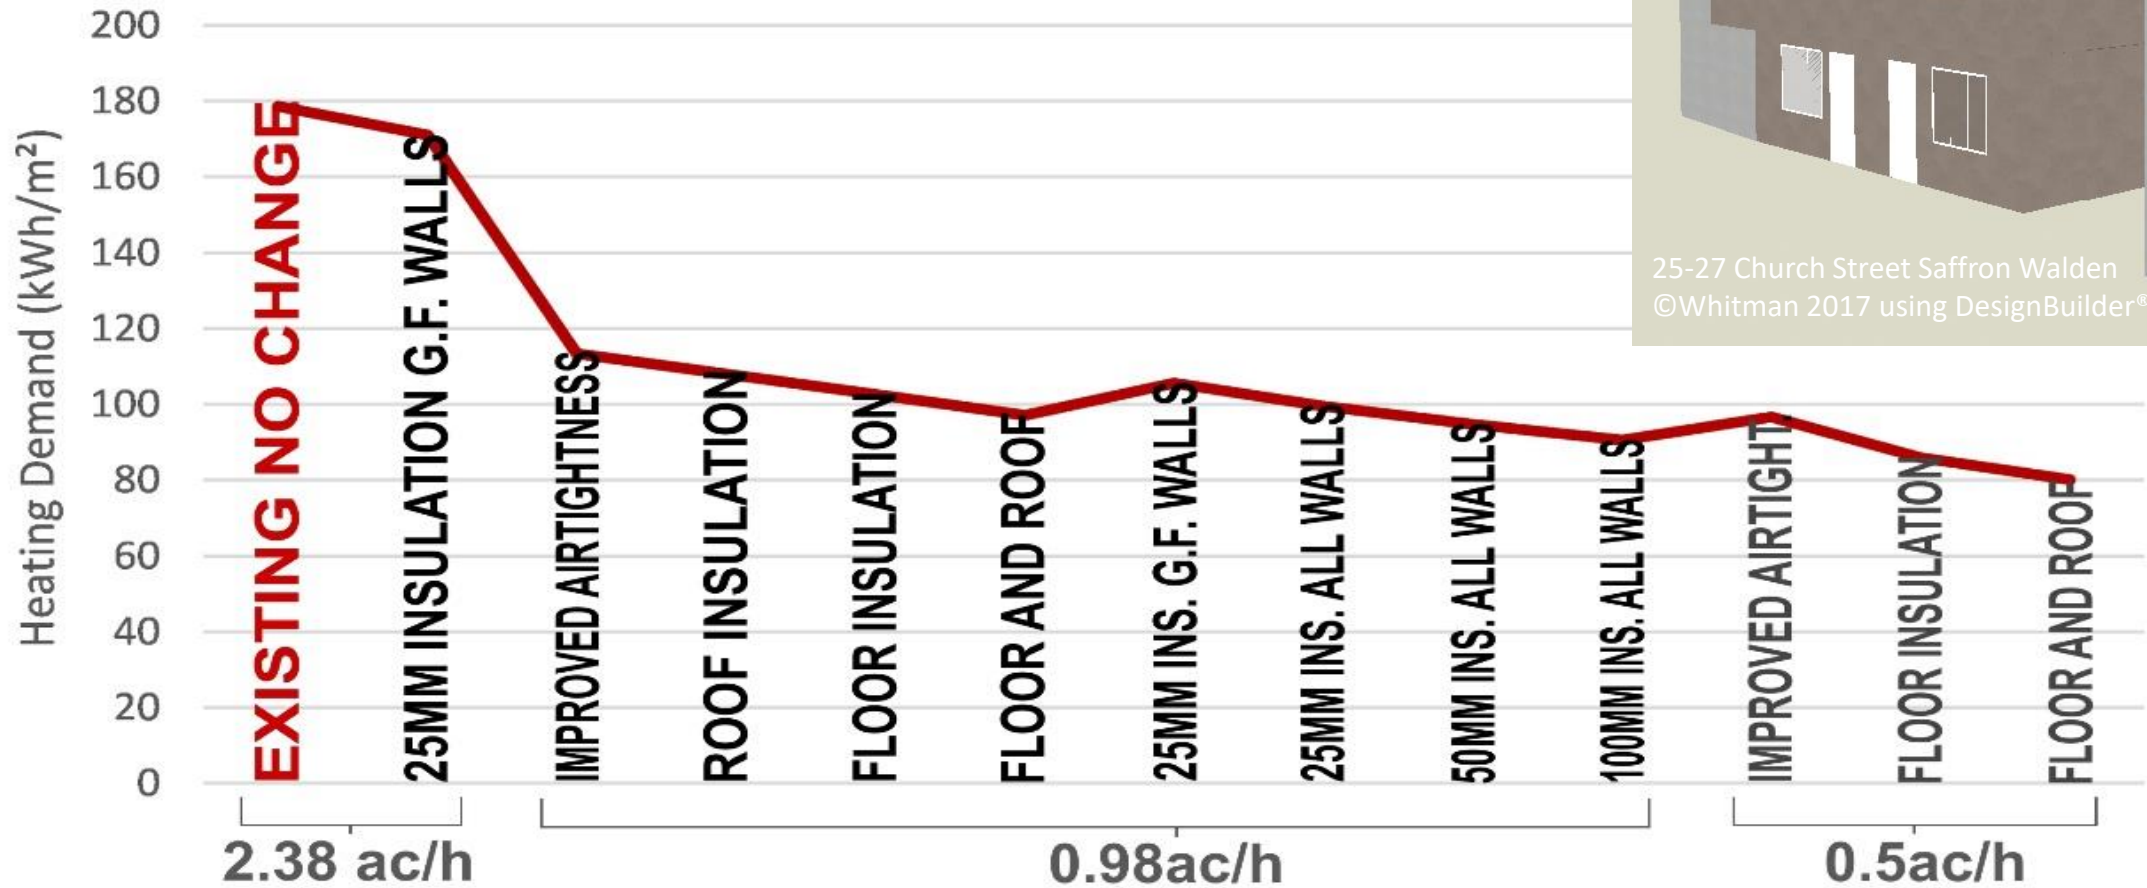
Simulated heating energy for current situation and a range of hypothetical retrofit actions at three different levels of airtightness. Existing situation shown in red. Source: (Author's own, 2017)

Digital simulation of both current energy demand and potential results of future energy retrofit actions were undertaken using the software DesignBuilder® Version 4.2.0.54, with measured U-values and airtightness imputed to improve accuracy. A climate file was created using the software Meteonorm® version 6.1 using the time period 1996-2005.
