Developing Test Methods for Compression after Lightning Strikes

Abstract

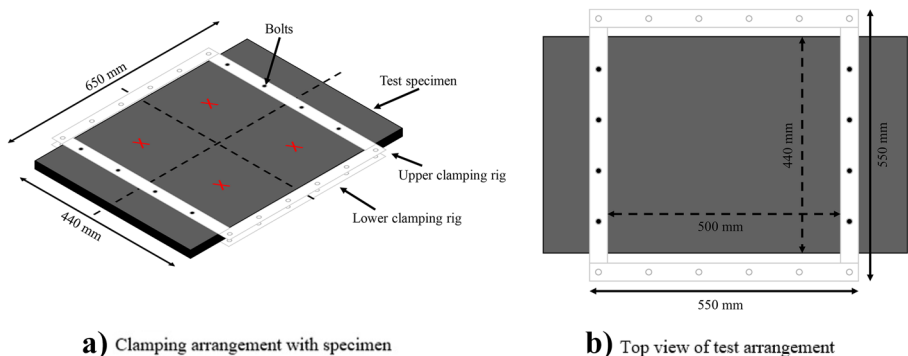
Fig. 1 Lightning specimen **a)** in the test bed (strike points shown with red x's), and **b)** its clamping arrangement

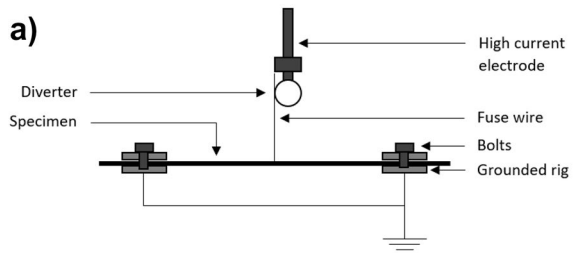
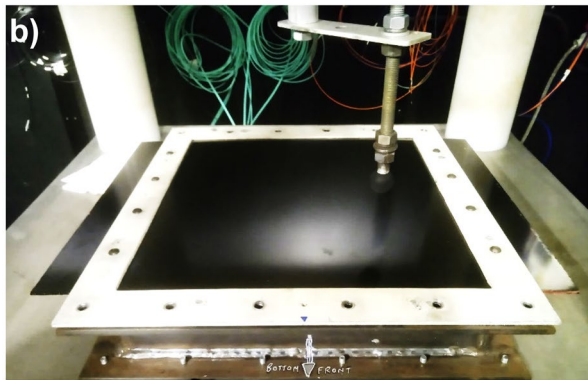
Fig. 2 Laboratory generated lightning strike test arrangement, **a)** labelled schematic, **b)** image of specimen in setup before test

The test specimen was bolted into a grounded rig at two opposite short sides below a high voltage electrode as shown in Fig. 2. This clamping arrangement was chosen since the specimen was longer and narrower than the testing rig. The bolted connection along both short edges maintains firm and tight contact between the specimen and the grounding clamps. The purpose of the bolts is to ensure tight contact between the specimen surfaces and the

grounding clamps, which is the primary route to ground for the injected specimen current. A very small fraction of the induced current may flow through the bolts from the specimen to the grounding clamps, but any such local effects are between the grounding upper and lower clamp and relatively far from the lightning attachment point (approximately 150 mm). The bolts have a small diameter (~ 8 mm) and the bolt holes will not be within the final post-strike test specimens. The drilling process is not expected to have any tangible effect on the mechanical properties of the specimen and resulting CAL strength. The use of different electrode sizes and shapes have been studied within the literature and this has been shown to affect the size of the predicted lightning damage [55–57]. Therefore, in this work to minimise variability, a small insulating plastic sphere, known as a diverter, was used to minimise any material being blown from the electrode onto the sample surface during the experiment, and a thin metallic fuse wire was used to guide the lightning arc to the exact point as required on the sample. The fuse wire, with a gap distance of 50 mm, instantaneously atomises during the initial stages of the arc formation and has no effect on the current flow or damage to the specimen.

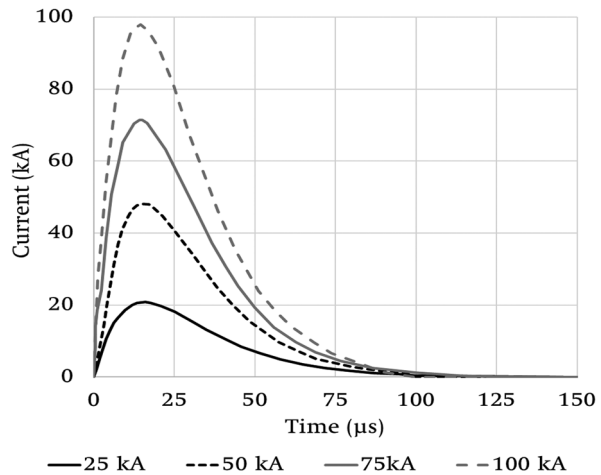
Fig. 3 Four laboratory generated D lightning waveforms with different peak currents

use of 250 mm×220 mm quadrants should be sufficient to contain the damage of the current waveforms used in this study. Figure 3 presents the injected current waveforms, showing slightly lower peak currents than the stated values. For example, the 25 kA waveform has an actual peak current of 21 kA. However, for convenience the four waveforms will be referred to as 25, 50, 75 and 100 kA throughout this paper. After these experiments, the specimen was carefully cut into its respective quadrants using a diamond-coated disk for further analysis.

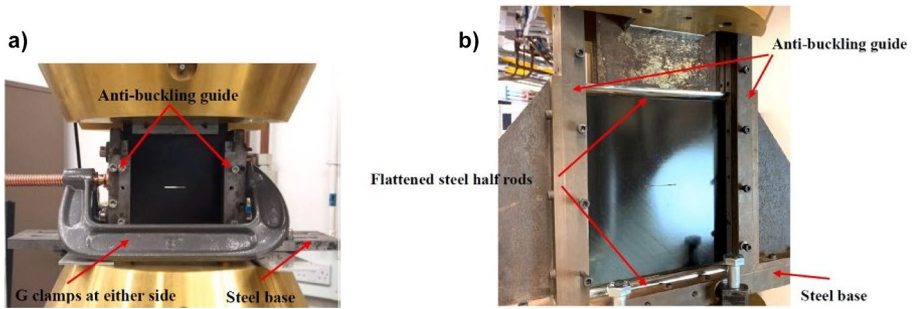
Fig. 4 Modified CAI jigs [59]: **a)** 120 mm wide notched specimen clamped to the test machine and **b)** 220 mm wide notched specimen edge-loaded

Previously, two CAI jigs (Fig. 4) modified from the standard CAI test jig [58] were successfully used to study the strength scaling in notched compression tests [59]. These jigs were selected for this study because their design would enable easy accommodation of a wide range of specimen dimensions from 120 to 220 mm in width. Unlike the standard CAI test boundary conditions, steel jaws were used in the smaller rig to clamp the top and bottom ends of the specimen over a width of 100 mm. Anti-buckling guides were then used to gently constrain the slightly wider specimen (Fig. 4a). The purpose of these modifications was to reduce the risk of global buckling when using large specimens with lightning damage, which may initiate failure at higher load than impact damage (which the rigs were originally designed for). Therefore, this smaller modified CAI jig can be used to adapt to the range of damage resulting from the artificial lightning strikes. The same clamping modification cannot be made to the larger jig (Fig. 4b) due to the limited width of the steel jaws of 100 mm. The modification to the larger jig is only to its size.

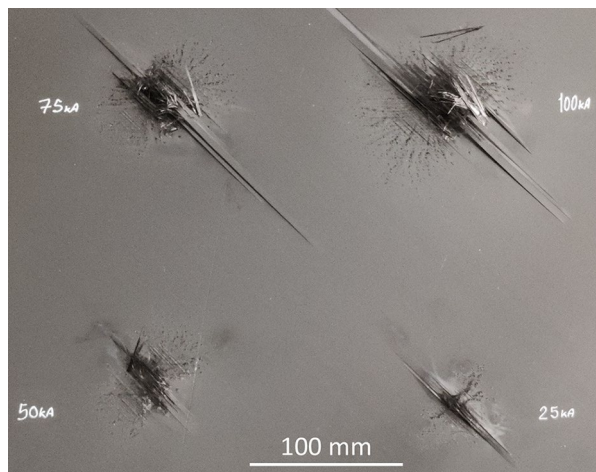
Fig. 5 Composite panel after lightning strikes (25–100 kA peak currents)

An initial inspection of the lightning damage to specimens showed many broken, lifted, and separated fibres and a large amount of surface pitting around the strike area (Fig. 5). As the peak current amplitude increased, the damage appeared to penetrate deeper into the

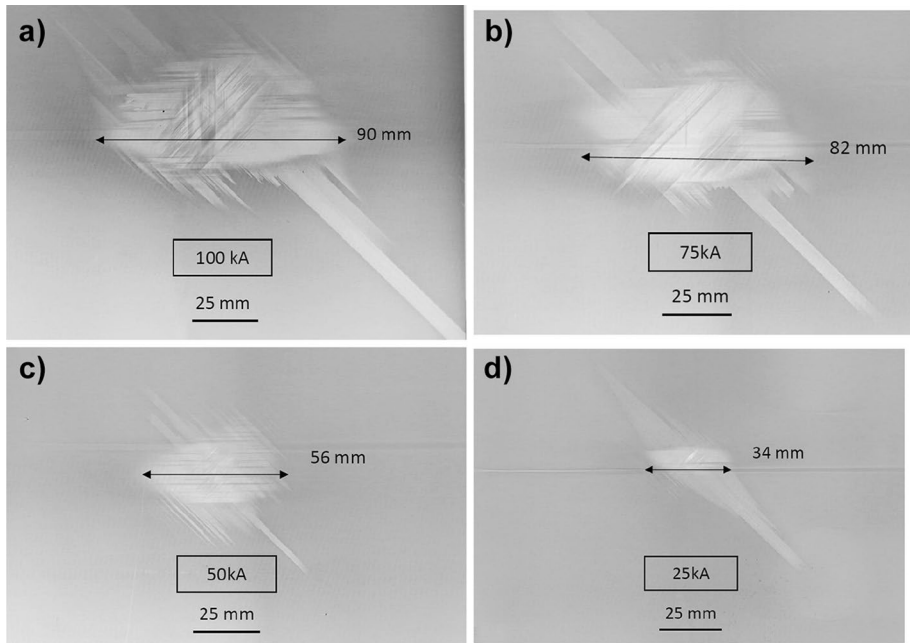
Fig. 6 CT images showing extend of internal damage after lightning strikes with a peak current of **a)** 100 kA, **b)** 75 kA, **c)** 50 kA, and **d)** 25 kA, respectively

The CT images taken through the specimen thickness, in Fig. 6, show the extent of damage in each sub-divided large test panel section and how this varies with peak current amplitude. These damage profiles dictate the CAL specimen dimensions by showing the extent of the maximum in-plane internal lightning damage through the thickness after lightning strikes at 100, 75, 50 and 25 kA peak currents, respectively. The internal damage did not reach the specimen edges so the damage in the four quadrants could not overlap in the panel.

The lowest current is expected to have the highest residual compressive strength, so the 25 kA case (Fig. 6d) is believed to be the hardest to test under compression. Therefore, CAL tests were conducted in decreasing order of peak current (100 to 25 kA) and hence decreasing damage volume to converge on an experimental design suitable for the range of peak currents.

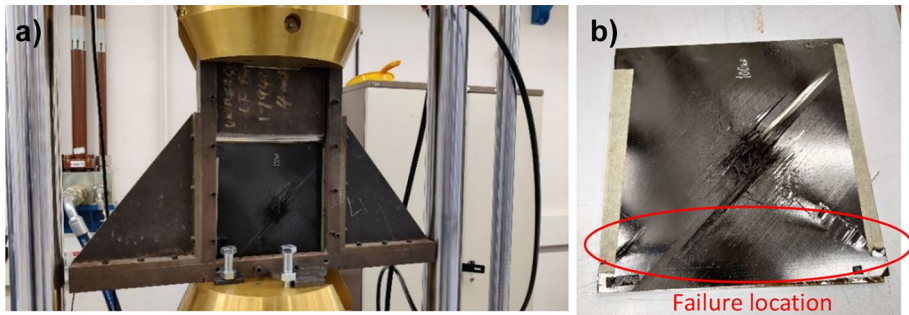
Fig. 7 100 kA CAL test **a)** set-up and **b)** failed edge-loaded specimen

The lightning damage did not initiate specimen failure and the specimen loading increased to a point where excessive out-of-plane bending was observed due to buckling. This caused an undesirable failure mode near the edges of the specimen (220 MPa, gross section), shown in Fig. 7b. It is speculated that because the lightning damage did not initiate specimen failure at a lower load, additional clamping constraints at both edges would have been necessary to eliminate the buckling behaviour and result in a direct damage-initiated material failure. This result is seen as undesirable. Smaller specimens and more constraints could reduce the tendency of buckling.

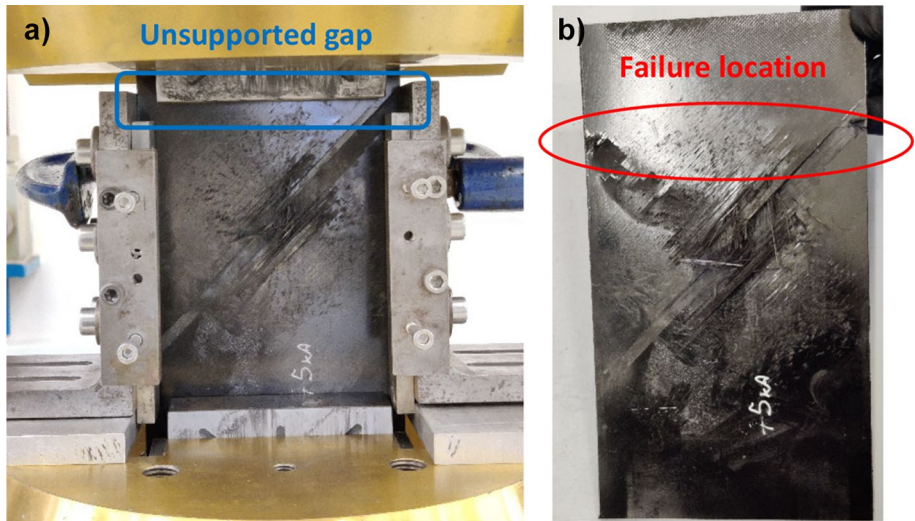
Fig. 8 75 kA CAL test a) set-up with an unsupported gap and b) failed clamped specimen

Given the challenges observed with the 100 kA specimen, the 75 kA peak current specimen was cut down to 120 mm × 150 mm. This made the specimen closer to the standard CAI size of 100 mm × 150 mm. This could be achieved because the lightning damage area was smaller for the 75 kA peak current lightning strike. This resulted in a distance greater than 19 mm between the edge of the internal lightning damage and the edge of the specimen based on Fig. 6b. However, the surface delamination was more extensive and reached the specimen edges as shown in Fig. 8a. The top and bottom edges of the specimen were also clamped to the test machine. It was expected that both measures (cutting down the specimen and specimen clamping) could reduce the tendency for buckling and out-of-plane bending. Failure occurred between the lightning damage and the end of the anti-buckling guides (264 MPa, gross section), shown in Fig. 8b. Because the failure location was at the unsupported gap in the jig but not at the specimen centre, this result was undesirable.

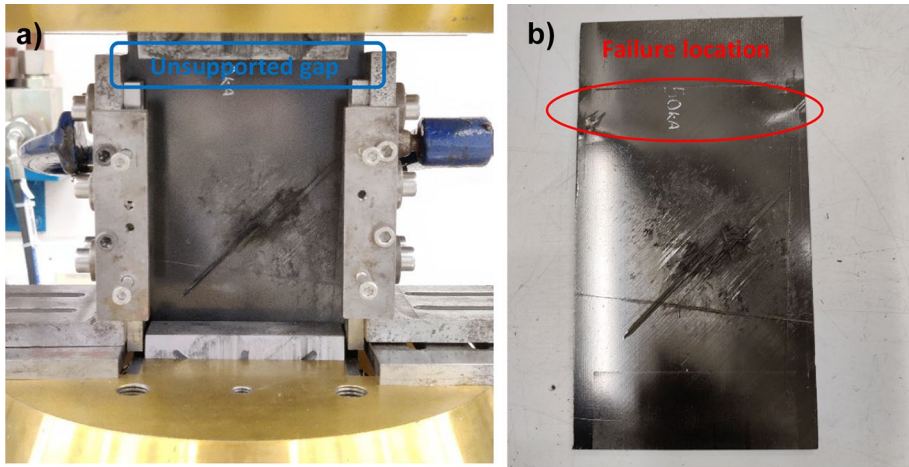
Fig. 9 50 kA CAL test **a)** set-up with an unsupported gap and **b)** failed clamped specimen

Given that the damage area decreased again for the 50 kA peak current specimen, the same specimen size as the 75 kA specimen could be used, 120 mm × 150 mm. This resulted in a distance greater than 32 mm between the edge of the internal lightning damage and the edge of the specimen based on Fig. 6c. It was expected that the failure load would be higher, but this was not the case (267 MPa, gross section), shown in Fig. 9. Failure was away from the lightning damage and at the end of the anti-buckling guide. This again highlights the limitation of the present CAI set-up as the lightning damage did not initiate specimen failure. Specimen failure was initiated where there is a small gap between the

upper loading point (grips in the current set-up) and the edge of the anti-buckling guides. The combination of compression, buckling and an unsupported gap at the corner of the specimen, initiated failure. Therefore, this setup and result was seen as undesirable. Additionally, given that the failure stress was like the preceding 75 kA specimen it confirms that the preceding test was undesirable due to buckling.

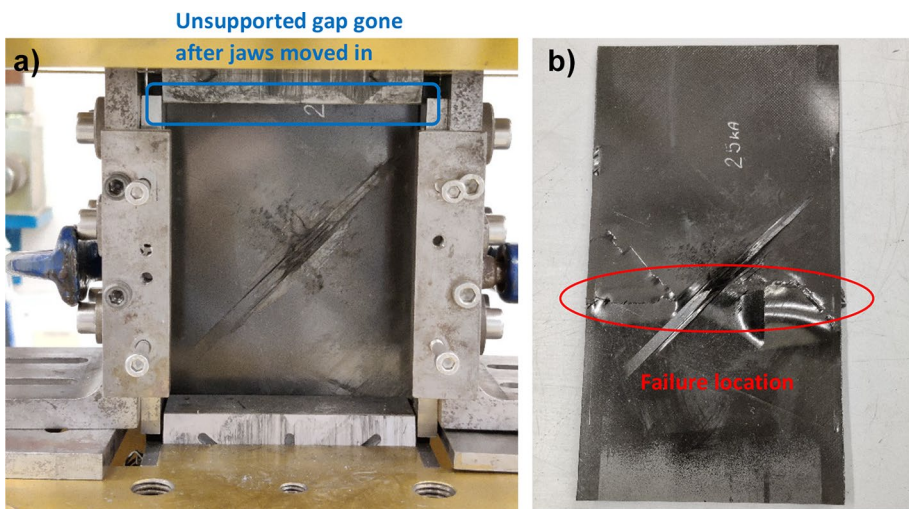
Fig. 10 25 kA CAL test **a)** set-up without unsupported gaps and **b)** failed clamped specimen

The damage area was smallest for the 25 kA specimen, therefore, the specimen was kept the same as the 75 kA and 50 kA peak current specimens (120 mm × 150 mm). This resulted in a distance greater than 43 mm between the edge of the internal lightning damage and the edge of the test rig boundary conditions based on Fig. 6d. Since the delamination was smallest, the expected failure load was highest. To avoid producing the same undesirable failure modes as the preceding tests, further modifications were made to the CAI jig. The previous unsupported gap was therefore eliminated. This was only possible by using a slightly wider specimen than the CAI standard, allowing the steel jaws to move down further without touching the anti-buckling guides. All edges of the specimen were constrained throughout the test. Failure was right in the specimen centre at the lightning damage (317 MPa, gross section), as shown in Fig. 10. The mode of failure indicates that this was a successful test.

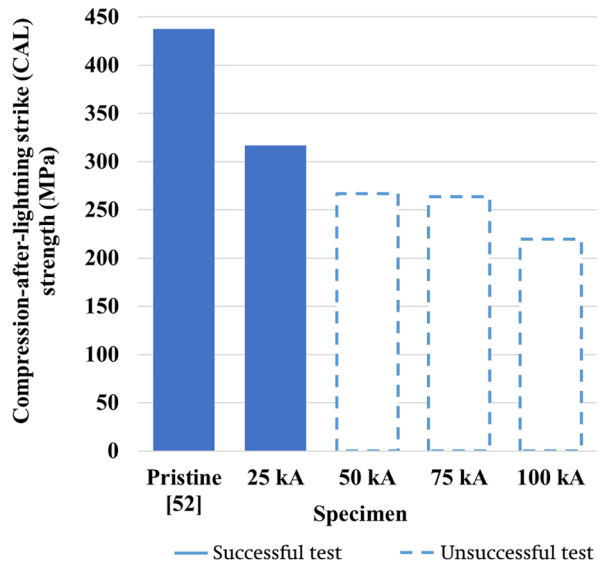
Fig. 11 Reduction in CAL strength from pristine to 25 kA peak current specimens

A summary of the reduction in CAL strength from a pristine composite specimen to a specimen subjected to 25–100 kA peak current strikes is shown in Fig. 11. The 25 kA specimen is 28% weaker than the pristine CAI strength (438 MPa [52]) of the same material and

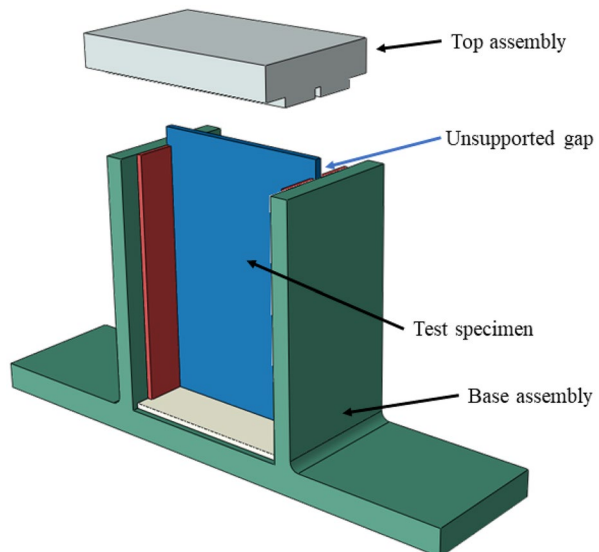
Fig. 12 ASTM D7137/D7137M standard [58] set-up with an unsupported gap

area before failure occurred at the test boundary conditions. As shown in Fig. 12 [58], there is an unsupported gap in the CAI jig which may initiate failure first if the damage in the test specimen does not initiate failure below 264–267 MPa for the tested combination of composite material and laminate stacking sequence. When this weakness in the setup was removed, the CAL strength for the selected material and laminate with damage from an artificial lightning strike with a peak current of 25 kA was found to be 317 MPa. These modifications effectively changed the failure location from the undesirable specimen edge to the centre, at the lightning damage region.
