Acoustic Emission Monitoring of Rolling Element Bearings Failures

Thesis submitted in candidature of the degree of Doctor of Philosophy at Cardiff University

Tribology & Performance Machines, Structures & Materials Research Group Cardiff School of Engineering Cardiff University

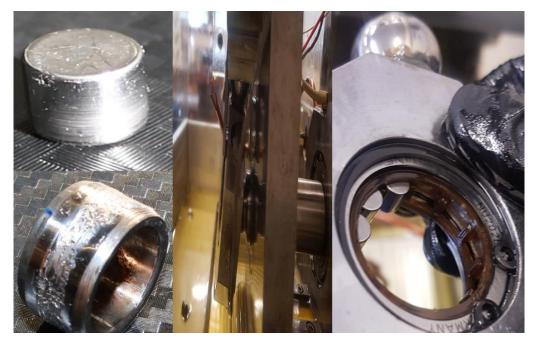
Figure 6-8: Images from the fourth attempt on SKF NIU202ECP bearing.

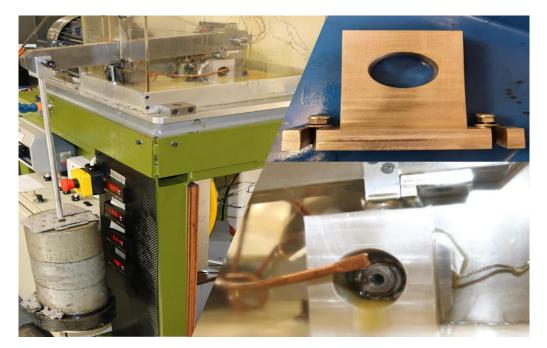
Figure 6-9: Manufactured piece to stop the test bearing housing's axial displacement.

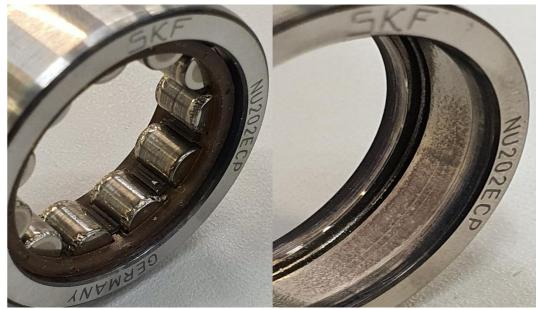
Figure 6-33: Second SKF NU202ECP, damage sustained on rollers and outer raceway.

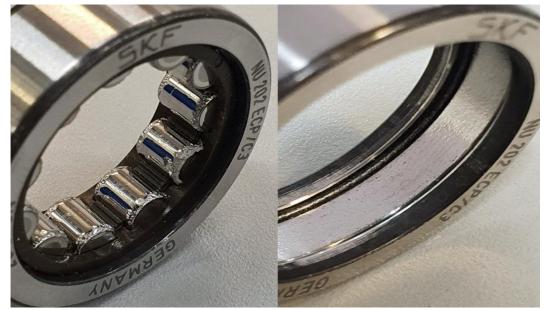
Figure 6-35: First SKF NU202ECP/C3, damage sustained on rollers and outer raceway.

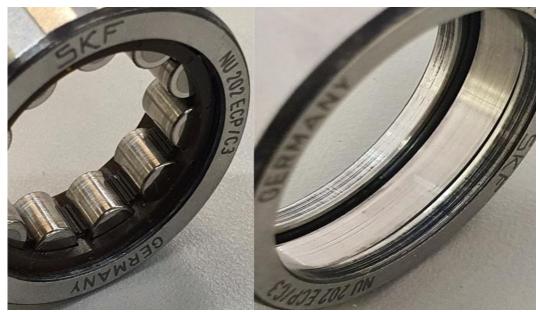
Figure 6-37: Second SKF NU202ECP/C3, damage sustained on rollers and outer raceway.

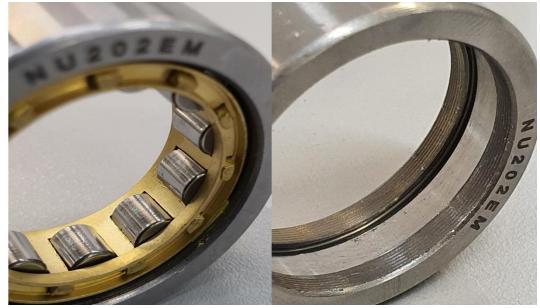
Figure 6-39: First Budget Bearing, damage sustained on rollers and outer raceway.
