Whitman, Christopher J. 2024. Retrofitting historic timber-framed buildings in the UK: Monitoring the risk of increased moisture content. *Journal of Building Survey, Appraisal and Valuation*

# Retrofitting Historic Timber-Framed Buildings in the UK: Monitoring the Risk of Increased Moisture Content.

Dr Chris J. Whitman<sup>1</sup>

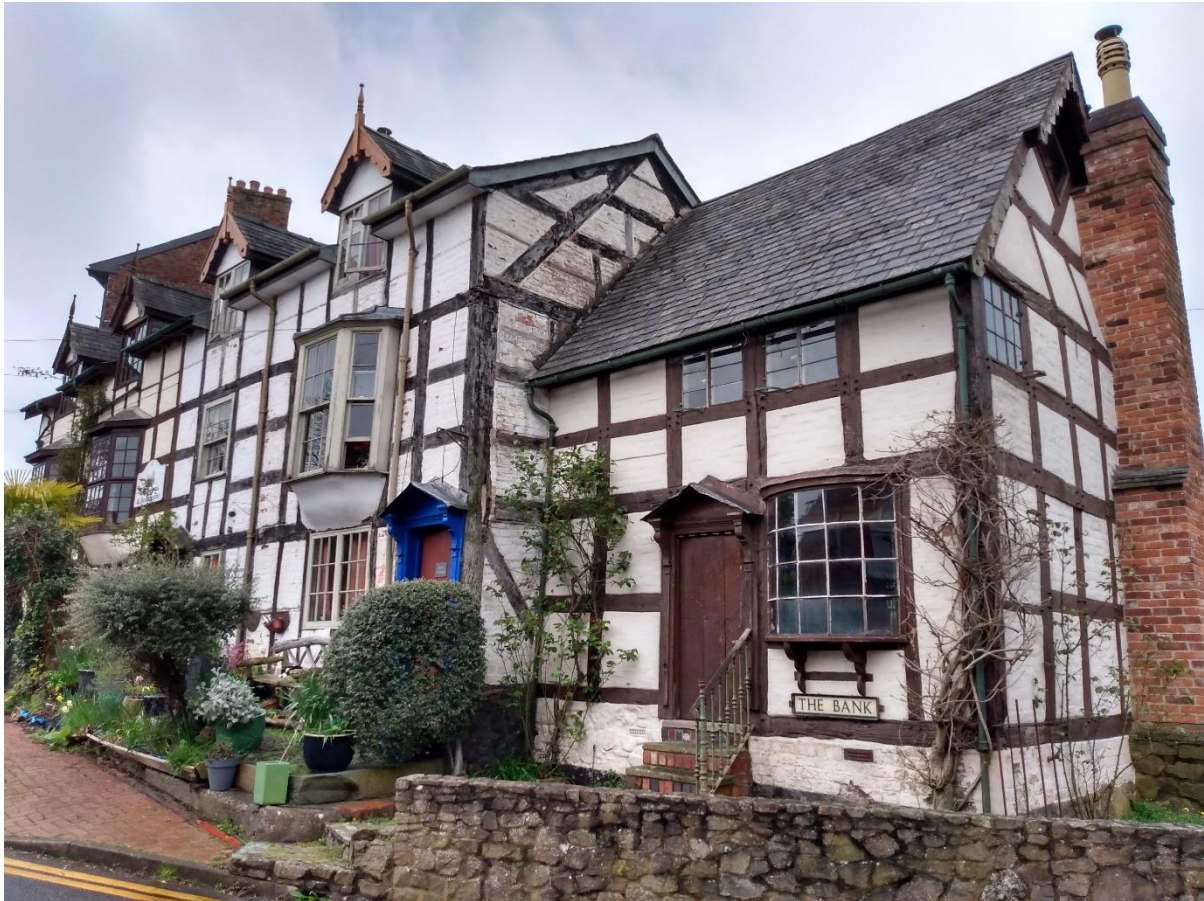
Figure 1. 17<sup>th</sup> century timber-framed buildings with 19<sup>th</sup> century alterations, Newtown, Powys, Wales (Source: author, 2024).

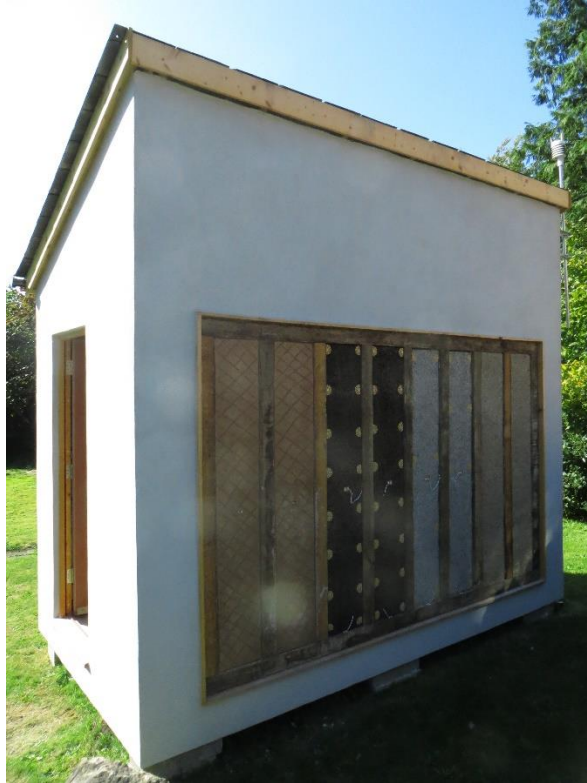
*Figure 2. Test cell showing north façade prior to application of external render. Panels left to right, wattle-and-daub, expanded cork board, wood fibre/wood wool composite and hempcrete. Source: (Author's own, 2019)*

To enable long-term monitoring, a test cell was constructed at Cardiff University (Figure 2), measuring 3.5m x 1.9m x 2.2m (width x depth x height). The test panels form the external envelope of the northern façade, their outer face exposed to the Cardiff climate. The internal environment is controlled during the UK heating season (Oct/Nov-March/April), with a temperature set point of >21°C and relative humidity of >60%. Outside of this period, internal climatic conditions are left free-running to replicate typical domestic building conditions in the UK. A pedestal mounted rotating fan, mounted behind the heater and humidifier circulates the air to avoid stratification. The fan is in operation throughout the year.

The dimensions of these panels were determined based on a study of 100 representative historic timber-framed buildings, which revealed that 53% were square-framed and 47% were close-studded. Square panels averaged 785mm x 950mm, while close-studded panels averaged 305mm x 1830mm. Given the test cell's configuration, close-studded panels were chosen to allow for the monitoring of eight adjacent panels at the same height above ground level.

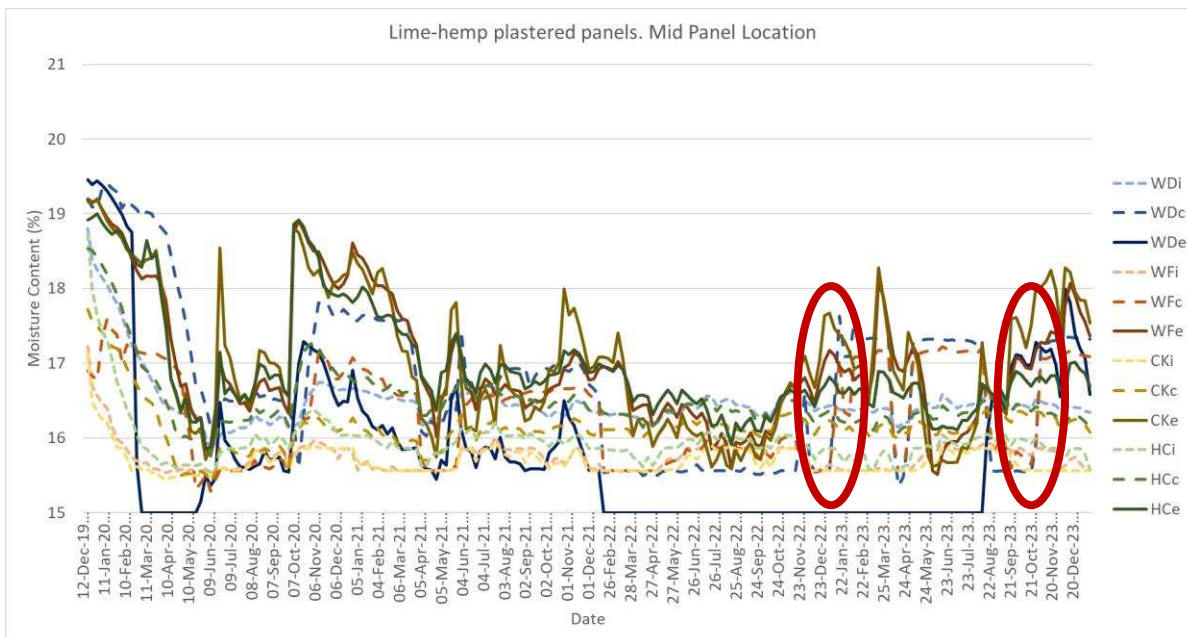
Figure 5. Moisture Content Measurements at mid-panel location of panels with Lime hemp-based finishes 12/12/2019 – 18/01/2024. With potential evidence of interstitial condensation highlighted. (WD-Wattle & Daub, WF-Wood Fibre, CK-Cork, HC-Hempcrete. i-internal, c-centre, e-external.) Note: Due to connection issues, no data was collected for monitoring point WDe from March-May 2020 and Jan 2022-August 2023.

However, as highlighted in Figure 5, in mid-January 2023 and again at the end of October 2023 there is also a measured increase in moisture content in the centre of the wattle and daub (WDc), and the wood fibre/ wood wool panels (WFc). This occurs in both those panels with finishes based on NHL 3.5 (Figure 4) and lime-hemp (Figure 5). Noticeably, these increases had a considerable offset from the increase at the outer layer resulting from wind-driven rain. Whilst this could represent the time taken for moisture to penetrate the panel, they could also suggest the occurrence of interstitial condensation.

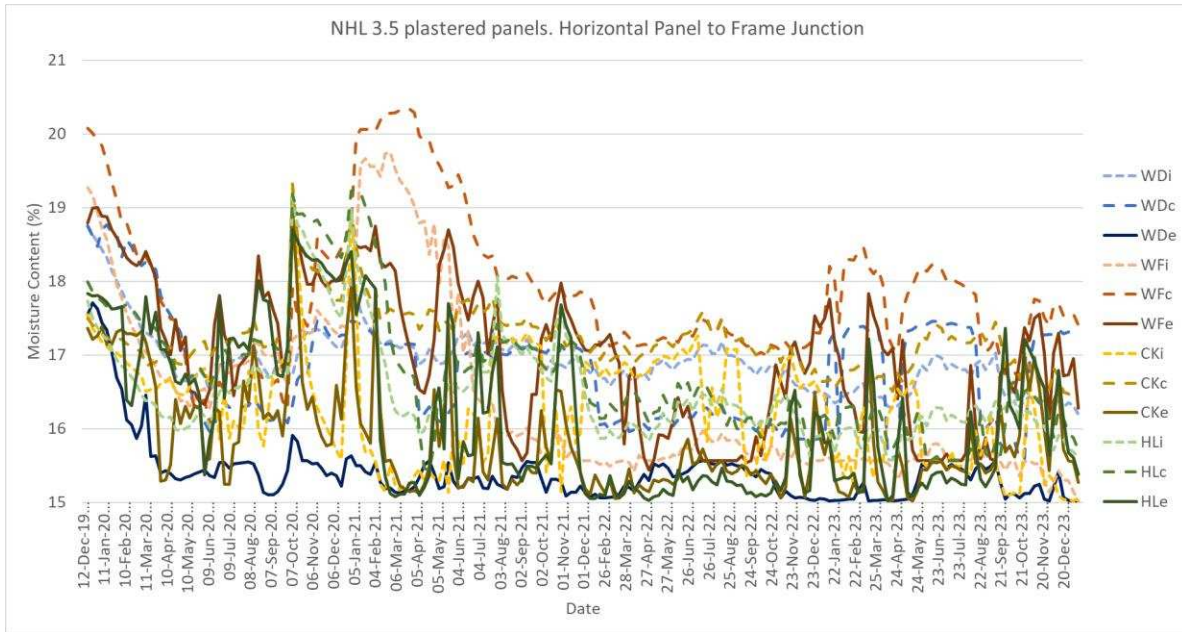
Figure 8. Moisture Content Measurements at horizontal panel-frame junction for panels with NHL 3.5 based finishes 12/12/2019 – 18/07/2023. (WD-Wattle & Daub, WF-Wood Fibre, CK-Cork, HC-Hempcrete. i-internal, c-centre, e-external.)

A similar situation can also be observed at the monitoring positions at the junctions between the panels and the oak frame of both the wood fibre and the wattle and daub panels (Figure 8 & Figure 9). This potentially calls into question the previous conclusion that the impermeable sealants, included in the junction detail for the wood fibre/ wood wool panels, were trapping moisture at this point that was entering via capillary action. There is no such sealant in the perimeter detail of the wattle-and-daub panels, which shows a similar behaviour to the wood fibre, whereas the cork infilled panels, which do have a perimeter seal, do not show any comparable marked increase in moisture content.
