## Evaluating the hygrothermal performance and associated benefits and risks of replacement infill panels for historic timber-framed buildings in the UK

Chris Whitman<sup>1,\*</sup>

<sup>1</sup>Welsh School of Architecture, Cardiff University, UK

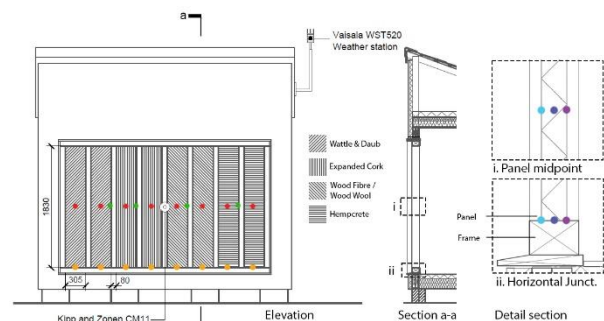
Figure 2. Monitoring positions in elevation (Red-centre of panel, Orange-midpoint of horizontal junction, Green-midpoint of vertical junction) and section (Cyan-interface external render and infill, Blue-midpoint of infill, Purple-interface internal render and infill).

Within each panel, interstitial temperature (°C) was measured using embedded Type T thermocouples and wood moisture content (%) using electrical resistance. Monitoring positions are located, in elevation, in the centre of each panel, at the midpoint of the horizontal junction between the panel and sill beam (lower member) and at the midpoint of the vertical junction between the panel and stud (upright member). At each of these there are sensors at three depths, i) the interface between external render and infill material; ii) midpoint of infill material; and iii) at the interface between internal render and infill material (Figure 2).

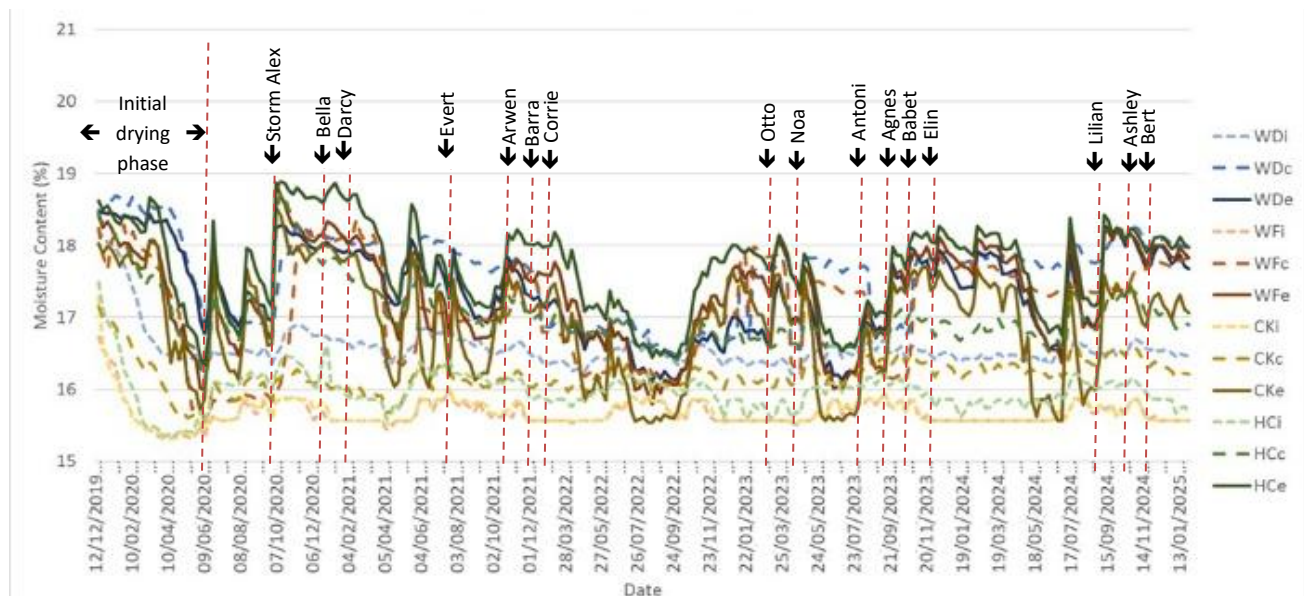
Figure 3. Wood Moisture Content at mid-point of NHL 3.5 finished panels 12/12/2019 – 05/02/2025. With UK named storm events overlaid. (WD-Wattle & Daub, WF-Wood Fibre, CK-Cork, HC-Hempcrete. i-internal, c-centre, e-external.)

The results for the moisture content monitoring (Figure 3 and Figure 4) show a pattern of wetting and drying for

all panels. These cycles generally coincide with wind-driven rain events, frequently related to named storms

(Figure 3) during which winds can come from the north. For the first three years of study, no evidence of measured interstitial condensation was apparent. However, since the beginning of 2023, high levels of moisture has been recorded at the central monitoring position in those panels with wattle & daub, and the wood fibre/ wood wool combination infills. These readings do not directly relate to wind-driven rain events and would therefore suggest interstitial condensation is

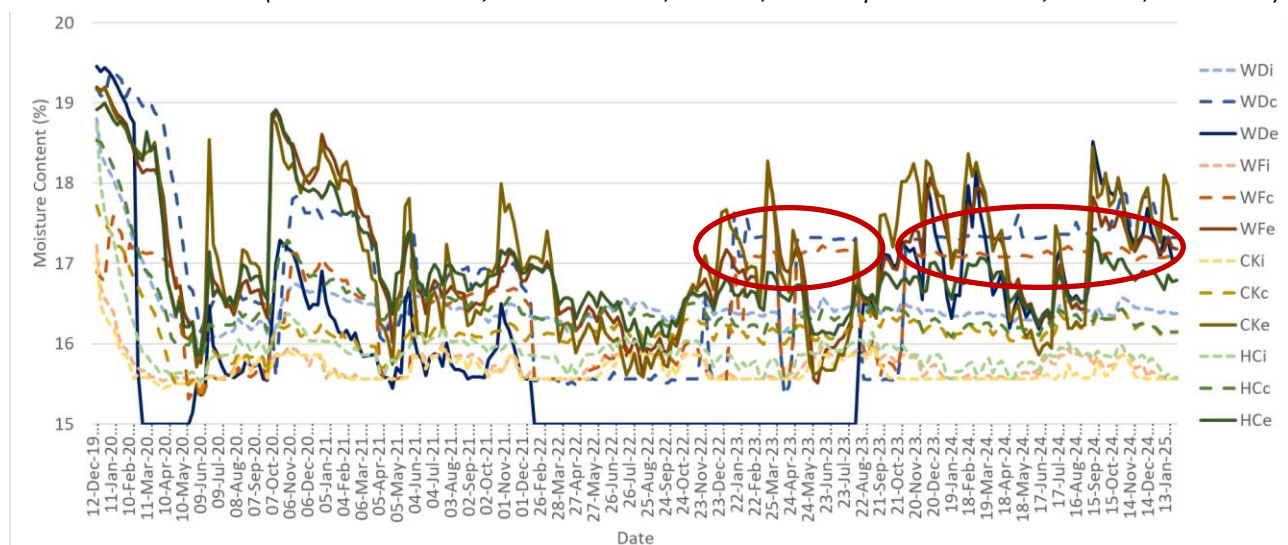
Figure 4. Wood Moisture Content at mid-point of Lime-Hemp finished panels 12/12/2019 – 05/02/2025. High moisture content at centre of Wattle & Daub (WDe) and Wood Fibre (WFc) panels highlighted.

Overall, those panels finished in the more moisture permeable lime-hemp maintain a lower moisture content, with faster drying times.

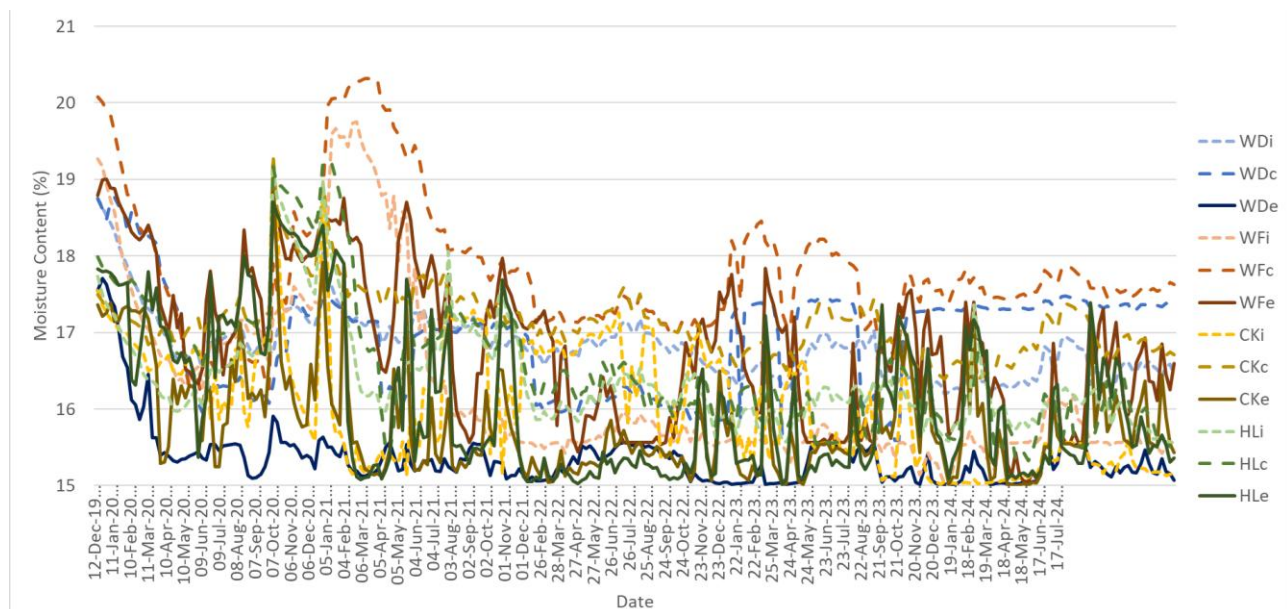
Figure 5. Wood Moisture Content at horizontal junction between NHL 3.5 finished panels and timber frame 12/12/2019 – 05/02/2025. (WD-Wattle & Daub, WF-Wood Fibre, CK-Cork, HC-Hempcrete. i-internal, c-centre, e-external.)

occurring. Glaser calculations according to (BS EN ISO 13788:2012) (British Standards Institution, 2012) using the average internal and external temperatures for these period, confirm that interstitial condensation is likely due to the changes in water vapour diffusion properties within these constructions. More evidence of this can also be seen to be occurring at the horizontal junction between the panel infill and timber frame (Figure 5 and Figure 6)

The high moisture content at this junction for the wood fibre/ wood wool detail had initially been thought to be due to the inclusion of an impermeable sealant. Whilst

this may exacerbate the problem and increase drying times, the recent occurrence in the wattle & daub panels, which have no such sealant, suggest that interstitial

condensation is the root cause. The fact that interstitial condensation is occurring in the most traditional material, wattle & daub may mean that our historic timber-framed buildings have always coped with these occurrences, or it may be a result of anthropogenic climate change and the increased occurrence of storm events. This would be an interesting area for future research utilising digital simulation using historic climate data and future climate predictions.

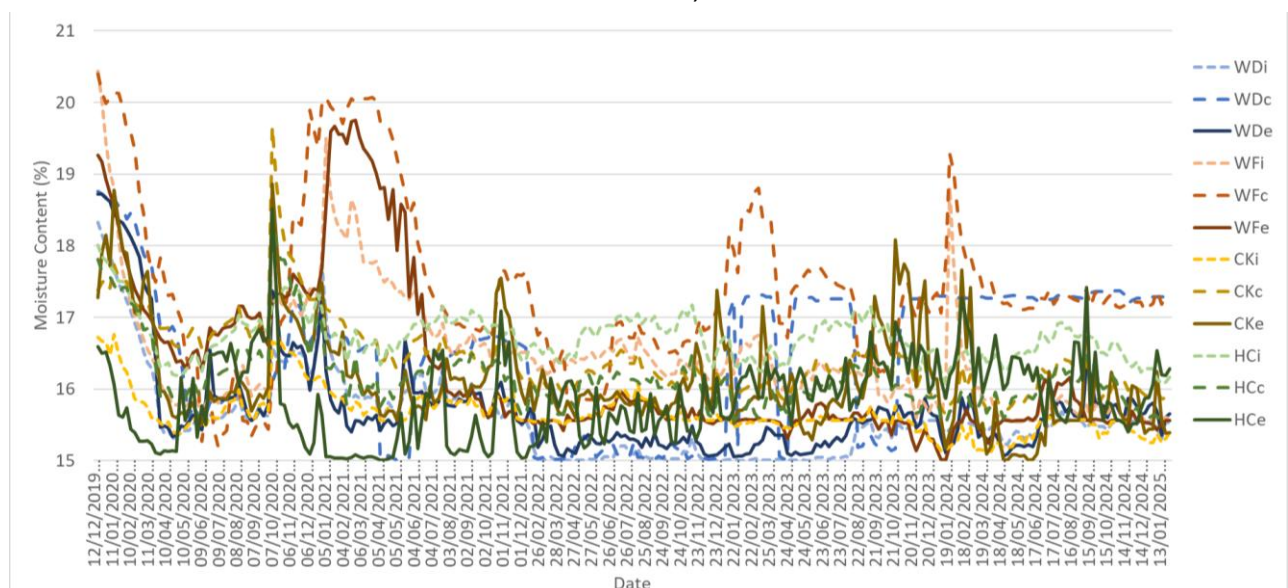
Figure 6. Wood Moisture Content at horizontal junction between Lime-Hemp finished panels and timber frame 12/12/2019 – 05/02/2025.

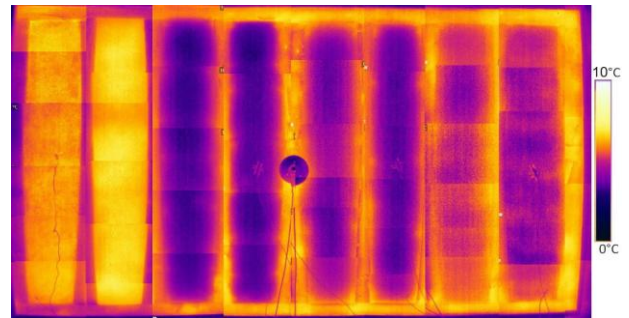
Figure 7. External thermography 07:00, 19/02/20.  
Internal temp. 20.6°C. External temp. 3.7°C

The external thermography (Figure 7- Figure 9) demonstrates the wattle & daub panels to be worst thermally performing, and the expanded cork the best. However, with the cork and wood fibre/ wood wool panels there is a large difference in surface temperature between infill and frame, with the frame forming a cold bridge. Internally this could be problematic, concentrating surface condensation on the historic fabric. The hempcrete, whilst not providing the same thermal efficiency, does create a more homogenous surface temperature and as such may provide less risk and be a more appropriate solution, especially for buildings of high heritage significance.

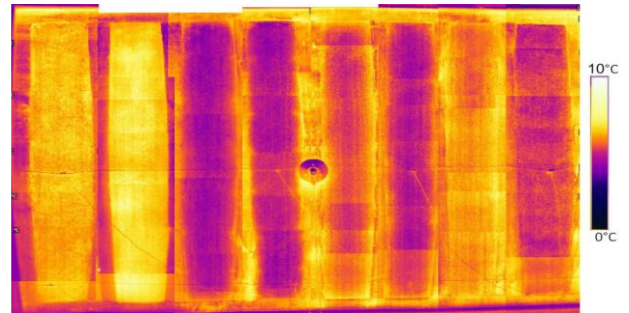
Figure 8. External thermography 07:00, 19/11/20.  
Internal temp. 20.5°C. External temp. 8.7°C

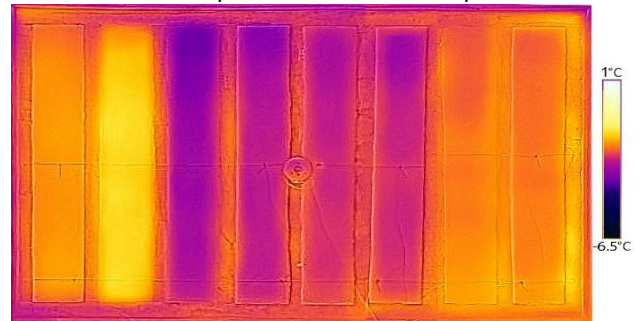
Figure 9. External thermography 07:00, 06/02/25.  
Internal temp. 20.5°C. External temp. 1.4°C
