BUILDING LIMES FORUM
CONFERENCE & ANNUAL GATHERING 2025

Lime in Retrofit: Monitoring Performance

Dr Chris Whitman

Welsh School of Architecture, Cardiff University,
WhitmanCJ@Cardiff.ac.uk

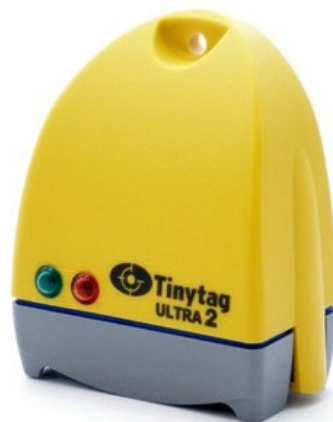
15/03/2024 – 28/03/2025

TinyTag Ultra 2

-25°C to +85°C ($\pm 0.6^{\circ}\text{C}$)

0% to 95% RH ($\pm 3\%$)

Manual download

Issues at 100% RH

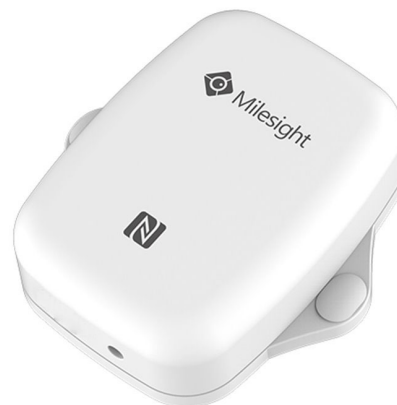
28/03/2025 – to date

Milesight LoRaWAN EM300-TH

-30°C to +70°C ($\pm 0.3^{\circ}\text{C}$)

0% to 100% RH ($\pm 3\%$)

Remote Access

Required LoRaWAN Hub

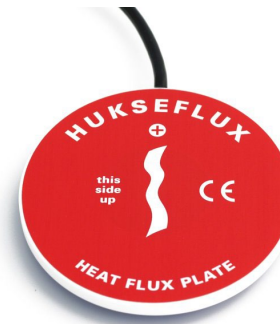
Heat flux Plate Hukseflux HFP01

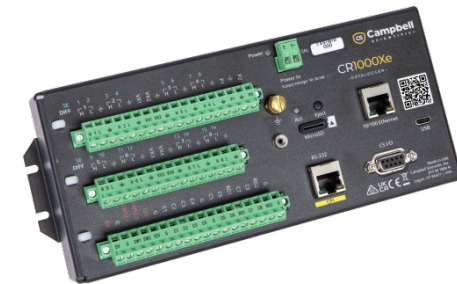
Campbell Scientific® CR1000 datalogger

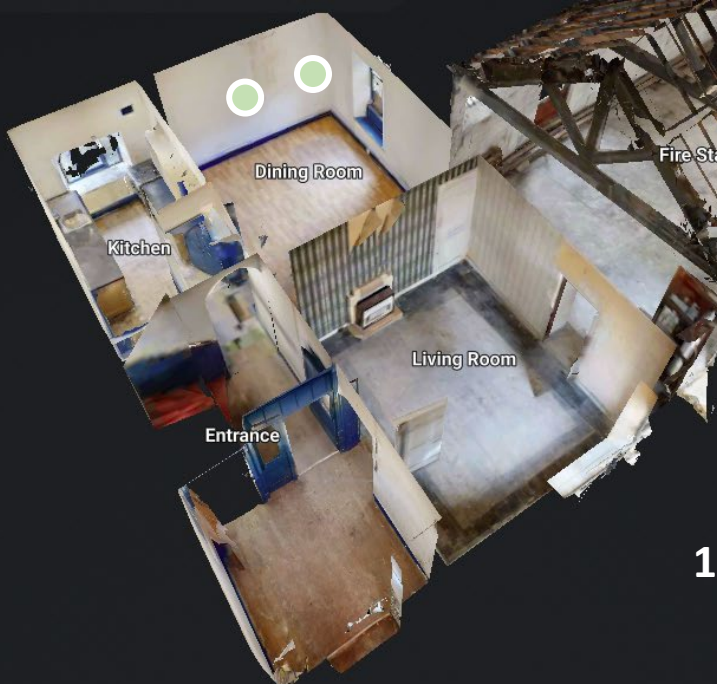
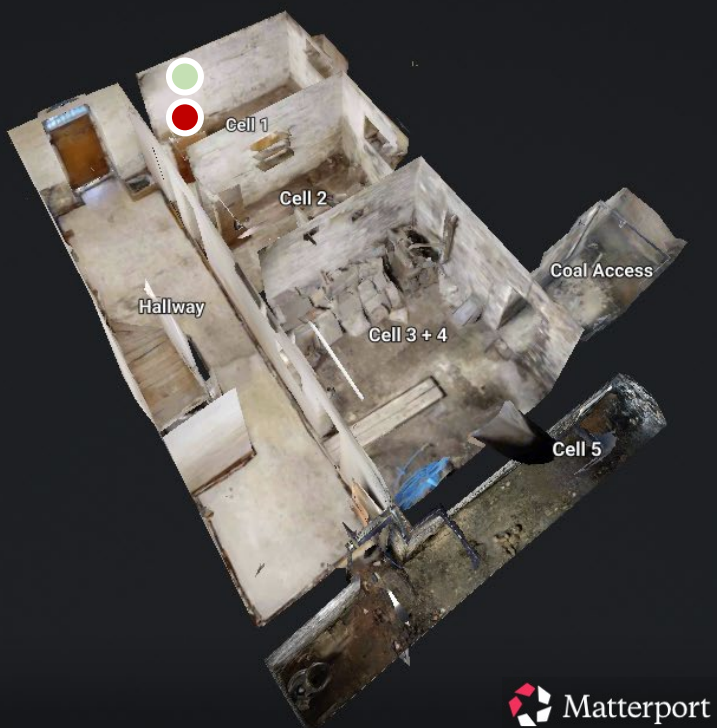
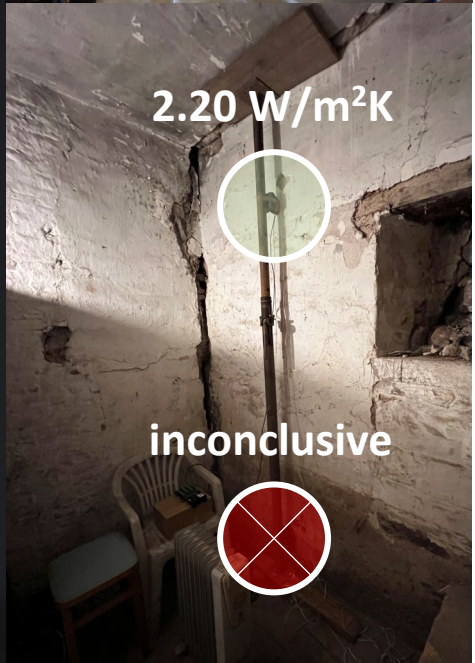
Measured in 4 locations (only 3 successful)

Brecon Postern Monitoring – In-Situ U-Value Measurements

Measured in 4 locations (only 3 successful)

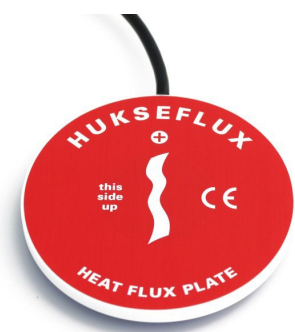
Heat flux Plate Hukseflux HFP01

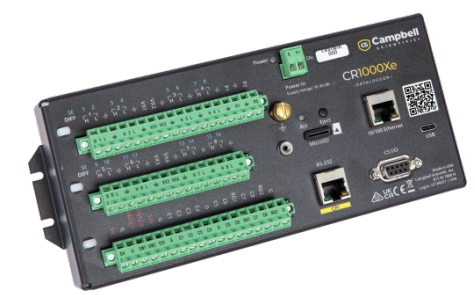
Campbell Scientific® CR1000 datalogger

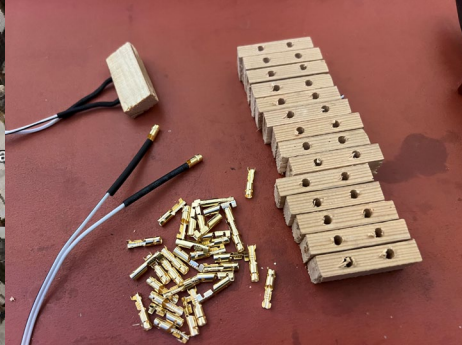
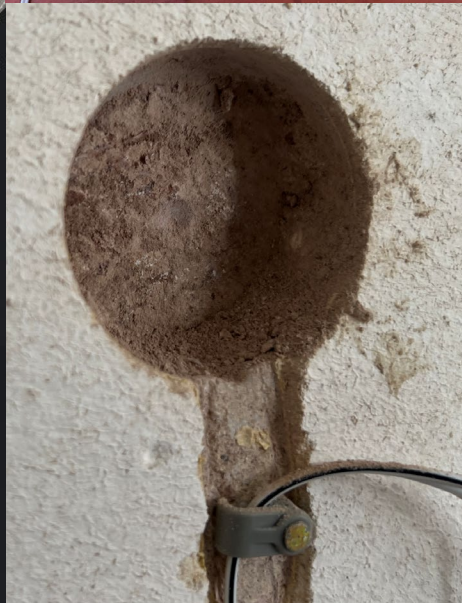
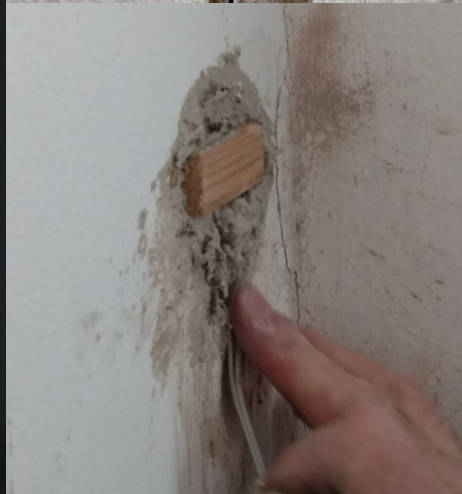
Brecon Postern Monitoring – Interstitial Moisture and Temp

6 installed so far – intention of 2 per room

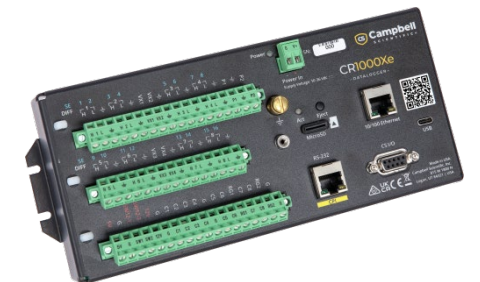
Omnisense S-4 Wireless Dual Channel and Gateway

Campbell Scientific® CR1000 datalogger

Initially using Omnisense S-4 wireless sensors but access to online data cost US\$20 per month, therefore looking to hardwire to Campbell® CR1000. Also investigating LoRaWAN option...

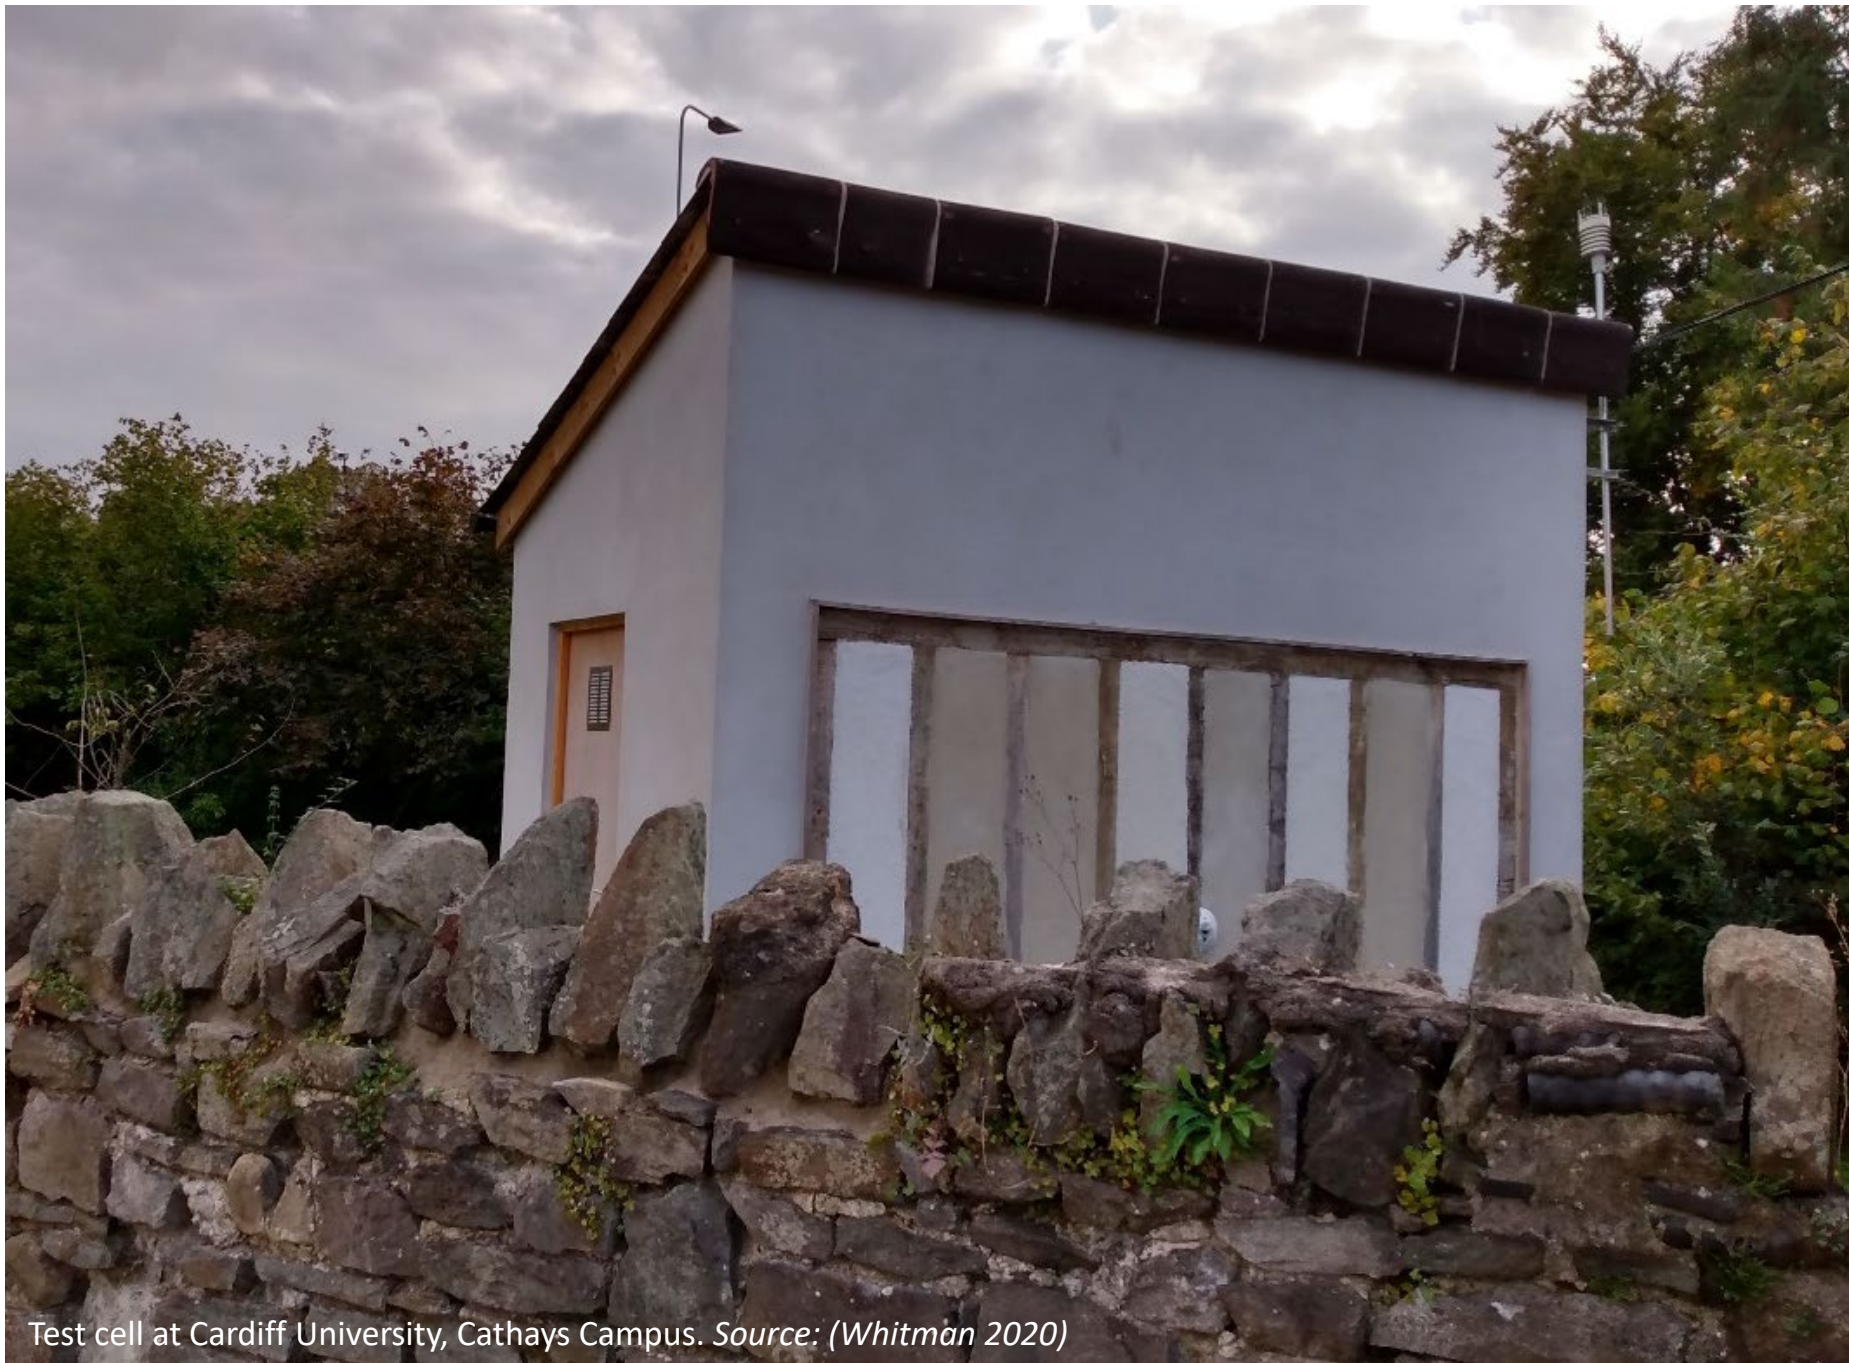
Test cell at Cardiff University, Cathays Campus. Source: (Whitman 2020)

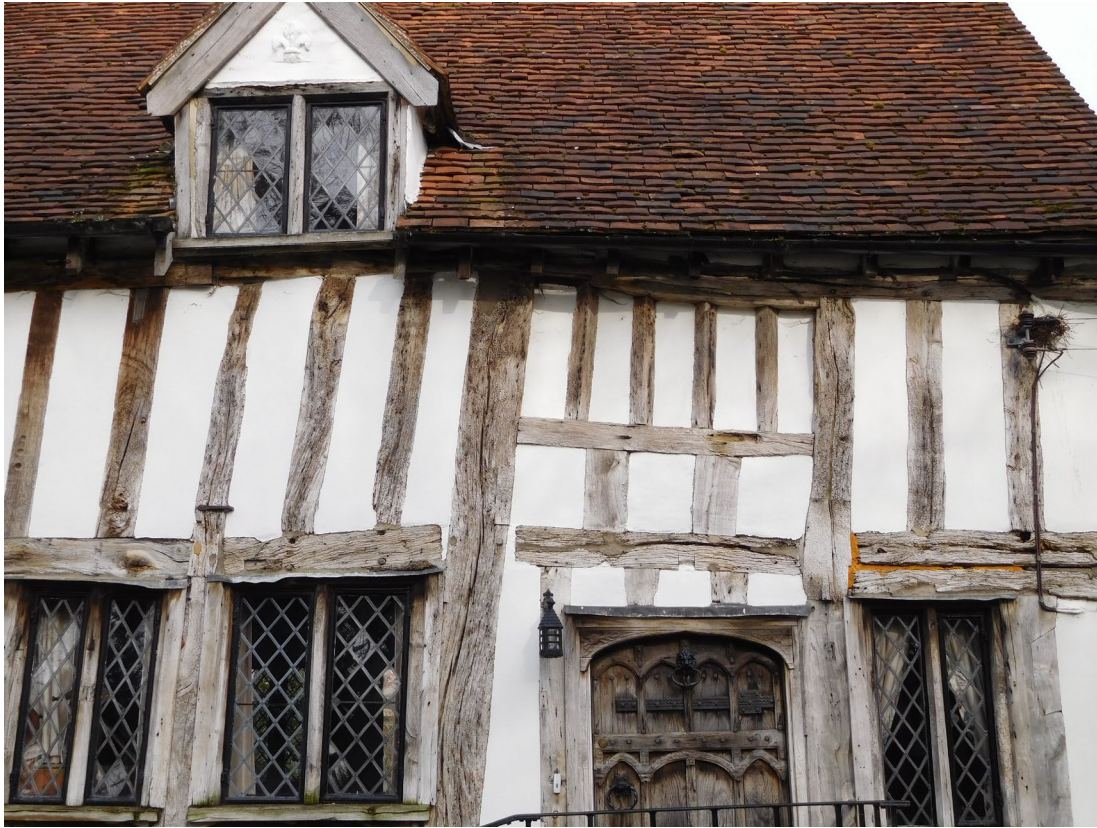
C15 house, Lavenham, UK. (Whitman, 2022)

For the purpose of this research, historic timber-framed buildings refer to those built pre-1850 with an exposed timber structural timber frame, infilled with non-loadbearing panels. There exist approximately 68,000 surviving examples in the UK (Whitman, 2017).

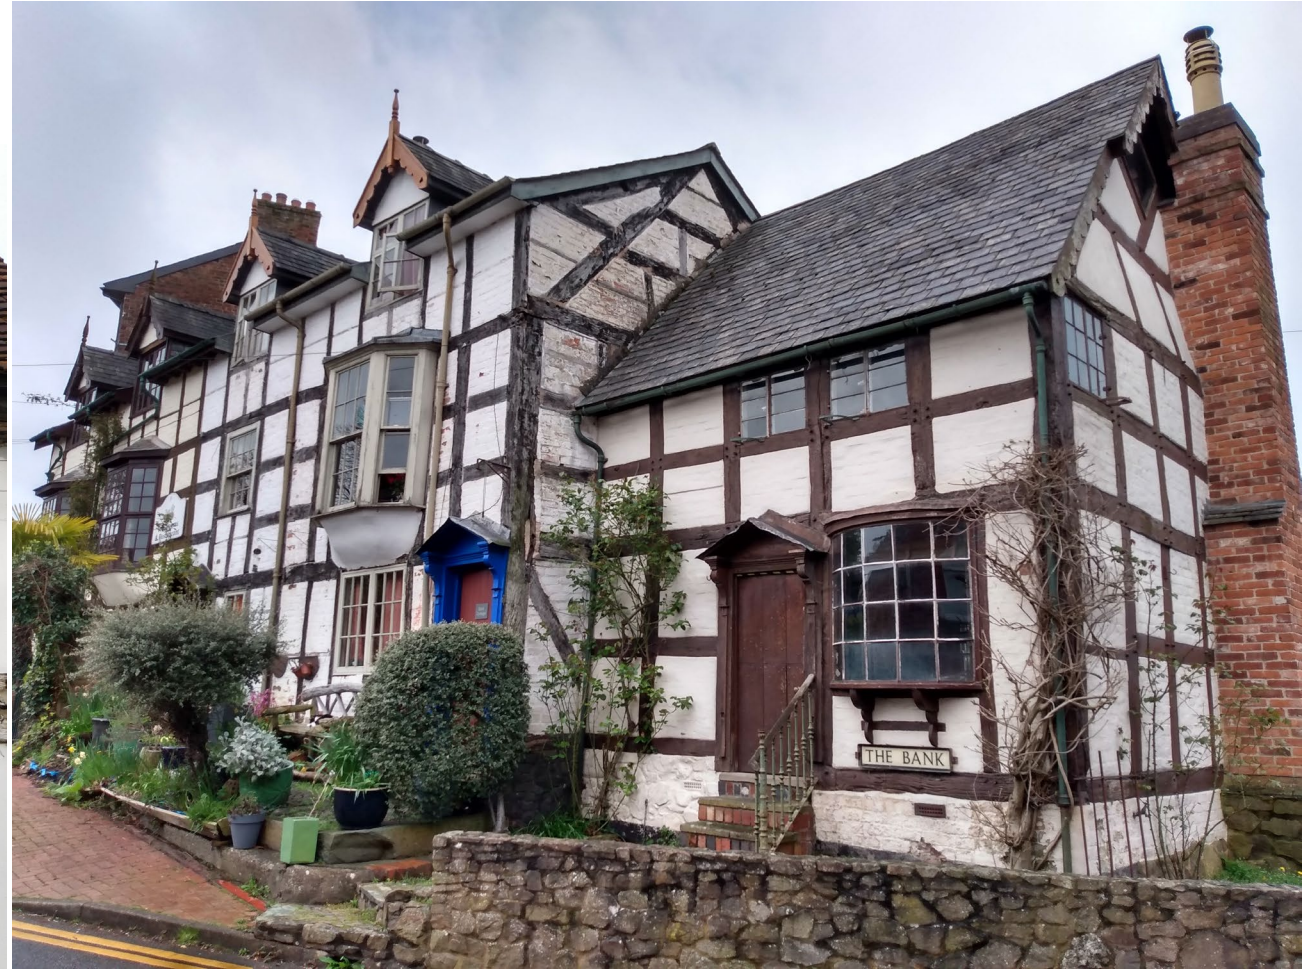
C17 buildings with C19 alterations, Newtown, Powys, Wales (Whitman, 2024).

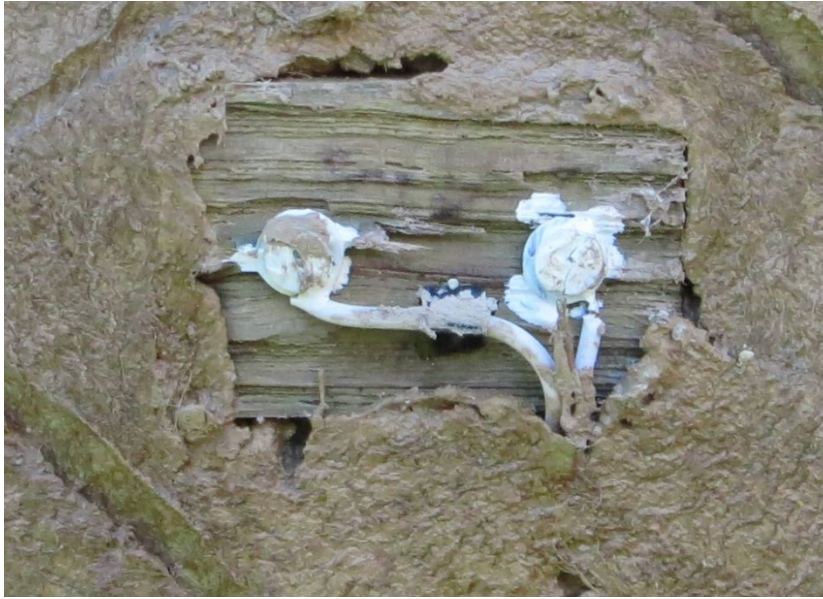
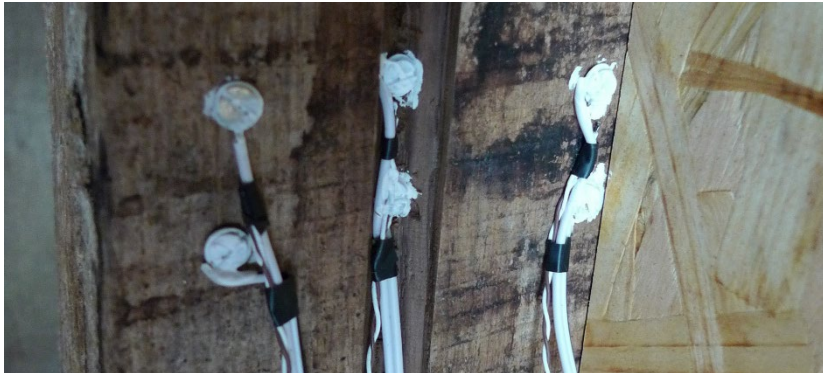
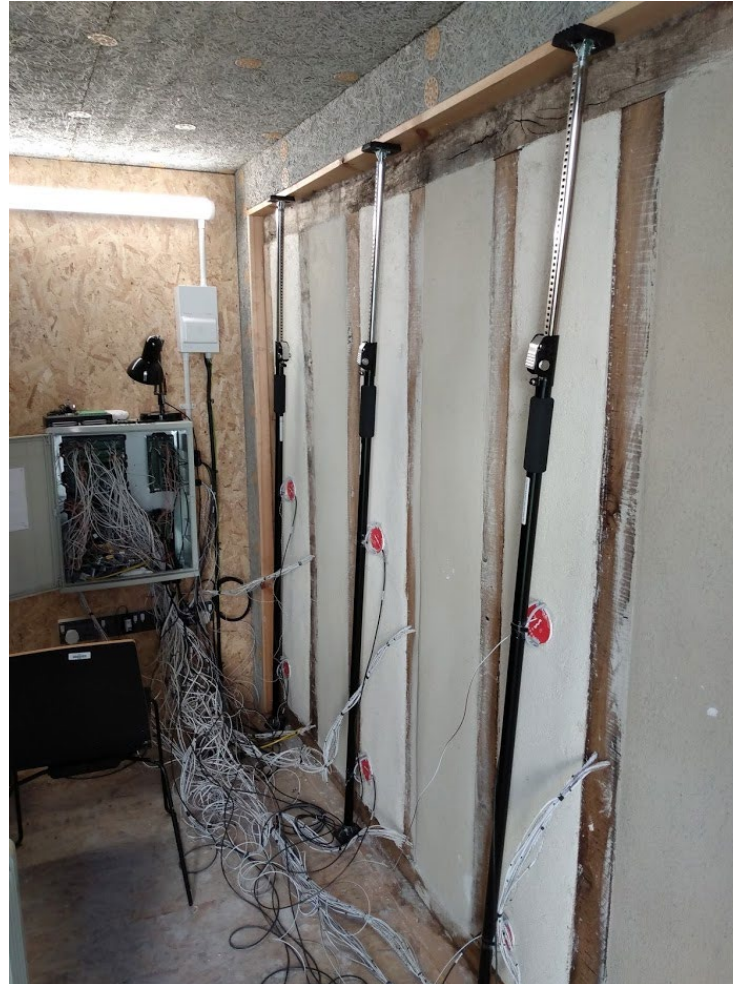
Interstitial Moisture content-

Electrical resistance measured by
Campbell Scientific CR1000

Interstitial Temperature-

Type T thermocouples

In situ u-value

Hukseflux heat flux plates and type T
thermocouples

Internal Hygrothermal Conditions of test cell-

Campbell CS215 probe

External Climatic Conditions-

Vaisala Weather Transmitter WXT520
Series and Kipp & Zonen CM5 pyrometer

Moisture content and temperature monitoring installed during construction. U-Value monitoring (Whitman, 2019)

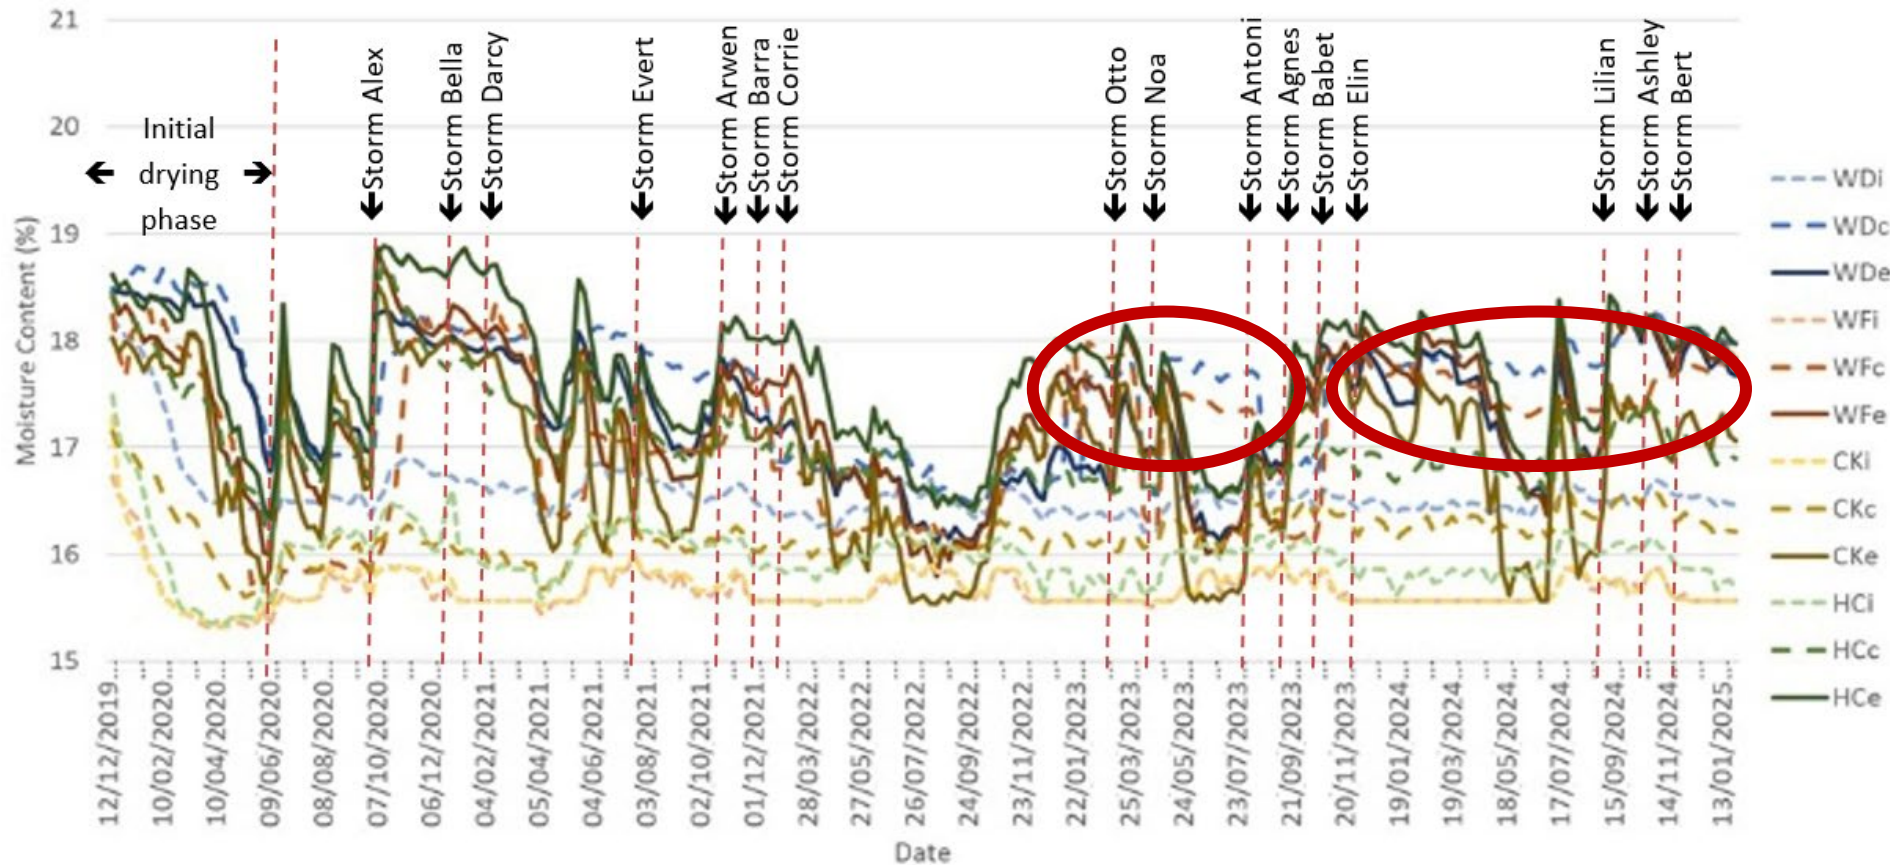
Measured Moisture Content – Mid-Panel Location

Wood Moisture Content at mid-point of **NHL 3.5 finished panels** 12/12/2019 – 05/02/2025. With UK named storm events overlaid.

WD-Wattle & Daub, WF-Wood Fibre
CK-Cork
HC-Hempcrete

- The more moisture permeable lime hemp render creates lower moisture contents, with reduced drying times when compared to those finished in the NHL 3.5 based renders.
- Evidence of Interstitial condensation has been identified in the wood fibre/wood wool detail and wattle & daub.
- Expanded cork boards achieve best thermal performance but can produce significant differences in surface temperature (up to 3°C) between timber frame and infill, as such potentially hempcrete which has a thermal performance similar to the timber frame may be more suitable.
- The use of perimeter, non-moisture permeable, sealants may potentially be trapping moisture at the junction between infill and historic timber-frame. They do however provide more consistency in achieving airtightness, however good workmanship is equally important.

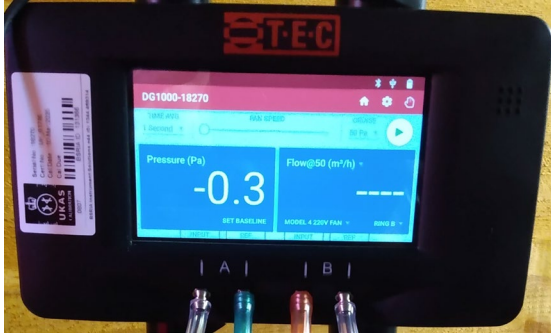
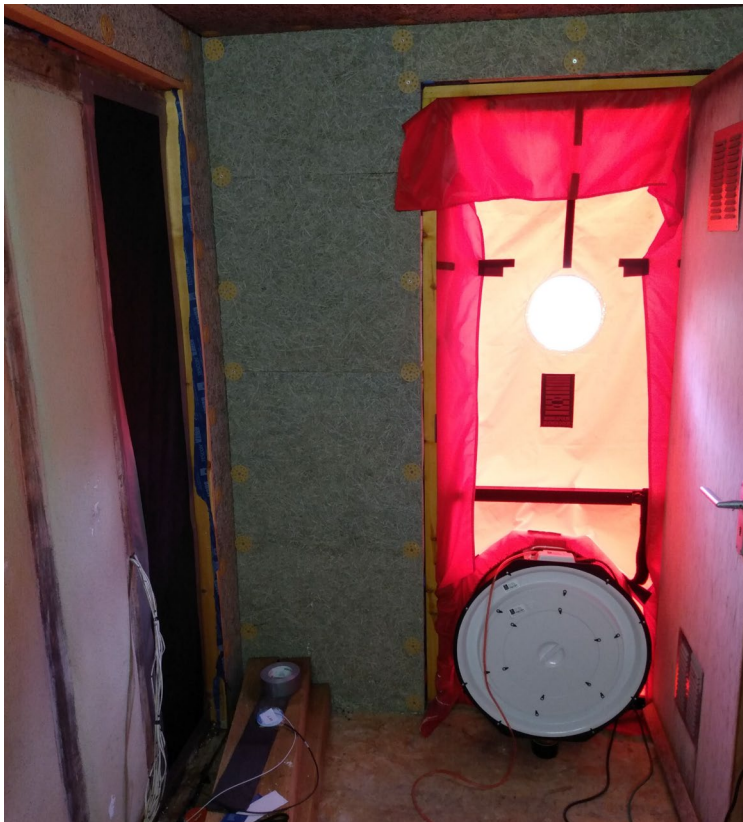
Airtightness

Comparison of diameters (mm) of holes equivalent to the open area around each panel as calculated from pressure testing BS EN ISO 9972:2015. Using a Minneapolis Blower Door, TEC® DG-1000 digital pressure and flow gauge, controlled by TEC® Auto Test™ software.

- No discernible difference was measured between those panels finished in the NHL 3.5 based render and the lime hemp render. Linear shrinkage measurements showed similar behaviour between the two renders.
- Expanding sealant tape at perimeter gives more consistent results
- Most airtight panel W&D has no sealant, proving **workmanship still key**.
