# Exploring Acoustic Emission for Integrity Assessment of Bolted Anchors used in Rock Climbing and Rope Access

Tim Atkinson<sup>1</sup>, Matt Pearson<sup>1</sup>, John McCrory<sup>1</sup>, Ryan Marks<sup>2</sup>, Rhys Pullin<sup>1</sup>

1: Cardiff University, School of Engineering, CUSP Lab  
5, The Parade, Cardiff, CF24 3AA  
e-mail: AtkinsonT1@Cardiff.ac.uk

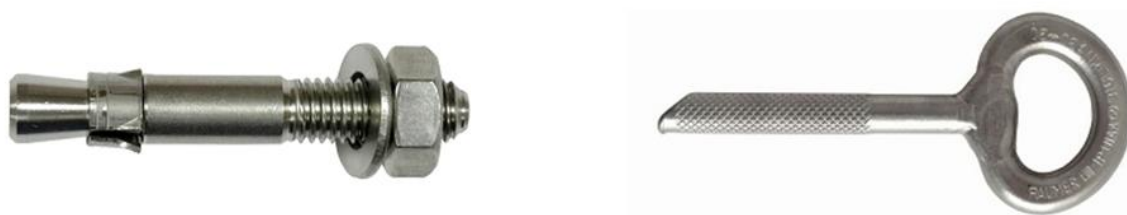
*Fig. 2. The two bolt designs used in this paper. A typical Expansion Bolt with a hanger (left) and Resin/Glue Bolt (right). [6], [7]*

There are primarily two types of bolts, expansion bolts and resin/glue bolts as shown in Figure 2. Both are installed by first drilling a hole in the material and then brushing out any loose debris. In the case of expansion bolts, they are first hammered in up-to the nut, a separate hanger is then attached, lastly the nut is tightened. Tightening the nut pulls the cone outwards, expanding the collar, and providing outward pressure. The hanger is a separate part which goes between the nut and the materials surface and provides a loop as an attachment point. For resin bolts the hanger is a part of the bolt itself. To install resin bolts the hole is instead filled with two-part structural epoxy, the bolt is then pushed into the hole and the epoxy left to set. The British Mountaineering Council (BMC) has written an installation guide covering both types of bolts in more detail [5].

In this test the expansion bolts used were Raumer Hang Fix 10 x 66 mm, and the resin bolts are Raumer Radius P Anchor 10 x 80 mm, both are shown in Figure 2. To install the bolts, a pillar drill was used to drill the holes perpendicular to the top surface at the centre of the face. For the expansion bolts a 10 mm hole was drilled, into which the bolts were hammered in, and then the nut tightened to 30 Nm according to the manufacturer specifications. The resin bolts require a larger diameter hole of 12 mm, this is to accommodate space around the bolt for the epoxy, additionally small recesses are drilled either side of the bolt hole to allow for the bolt to be slightly recessed as is

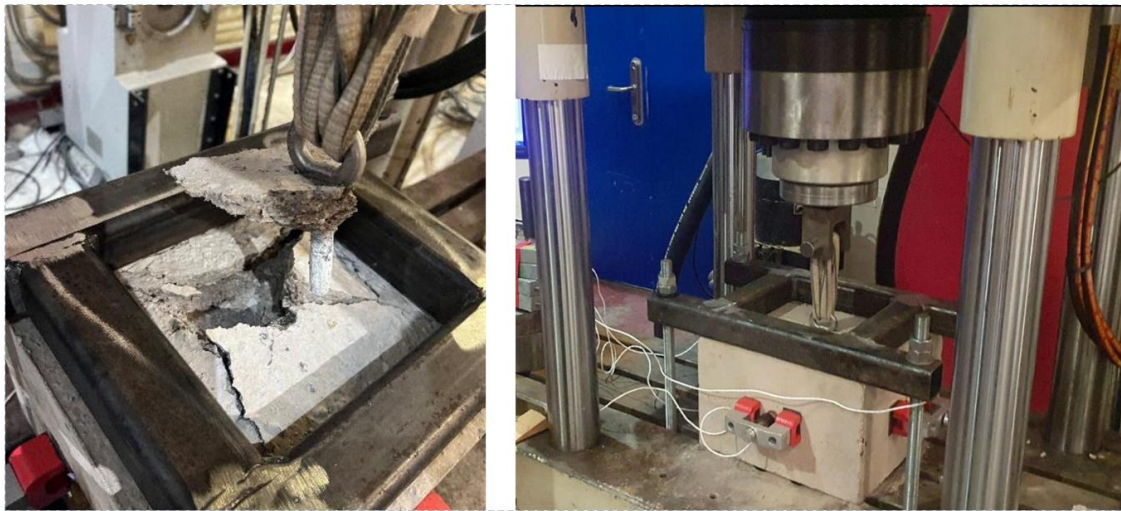
*Fig. 3. Photos of the testing setup. An example of resin bolt failure (left), and an image showing the restraining method and sensor mounting method, along with the sling connection between the load machine and bolt.*

Once the bolts were installed, tensile testing was carried out. For each test, the block was restrained in the load machine and the bolt connected to the load machine by multiple strands of an 11 mm DMM dyneema sling as seen in Figure 3. This soft linkage was necessary as the geometry of the hanger prevented a hard linkage. The tensile test was load controlled with a loading rate of 10 N/s until bolt failure, in this case failure is defined as complete removal of the bolt from the concrete block. An example of failure for a resin bolt is shown in Figure 3.
