Characterisation of Textured Insulators for Overhead Lines and Substations

**A thesis submitted to Cardiff University
in candidature for the degree of
DOCTOR OF PHILOSOPHY**

**High Voltage Energy Systems Group (HIVES)
School of Engineering
Cardiff University**

2012

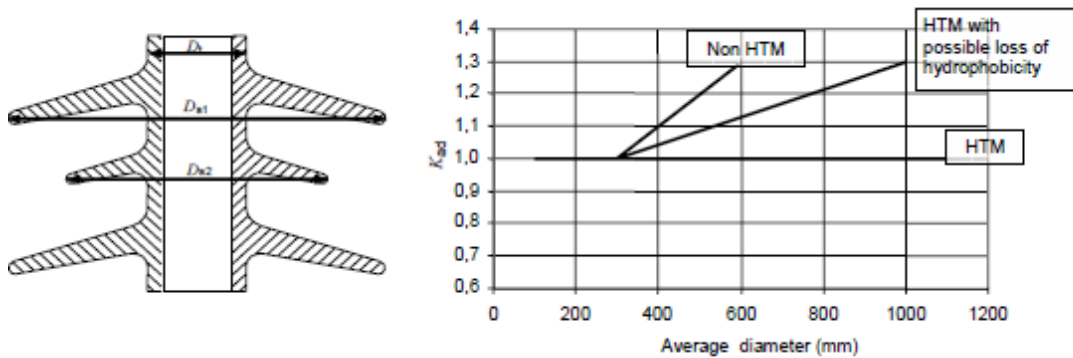
Figure 2-9. Average diameter correction factor K_{ad} where the average diameter is $(2D_t + D_{s1} + D_{s2})/4$. Figure adopted from [2.50].

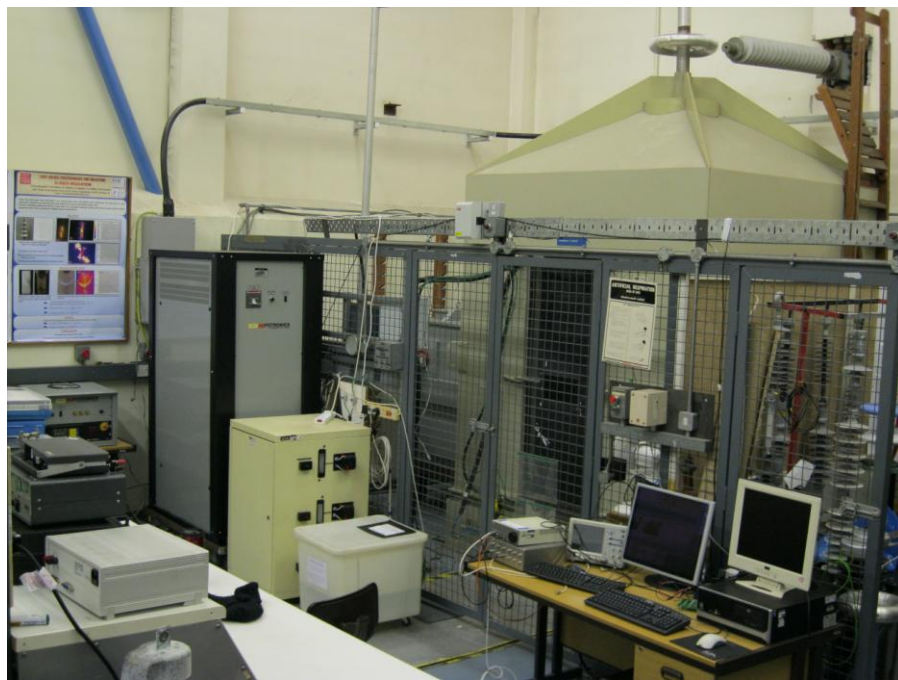
Figure 3-1. Cardiff University high voltage laboratory fog chamber.

The insulators were tested in the fog chamber of Cardiff University high voltage laboratory (Figure 3-1). The chamber is situated in one of the three high voltage cages subdividing the laboratory. The safe access to the cage is secured by an interlock system that interrupts high voltage supply until all precaution measures have been followed. The chamber shell is made of polypropylene and the dimensions are 2m x 2m x 3m. An earthed aluminum mesh covers the chamber floor and beneath is a collection sump for accumulated water due to condensation. The sump is drained with the help of a pump. Access to the fog chamber is possible through a transparent door made of polycarbonate. The door has a rectangular opening at approximately the height of the tested sample to allow the visual and infrared cameras to record during the test.

The high voltage supply enters the fog chamber from the chamber ceiling. A vertical aluminum tube with stress rings at both ends, serves as the high voltage conductor. Different types of insulator terminals (cap, pigtail) can be mounted by using the appropriate mounting extension. The test sample is earthed by connecting the lower terminal at the earthed mesh. Measurement coaxial cables also have access through the lower side of the chamber walls.

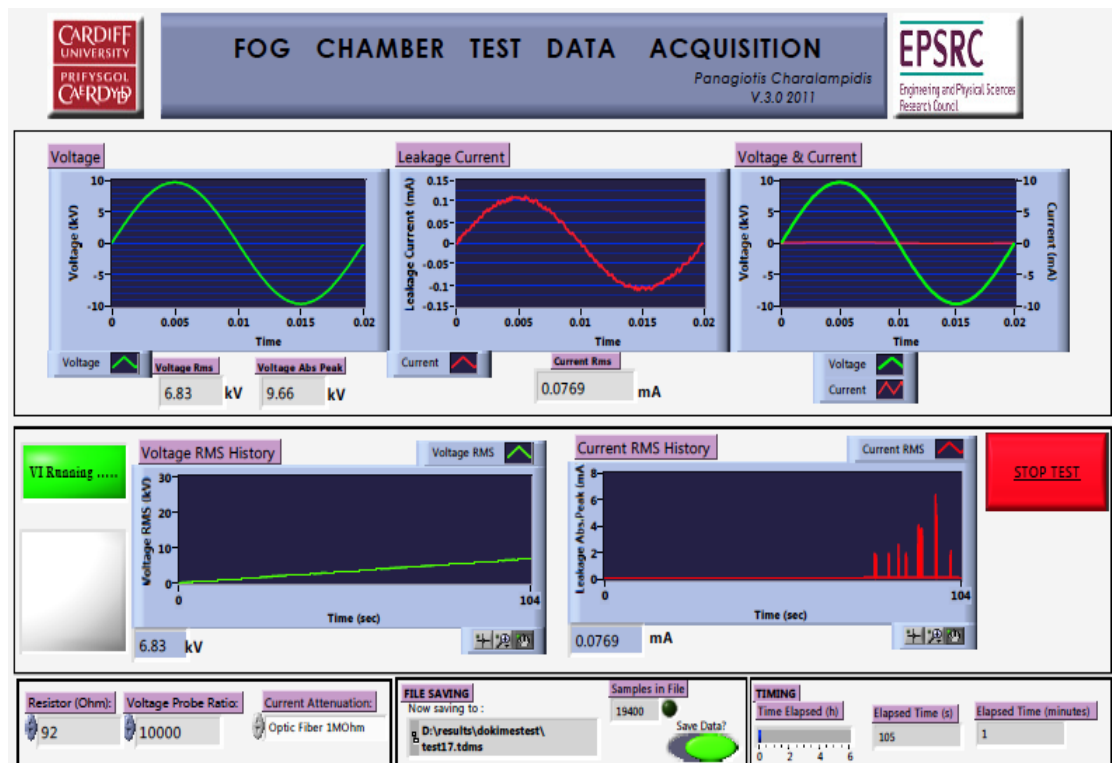
Figure 3-5. Front panel of LabVIEW data acquisition programme for the fog chamber tests series.

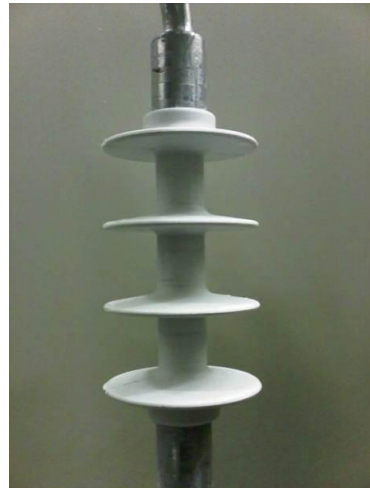
SiR insulator Type 1 design

<i>Dimension (mm)</i>	<i>Type 1</i>	<i>Type 2</i>
Creepage distance (Lc)	375	530
End fitting separation (L)	175	134
Shank diameter (d)	28/42	28/42
Shed diameter (D)	90	142
Shed separation (s)	46	50
Core diameter	18	18
Form factor (F)	2.76	2.78

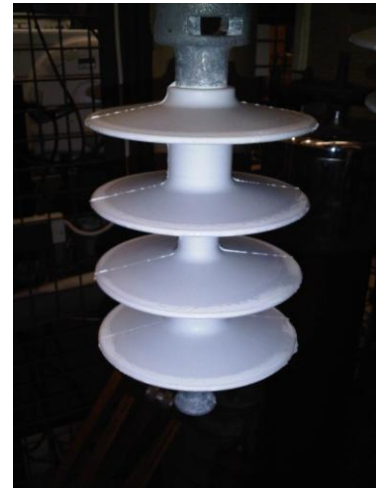
SiR insulator Type 2 design

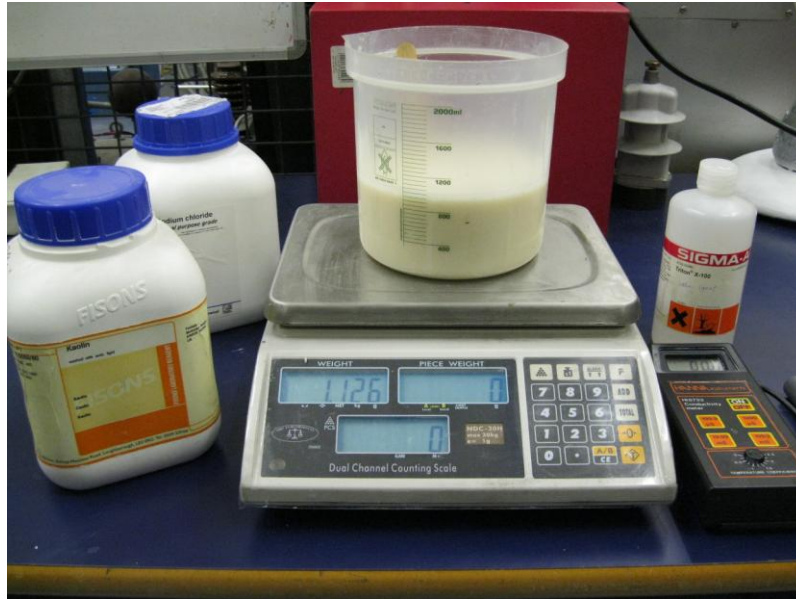
Figure 3-11. Kaolin and sodium chloride suspension with Triton X-100 wetting agent.

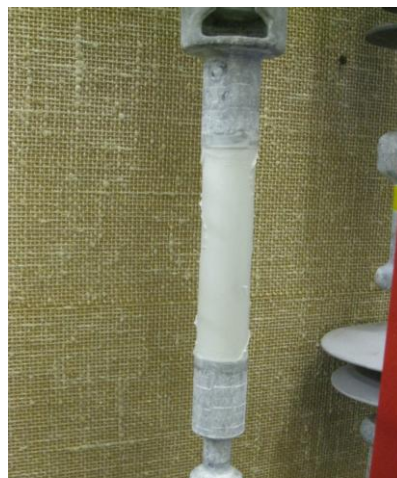
Figure 3-13. Cylindrical silicone rubber prototype with no sheds.

A series of tests were performed for cylindrical samples without sheds (Figure 3-13). These early stage tests were useful to establish a comprehensive test procedure and to explore the capabilities of the infrared camera in detecting dry-band formation and development. The test sample was tested in the fog chamber with a fog rate of 3 l/h and pressure 35 psi, and it was polluted with a pollution slurry of volume conductivity 0.3 S/m. The voltage was increased in steps manually with a rate of 2kV every 5 minutes, and the sample was monitored by the infrared camera throughout the test until flashover. These prototypes were manufactured using special silicone rubber moulds, as described in detail in Chapter 5.

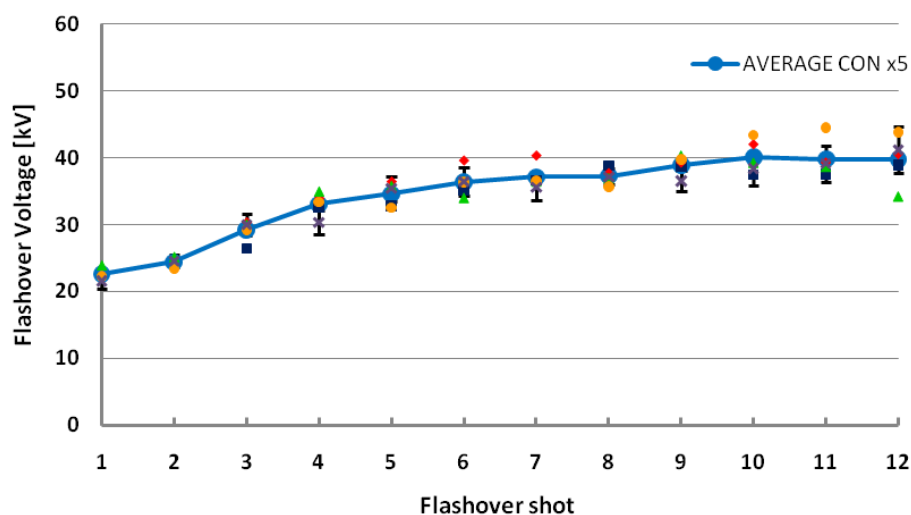
Figure 4-6. Average curve of 5 ramp voltage test series for a conventional silicone rubber insulator. Each ramp voltage test series consists of 12 flashover shots.

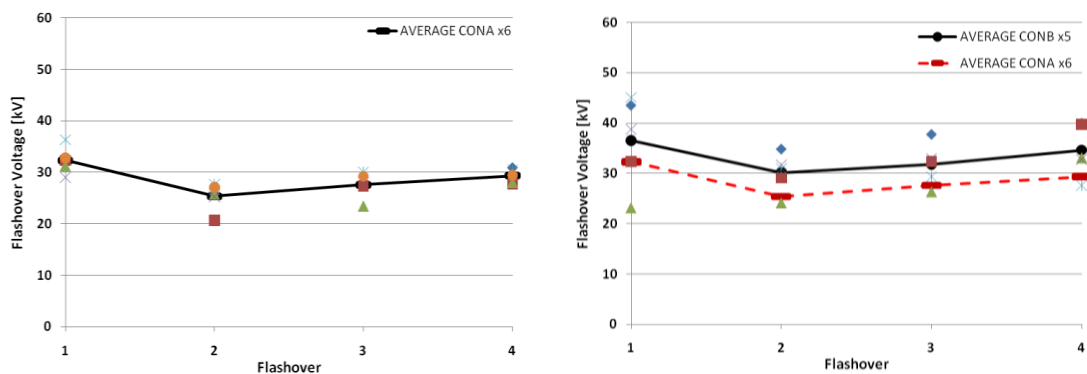
Figure 4-8. Average flashover curve for CONA insulators (left) and for CONB insulators (right) for 11.2 S/m and 3 litres/hour pollution conditions.

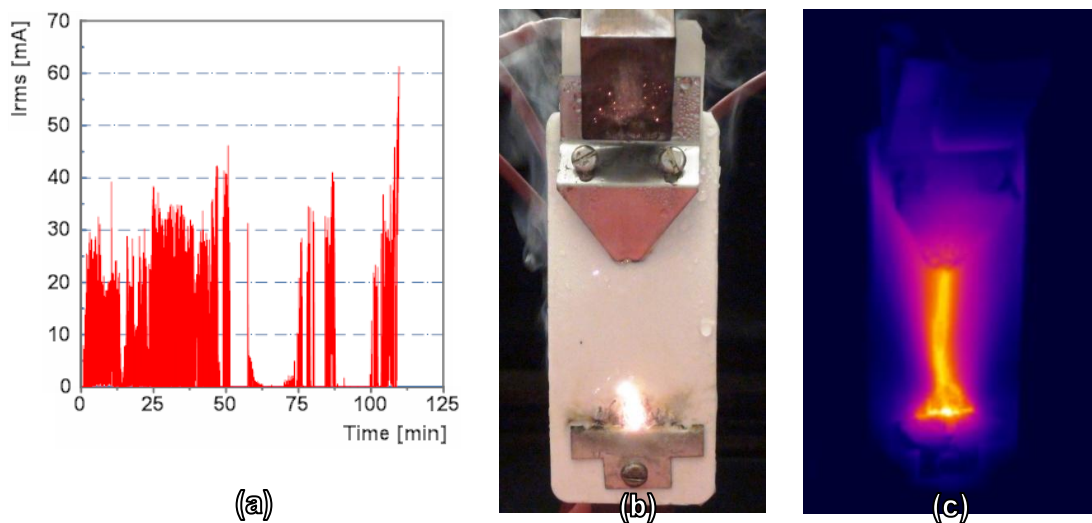
Figure 5-9. Non-textured sample during an inclined-plane test. The current rms record (a), a visual record showing anchored metal-arc discharges at the ground (b) and infrared record showing the narrow contaminant stream and the arc discharging near the ground electrode (c).

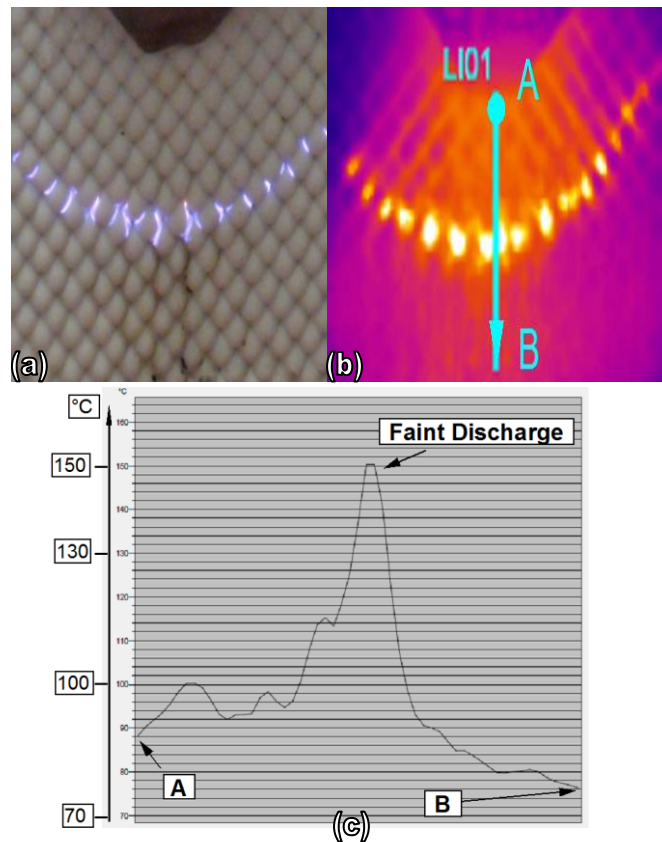
Figure 5-12. Dry-band formation on a 4mm intersecting square sample: Visible record (a), IR record (b) and temperature profile along the path A→B (c).

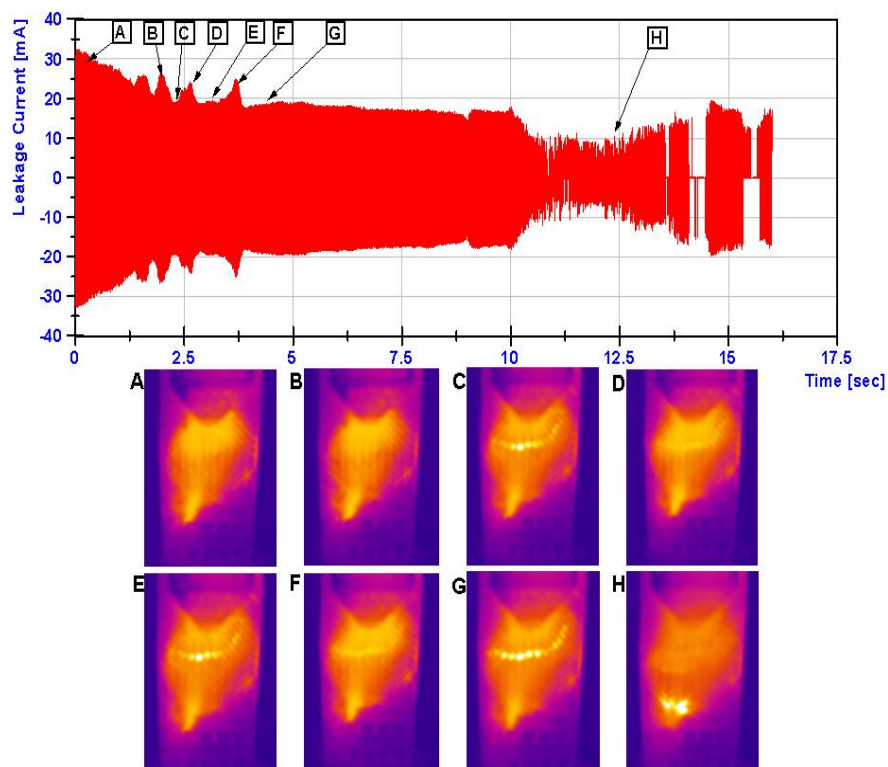
Figure 5-17. Leakage current waveform decay associated with the progression of streamer discharges and corresponding infrared images. The onset of streamer discharges is associated with leakage current valleys (C), (E) and (G) while current peaks (B), (D) and (F) occur when discharges extinguish. The event ends with metal-arc discharges (H).

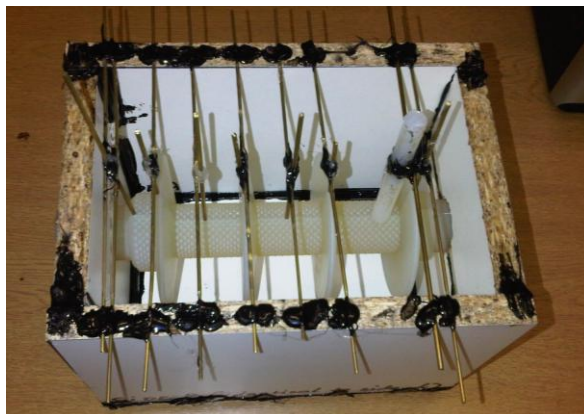
Figure 6-9. Moulding box with the SLA model in position for the manufacturing of silicone rubber moulds.

A moulding box made of chipwood parts was designed and constructed to mount the SLA model in a horizontal position. A structure made of bronze rods and a plastic rod was mounted with the help of a glue-gun to reproduce the ventilation channels and the injection gate respectively. The injection gate was positioned at the upper shank section and the rest of the shank sections and sheds had a one ventilation channel each (Figure 6-9).

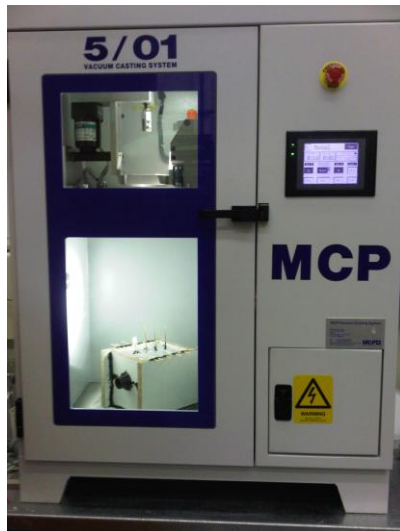
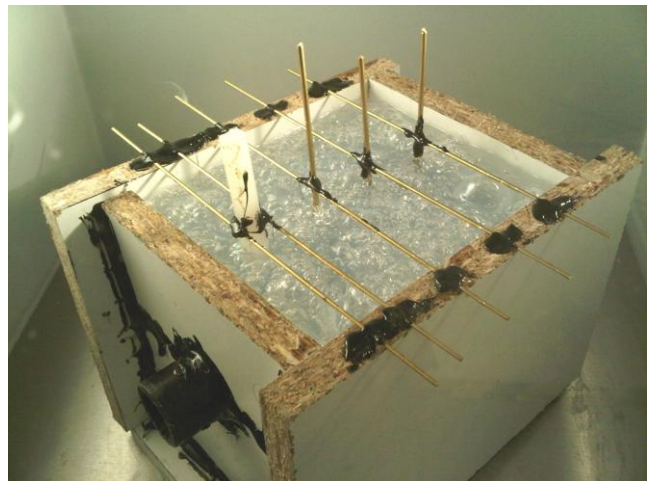
Figure 6-10. Secondary degassing in the vacuum casting machine (left). A mould for cylindrical samples during secondary degassing in vacuum, showing the trapped air escaping the silicone rubber (right).

After removal from the casting machine, the silicone was poured carefully in the moulding box, making sure that each area of the model was covered with a minimum of 15 mm thick silicone layer. The moulding box was placed in the casting machine for secondary degassing for 25 minutes.

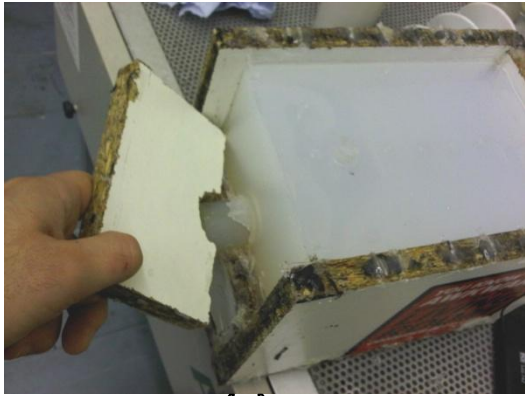
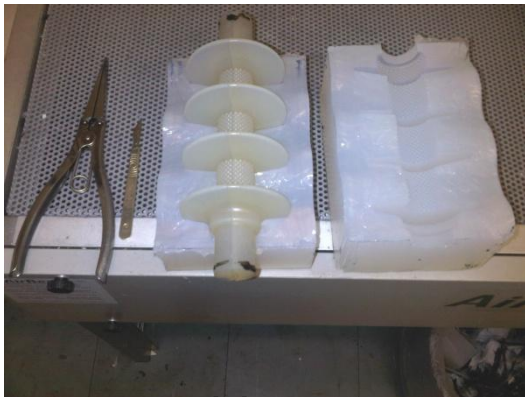
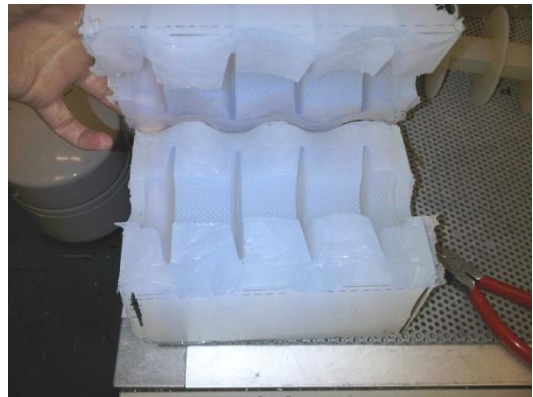
Figure 6-11 .Removing the chipwood box (a), wave-shape cut along the axial length of the model (b), the mould separated in two halves (c & d).

The mould was then cured at 50°C for 10 hours. After removal from the curing oven, the ventilation and injection gate rods and the chipwood structure were removed. The cured mould was then cut open in two halves. A line was drawn along the axial length of the model to be used as a cut guide. The cut is performed with a sharp scalpel and a pair of special pincers. The cut had a wave-shaped edge to ensure the correct positioning of the two halves during casting.

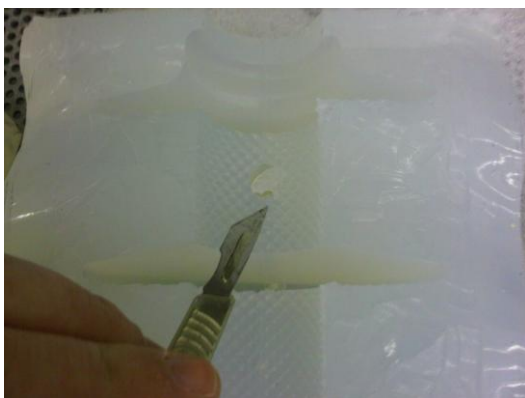
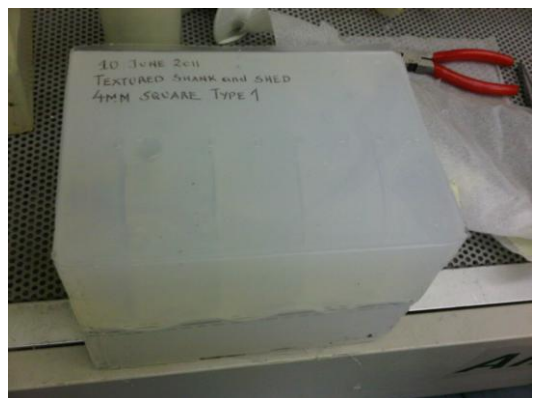
Figure 6-12. Clearing the ventilation and injection channels (left) and a completed silicone mould (right).

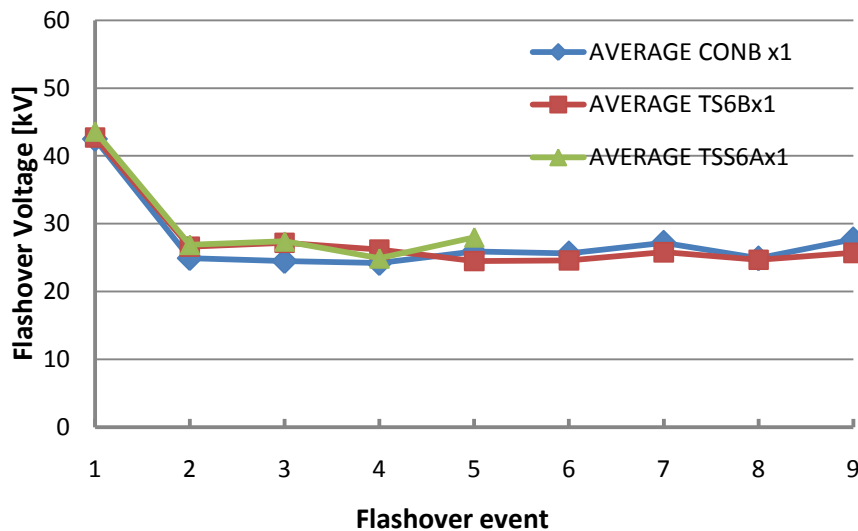
Figure 6-24. Flashover curves for CONB, TS6B and TSS6B for ramp voltage tests under conditions of extremely high pollution, 19.9 S/m, and low fog, 3 litres/hour (for the TSS6B design, the ramp test series consisted of 5 flashover events).

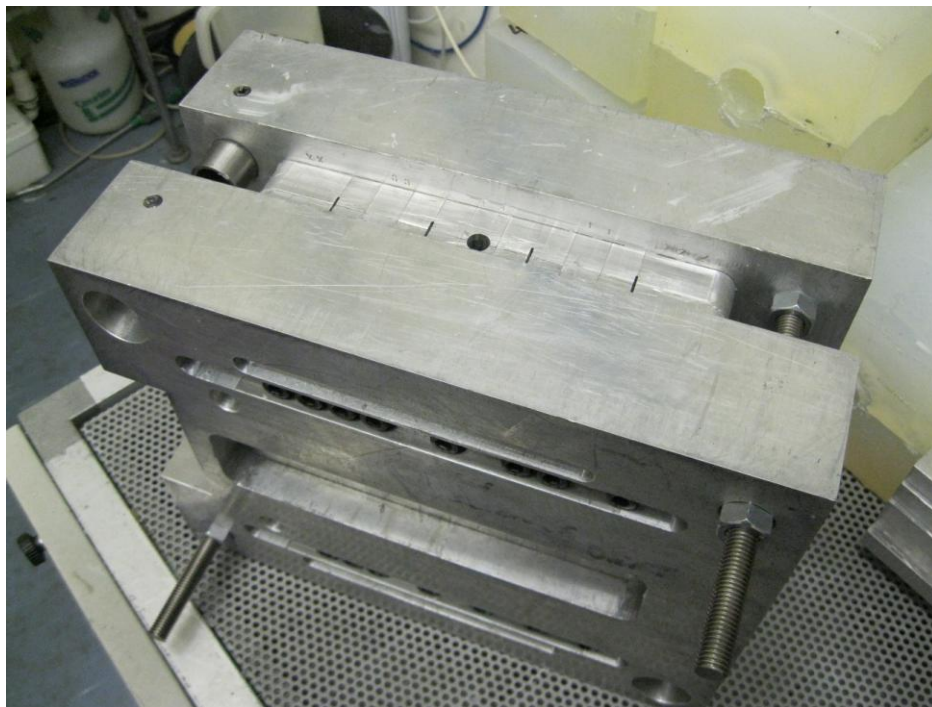
Figure A-2. The mould ready for casting.

A set of 'allen' bolts at the back of the mould plates secures the inserts in position. After the mould assembling is completed, it is thoroughly cleaned with propanol to remove any contaminants or grease in the mould cavity.

The core with the metal fittings was also thoroughly cleaned with propanol. Silicone rubber bonding with the core material and the metal terminals is poor. A special chemical primer was required to transform the bonding properties of the substrate surface. A commercial primer was used consisting of siloxanes and silicones resins in a mixture of isoalkanes. A very thin layer of this primer was applied using a brush on the surface where the silicone rubber would be overmoulded. Then it was left in room temperature for 2 hours. Casting should be performed not more than 5 hours from the primer drying. After the core is placed in position in the mould, the two plates are joined and sealed with the help of threaded rods and bolts.
