**ACOUSTIC EMISSION TECHNIQUES FOR THE DAMAGE
ASSESSMENT OF REINFORCED CONCRETE STRUCTURES**

NORAZURA MUHAMAD BUNNORI

Ph.D. MARCH 2008

PhD Thesis

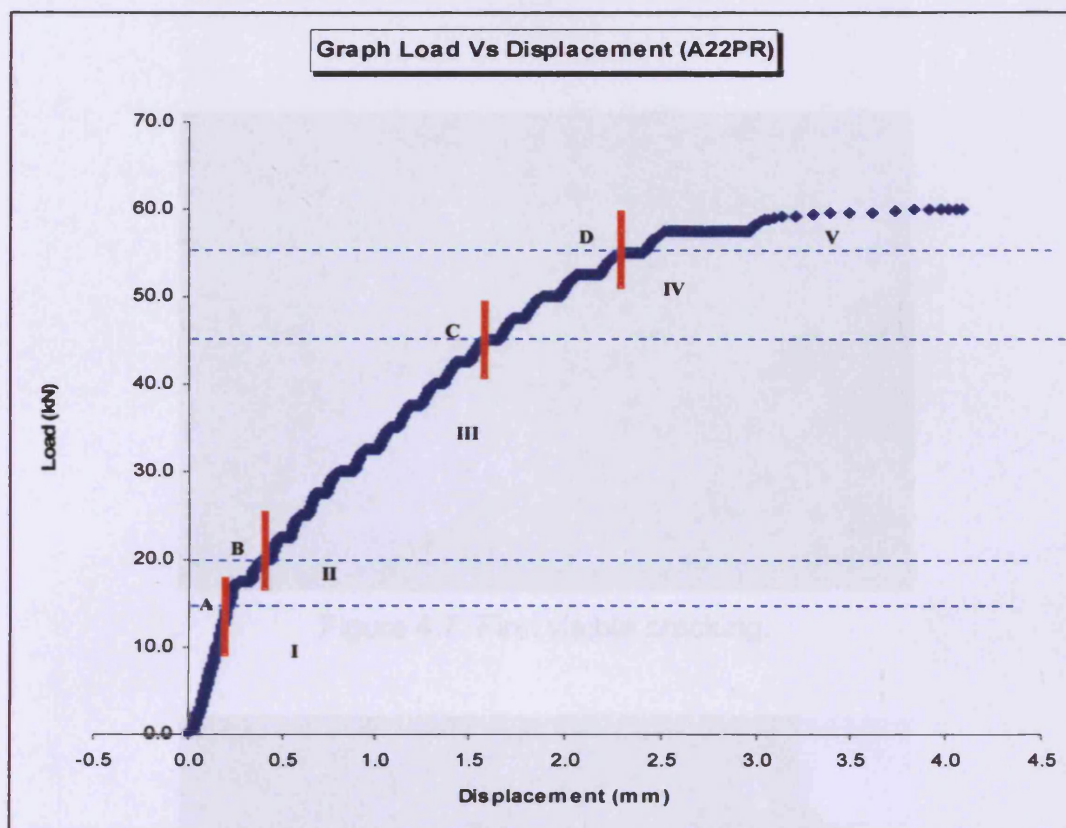
Figure 4.6: Load against displacement for beam A22PR

- i. Micro-cracking
- ii. Localized crack propagation (**Point A**)
- iii. Distributed flexural cracking (**Point B**)
- iv. Shear cracking (**Point C**)
- v. Damage localization (**Point D**)

The micro-cracking occurs in region I (before point A). Initiation of the internal micro-cracking is negligible during the first stage. The first visible cracking was observed at point A. Before point A, no visible cracking could be detected by the naked eye. Photographs showing the progression of the visible damage are presented in Figure 4.7 to Figure 4.11.
