## Separation of bricks and mortar using pressure waves

PhD thesis

By Richard Gregory B. Eng. (Hons)

University of Cardiff

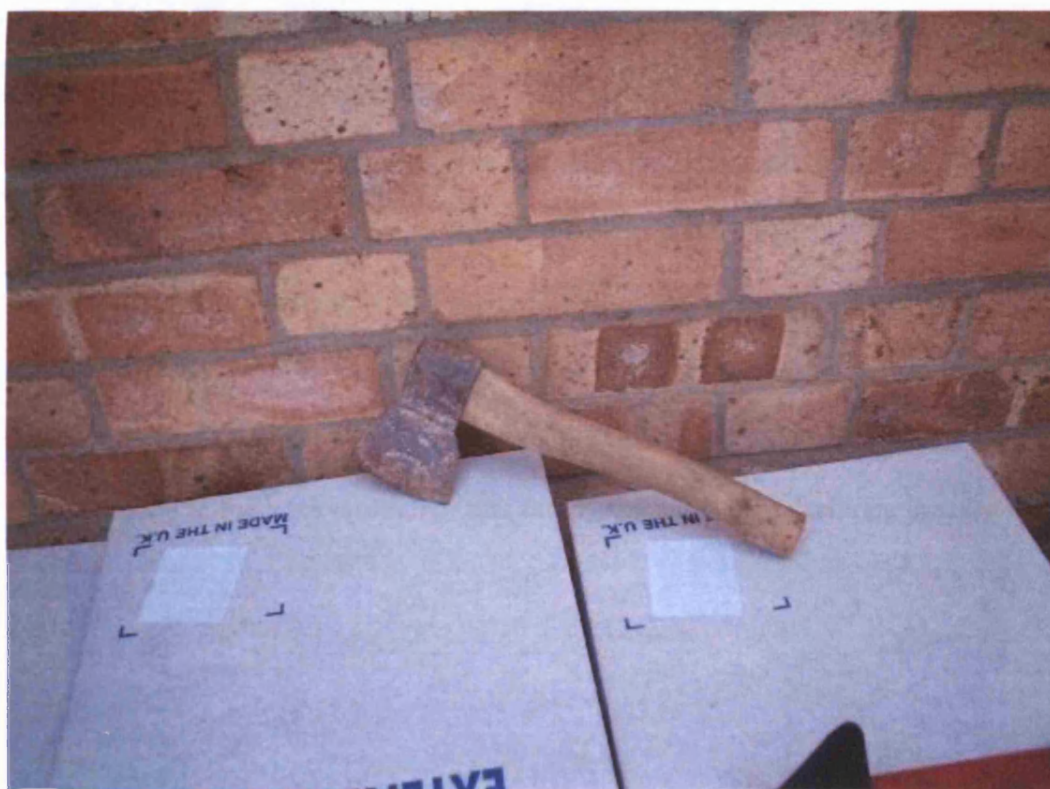
Figure 2-9. Typical hand-axe used to clean lime mortar from bricks

enough, it is preferable for the building to be demolished by hand a brick at a time, so each brick can be individually cleaned and placed on a pallet as it is removed. If the mortar is too strong to allow the individual bricks to be removed by hand, the walls can be pushed over with machinery, and the force of the fall will loosen bond between the bricks, allowing them to be picked up and cleaned by hand. This method will cause damage to some of the bricks, and may render some unsuitable for reclamation, so this method is only used when absolutely necessary. The mortar is subsequently removed from the bricks by hand using a small light hand axe (see Figure 2-9) and an experienced person can clean some 1000 bricks in a day.

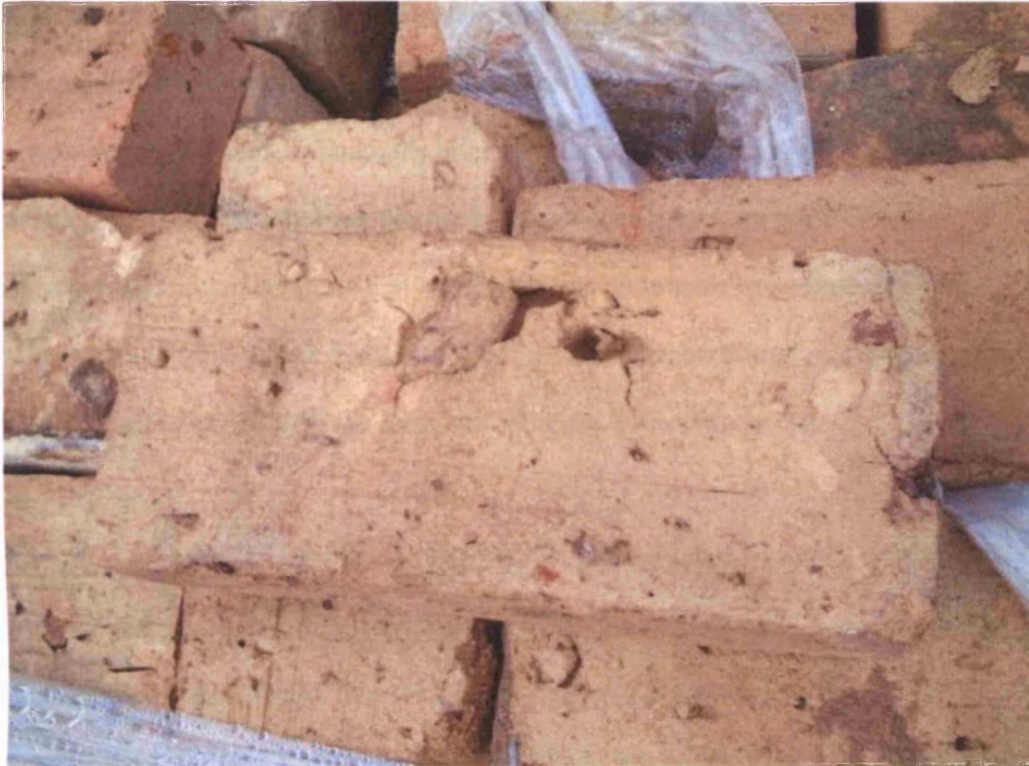
Figure 2-11. Wire cut brick containing foreign material

The cheapest bricks available were wire cut bricks. These were not as old as the more expensive bricks, but they appeared to be better quality than the multi bricks, and similar to the soft reds in terms of the shape they have retained. They were similar in colour and appearance to modern bricks, whereas the hand-made soft reds have a noticeably different colour and texture. Like the multi bricks, some of the wire cut bricks also contain foreign materials as shown in Figure 2-11.

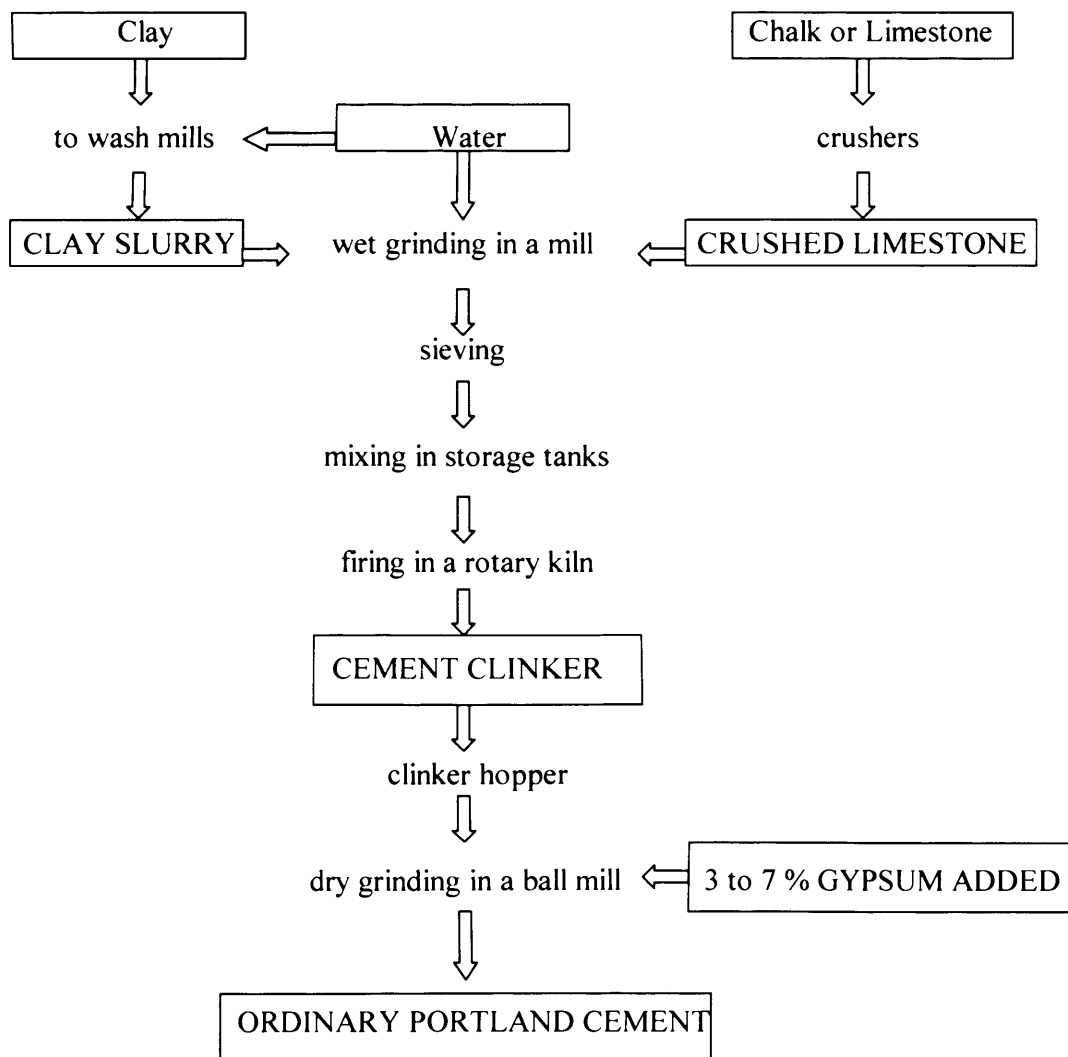
Figure 3-1. The key stages in the production of Portland Cement

Modern mortar made with a Portland Cement hardens because of the chemical reactions that take place. The key chemical ingredients contained within a Portland Cement are lime, silica, alumina and iron oxide. These components are combined and fired within a kiln, following the process summarised in Figure 3-1.

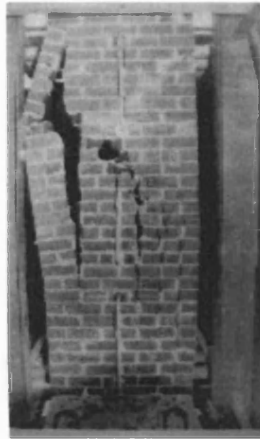
Figure 3-4 – Failure of a brick column

Work has been performed to establish the factors that determine the strength of brickwork for many years.<sup>33 34 35</sup> The majority of this work has considered brickwork in the state that it is mostly frequently used, and has therefore usually investigated the failure of columns loaded in axial compression. A typical failure of a brickwork column tested in this manner is shown in Figure 3-4. In this figure four vertical cracks parallel to the axis of loading can clearly be identified. The brickwork on the left of the column has split away from the rest of the column by the largest crack.

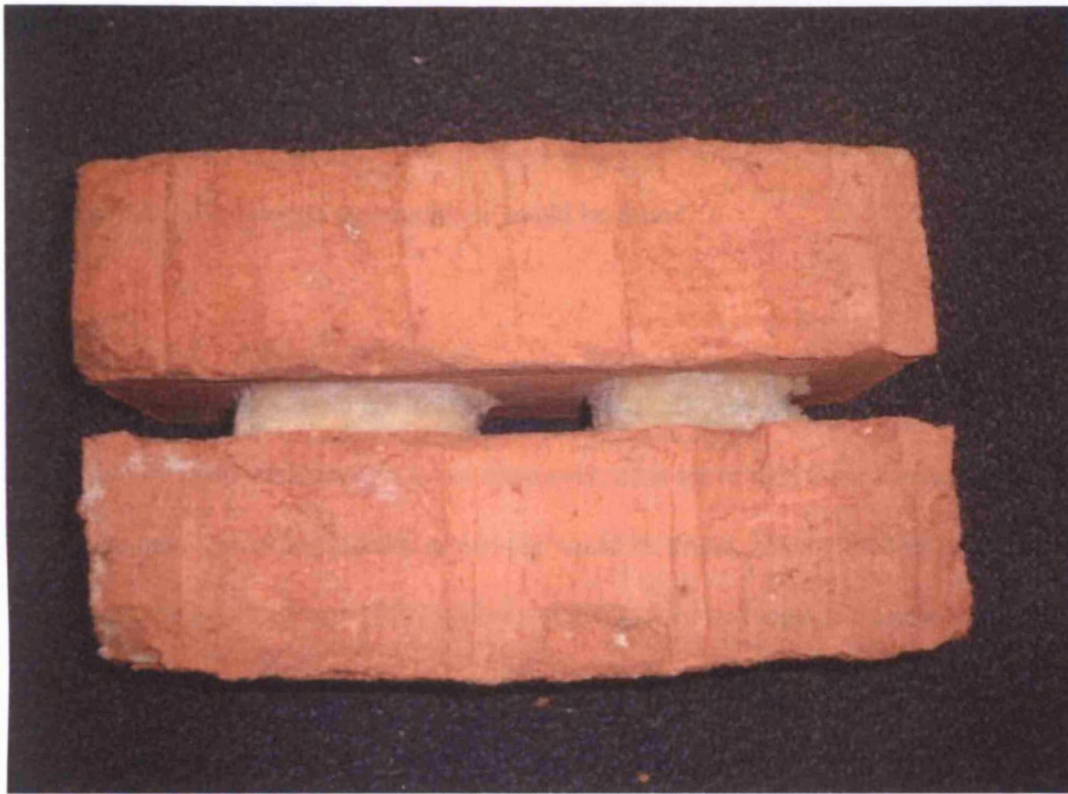
Figure 6-13. The couplet with a reduced mortar area

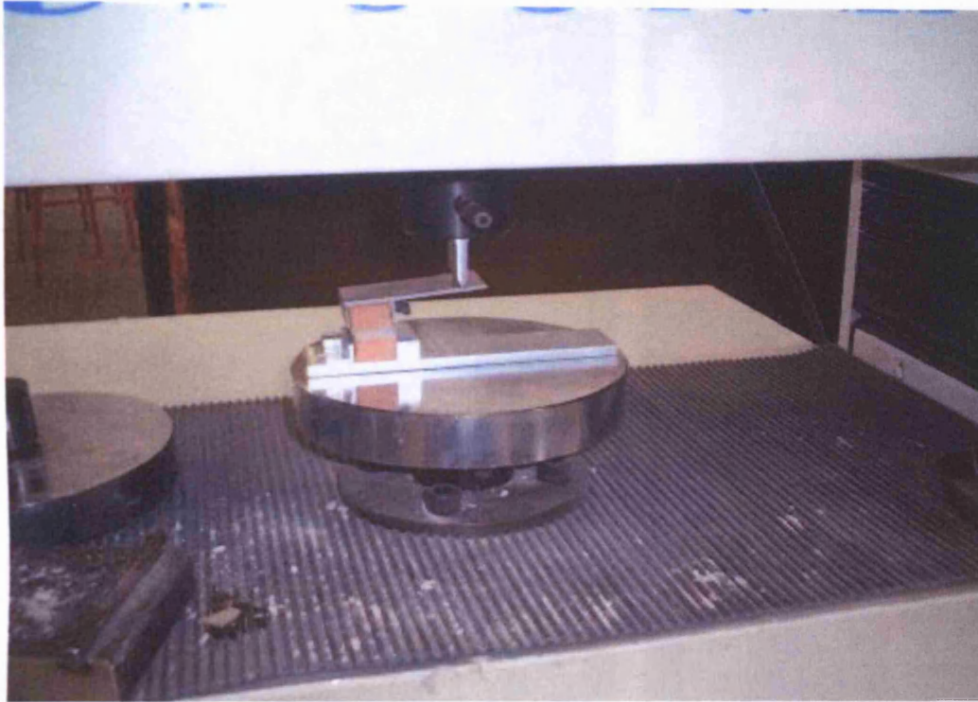
D 3.1. The bond wrench test system for one-sixth scale couplets

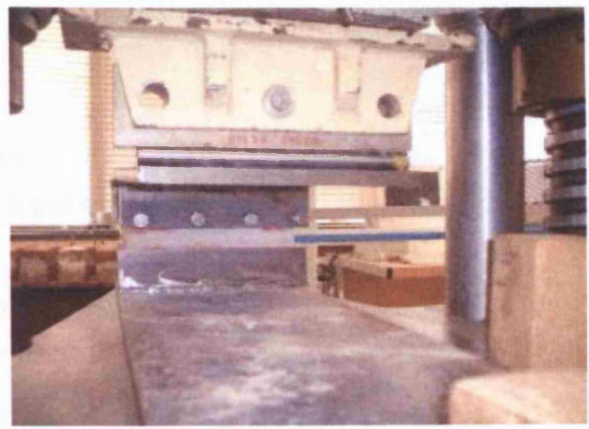
D 4.4 The mechanism for loading the full scale bond wrench testing jig.

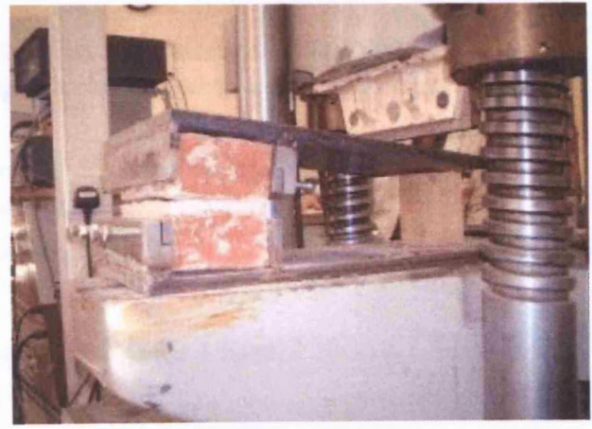
D 4.6. The full-scale bond wrench test after failure has occurred
