# **COATINGS FOR OUTDOOR HIGH VOLTAGE INSULATORS**

Thesis submitted to Cardiff University in  
candidature for the degree of PhD

School of Engineering  
Cardiff University, Cardiff

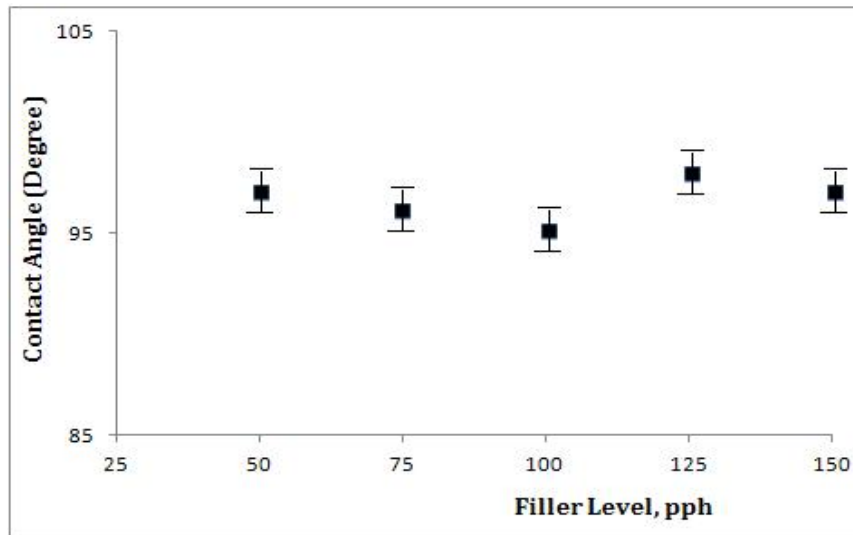
**Figure 2.7: Variation of contact angle on the surface of RTV- SiR with ATH filler level. Particle size 13  $\mu\text{m}$ ; thickness 0.39 mm [2.38]**

measuring the contact angle of water droplets on the surface [2.38]. Figure 2.7 shows that the contact angle on the surface of a virgin RTV- SiR coating at filler levels ranging from 50 to 150 pph is constant at  $(98 \pm 2^\circ)$ . The reason for this is that filler particles on the surface of the coatings were encased in the silicone rubber for all concentrations of ATH filler [2.38].

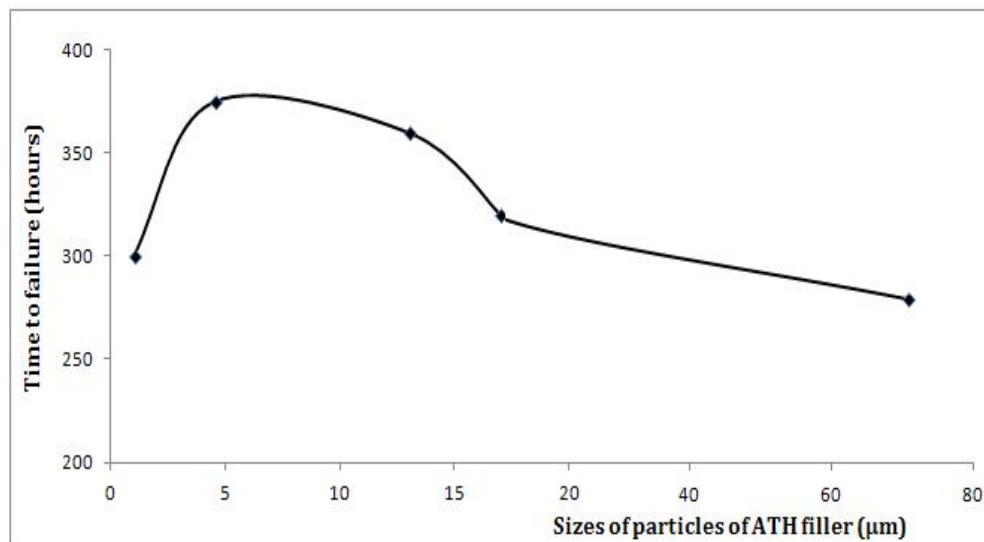
**Figure 2.10: Time to failure of RTV coatings as a function of ATH particle size (reproduced from[2.36])**

The heat generated from dry band arcing is considered as the main factor in determining the lifetime of a compound. The time to failure of ATH filled RTV-SiR with varying particle size can be seen in Figure 2.10. The 4.5  $\mu\text{m}$  particle gives the longest time to failure. This demonstrates that the size of the particles play an important factor in determining the material's time to failure. The surface of the RTV- SiR is rougher, with larger ATH particles. This leads to increased leakage current, rapid loss of surface hydrophobicity and considerable surface damage due to the resulting intense discharges. These discharges result in shorter lifetime of the material. RTV coatings with an average ATH filler particle size of 1.0  $\mu\text{m}$  failed in a short time due to aggregation of particles come at discrete points on the surface. The finer particles can produce greater surface roughness which can lead to localized hot spots. The corresponding non-uniform surface was investigated using a surface roughness detector, giving a value of 9.2  $\mu\text{m}$  in certain locations of the virgin specimen. The coating with 4.5  $\mu\text{m}$  average particle size gave a surface roughness of 1.2  $\mu\text{m}$  [2.33]. However, the diffusion of silicone fluid for coatings with 4.5 and 13  $\mu\text{m}$  particles resulted in a quicker recovery of surface water repellency, and resulted in longer life time. The influence of fillers type, particle size, and concentration on the erosion resistance of SiR materials has been reported in [2.42, 2.43].

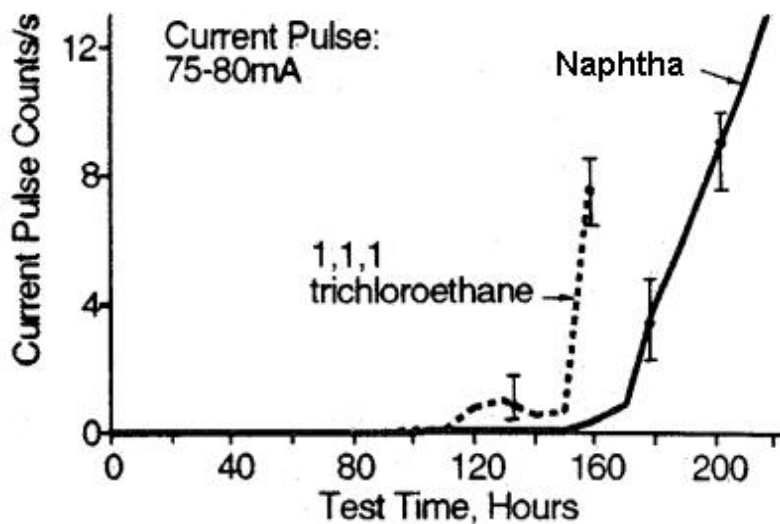
**Figure 2.17: Dependence of current pulse for RTV coating on type of solvent [2.31]**

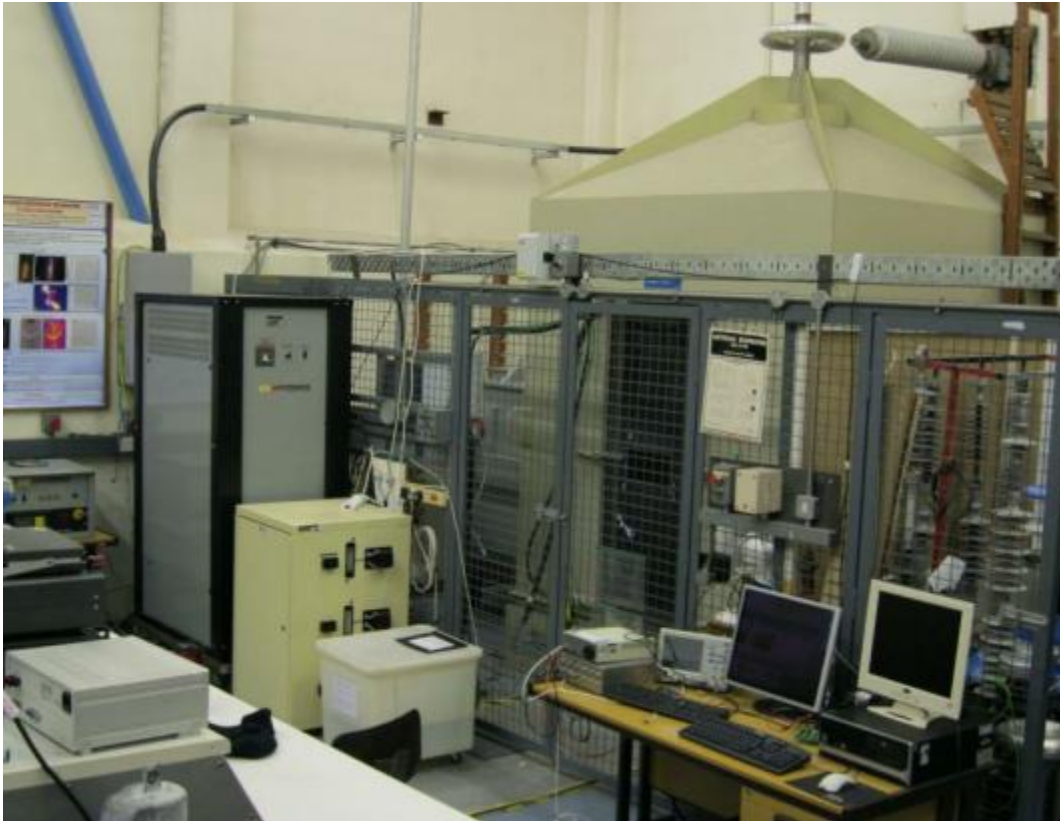
**(b) Fog chamber in the high voltage laboratory (Cardiff University)**

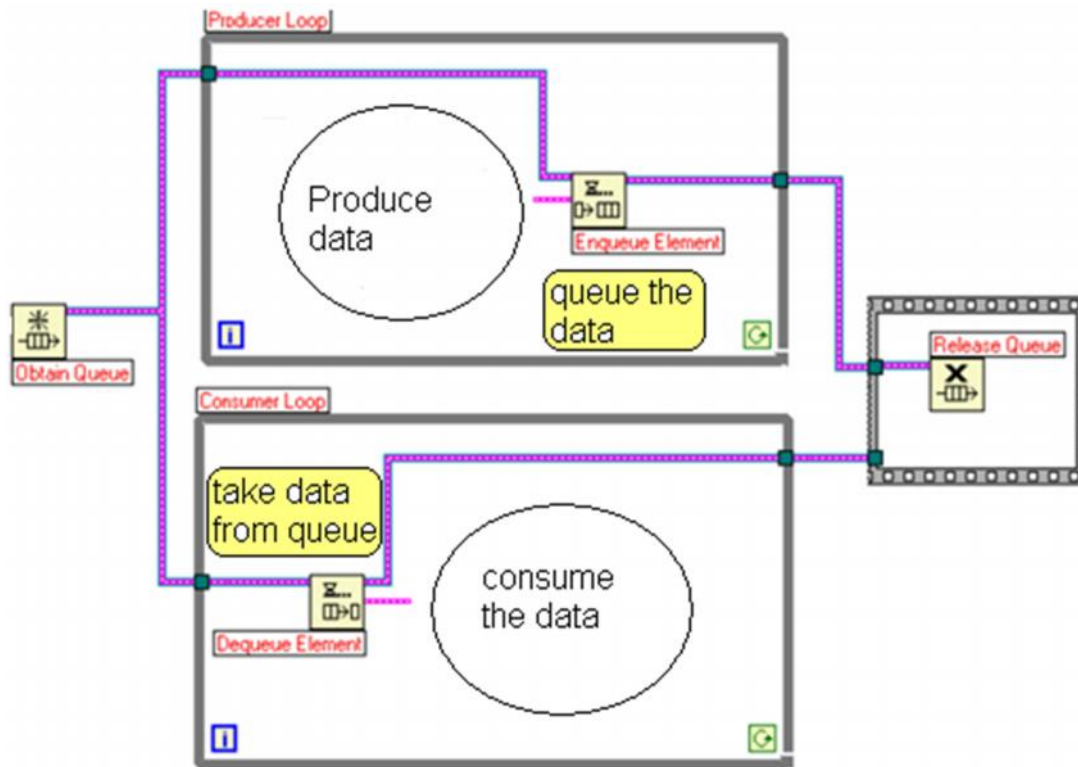
**Figure 3.8: Producer/Consumer Design Model**

The DAQ hardware consisted of the DAQ card and its accessories. The DAQ software is a custom computer program designed to control the application of the test voltage to the samples, to acquire waveforms of the applied test voltage and the leakage current for each sample throughout the test and to manage the storage of the acquired data in series of files for later analysis. In order not to lose any data due to acquiring and processing the data at the same time, a Producer/Consumer architecture was implemented [3.5]. This architecture was used to decouple the processes that produce and consume data at different rates. The Producer/ Consumer patterns are broken down into three categories; those that produce data, those that consume the produced data and the data queues which are used to communicate data between the producer and the consumer loops. The Producer/Consumer configuration is shown in Figure 3.8. The Producer/Consumer pattern approach to this application was to acquire the voltage and current signals, and to queue the data in the producer loop based on the first-in/first-out technique. The consumer loop performed the calculation of the RMS values of the voltage and the leakage current, and saved the data while being displayed on the computer screen. This allows the consumer loop to process the data at its own pace, while allowing the producer loop to queue additional data at the same time.

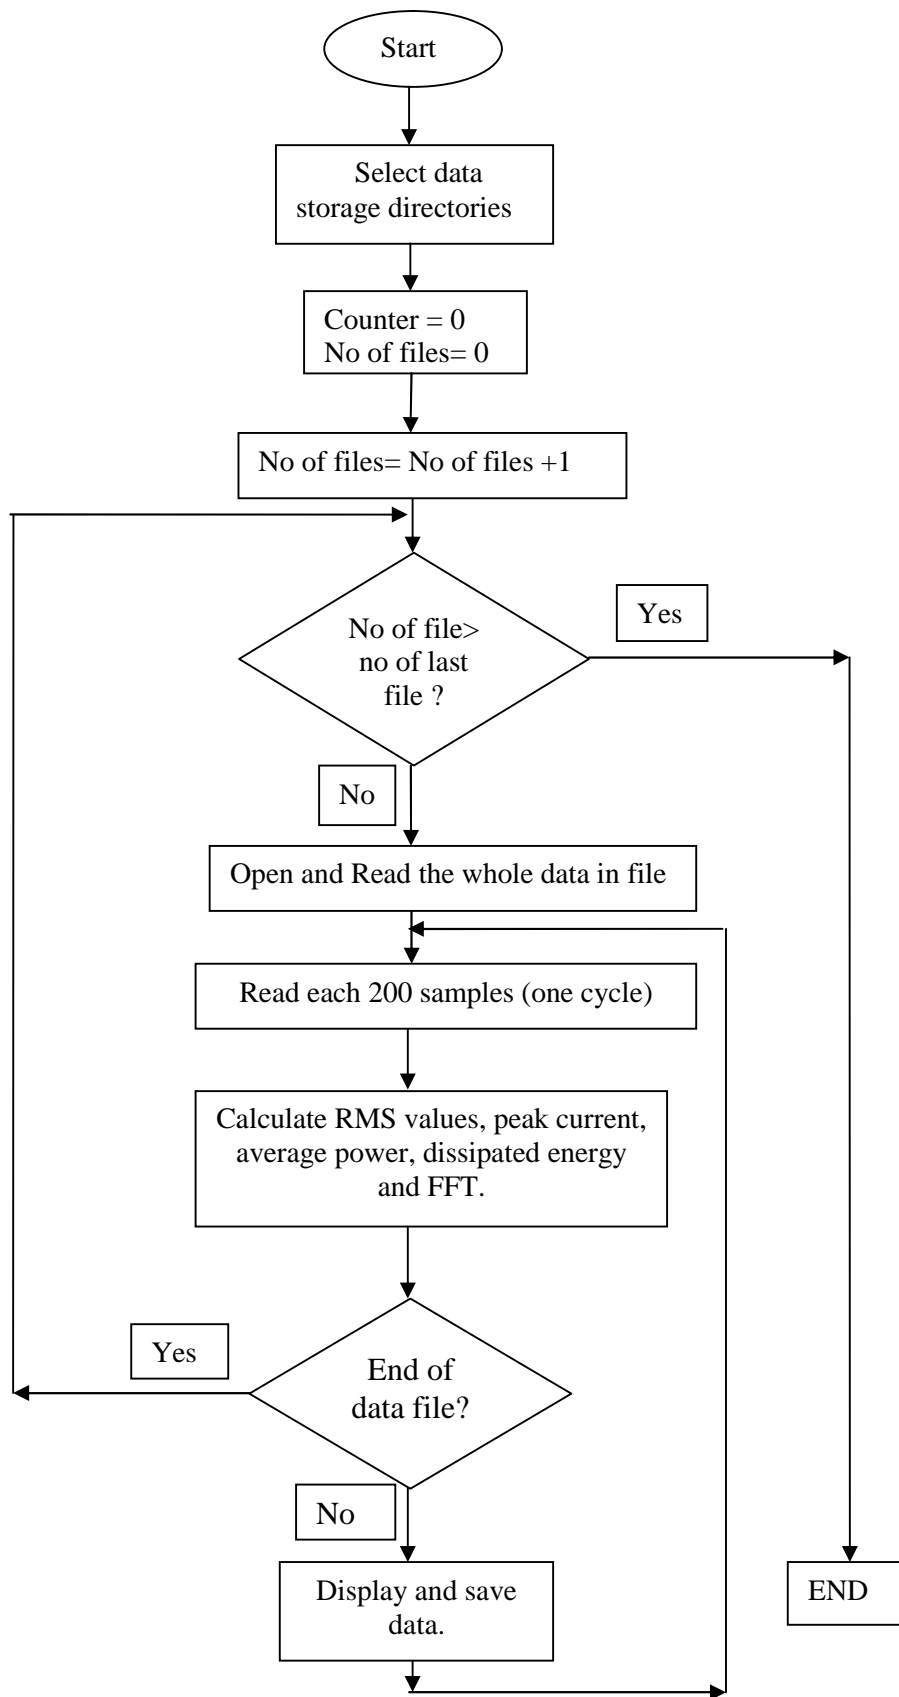
**Figure 3.12: Data flow diagram for the data analysis program**

A data analysis program was also developed using NI LabVIEW to read the files of the data which were stored during the tests and to calculate characteristics of the leakage current and the voltage waveforms for the purpose of describing the behaviour of the test objects. These results were displayed and stored for later analysis. The flow diagram for the data analysis program is shown in Figure 3.12. The front panel of the data analysis program is shown in Figure 3.13.

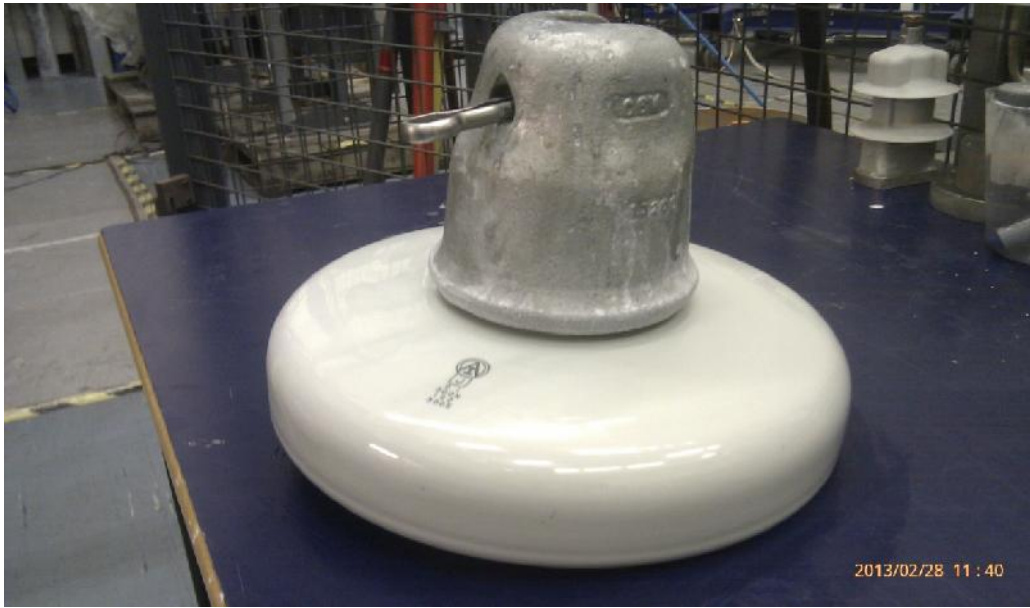
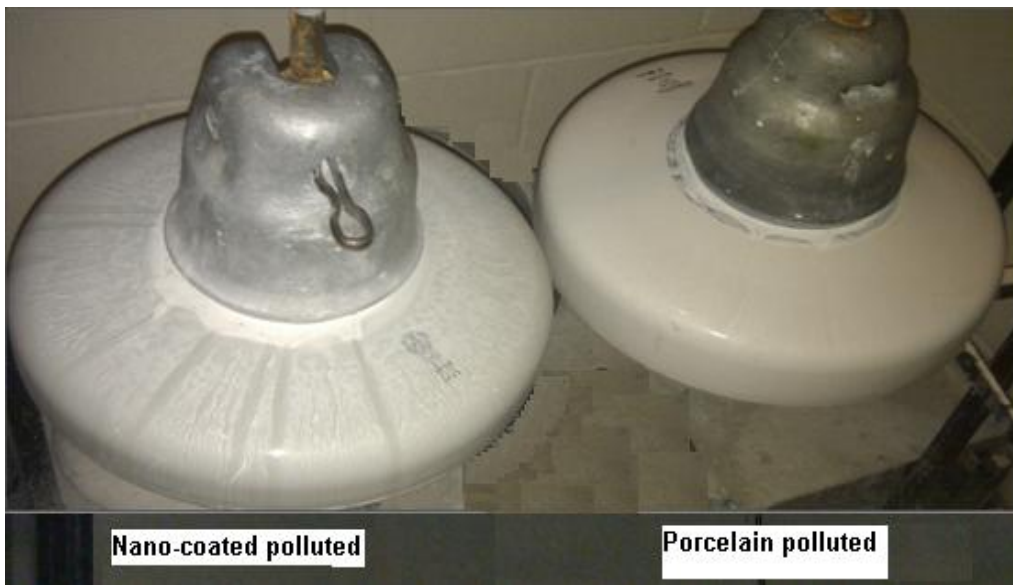
**Figure 4.2: Nanocoated and uncoated insulators**

(a) Nanocoated insulator

(b) Nanocoated and uncoated porcelain insulators

Cap and pin porcelain insulators, see Figure 4.1, with different creepage distances coated with four different coating systems were used in this study. Figure 4.1 shows a cap and pin type porcelain insulator with creepage length of 300 mm. This was coated in the laboratory with RTV1, RTV2 and grease coatings. A cap and pin type porcelain insulator with creepage length of 430 mm coated with Nanocoating was supplied by a utility. A bare porcelain insulator with creepage length of 470 mm was tested to compare its performance with that of the Nanocoating insulator. The Nanocoated insulator and a similar uncoated insulator are shown in Figure 4.2. Details of all the insulators used in these investigations are given in Table 4.1.

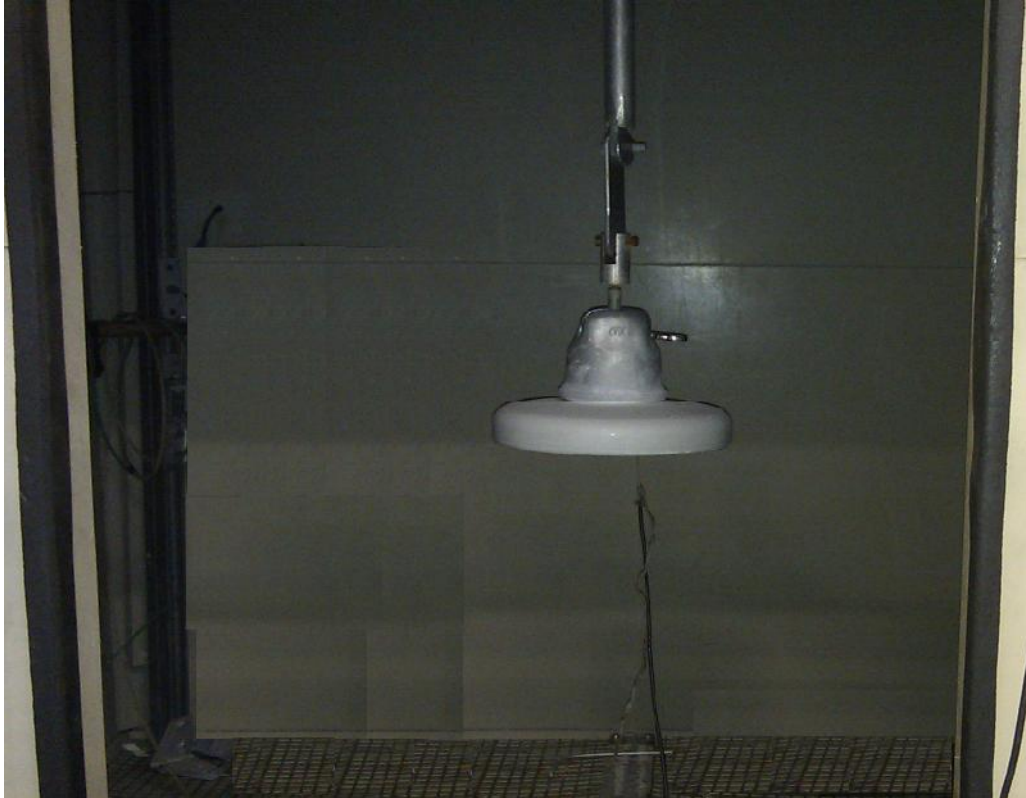
**Figure 4.3: Insulator placed in the fog chamber**

The insulator was energised continuously at the specified test voltage. The test voltage for each of the tested insulators is as shown in Table 4.1. The test duration was 60 minutes. The voltage and leakage current waveforms were recorded throughout the test. Figure 4.4 shows the data acquisition system used for the artificial pollution tests.

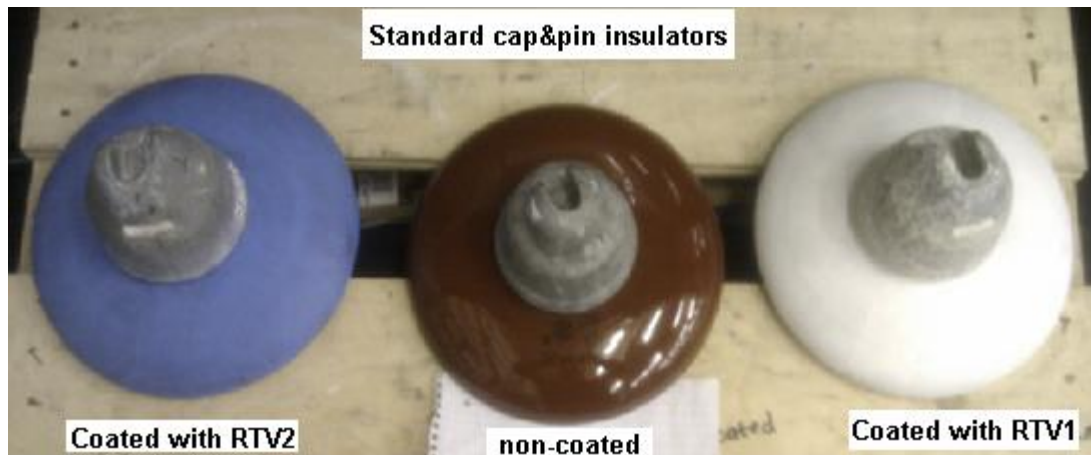
**Figure 4.8: Standard porcelain insulators**

Three cap and pin type C porcelain insulators (creepage length 300 mm) were used in these experiments, the insulators are shown in Figure 4.8.

Two RTV coatings of commercial purity from two different manufacturers identified as RTV1 and RTV2, were applied to the insulators by brushing, and then left to vulcanize in room temperature for one week before the tests. The third insulator was left uncoated for comparison purposes. This section shows the results of the tests performed on RTV coated insulators, compared with results of uncoated insulators of similar geometry.

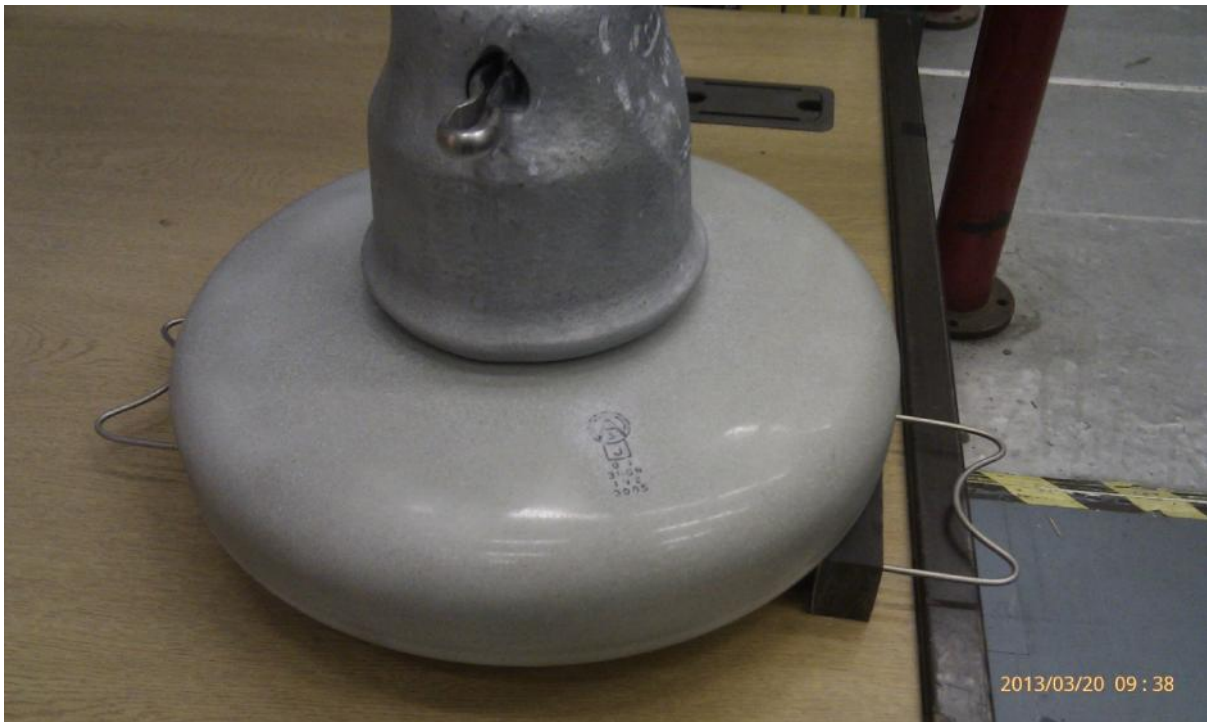
**Figure 4.17: Nanocoated insulator after sandblast exposure**

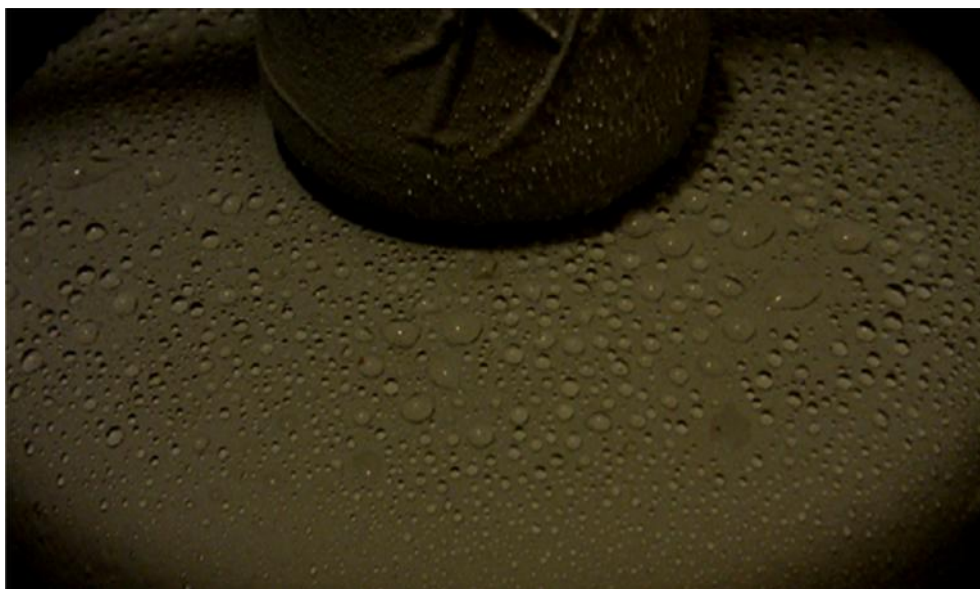
(a) Surface newly coated with RTV1 (HC1)

Most hydrophobic coatings lose their hydrophobicity on exposure to fog. In this section, hydrophobicity tests were performed on the RTV1 coated insulator according to STRI Guide 92/1 [4.15] using a spray bottle filled with tap water capable of producing a fine mist. The results of the hydrophobicity tests are shown in Figure 4.20. Figure 4.20(a) shows a photo of an insulator newly coated with RTV1. As can be seen on the figure, the hydrophobicity of this surface can be classified as HC1 as the water droplets dispersed across the surface in scattered fashion with contact angles in excess of  $90^\circ$ , and thus conformed to the STRI guide.

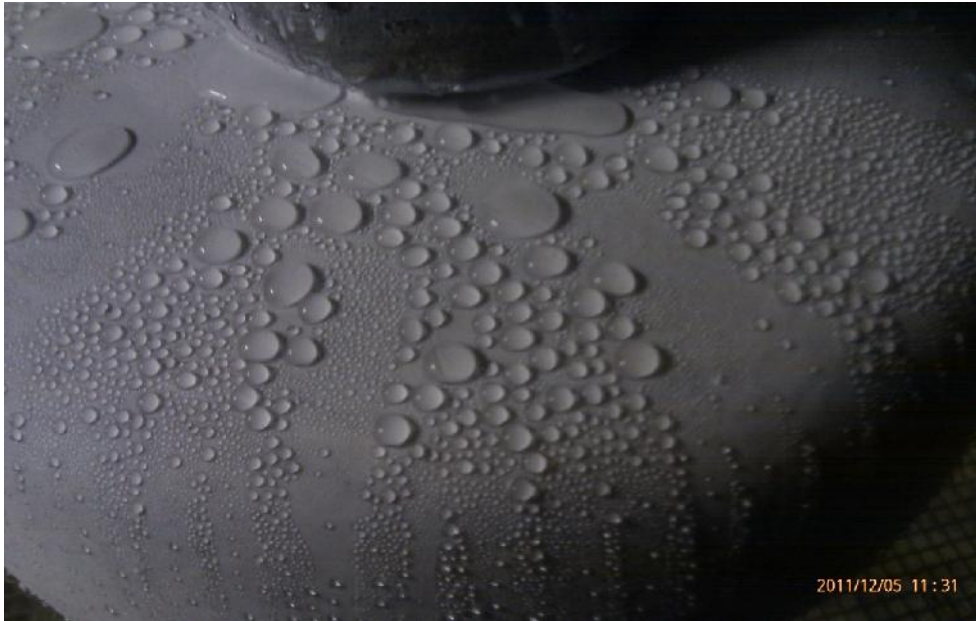
(b) RTV1 coating after 1hour wet test in the fog chamber (HC3)

The surface hydrophobicity was also checked after wet tests in the fog chamber. Figure 4.20(b) shows the insulator in the fog chamber immediately after the wet test. In this case, the surface may be classified as HC3 as the majority of droplets are no longer circular. Figure 4.20(c) shows a picture of an insulator newly Nanocoated. The surface can be classified as HC4 as both discrete droplets and wetted traces from on the surface.

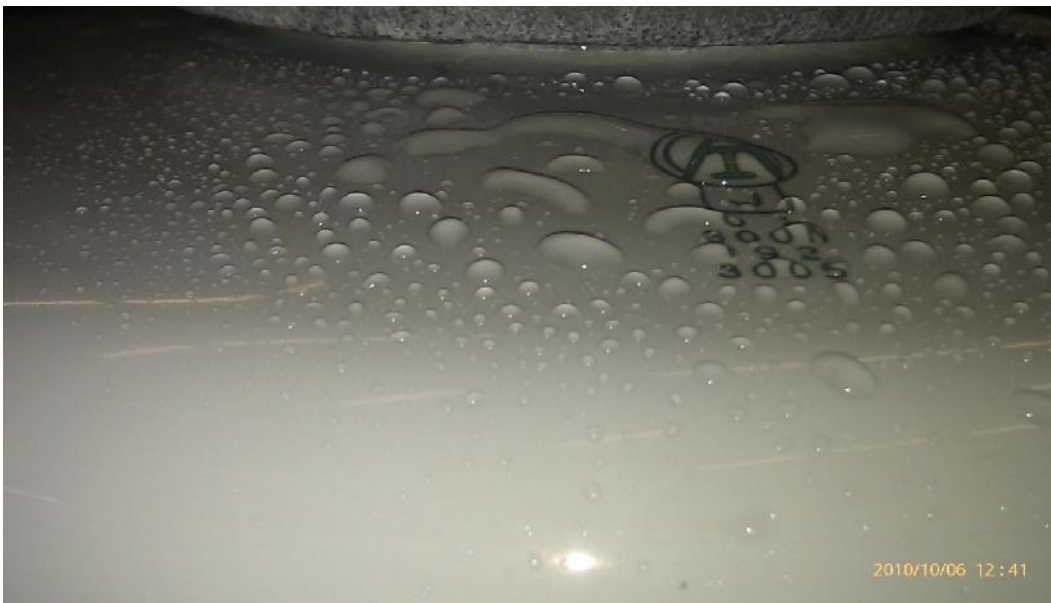
(c) Insulator surface newly Nanocoated (HC4)

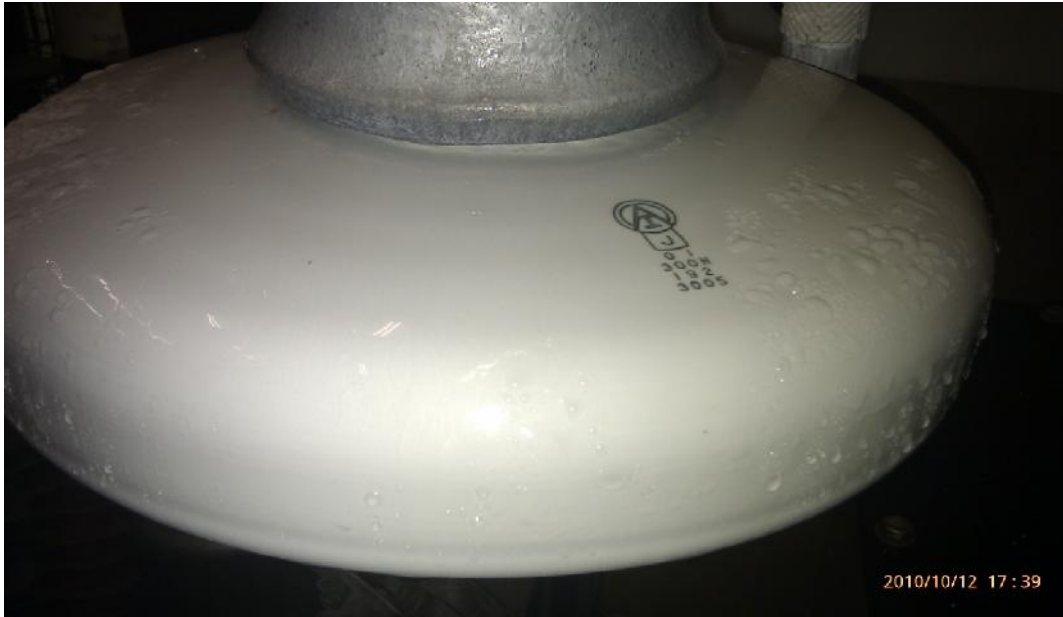
(d) Nanocoating after wet test in the fog chamber (HC6)

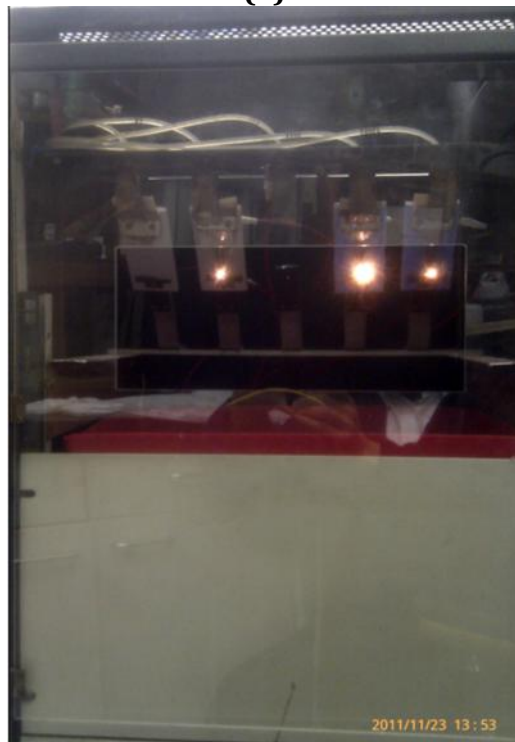
The contaminant solution consisted of  $0.1 \pm 0.002$  % by mass of ammonium chloride and  $0.02 \pm 0.002$  % by mass of iso-octylphenoxypolyethoxyethanol (a non-ionic wetting agent) in water. This contaminant had a resistivity of  $3.95 \pm 0.05$   $\Omega\text{m}$  at  $23 \pm 1$  °C as in IEC 60587. Before the start of each test, the electrodes and the filter papers were attached to the samples and the samples were installed in the IPT unit. The upper electrode was connected to the HV source, while the lower electrode was connected to the DAQ system through current measuring resistor in parallel with protection elements. The tube for feeding the contaminant solution was installed and adjusted so that the contaminant solution would flow through the filter paper to the test samples and the conductivity of the contaminant solution was verified. A series resistor of value appropriate to the test, as was shown in Table 3.2, was selected. When all samples were installed, the pump started and the contaminant flow rate adjusted to the required level, as was shown in Table 3.2. When a uniform flow of the contaminant covered the surface of the tested sample, a 50 Hz high voltage was applied to the samples. Figure 5.1(b) shows RTV coated samples during a test in the inclined plane test machine.

**Figure 5.1: RTV coated sample under test: (a) Zoomed view showing electrodes and filter papers, (b) RTV coated samples under test**

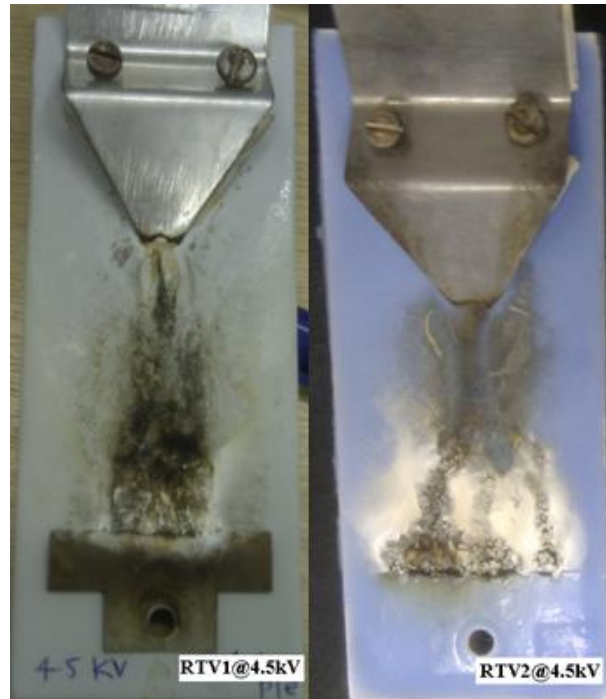
**Figure 5.7: Photos of RTV1 and RTV2 tested at 4.5 kV for 6 hours**

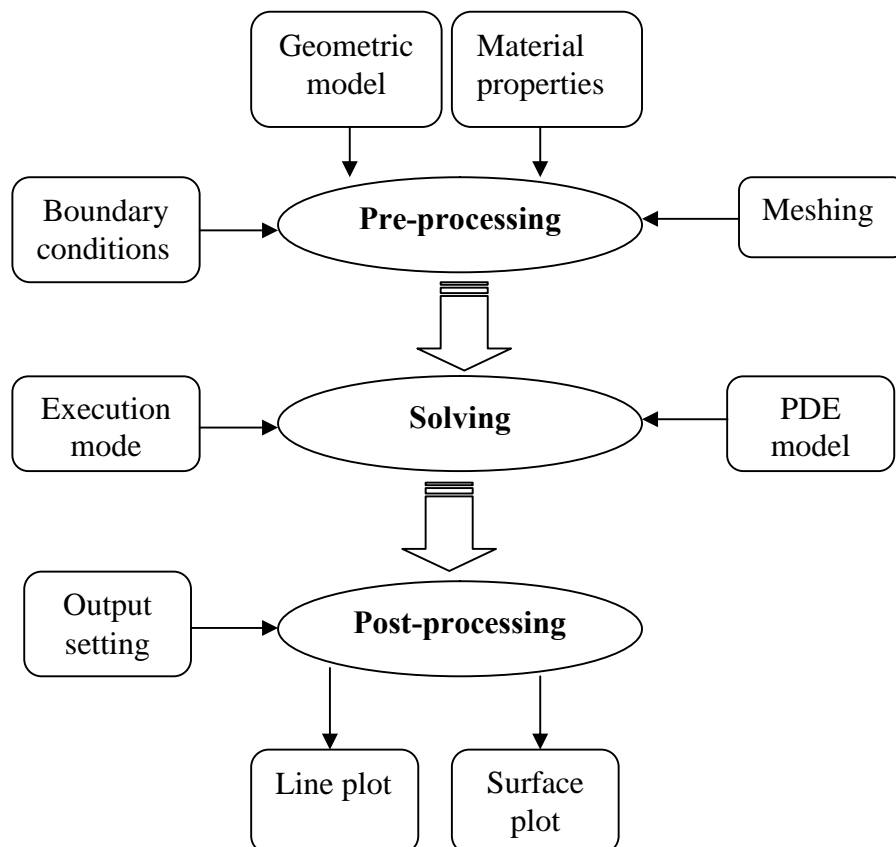
**Figure 6.2: General procedures for FEM simulations**

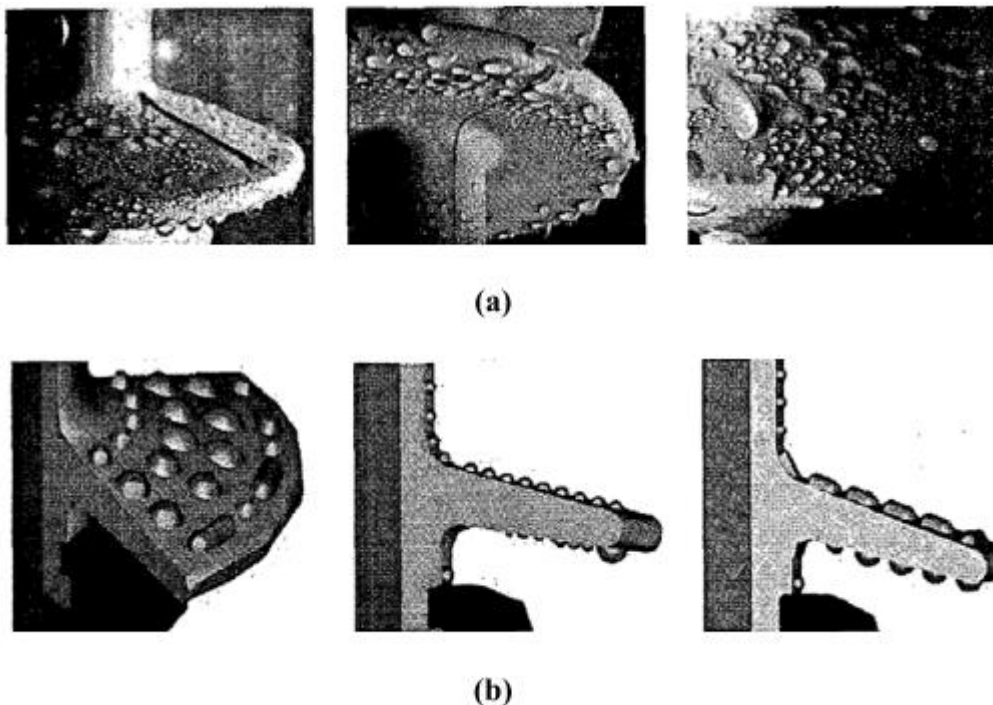
**(a) Photographs of water droplets on the insulator surface,**

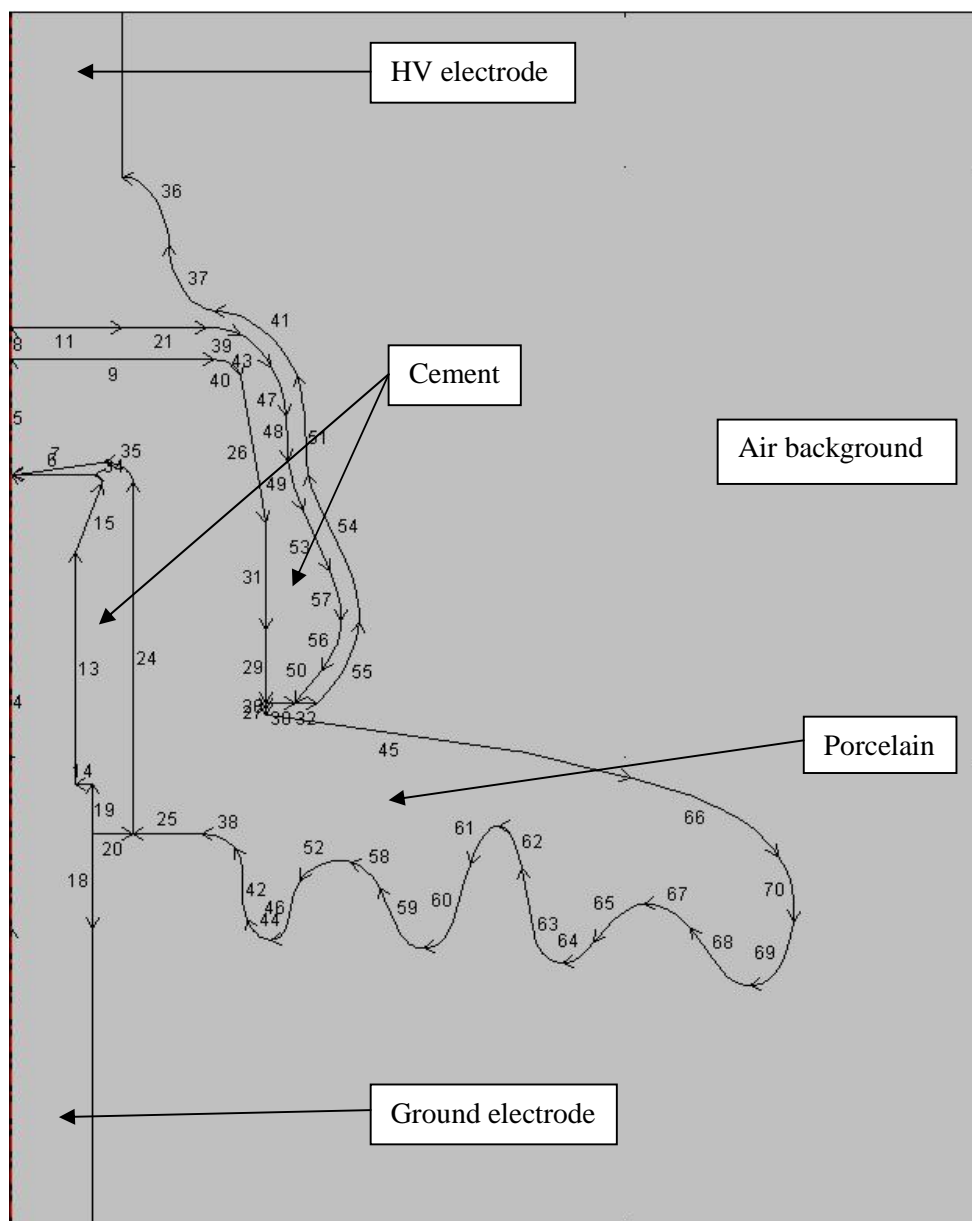
**Figure 6.4: 2-D axi-symmetry model for a clean dry insulator**
