# PREPARING HISTORIC WROUGHT IRON FOR PROTECTIVE COATINGS: QUANTITATIVE ASSESSMENT TO PRODUCE EVIDENCE-BASED PROTOCOLS

N Emmerson\*, D Watkinson

## Abstract

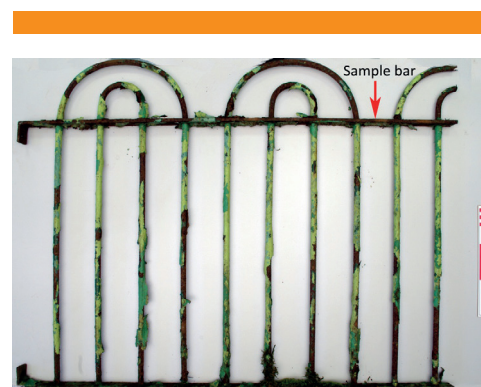
Figure 1: Iron railing

Nevertheless, it would be preferable to use heritage material as samples and subject these to real time testing. In keeping with a focus on real life contexts, corroded historic wrought iron samples are used in this study rather than analogues. The sample material, sourced by Historic Scotland, is an un-provenanced wrought iron railing from an Edinburgh scrap yard. Vestiges of failed coating systems remain on approximately 40-50% of the surface, adhering closely in some areas and loosely in others. Corrosion products also cover the entirety of the railing in the form of closely adhering, coherent oxide layers as well as laminating and powdery corrosion products and pitting (Fig. 1).

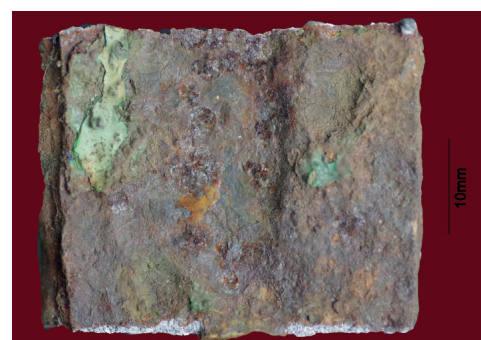
Figure 2: Sample of wrought iron railing used in control tests

Following this, five samples of the iron were tested to determine their corrosion rate. The samples were uncleaned, contained residues of paint and areas of corroded iron on their major faces and had two fresh cut edges (Fig. 2). Each sample was sealed within an individual reaction vessel containing silica gel conditioned to 90% relative humidity (RH). Corrosion rates for the samples were determined using remote recording of oxygen concentration within the reaction vessel. This used an Oxymini Micro fibre optic meter to record the quenching of fluorescence in an oxygen sensitive dye contained within a sensor spot adhered to the inside of the reaction vessel. The airtightness of the 250 cm<sup>3</sup> reaction vessels was tested for oxygen ingress by adding nitrogen to a jar and determining oxygen concentration over 257 days. Control jars were set up containing only conditioned silica gel. Each jar contained a MadgeTech humidity and temperature sensor accurate to ± 3% RH and 0.5 °C. The reaction vessels were kept in a

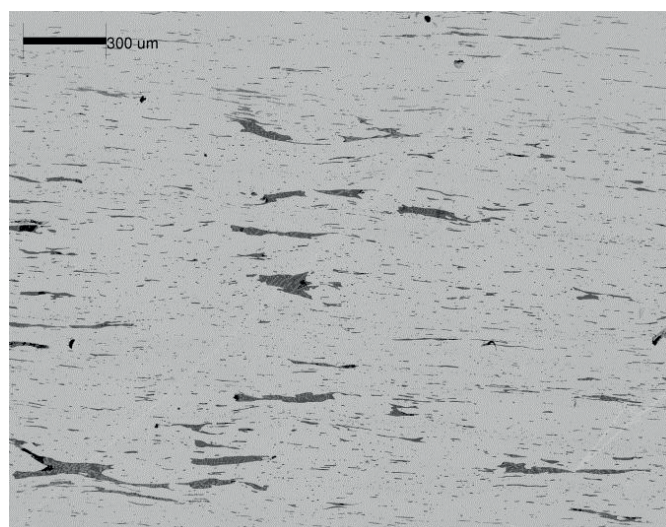
Figure 3. SEM backscattered electron image of a polished section of wrought iron railing showing slag distribution.

The sample dimensions and their weight range are shown in Table 1. The mean composition of the sample analysed was 99% iron, 0.37% silicon, 0.36% phosphorus and 0.27% manganese (Table 2) which is typical of a wrought iron. Slag content was moderate and relatively evenly distributed in stringers, although inclusions varied in size from <10 µm to >600 µm (Fig. 3). Corrosion was localised and pitting was present (Fig. 2). XRD identified goethite ( $\alpha\text{FeO}(\text{OH})$  diffraction code 01-081-0462), magnetite ( $\text{Fe}_3\text{O}_4$  diffraction code 01-085-1436) and lepidocrocite ( $\gamma\text{FeO}(\text{OH})$  diffraction code 01-074-1877) to be present as corrosion products (Fig. 4). There were at least nine layers of paint on the samples and the compositions of these (Figs. 5 to 9) indicated the presence of lead based coatings, those with barium sulphate fillers, cobalt drying agents, copper based pigments and a suggestion of zinc. Overall the picture is of an ad hoc painting maintenance regime with a range of pigment and paint types such as might be expected in the protective coating of an outdoor railing.

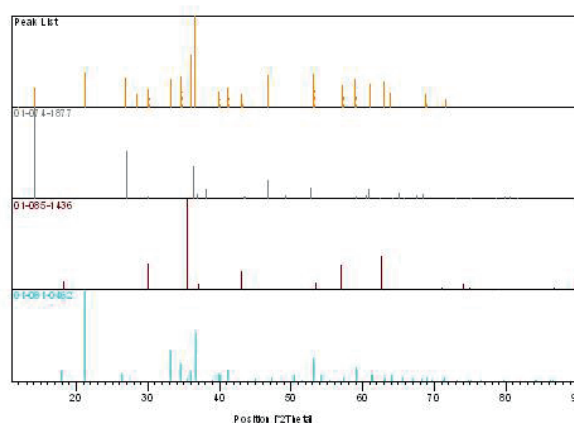
Figure 4: Diffraction patterns of corrosion sample and matching compounds (top to bottom): the corrosion product sample; lepidocrocite (01-074-1877); magnetite (01-085-1436); goethite (01-081-0462).

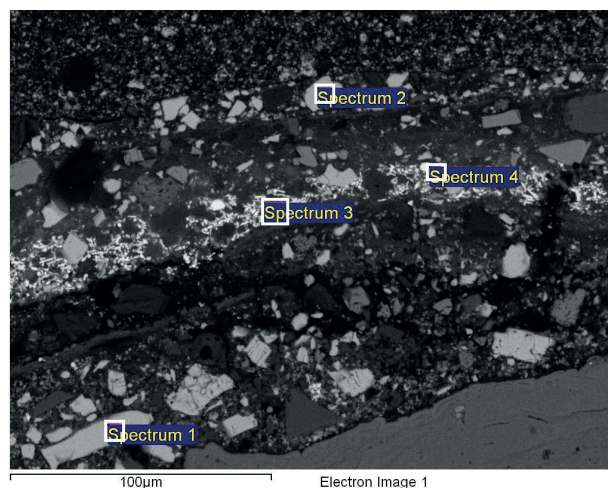
Figure 5: Backscattered electron image showing location of analyses of paint layers from the sample material (indicated by white squares). Spectra 1-4 are given (Figs. 6 to 9).

Paint layers were examined in profile and elementally analysed using a CamScan Maxim 2040 scanning electron microscope (SEM) equipped with Oxford Instruments energy and wavelength dispersive X-ray spectrometers. Polished sections of the railing were also analysed using the SEM to determine the composition of the wrought iron. Samples of corrosion products were removed from exposed areas and beneath exfoliating paint and analysed using a PANalytical X'Pert Pro (Cu) X-ray powder diffraction.

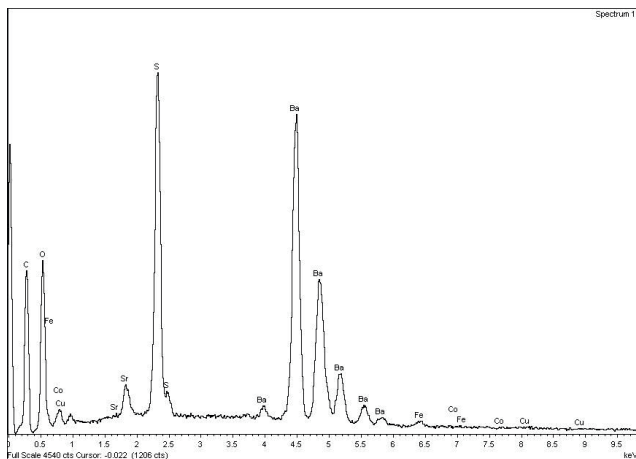
Figure 6: Spectrum 1 of SEM analysis of paint layers on sample material (location indicated in Fig. 5) showing major peaks for sulphur, and barium with minor peaks for copper, cobalt, strontium and iron.

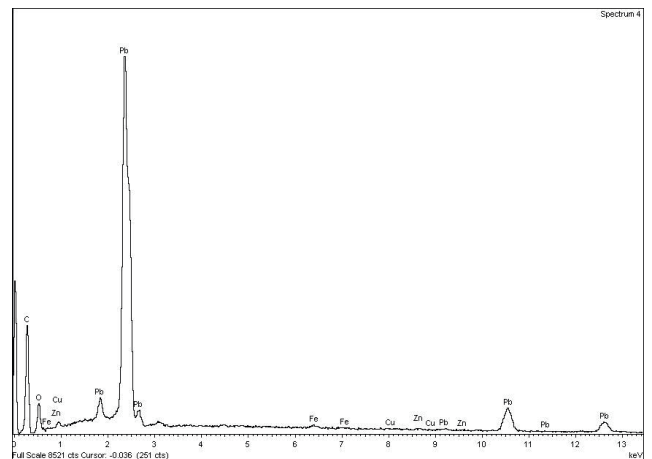
Figure 9: Spectrum 4 of SEM analysis of paint layers on sample material (location indicated in Fig. 5) showing major peaks for lead and minor peaks for copper, zinc and iron.

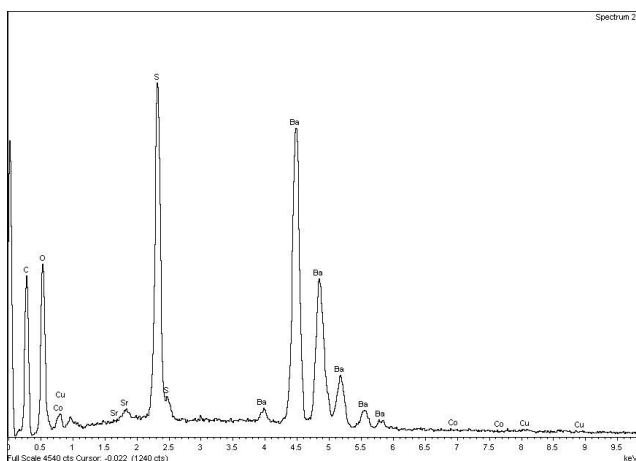
Figure 7: Spectrum 2 of SEM analysis of paint layers on sample material (location indicated in Fig. 5) showing major peaks for sulphur and barium and minor peaks for copper, cobalt and strontium.

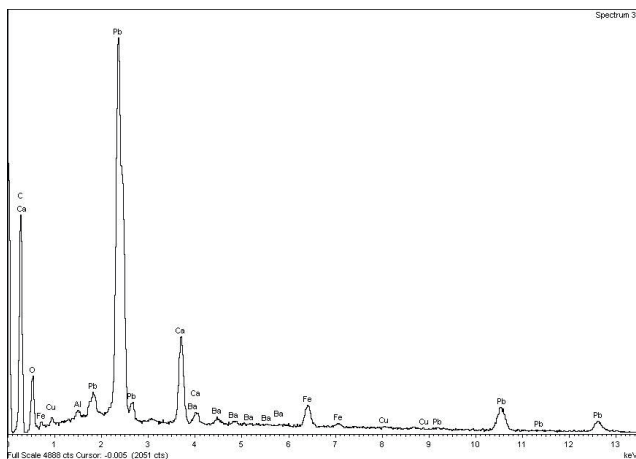
Figure 8: Spectrum 3 of SEM analysis of paint layers on sample material (location indicated in Fig. 5) showing major peaks for lead and calcium and minor peaks for aluminium, barium and copper.

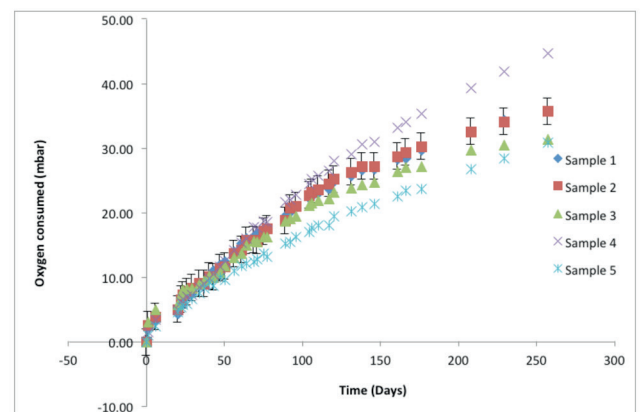
The corrosion rate of each sample was recorded over a period of 257 days (Fig. 10). Representing the daily corrosion rate as oxygen consumed per sample reveals that the corrosion rate averaged 0.14 mbar/day and each sample was within 0.02 standard deviations of this value (Table 1).

Figure 10: Graph showing oxygen consumption of five un-cleaned samples of wrought iron railing..

The data revealed that it is possible to use the railing wrought iron to produce test samples for determining the effect of selected surface cleaning techniques on the corrosion rate of historical iron. The corrosion rate of the samples was sufficiently consistent to allow comparison between surface treatments that would not be influenced by the nature of the sample. The graph shows a good agreement between the oxygen consumption rates of the samples, demonstrated by the clustering of the points over the first 70 days. Rate agreement between samples 1 and 2 means their points on the graph overlie each other throughout the test period. The oxygen consumption rates do not form straight lines and to increase clarity no trendlines are shown. The trendline gradient for each sample over the first 75 days is given in Table 3. The slight falling off of the rate seen for each sample may be due to the limiting effect of diminishing oxygen concentration within the reaction vessels or a consequence of a build-up of newly formed corrosion products.

Errors need to be considered when interpreting these results; the first is inherent in the oxygen meter readings. Displaying the error bars relating to the meter error for each point renders the graph unreadable; inclusion for one sample (Sample 2) indicates the range of the error (1%) to be factored in for each measurement. A second error can be calculated to interpret results of surface cleaning tests, derived from the maximum difference between corrosion rates of the un-cleaned samples and is 0.05 mbar/day in this case (min. corrosion rate 0.12 mbar/day and max. 0.17 mbar/day).
