Whitman, Christopher J. 2014. Straw bales, a possible solution for hygro-thermally comfortable dwellings in Chile's central valley: physical test chambers and in situ measurements. *Journal of Green Building* 9 (2) , pp. 161-181. 10.3992/1943-4618-9.2.161

# Straw bales, a possible solution for hygro-thermally comfortable dwellings in Chile's Central Valley: Physical test chambers and in situ measurements.

Christopher J. WHITMAN<sup>a</sup>

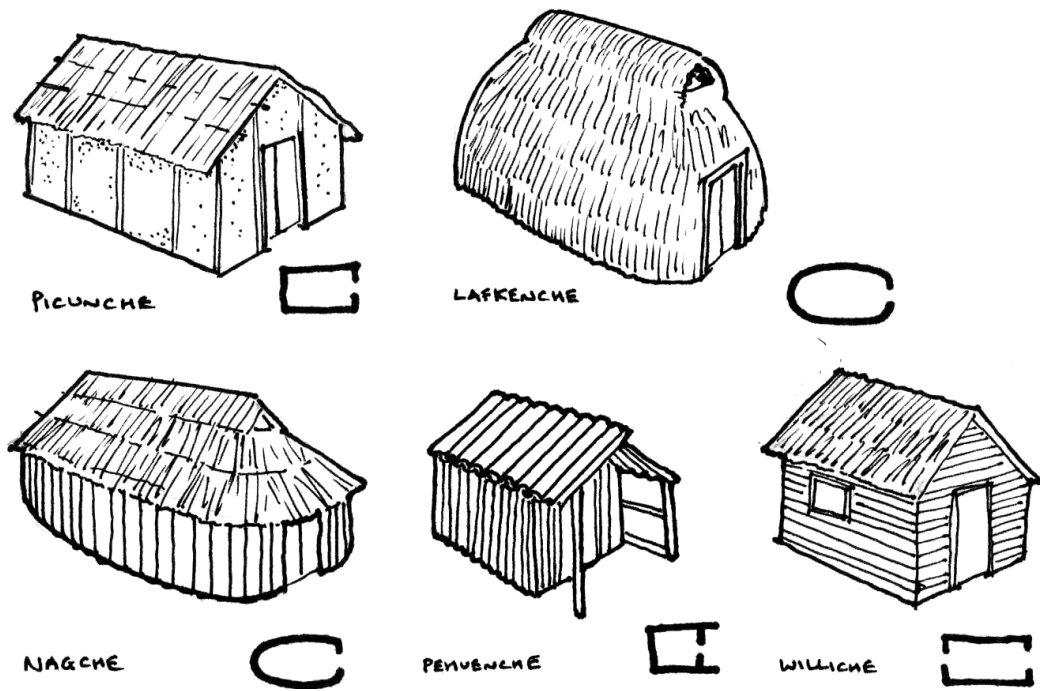
Figure 1. The architecture of the different tribes of the Mapuche, Chile's indigenous people [3].

Historically the construction of dwellings in the region consisted of the pre-Columbian indigenous timber-framed thatched *rucas* of the Mapuche. These single roomed constructions vary in their materiality depending on the specific sub region (Fig. 1.).

In the north of the Central Valley the *Picunche* tribes built their homes from wattle and daub, the *Lafkenche* from the coast, to this day, use local reeds and grasses, whilst the *Nagche* from the central plains build their walls from vertical timbers. The *Pehuenches* from the Andean foothills are the only Mapuche tribe that do not thatch their rucas, opting instead for a construction of hollowed logs or canoes used as large tiles. Further south the *Williche* use thatch for the roof but the walls are constructed of horizontal timbers, and there is the introduction of windows. With the arrival of the Spanish in 1537 came the introduction of the unfired earth brick or Adobe. This building technique consists of earth to which natural fibres are added. In Chile the most commonly used natural fibre is straw. The earth-straw mix is formed into bricks or adobes in wooden moulds. The adobes are then left to dry in the sun. Adobes are used as both load-bearing solid masonry construction, bedded with an earth mortar, with walls typically between 600mm and 1,200mm thick, and as an infill between timber structure forming thinner walls and partitions. Both systems are traditionally finished with an earthen render. In time adobe became the predominant construction technique in Chile's Central Valley and remained so until the beginning of the 20th Century. According to the latest national census of 2002 earth construction represented 5.5% of the Chilean building stock [1] and forms a large proportion of Chile's National Monuments and heritage buildings.

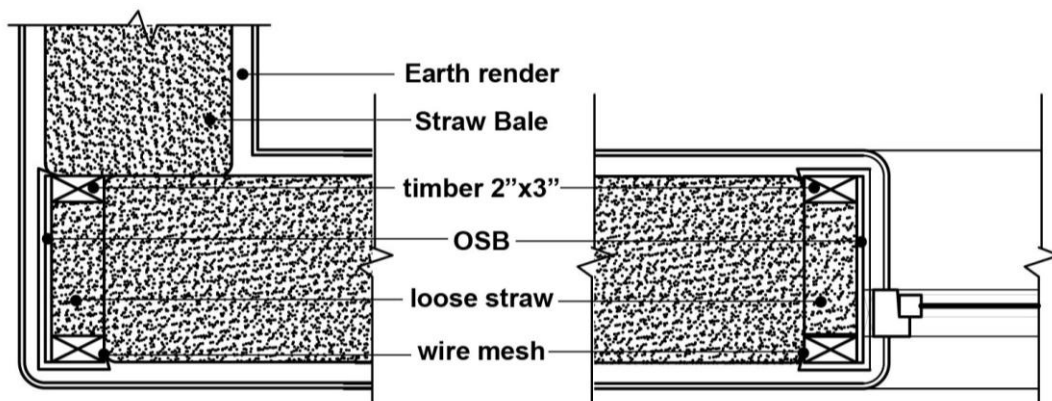
Figure 2. Plan of straw bale test chamber corner and window jamb construction detail.

- Un-insulated timber construction to simulate rural housing pre 2007 and emergency housing “*mediaguas*” constructed immediately following the earthquake.
- Insulated timber construction, insulated with expanded polystyrene to comply with Chilean building regulations (U-Value 1.9 W/m<sup>2</sup>K), to simulate rural housing constructed post 2007 and the government certified housing solutions for rural reconstruction.
- Earth rendered straw bale laid on edge, with “modified post and beam” timber structure [Fig. 2.]

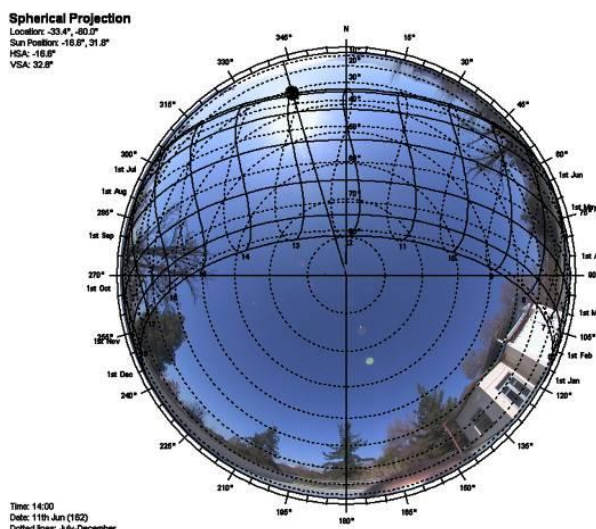
Figure 3. Site photo taken with Nikon Coolpix digital camera fitted with fish-eye lens, with solar chart for Santiago overlaid.

Various possible sites within the university's Campus Casona de las Condes were reviewed with regard to solar exposure, over-shadowing, security, and minimum disruption to other academic and administrative activities. As a result of this review the roof terrace of the Library building was selected. A photograph was taken with a Nikon Coolpix digital camera fitted with a fish-eye lens and a solar chart overlaid to evaluate solar access (Fig 3.). This exercise confirmed minimal overshadowing of the site, with minimal shade from trees in winter until 10:00am and after 16:00pm in summer. Winter sun angles were used to calculate the separation between test chambers to ensure that one would not cast a shadow on another.

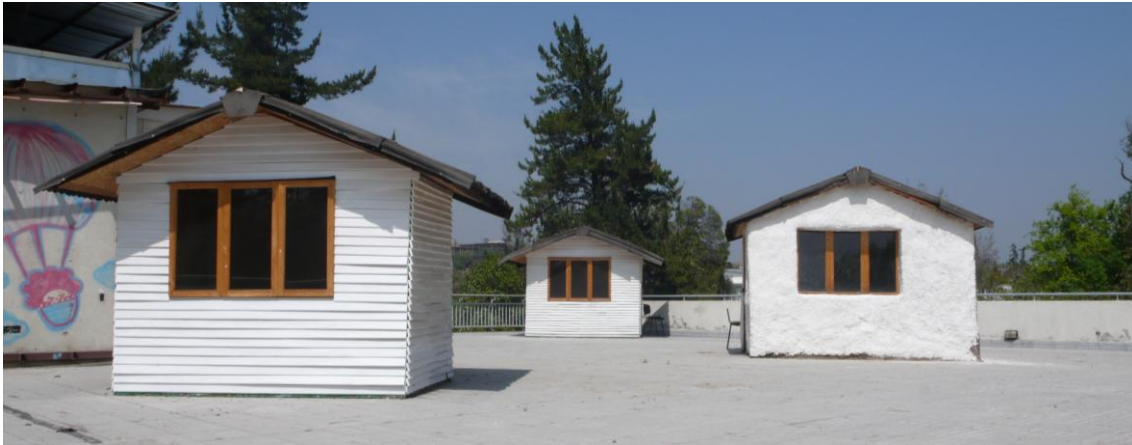
Figure 4. Finished physical test chambers as measured May 2010-November 2012.

The construction of the three test chambers took place between November 2009 and May 2010 during the summer months (Fig. 4). Owing to the lack of rainfall during this season there was no need to protect the bales during construction. The construction was undertaken by 4<sup>th</sup> year Industrial Design undergraduates as part of their course “laboratory Practice”. The construction team represents an unskilled workforce not uncommon in rural Chile. The timber constructions were painted white with ordinary exterior quality water-based emulsion paint; their joints were not sealed as this is not common practice in rural Chilean construction.

The straw bale test chamber was finished with a 30mm thick earth render using recycled “adobe,” earth blocks, from a historic house in Pirque, South West of Santiago, that was demolished following severe structural damage in the 27<sup>th</sup> February 2010 earthquake. The earth render was applied by hand directly to the straw bales in two coats. The few cracks in the render were repaired prior to the application of the whitewash.

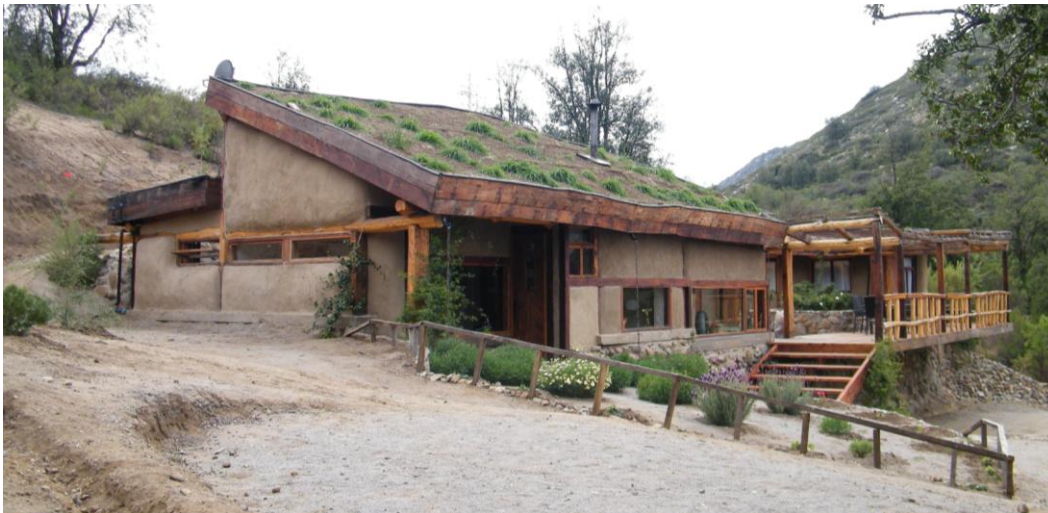
Figure 5. Case Study house Casa Caleu, Caleu, Metropolitan Region, Chile

The house is a second home located on the outskirts of the small village of Caleu, situated 60km North West of the capital Santiago de Chile, high in an eastern lateral valley of the central coastal range. At an altitude of around 1,200m above sea level the diurnal thermal oscillation is at the higher end of those experienced in the region.

Owing to the climatic conditions of the region it was acknowledged that there was a need for high levels of insulation and exposed thermal mass. Straw bale construction was chosen for the walls with an earth render to both protect the bales and provide thermal mass. Additional thermal mass was introduced in the form of stone floors and stone dwarf walls. The detailing of the dwarf walls could prove problematic in winter due to the lack of insulation and thermal bridging at this point. The roof is an inverted green roof planted with species endemic to the site. Once established these plants will require only the water provided by the winter rains and humidity present naturally in the atmosphere avoiding additional irrigation and use of potable water. The plants, a mixture of grasses and low shrubs will provide shade to the roof surface thereby reducing direct solar gains.

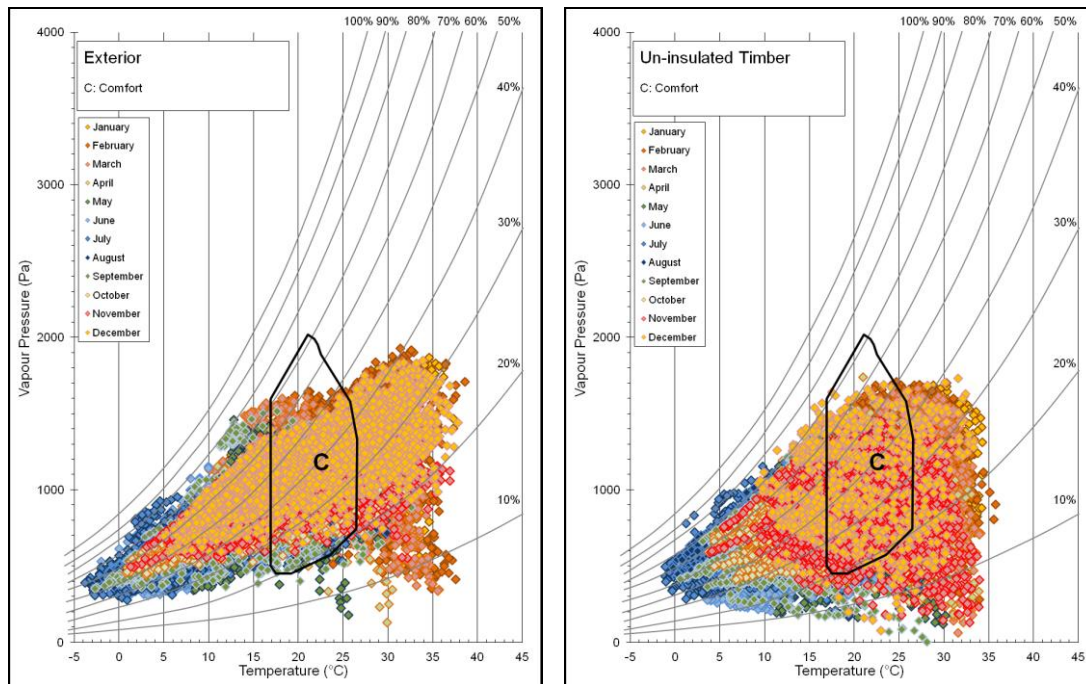
Figures 6& 7. Psychrometric chart according to Givoni of external conditions and un-insulated timber test chamber. Temperature and relative humidity as measured May 2010- December 2013

Using Logtag HAXO-8 Temperature and Humidity Recorder (maximum temperature 85°C), measurements of dry bulb air temperature (°C) and relative humidity (%) began in May 2010. The Logtag recorders were suspended centrally in each test chamber 1.7m above finished floor level and were programmed to record readings at hourly intervals. Measurements of external dry bulb air temperature (°C) and relative humidity (%) were recorded by the La Crosse Technology 2317 weather station of the Laboratory of Energy and Lighting. Results of these measurements are presented in section 4.1.1 as psychrometric charts according to Givoni (Figs. 6-9) [27].

The psychometric charts show that the temperatures and relative humidity in the straw bale test chamber are more stable and are grouped closer to the comfort range than those of the other two test chambers. Temperatures never drop below 3.3°C whilst outdoor temperatures drop to minus -3.8°C. Periods of extreme heat and dryness are also avoided. The most notable difference in the charts is seen in the relative humidity which in the straw bale chamber never rises above 60% humidity. Whilst bearing in mind that the test chambers do not have any of the humidity creating activities encountered in real dwellings, this low humidity is an important factor considering that the 80% of Chilean dwellings suffer problems of condensation [11]. A direct comparison of the diurnal thermal oscillation shows that the insulation provided by the straw bales in conjunction with the thermal mass provided by the earth render produces temperatures much more stable than those of the other test chambers (Table v) with an average daily temperature oscillation of only 7.8°C in comparison to that of the average diurnal external temperature oscillation of 16.8°C.

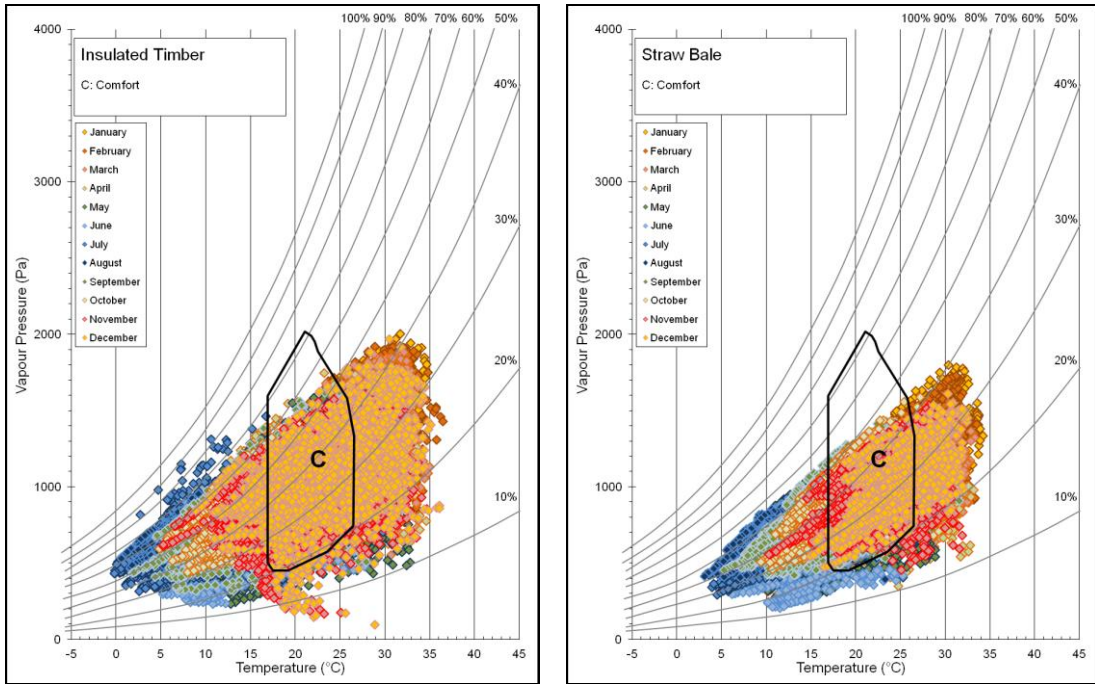
Figures 8 & 9. Psychrometric chart according to Givoni of insulated timber test chamber and straw bale test chamber. Temperature and relative humidity as measured May 2010- December 2013

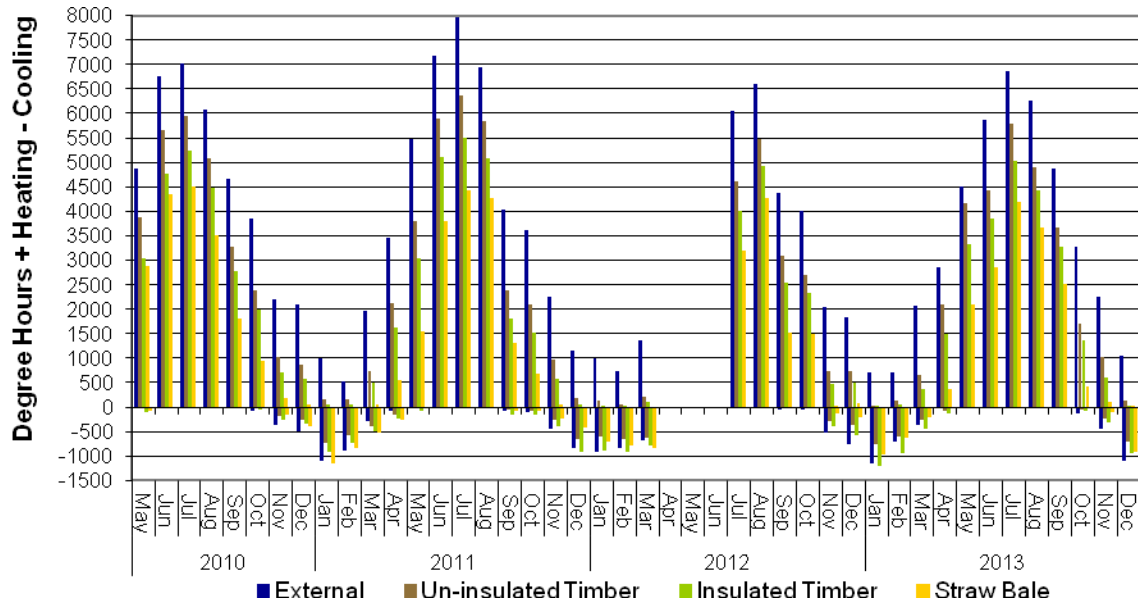
Figure 10. Monthly heating (+) and cooling (-) demand in degree hours. Based on dry bulb temperatures as measured May 2010 – December 2013

Based on the recorded dry bulb temperatures, the heating and cooling demand in degree hours for the three physical test chambers was calculated using a comfort range as defined by Givoni 18°C-27°C [27]. Results of this calculation are shown as monthly figures in Figure 10. Heating hours are presented as positive and cooling as negative.

The calculation of heating and cooling demand shows that the heating demand of the straw bale chamber is significantly reduced as shown in Figure 10. On average during the year the heating demand is 29% less than that required by the test chamber insulated to comply with the Chilean thermal building regulations. The average cooling demand is 32% less. During the first summer due to the lack of solar protection the cooling demand of the straw bale test chamber was 9% more than that of the insulated timber chamber, however following the introduction of solar protection to all three test chambers, and additional internal render to the straw bale chamber, the cooling demand for the straw bale chamber in comparison to that of its insulated timber counterpart was 26% less during the second summer and 43% less during the third summer. The cooling demand of all the test chambers could be further reduced with the introduction of a ceiling with ventilated roof void and the use of free cooling through nocturnal ventilation [27]. In reality few rural Chilean dwellings have air conditioning and so this cooling demand represents the hours of discomfort from overheating as opposed to a real energy cost. The trend of the graph in Figure 10 shows that although Santiago de Chile has a Mediterranean climate it still has a largely heating based demand curve. It should however be considered that during the months November to May this demand is almost 100% during the middle of the night and heating is rarely used during these months.

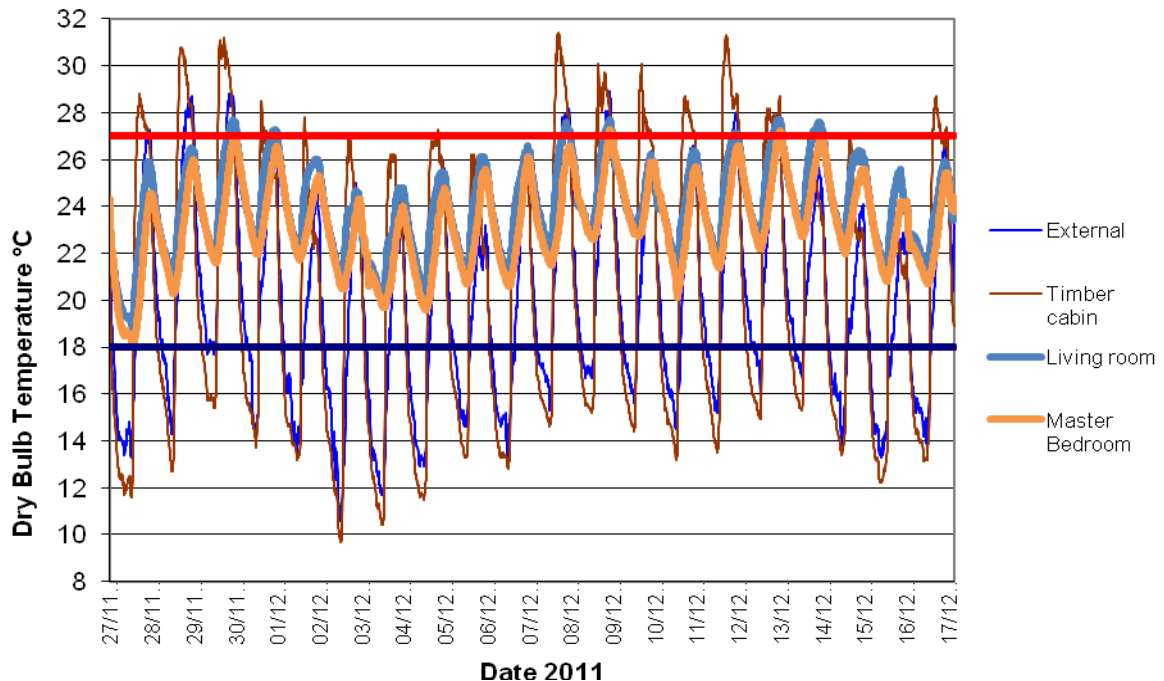
Figure 11. Dry bulb temperatures (°C) as measured in situ 27.11.11 – 17.12.11

The results of the LogTag HAXO-8 Multi Use Temperature/Humidity data loggers are presented in Figures 11-14 compared with a comfort range as defined by Givoni 18°C-27°C [27].

The summer internal dry bulb air temperatures of the case study house (Fig.11) remain almost constantly within the thermal comfort zone as defined by Givoni [28] with only a few hours passing beyond the higher limit of 27°C. In winter the temperatures group around the lower end of the comfort range with night time temperatures falling below 18°C (Fig.12). No heating was used during the measurement period as the house was unoccupied. In general the house shows good insulation, in the worst cases maintaining 20.5°C in summer and 12°C in winter whilst external temperatures dropped to 10.5°C and 4°C respectively. The amplitude of the thermal oscillation is reduced from an average external oscillation of 12°C to an internal oscillation of 5°C. In comparison the un-insulated timber cabin amplifies the oscillation to an average 15°C.

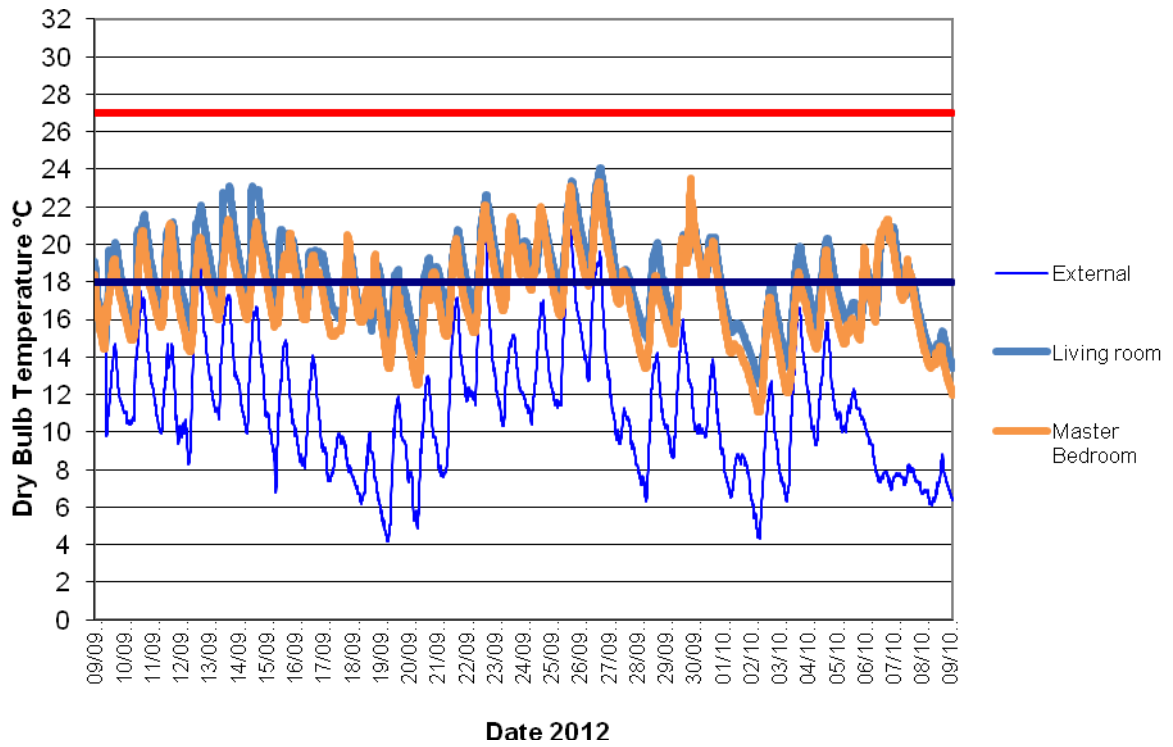
Figure 12. Dry bulb temperatures (°C) as measured in situ 09.09.12 – 09.10.12

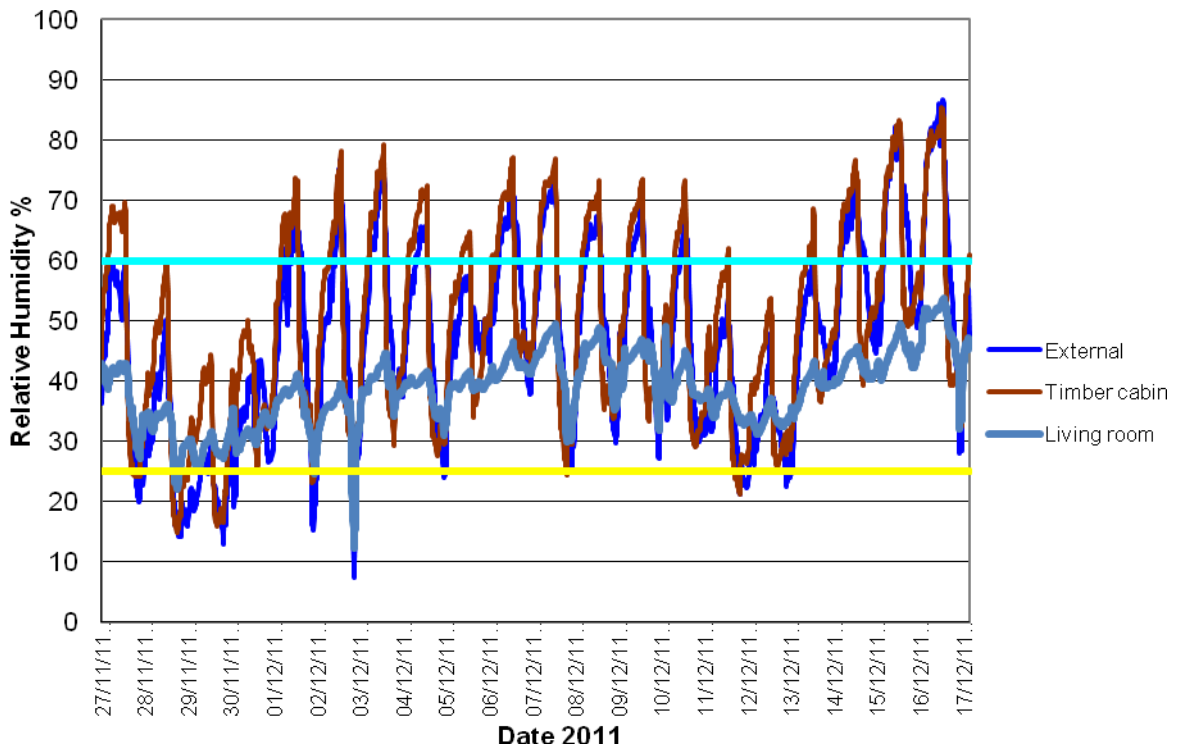
Figure 13. Relative Humidity (%) as measured in situ 27.11.11 – 17.12.11

Summer internal relative humidity measurements (Fig.13) in the house are more stable than both external measurements and those of the timber cabin. Except for a couple of hours when readings dropped below 25%, readings remained within the range of 25-60% relative humidity. External relative humidity varied between 9-85% and that of the timber cabin was almost equal to external measurements at all times. In the winter the internal relative humidity measurements stay constantly within the 25-60% range whilst the external conditions reach up to 100% relative humidity.

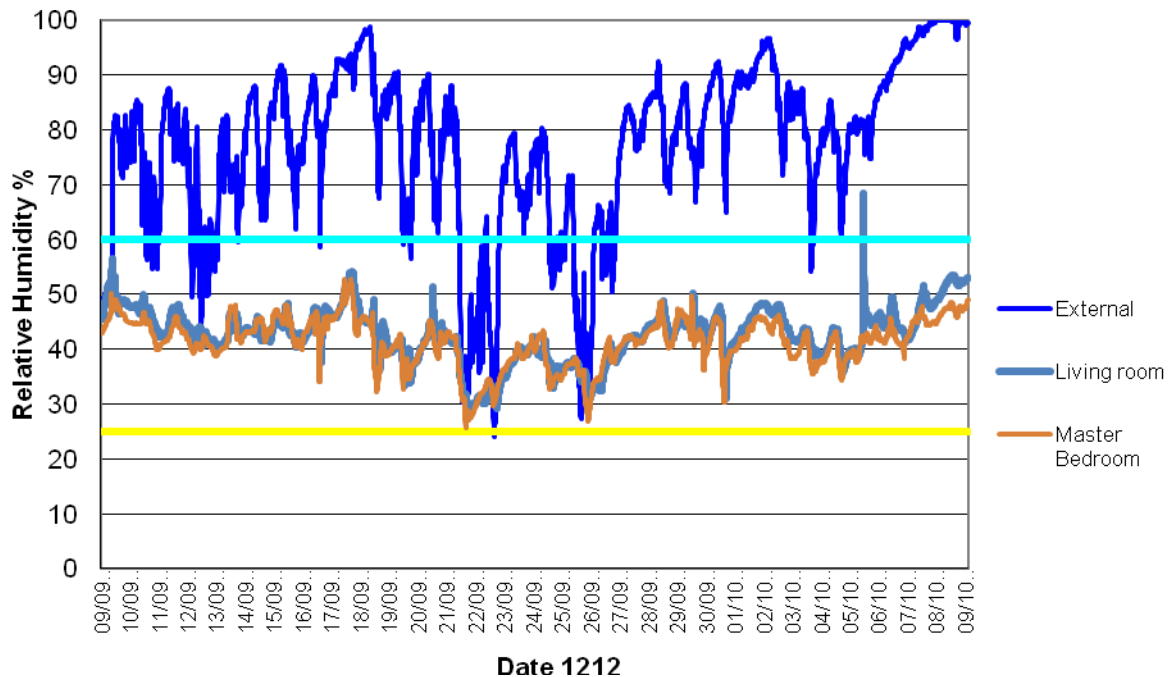
Figure 14. Relative Humidity (%) as measured in situ 09.09.12 – 09.10.12
