Whitman, Christopher J. 2014. Heritage Earth Construction and Hygrothermal Comfort: The Challenge of Rebuilding in Central Chile. *Key Engineering Materials* 600 , pp. 186-195. [10.4028/www.scientific.net/KEM.600.186](https://doi.org/10.4028/www.scientific.net/KEM.600.186)

# Heritage earth construction and hygrothermal comfort: The challenge of rebuilding in Central Chile

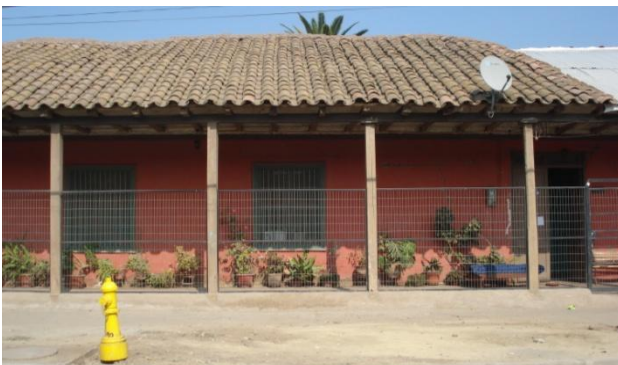
As part of the research project “*Restauración y reconstrucción de viviendas de adobe en el valle de Colchagua; Un desafío técnico y patrimonial,*” dry bulb temperatures, relative humidity and internal radiant surface temperatures were measured on the 25th April 2012 in two surviving adobe dwellings, Casa Enrejada (fig. 4) and Casa Pampa de Lima (fig. 5). The results of these measurements are presented below.

Figure 4: Casa Enrejada, Chépica, VI Region Chile.

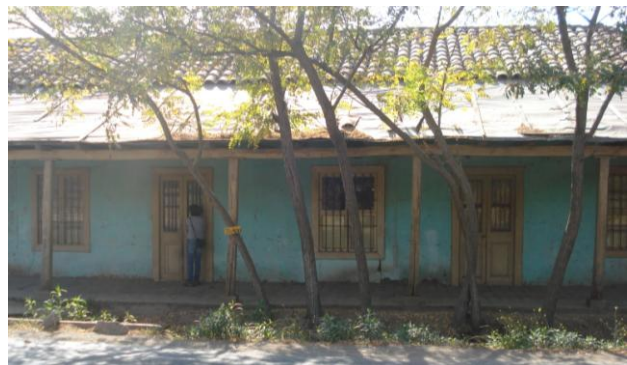
Figure 5: Casa pampa de Lima, Chépica, VI Region Chile

**Density of Adobe from Casa Pampa de Lima Chépica.** Samples of adobe and earthen renders were taken from the Casa Pampa de Lima, one of the adobe dwellings. The samples were then cut into regular blocks, measured and weighed. With these measurements their density was calculated. (Table 2.)

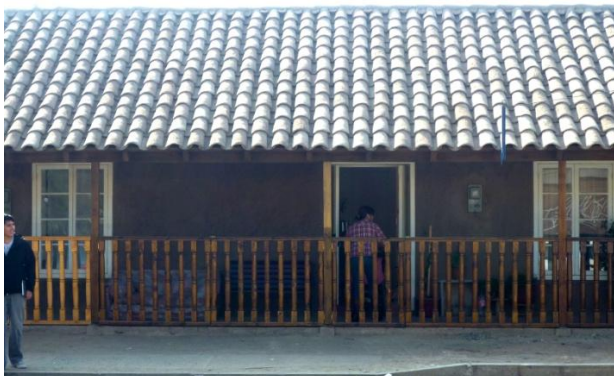
As part of the reconstruction work following the earthquake the architects Patricio Larraín and Eduardo Rodway have been working with state funds on the rebuilding of dwellings in Chépica and the neighbouring villages of Lolol and Auquinco. The designs by the architects use earth rendered straw bales in place of adobe to maintain the thick-walled architectural tradition. The straw bales are used as infill between a post and beam timber frame. The timber frame complies with the Chilean standard for the seismic design of buildings NCh 433 Of.96. The rear walls of the dwellings are of mineral wool insulated timber frame construction. Straw bale was not used for the rear walls due to pre-envisaged occupant extension of the properties following official hand-over. Although state funded projects normally demand the use of conventional or certified building materials, straw bale was in this case accepted due to special dispensations arising from the projects' locations within designated "heritage polygons". Dry bulb temperature, relative humidity and radiant temperature readings were recorded in one of these projects in the neighbouring village of Auquinco also on the 25<sup>th</sup> April 2012. The owners of this dwelling have extended the house using un-insulated reinforced concrete construction. When questioned as to their choice of building material they expressed the opinion that concrete was more "solid" than the straw bale construction and acknowledged that the thermal properties of the material had not been a consideration. The presence of the two construction techniques in the same dwelling provided the possibility of comparative measurements.

Figure 6: Dwelling rebuilt with straw bales, Chépica, VI Region, Chile.
