The Challenge of Sustainable Tourist Infrastructure in the Araucania Andina, Chile

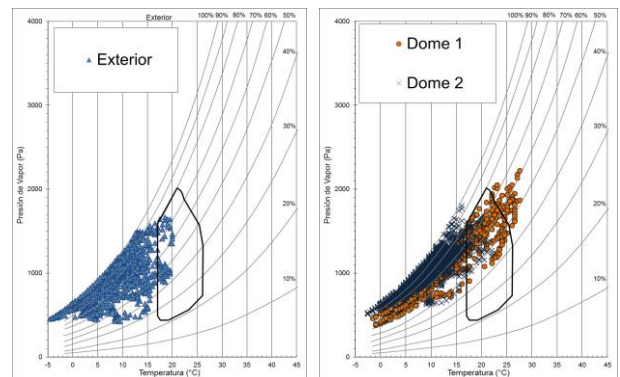
Figures 4&5 show that the relative humidity in the domes is constantly high and is at times higher than the outdoor levels. The readings for Dome 2 rarely fall within the hygrothermal comfort zone.

Figure 4: Psychrometric chart of outdoor air temperature and relative humidity.

Figure 5: Psychrometric chart of indoor air temperature and relative humidity domes 1 and 2

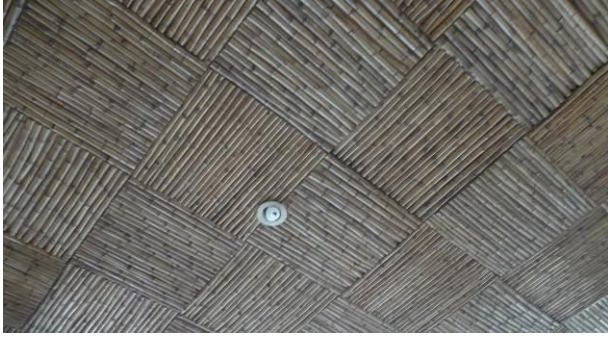
Establishment F: In general both dry bulb temperature and relative humidity readings during winter months fall within the comfort zone in this establishment heated by only one wood burning stove. This clearly illustrates the advantages of insulating the walls and double glazing the windows. The main problem identified by both the measurements and the owners is the overheating of the second floor during summer. This could be reduced by insulating the roof and the introduction of a ventilated roof space. Exploring the use of the endemic bamboo colihue as an insulating internal finish could be interesting to explore, especially as some ceilings are already treated in this way (fig.9). Research by the authors, presented in the paper “Natural fibre insulation in rural southern Chile,” at this congress, shows that colihue has a coefficient of thermal conductivity of 0.161W/mK.

Figure 9: Colihue an endemic bamboo as internal finish. Establishment F
