COMPARATIVE LABORATORY PERFORMANCE CHARACTERISATION OF SILICONE RUBBER TEXTURED INSULATORS

Thesis submitted to Cardiff University

DOCTOR OF PHILOSOPHY

ADVANCED HIGH VOLTAGE ENGINEERING RESEARCH CENTRE

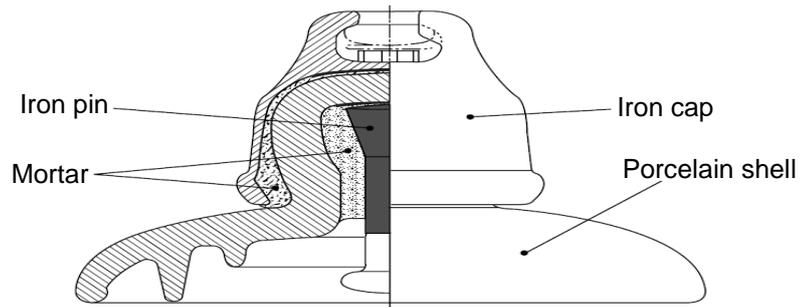
Figure 2-1: Standard design cap-and-pin porcelain insulators.

material. Therefore, the insulator is mechanically solid and has a good resistance surface against corrosion [2-2, 2-5, 2-6]. Figure 2-1 shows a typical standard profile of a cap-and-pin porcelain insulator, with the main components of a glazed porcelain shed and metal cap-and-pin, which are all embedded together with the mortar [2-7]. The insulators are joined in series to achieve a string. The number of units used in the string varies based on the system voltage.

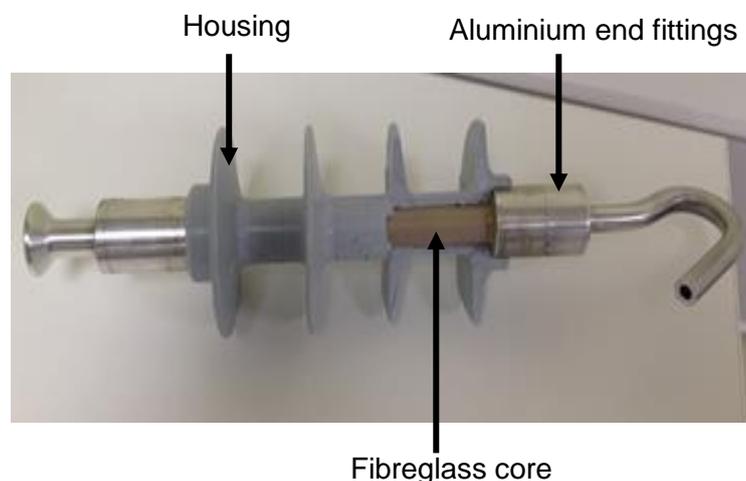
Figure 2-4: Cross-section of 11kV silicone rubber insulators.

- 1- The fibreglass reinforced core, which is an internal part of a polymeric insulator, is intended to provide the mechanical strength.
- 2- The metal end fittings are usually forged steel or aluminium alloy and are selected to convey the mechanical load to the core. Their shape is very important to limit the corona discharges that cause the polymeric material to become fragile and possibly to crack, thereby, damaging the insulator due to moisture ingress into the fibreglass core [2-26].
- 3- The housing, which is the external part of the core, consists of weather sheds and a sheath. The weather sheds provide the required leakage distance, and the sheath is an insulating material between the core and the weather sheds.

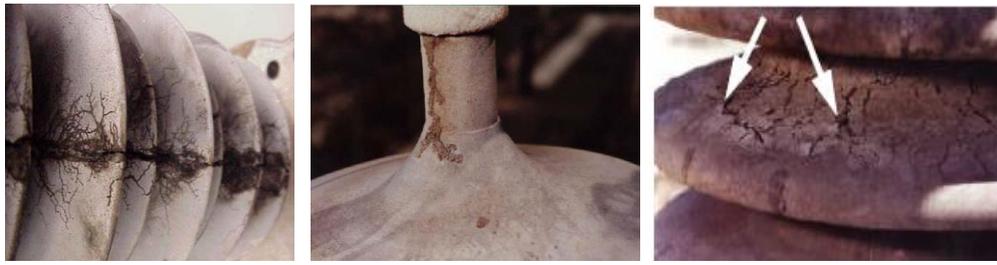
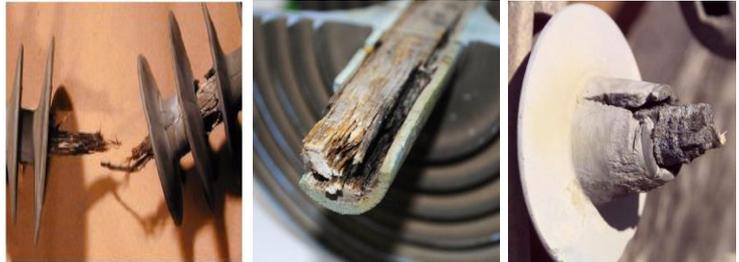
(a) Tracking

(g) Puncture

(h) Brittle fracture

- Puncture: hole in the insulator sheds or/and shank/sheath. See Figure 2-7(g).
- Brittle fracture: this leads to mechanical degradation of the fibreglass core rod and is characterised by some smooth fracture surfaces. This failure mode is attributed to an attack by nitric acid generated by corona discharge activity in a moist environment [2-94]. The exact source of the acid has been a topic of much debate. However, it is now thought [2-94] that the brittle fracture may be due to a combination of factors and is not always described by a single mechanism. See Figure 2-7(h).

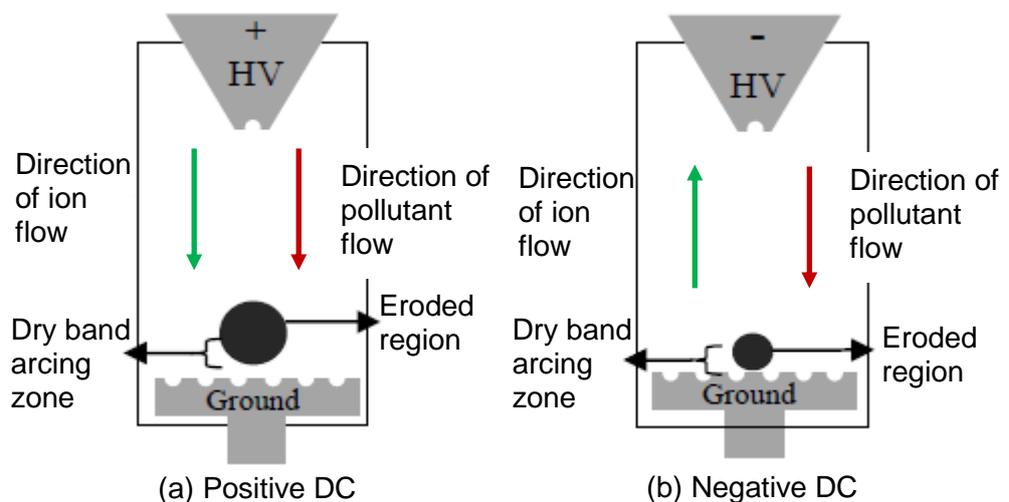
Figure 2-8: Model of the IP test setup illustrating the flow direction of for the contaminant and the ion under (a) positive DC and (b) negative DC voltages [2-82].

Energy dispersive X-ray (EDX) studies on samples tested under positive DC have shown a migration of conductive ions from both the pollutant and the electrodes. This may have resulted in an increase in the surface conduction, and, therefore, a higher leakage current in the case of positive DC. In contrast to the observations under positive DC, no ion migration was observed for the samples under negative DC [2-82]. This migration of ions under positive DC excitation may be due to electrolysis, as suggested by Bruce et al. [2-84]; they demonstrated that there is a definite relationship between the electrode erosion and the cumulative charge under positive DC. The presence of ions in the event of positive DC can be clarified as follows. The normal condition for electrolysis process is that both electrodes should exist in an ionic solution. This condition is satisfied to a certain degree in this case since there is a certain electrode-pollutant interface close to the HV electrode. However, near the ground electrode, this interface is sporadic. Significant heating due to the dry band arcing may lead to evaporation of the contaminant near the ground electrode. The direction of ion flow and pollutant flow for both DC voltage polarities is shown in Figure 2-8.

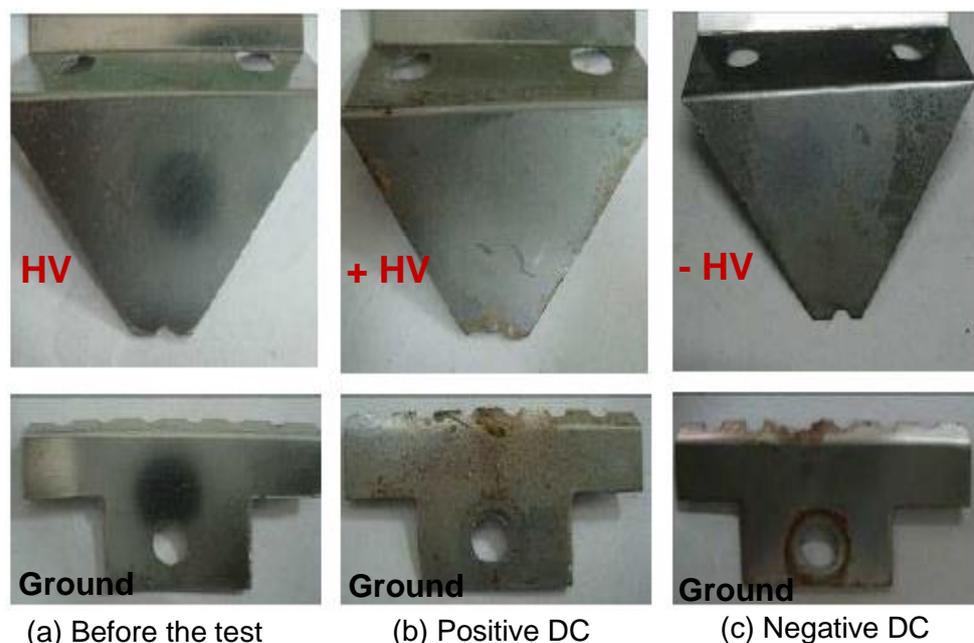
Figure 2-9: Captures of the electrodes (a) before the IP test, (b) after seven hours of IP test under positive DC, (c) after seven hours of IP test under negative DC [2-82].

Under negative DC, the ion has to be released from the ground electrode, but because of the strong arcing, this region is entirely dry. Since there is no interfacing between the electrode and the pollutant, the ion is unable to flow into the solution. Therefore, the electrolysis process will not occur under negative DC. Figure 2-9b illustrates the erosion of the HV electrode surface under positive DC, which is correlated to the gradual removal of the electrode surface into the solution due to the electrolysis process, while Figure 2-9c shows that under negative DC, the erosion is caused more by oxidation than by electrolysis. It seems that the probability of electrolysis under negative DC excitation is very limited. In addition, as there is no migration of ions under this case, the leakage current is much less, and so a better tracking and erosion resistance is observed in the samples under negative DC [2-82]. However, the ground electrode was seen to be eroded under negative DC. This could be due to the oxidation of the electrode as a consequence of the intense arcing that occurs close to the pit.

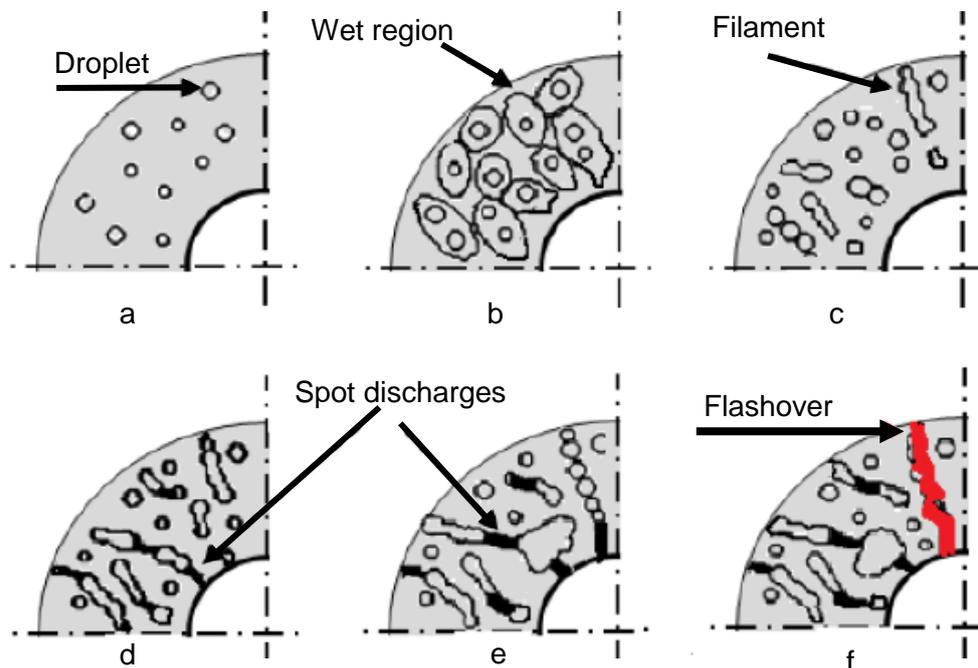
Figure 2-10: Flashover development on SiR insulators [2-88].

along the surface of the conductive layer and causes flashover, as demonstrated in Figure 2-10f.

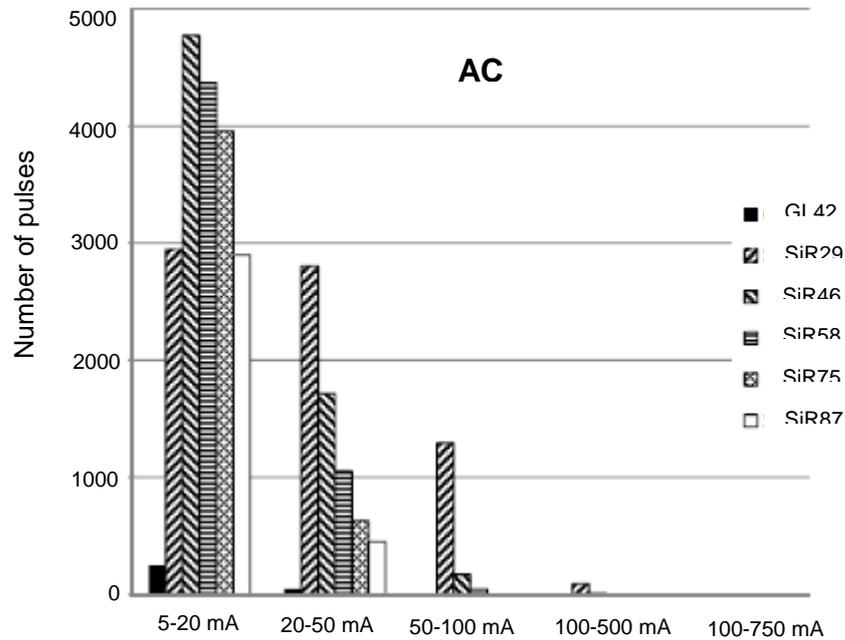
Figure 2-12: AC leakage current bin count data for tested insulators during a period of 150 days [2-83].

recorded at the sampling rate of 2 kHz, i.e 40 samples per 50 Hz cycle. The data was then post-processed and saved every 10 minutes. As can be seen in Figures 2-12, 2-13, 2-14, the highest leakage current of each test insulator was analysed and stored into bin classes at the termination of the test period.

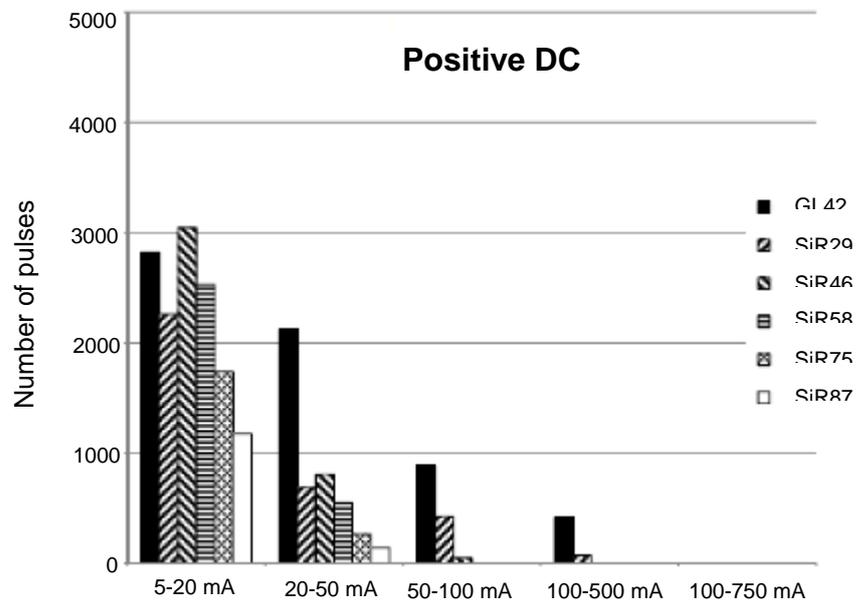
Figure 2-13: Positive DC leakage current bin count data for tested insulators during a period of 150 days [2-83].

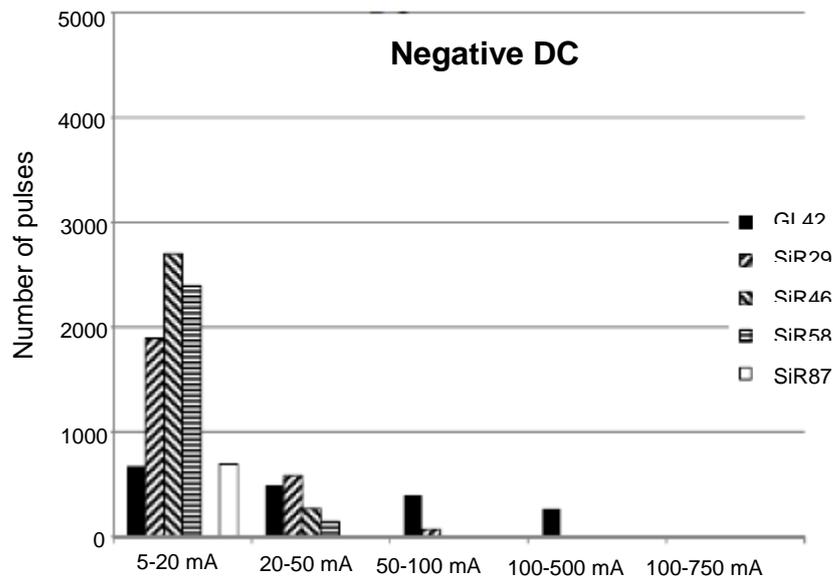
Figure 2-14: Negative DC leakage current bin count data for tested insulators during a period of 150 days (Note that data for the insulator SiR 75 are not presented) [2-83].

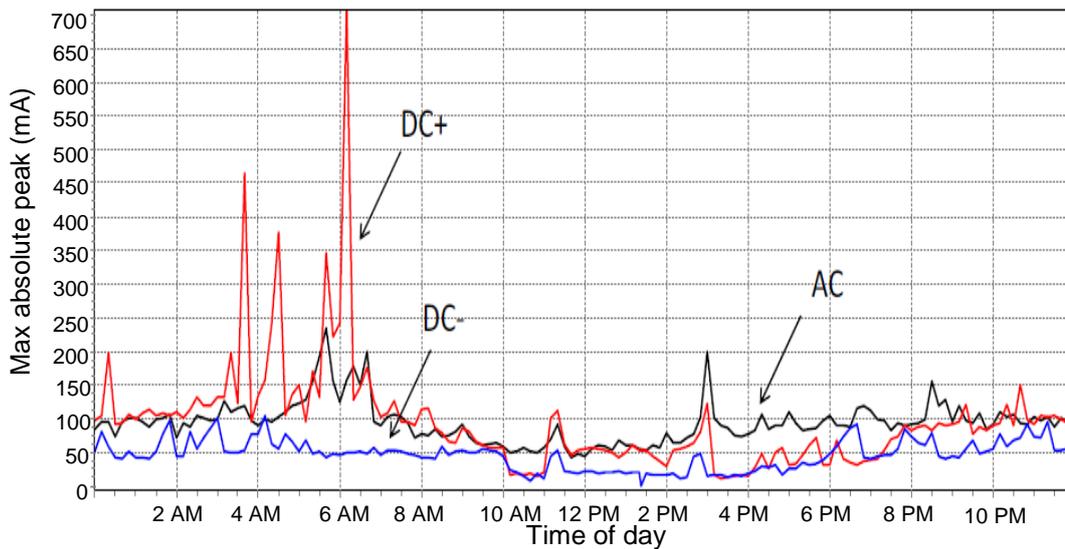
Figure 2-15: Time of day average of 10 minutes peak leakage currents for insulator SiR 29 for test period of 150 days [2-83].

Figures 2-15 and 2-16 show the peak of leakage currents for insulators SiR 29 and SiR 87, computed per 10 minutes interval for a complete day [2-83]. The values on the Figures were recorded by calculating the average of the peak leakage current for each instant. The highest leakage currents observe at 6 AM. The positive DC leakage current was the highest during the early morning time.

For the both silicone rubber insulators (SiR 29 and SiR 87), the positive leakage current exceeds the negative DC current. This result is also confirmed by the finding results obtained in the Figures 2-13 and 2-14 and also by the peak waveforms of the leakage current during a pollution event as shown in Figure 2-17. For silicone rubber insulator SiR 87, in comparison to the shorter SiR 29 insulator, the AC peak leakage current exceeds the positive DC current [2-83].

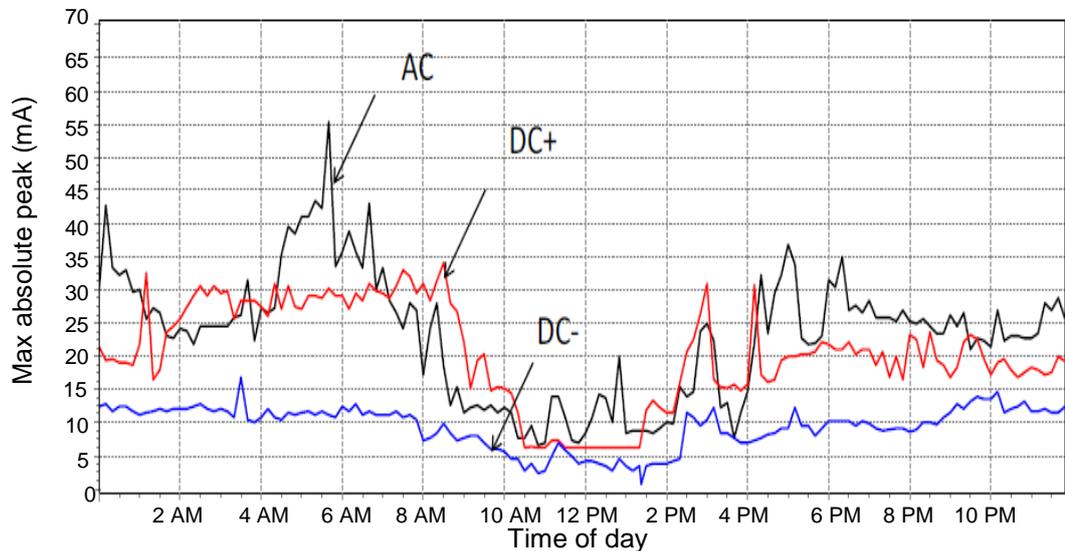
Figure 2-16: Time of day average of 10 minutes peak leakage currents for insulator SiR 87 for test period of 150 days [2-83].

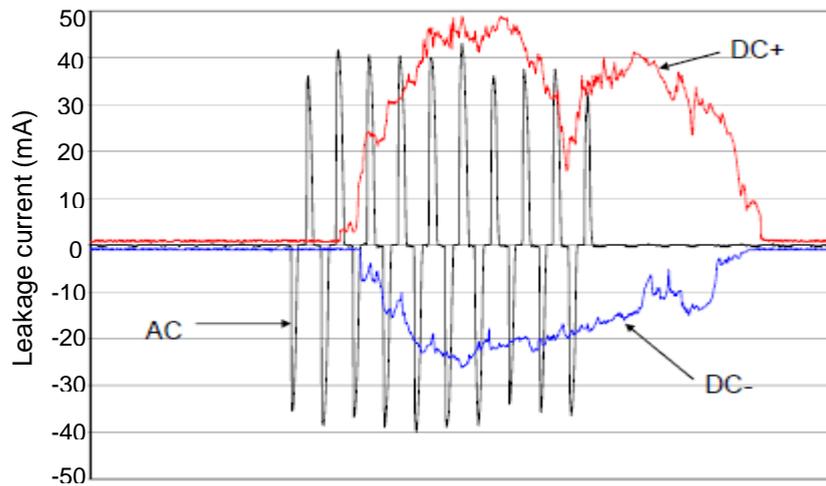
Figure 2-17: Peak current waveforms for SiR 87 insulator during a pollution event [2-83].

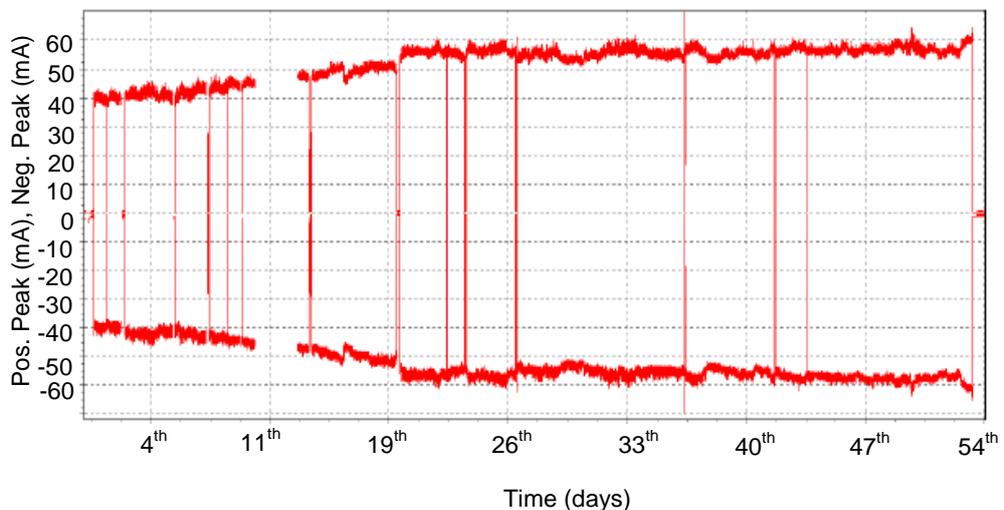
Figure 2-18: Maximum leakage current of the SiR insulator under AC [2-119].

An interesting result found is that on the SiR insulators, the leakage current of the positive polarity DC was higher than that of the negative polarity DC [2.83]. This result is also confirmed in [2-119] by using the rotating wheel dip tests. The test was conducted on the SiR sample has a unified specific creepage length of 28 mm/kV. The test was approximately 7 weeks and the SiR sample was evaluated at the end of the test. The current traces recorded under AC, positive DC and negative DC voltages are shown in Figures 2-18 and 2-19. The highest leakage current value measured was 150 mA for the positive DC. While for the negative DC and AC cases, the maximum leakage current value was only 110 mA and 60 mA respectively [2-119].

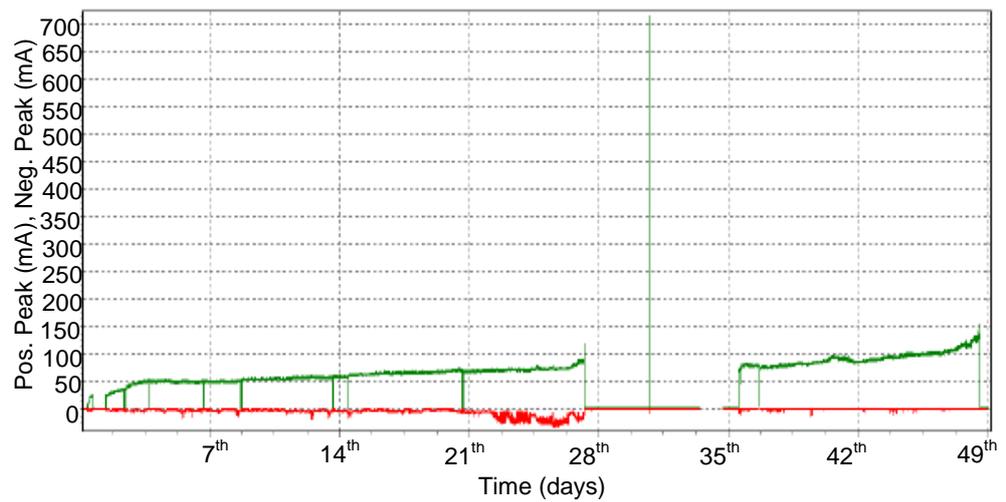
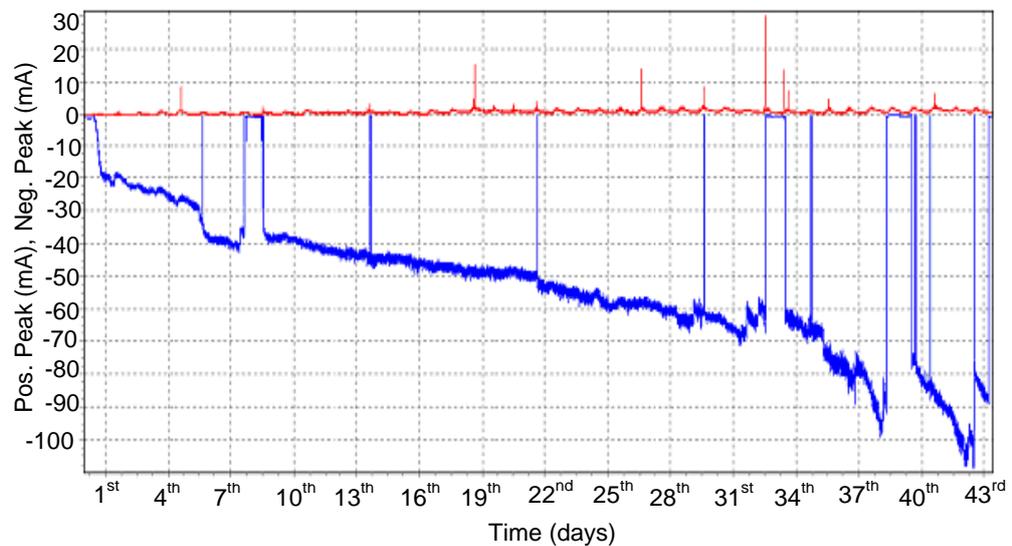
(a) Positive DC

(b) Negative DC

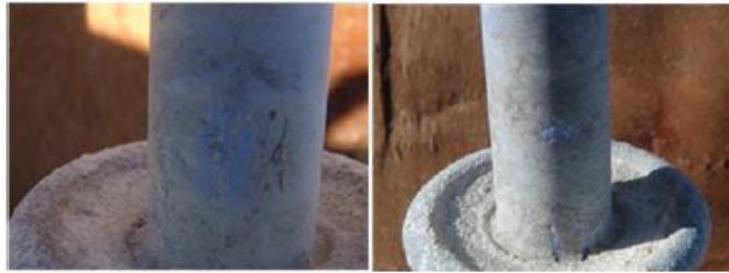
(a) Erosion AC (Week 22)

For electrical discharge observations, both corona and dry band discharge activities mainly occurred on the sheds interfacing with both the high voltage and ground electrodes for all the SiR insulators [2-83]. These observations are particularly interesting in correlation with the finding of erosion detected on the tested insulators as shown in Figures 2-18. The measurement of hydrophobicity illustrated the upper surface of the sheds of the SiR insulators to be more hydrophobic than the bottom [2-83]. The rods of the longer insulators were also more hydrophobic than those of the shorter insulators. Hydrophobicity recovery was also faster for DC insulator surfaces than on the AC [2-83].

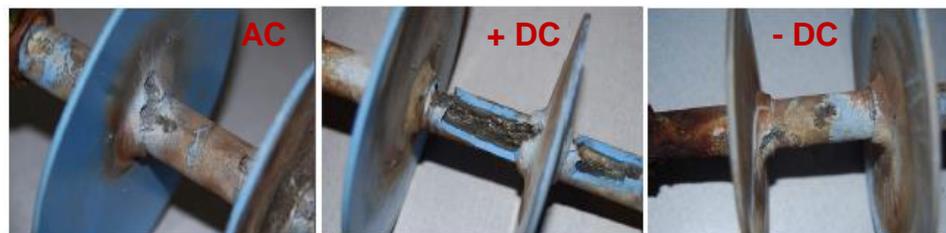
(a) Shed puncture after 920 h

As expected, significant erosion was observed on the rods near to the metal end fittings, though some cases were also noticed in the central parts of the longer insulators. For all insulators with all voltage types, the lowest erosion was observed on the SiR 29 insulator. This unexpected result might be related to the stationary nature of discharges, connected with the small leakage current range. This suggestion is supported by the fact that leakage current on SiR 29 in the range of 5-20 mA are less frequent than on others insulators. In general, SiR insulators were severely eroded when energised by positive DC voltage [2-83]. This severity of DC testing compared with the AC was also confirmed in [2-119]. The amount of erosion on the SiR insulator under positive DC was being the worst over all voltage classes (Figure 2-21).

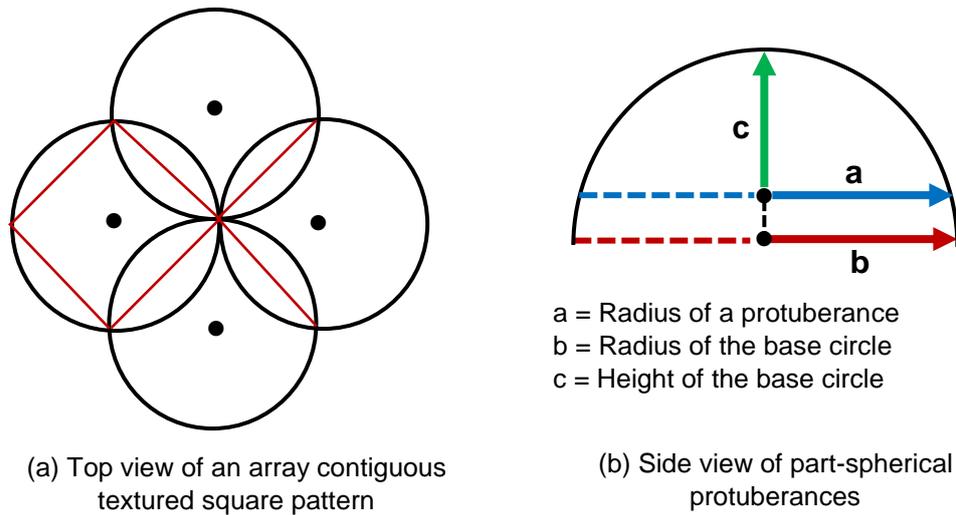
Figure 3-1: Hemispherical protuberances: square-intersection pattern [2-25].

With the aim of improving the pollution performance of polymeric insulators, a novel approach to controlling dry-band formation using a textured pattern design was investigated in [2-24, 2-25]. The geometrical pattern of textured insulators can achieve two valuable objectives; firstly, a substantial increase in the surface area can reduce the leakage current density in the susceptible shank region, and secondly, the textured surface increases the longitudinal creepage distance, which can, therefore, decrease the field stress, in particular areas of the insulator [2-23, 3-3, 3-4]. The textured samples comprised an array of hemispherical protuberances moulded with a square intersection of 4 mm or 6 mm in diameter, as illustrated in Figure 3-1.

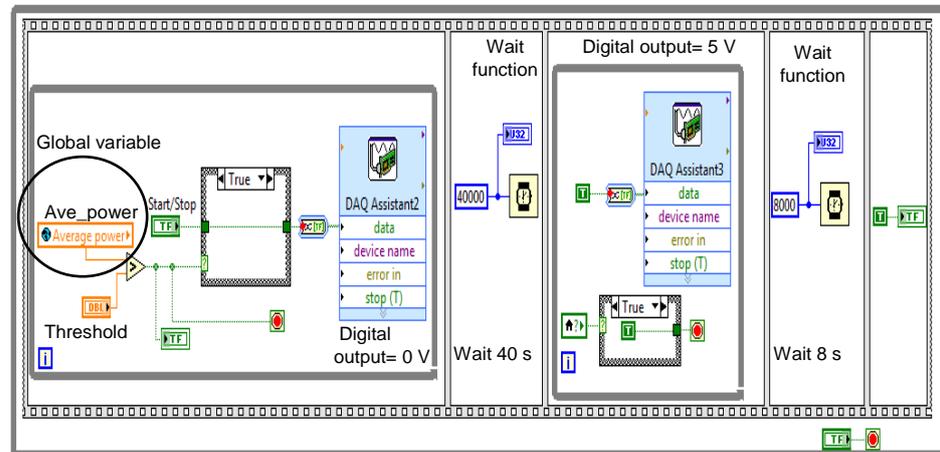
Figure 3-9: The graphical LabVIEW program of the motor control of RWDT.

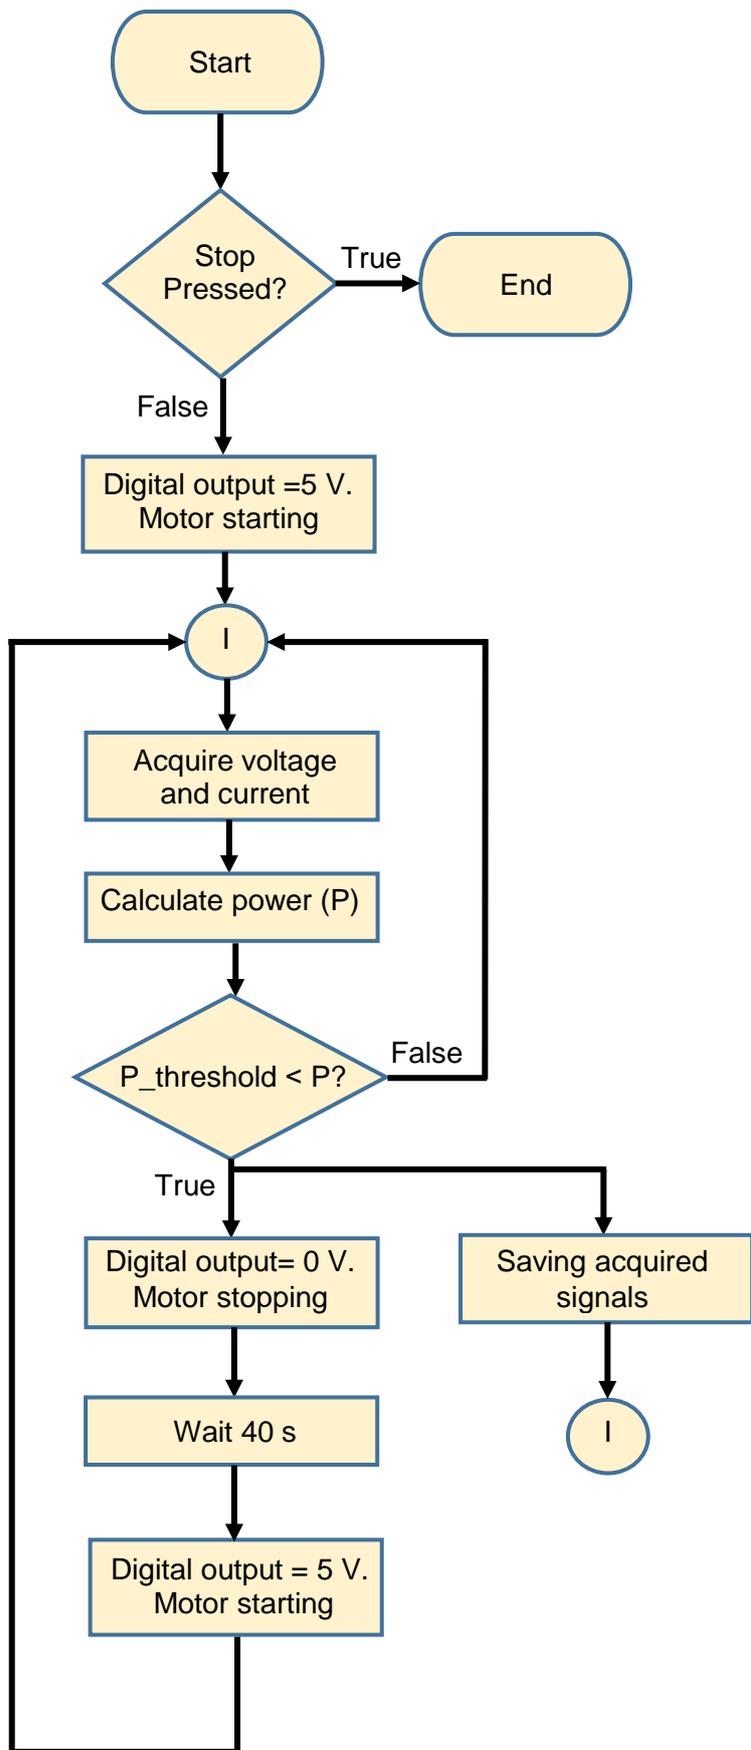
Figure 3-10: Flow chart of the motor control program.

determine the optimal threshold value required to stop the motor. Figure 3-10 shows clearly the flow chart of the motor control program and how it communicates with the main data acquisition system.

- a) The global variable value of the instantaneous power is created to interface both programs, and through this value, it is possible to check whether the motor has to be stopped.
- b) When the insulator rotates between the two positions, the program outputs a digital pulse of 5 V, and the average power value is under the threshold level.
- c) While the insulator is in a perpendicular position, where it is energised, the average power value exceeds the threshold level and the digital output of the program is carried down at 0 V, thus driving the motor to stop.
- d) Once the motor has stopped, the global variable of the average power is set to true, thus allowing the DAQ system to run. After 40 s, a pulse of 5 V is sent again to activate the motor and rotate the insulator to the next position.

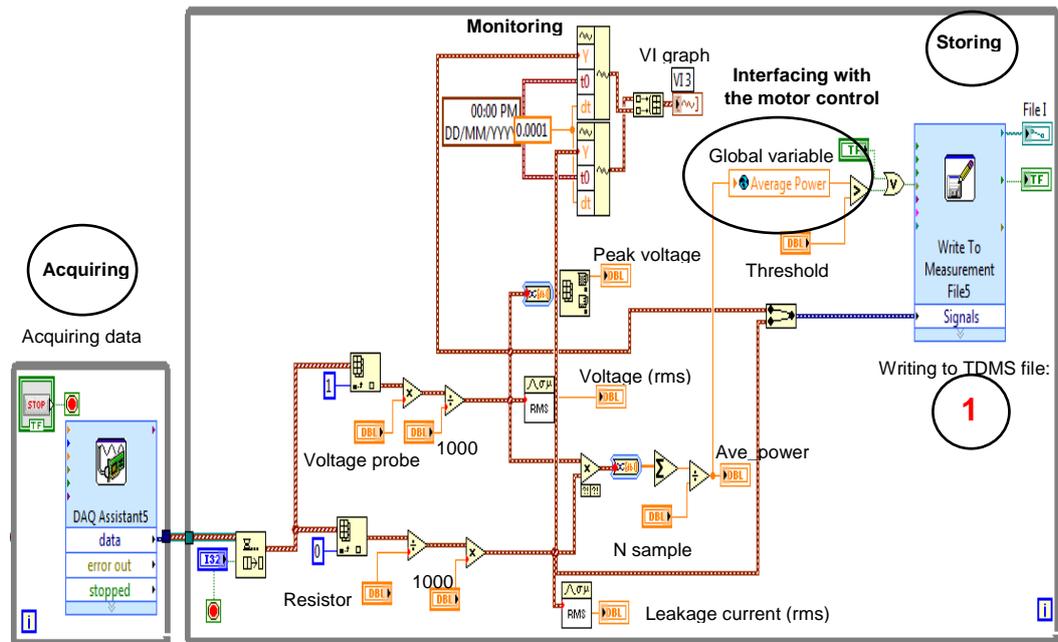
Figure 3-11: The LabVIEW block diagram code for acquiring, monitoring and saving the leakage current and applied voltage signals.

Data were saved in sets of 200 samples, which represent one cycle of the 50 Hz voltage and current waveforms. The acquisition of samples was repeated until all 4×10^5 samples had been processed and, then, the next file was accessed. Each acquired file represented the saving data of one wheel revolution.

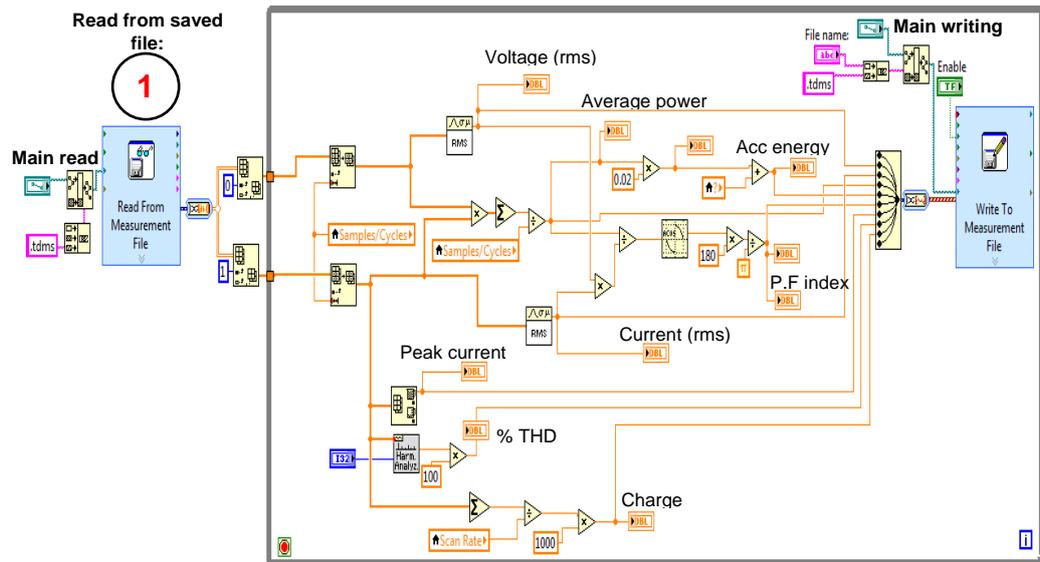
Figure 3-12: The post-processing LabVIEW programming code: analysing and storing functions of the electrical properties.

The post-processing LabVIEW program was developed to read and analyse the data acquired from the RWDTs and the fog chamber tests. The block diagram of the software user is shown in Figure 3-12. The program allows the user to choose the path from which to read the saved files and determines a specific path for the calculated parameters. The code is also responsible for specifying the electrical characteristics to be analysed. The electrical parameters, such as the peak and root mean square (rms) leakage current of the applied voltage, average power dissipation, total harmonic distortion (THD), power factor angle, and absorbed energy are calculated. Studying the behaviour of these parameters helps to evaluate the performance of SiR insulators and material degradation under test conditions.

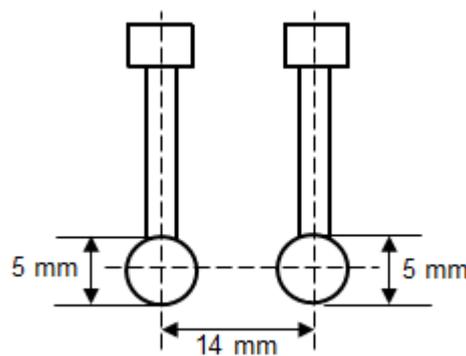
(a) Spherical electrodes [3.9]

The device was built in [3-13] according to IEC 60507 standards to evaluate the local surface conductance of the pollution layer and to check its uniformity on the insulator surface [3-9]. The possible arrangement of this device is described by a conductance meter with two spherical electrodes built as illustrated in Figure 3-13. The electrodes were made of stainless steel pins 5 mm in diameter with a distance of 14 mm between their centres. The pins were spring-loaded so they could be pushed by hand against the insulator surface. The spring force at full compression was approximately 9 N.

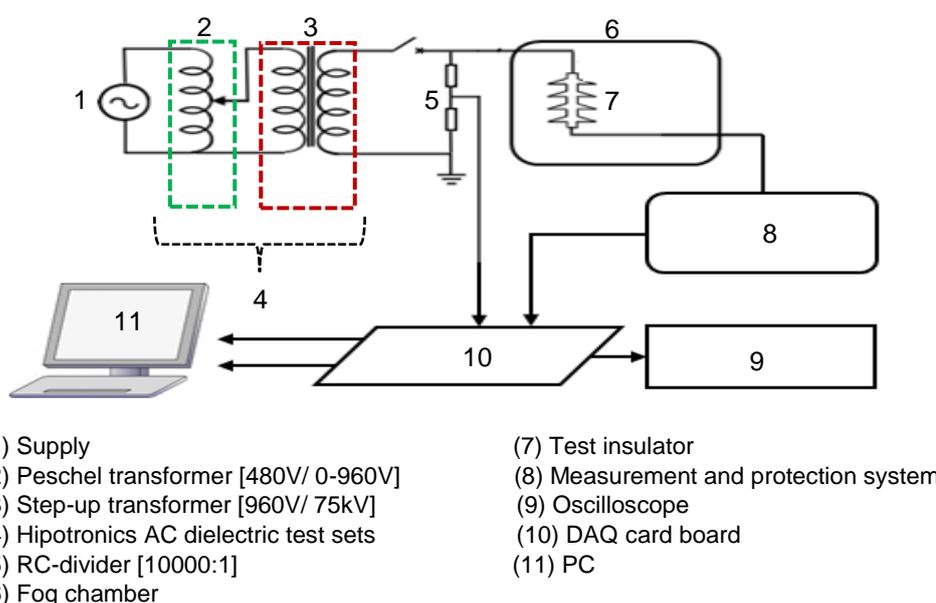
Figure 3-15: The test circuit diagram of fog chamber.

The current measurement and protection consists of a leakage current measurement resistor (selected from values of 4700 Ω , 1140 Ω or 94 Ω) with shunt branches of back-to-back high power Zener, Schottky diodes and gas discharge tube, which together suppress any overvoltage that might occur and protect the data acquisition card (DAQ). The data acquisition system monitors and records the voltage and leakage current waveforms using a developed LabVIEW program on a personal computer.

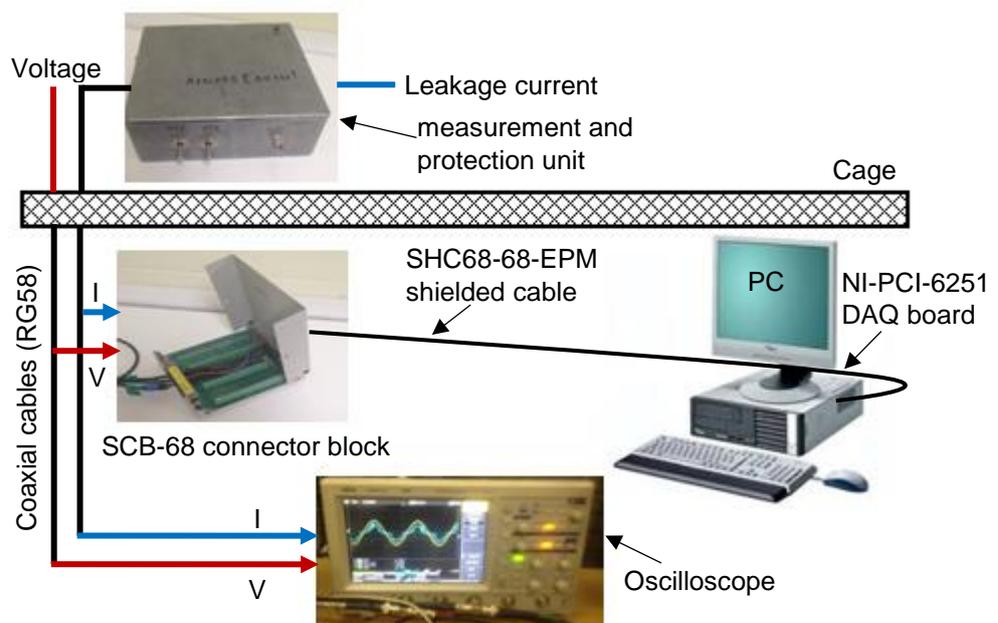
Figure 3-16: Arrangement of data acquisition system.

A data acquisition (DAQ) system program that acquires, monitors, and stores the waveforms of leakage current and voltage applied signals was built based on the NI-LabVIEW platform. The program received the digitised data by an NI-PCI-6251 data acquisition board with the assistance of an SCB-68 connector block, as illustrated in Figure 3-16. The DAQ board was fixed to a personal computer (PC). The connection between the SCB-68 connector and the DAQ board was achieved using an SHC-68-68-EPM shielded cable. The selected sampling rate was 10^4 for both DAQ card channels, which acquired leakage current and voltage signals. The signals were then saved in sets, as each cycle of 50 Hz consisted of 200 samples. The acquisition of samples was repeated until all 6×10^4 samples had been stored; then, the next file was opened. As these stored samples were segments of leakage current and voltage waveforms, an appropriate post-processing software program was used to analyse and assess the data recorded during the test. The program features and the electrical parameters calculated were clearly described in section 3.4.5c.

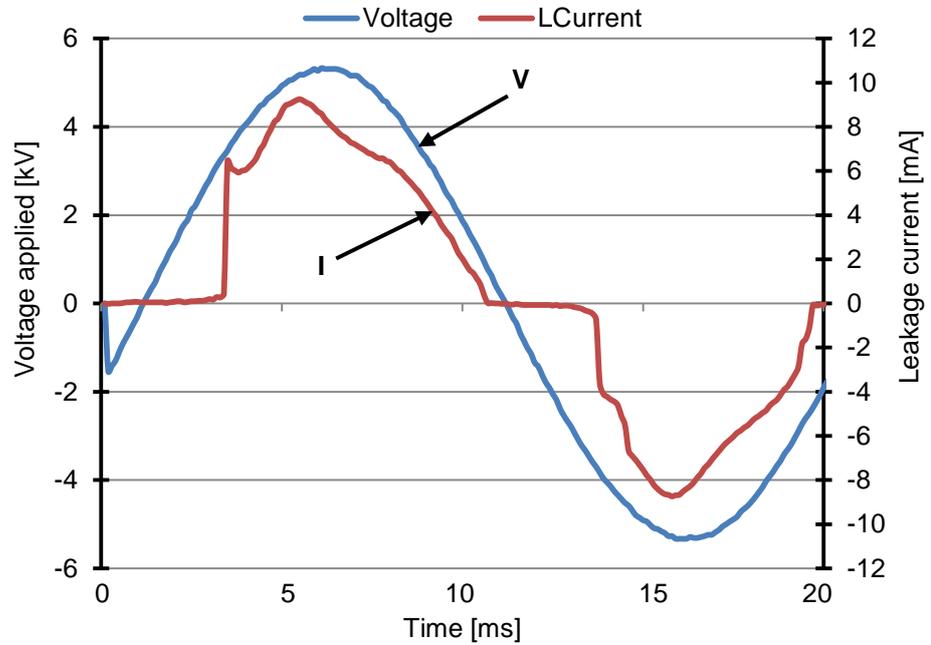
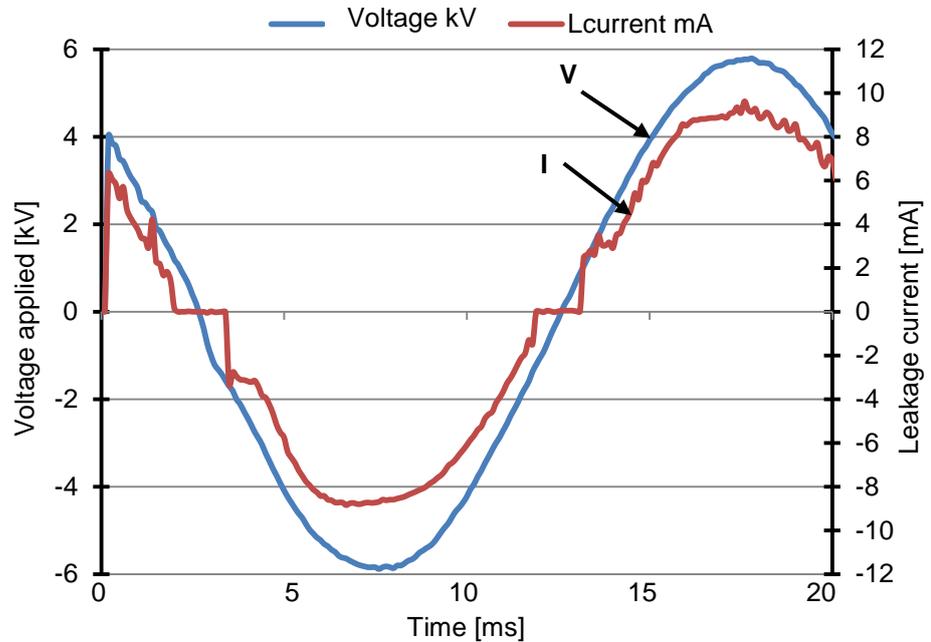
(a) Conventional insulator

(b) Textured insulator

When the formation of dry band arcing occurs, this can be seen in the current waveform of the conventional insulator by the steps at 3.5 ms. This waveform is similar to that observed in [3-11, 4-4]. In the case of a textured surface, the discharge activity is much lower, and a mostly conductive behaviour is observed.

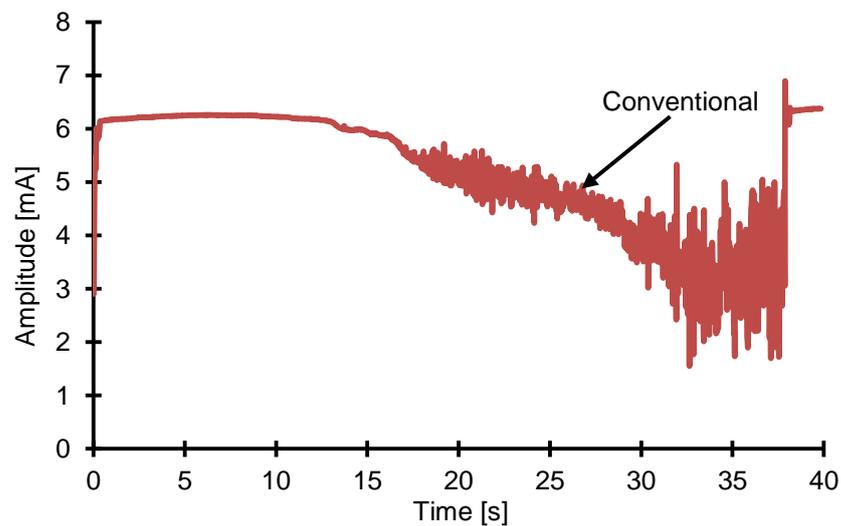
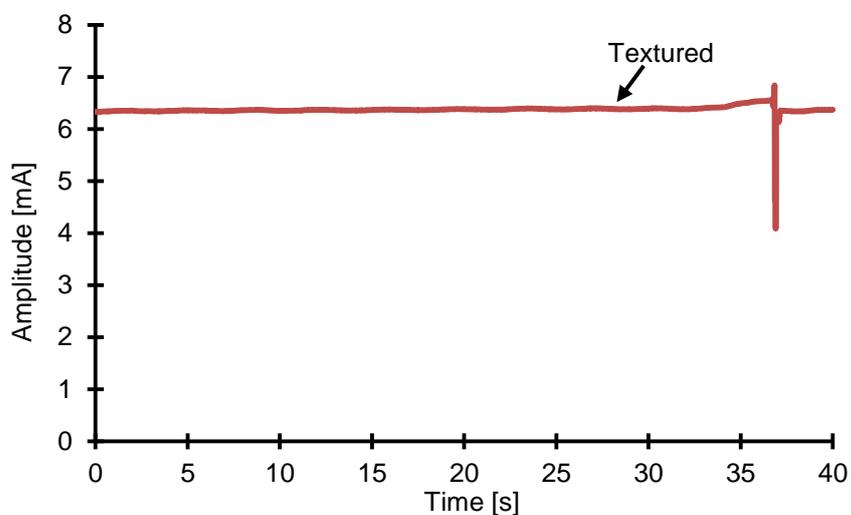
(a) Conventional insulator

(b) Textured insulator

Figure 4-3 shows the typical shapes of RMS leakage current measured for the tested insulators. As described earlier, each insulator was energised for a period of 40 s. For the conventional insulator, the wet surface dried over time due to the dripping of water and Joule heating. Non-uniform discharge activity caused heavy arcing and further drying. This drying progression was accompanied by a fall in the leakage current magnitude reaching to 3 mA at the end of the energisation period. For the textured insulator, a continuous thin conducting layer was maintained. Discharge activity was limited on the surface, and the magnitude of leakage current was slightly reduced.

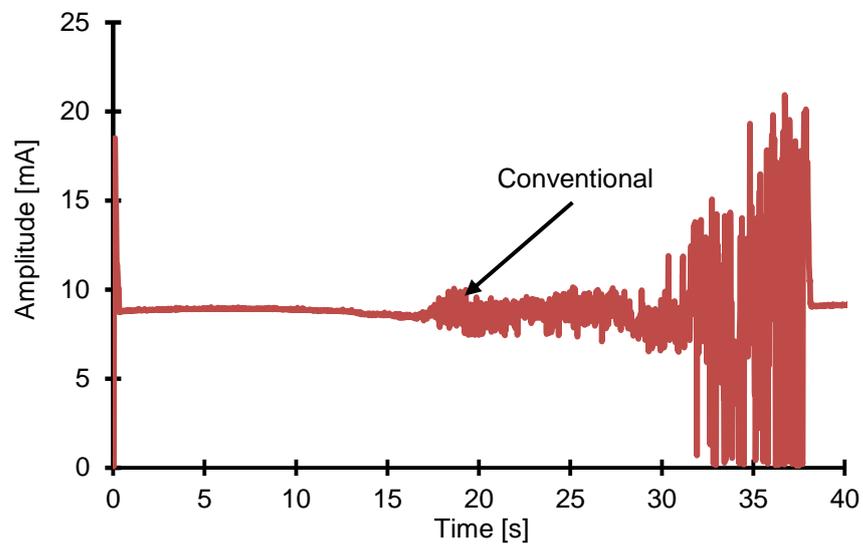
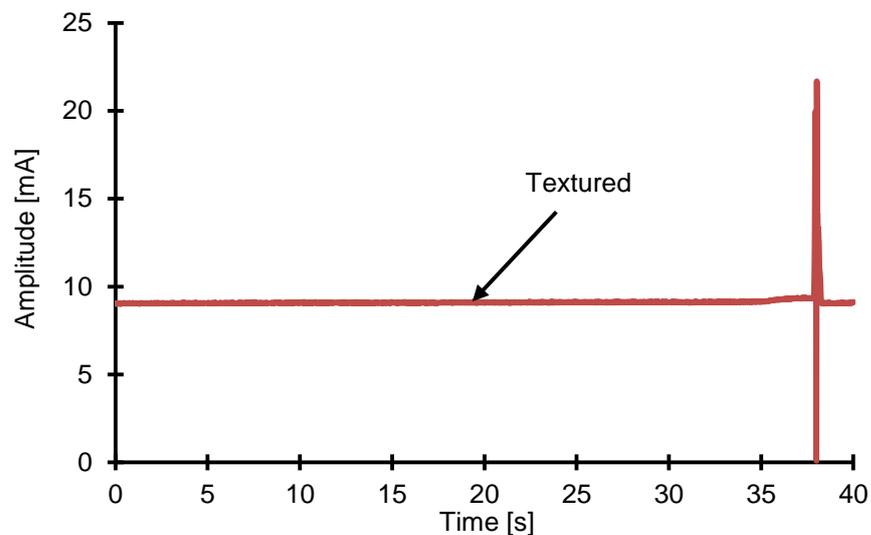
(a) Conventional insulator

(b) Textured insulator

As can be seen in Figure 4-4, the typical variation of the absolute peak magnitude of leakage current was measured for the two insulators. The average peak current magnitude for both insulators was approximately 8 mA. It is obvious that on a conventional insulator, there are significant variations in current magnitude due to intermittent discharge activity reaches up to 18 mA at the termination of a 40 s period. In contrast, the textured insulator exhibits very little evidence of discharge activity.

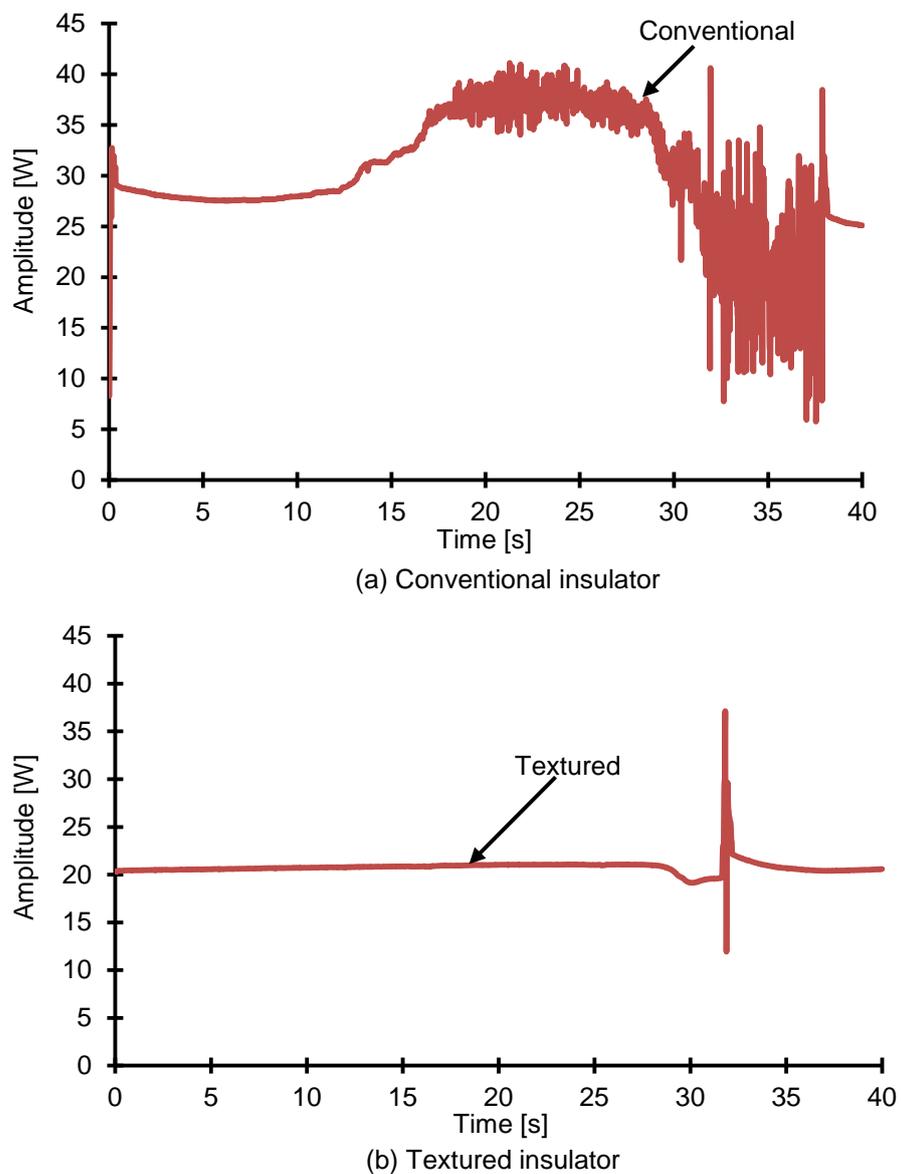
Figure 4-5: Average power dissipated by conventional and textured insulators.

Figure 4-5 illustrates the average power dissipated on the surface of the test insulators during the 15th wheel revolution. It can be seen that the power dissipation for the conventional profile increases significantly until it reaches the initial peak value of 40 W after 20 s. However, with a textured profile, the trend of the shape is mostly constant with a lower value of power dissipation about 20 W. After the initial peak of the conventional surface, the dissipated power decreases gradually and significant distortion is observed during this period. This distortion is caused by the increasing discharge activity occurring on the insulator surface.
