COMPARATIVE LABORATORY PERFORMANCE CHARACTERISATION OF SILICONE RUBBER TEXTURED INSULATORS

Thesis submitted to Cardiff University

DOCTOR OF PHILOSOPHY

ADVANCED HIGH VOLTAGE ENGINEERING RESEARCH CENTRE

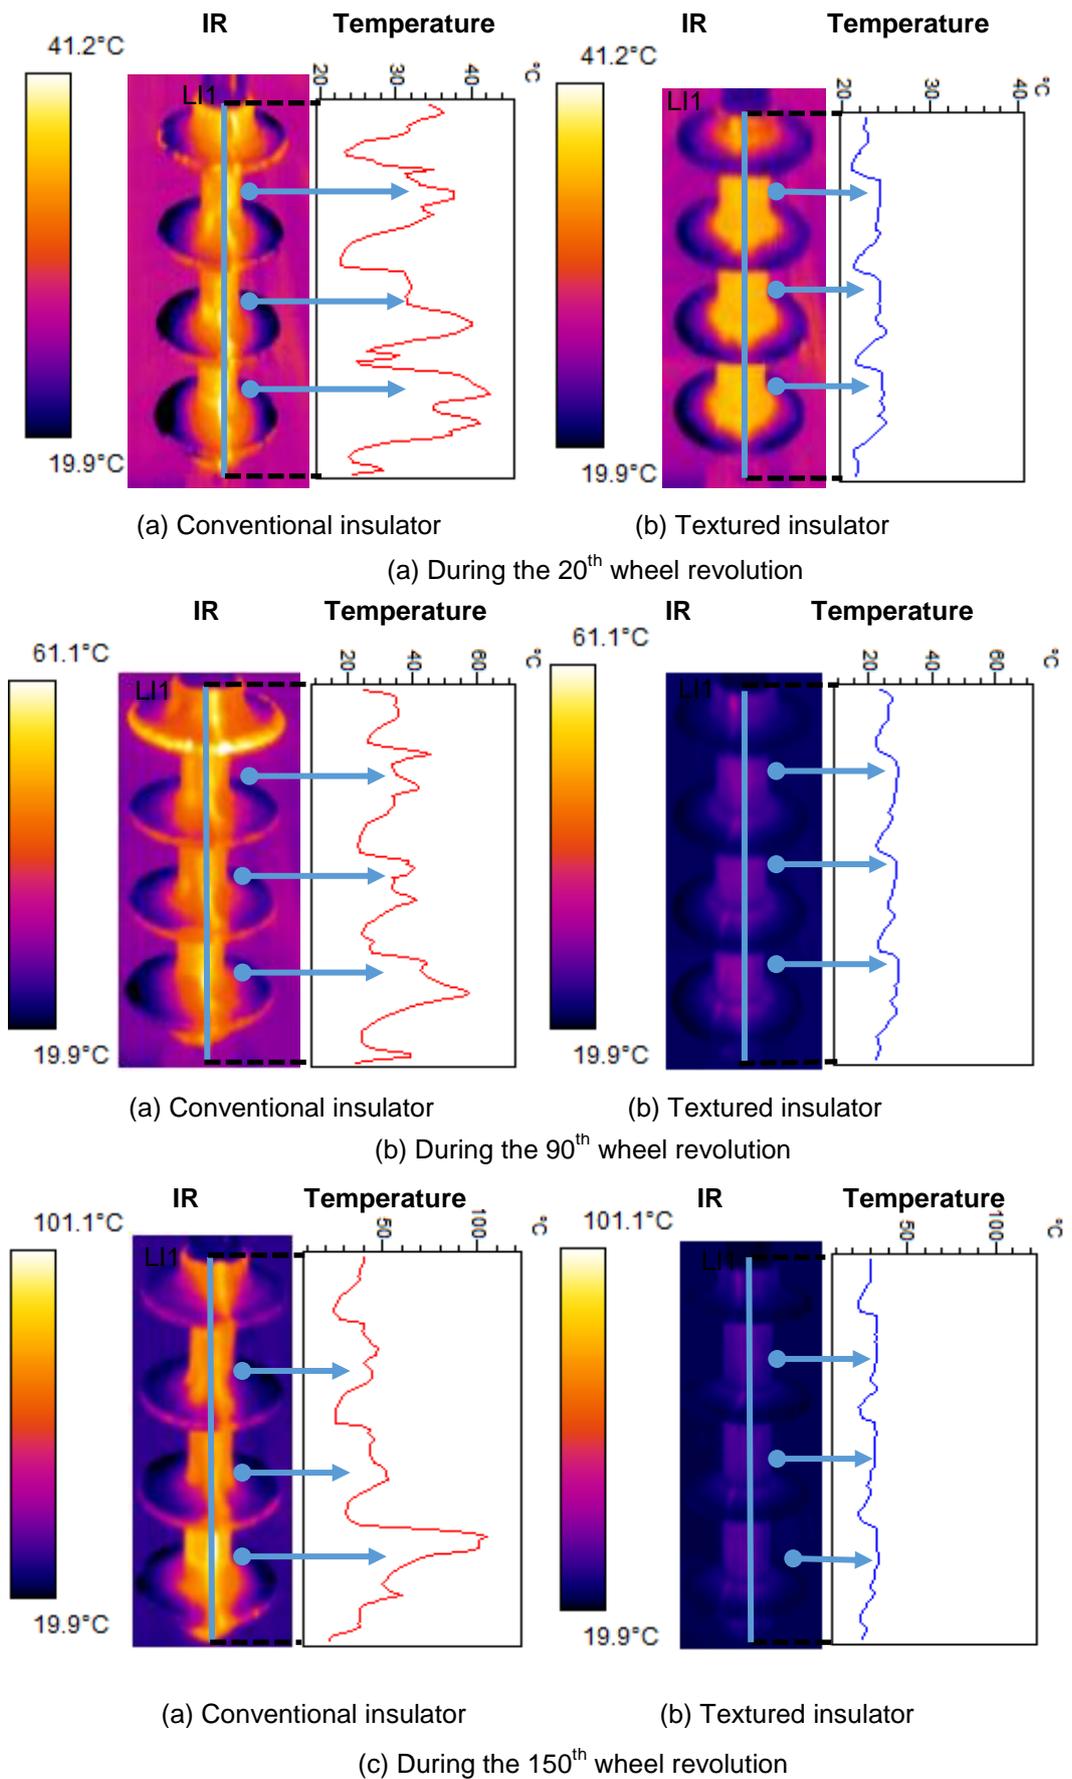
Figure 4-10: Infrared record and temperature distribution along the surface profile of tested insulators during rotating wheel dip tests, of different instants.

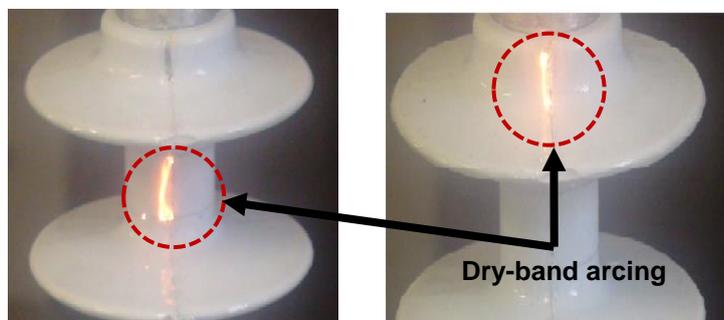
Figure 4-11: Visible discharges activities during rotating wheel dip test.

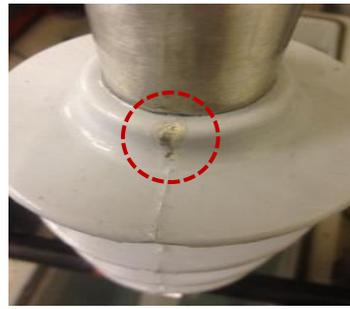
(i) Tracking and erosion

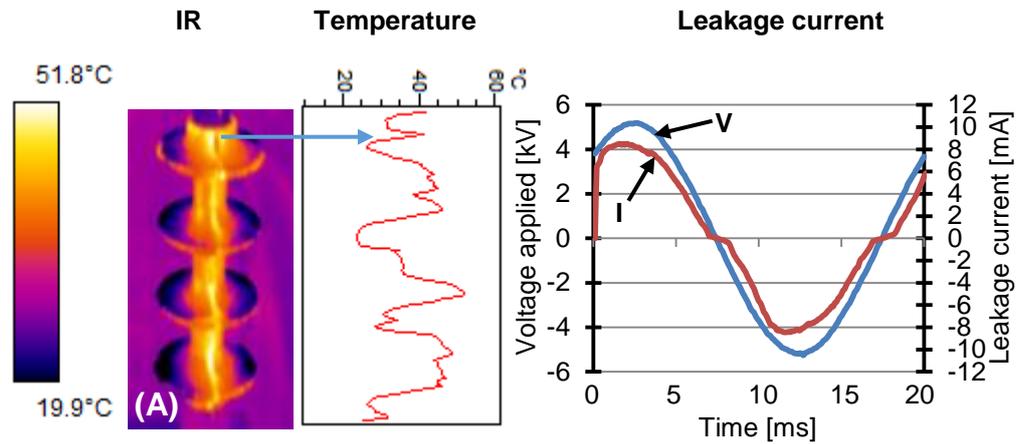
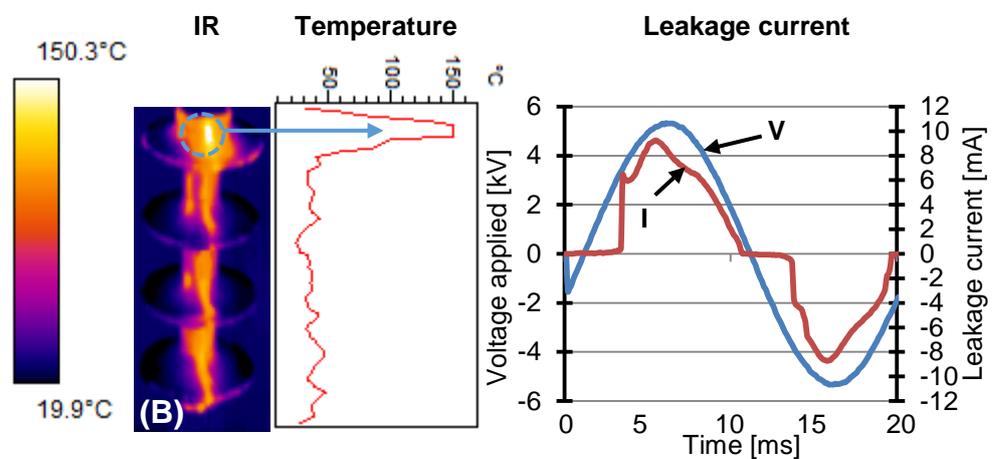
(a) Thermal image A recorded after 16 s of energisation period.

(b) Thermal image B recorded after 23 s of energisation period.

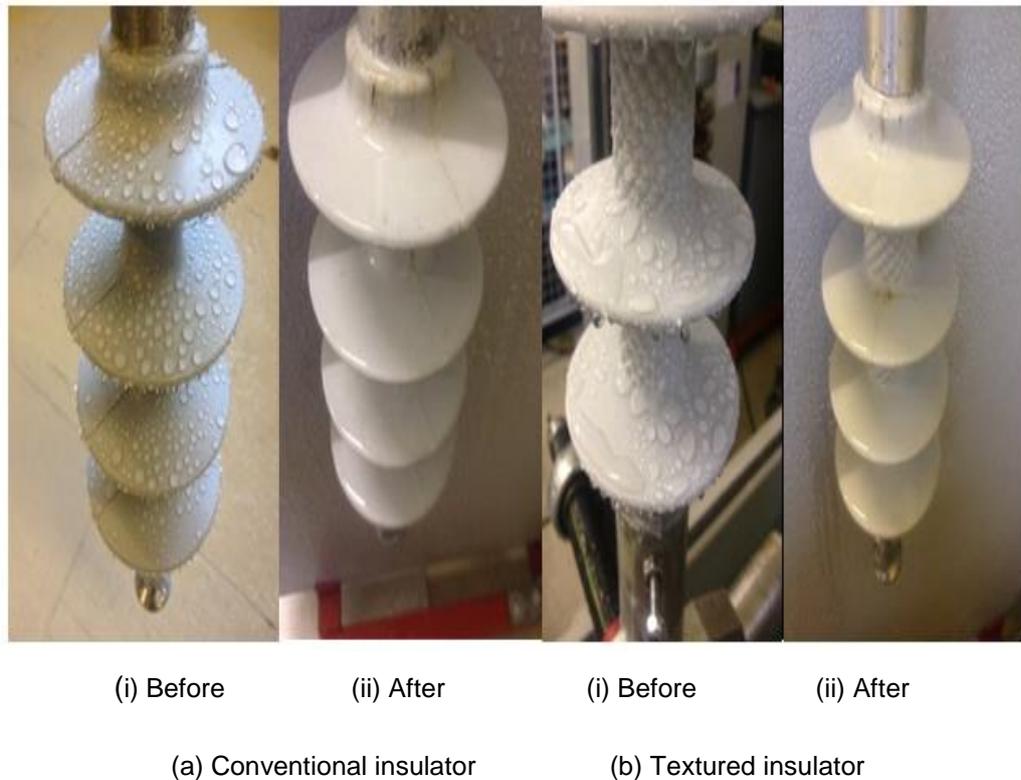
Figure 4-14: Hydrophobicity comparisons between tested insulators.

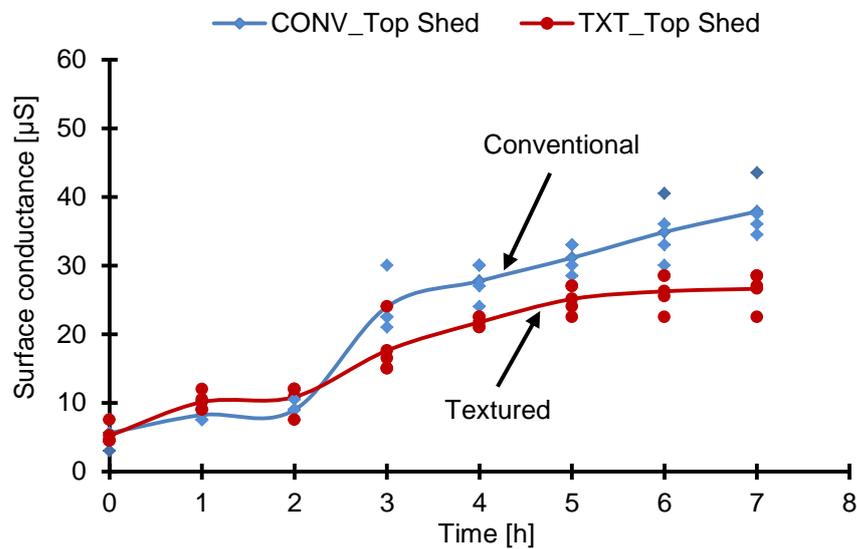
Figure 4-15: Average surface conductance measurements for the top sheds of tested insulators.

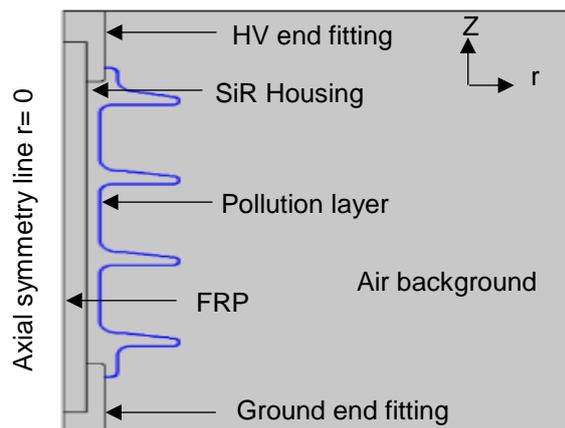
Figure 4-19: Two dimension (2D) axis symmetric model for a polluted insulator

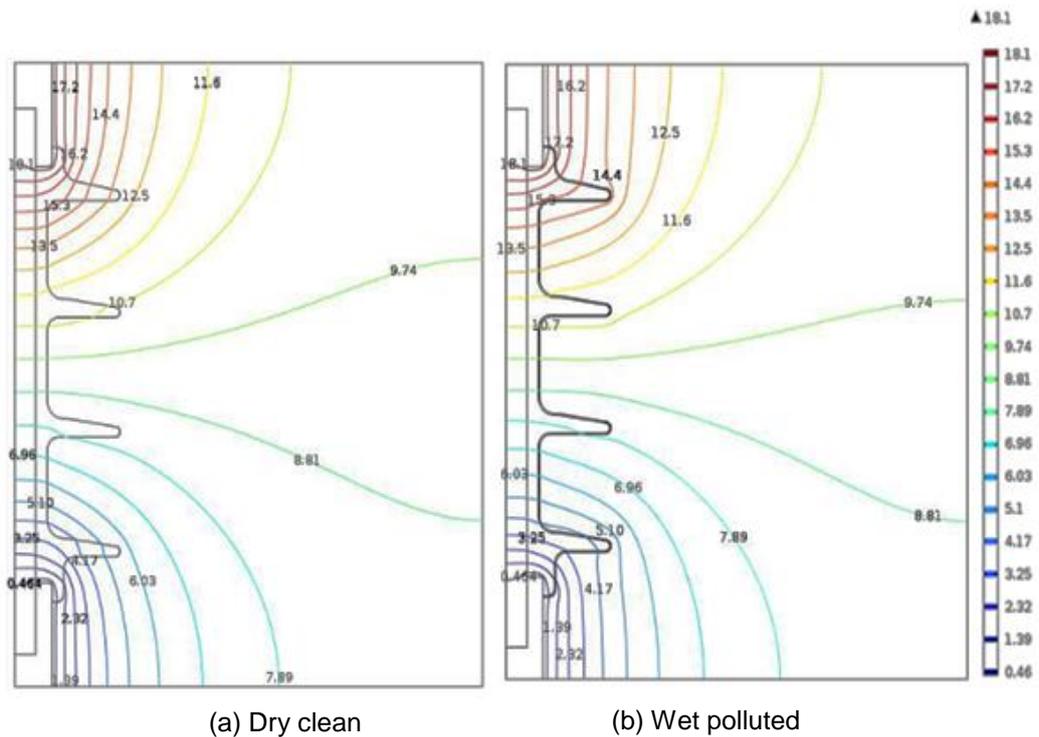
Figure 4-20: Equipotential lines along the surface profile of the clean dry and wet polluted SiR insulator

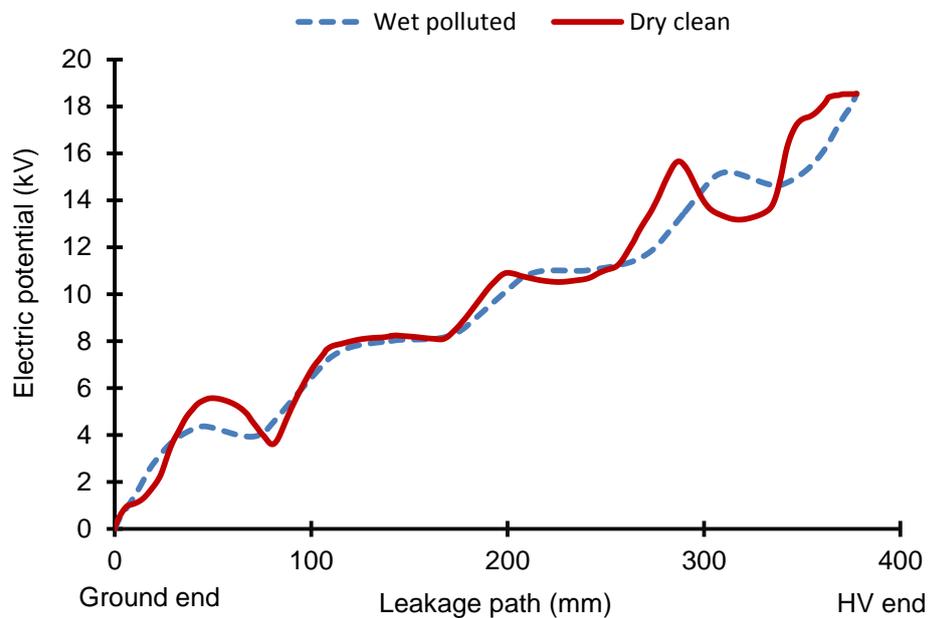
Figure 4-21: Voltage profile along the SiR insulator surface

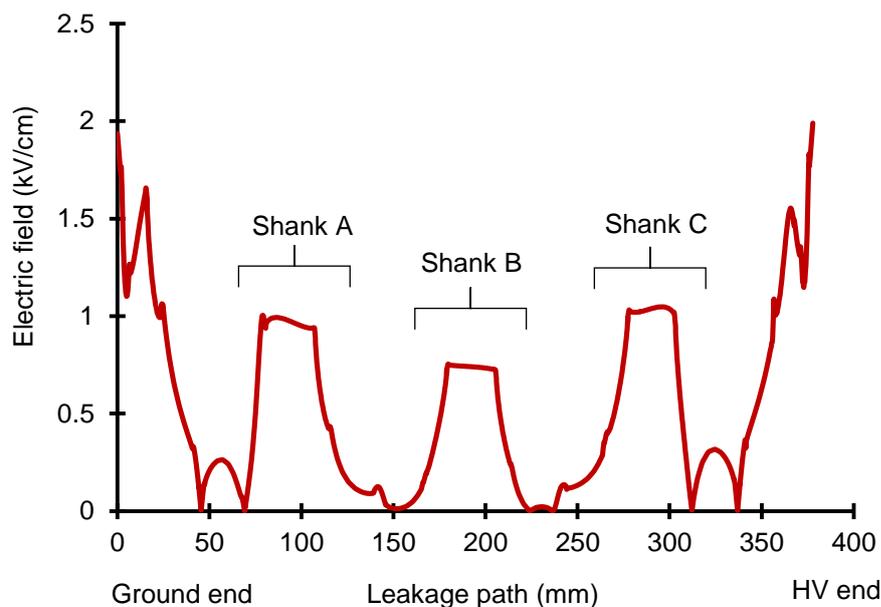
Figure 4-22: Tangential electric field along the leakage path for insulator under wet polluted surface condition

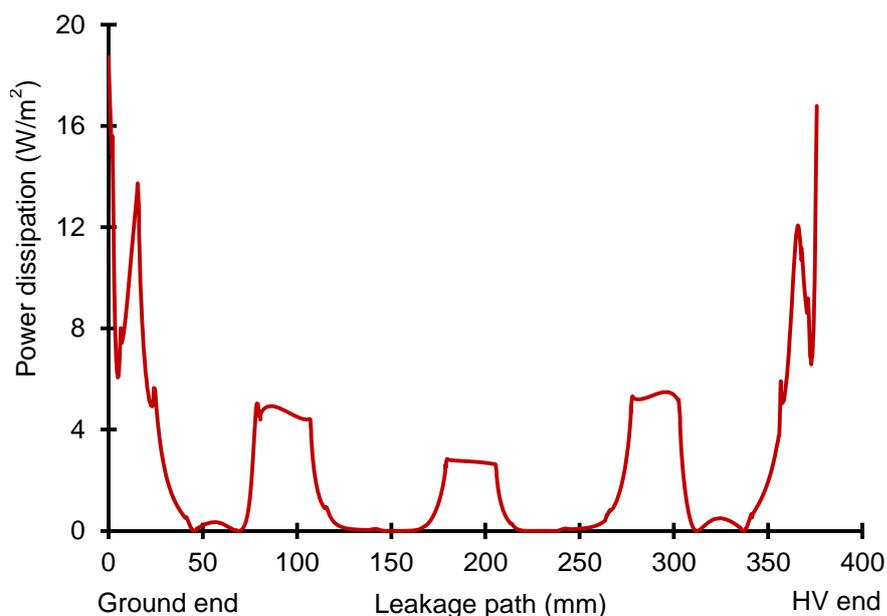
Figure 4-23: Surface power dissipation in pollution layer along polluted insulator surface

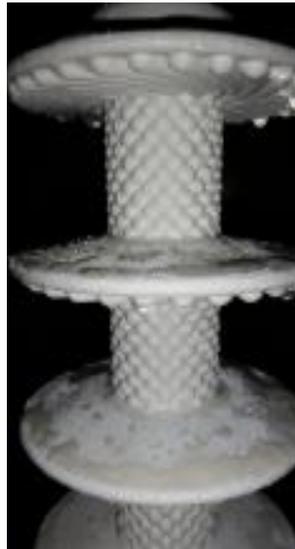
Figure 5-7: Wetting on TTS6 insulators.

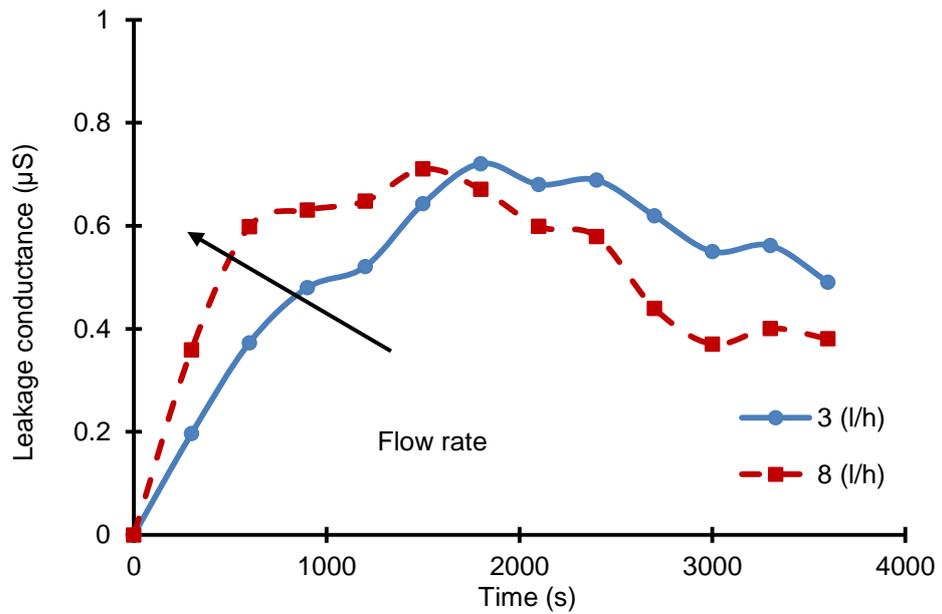
Figure 5-9: AC leakage current of a conventional insulator versus applied fog time; ESDD 0.21 mg/cm².

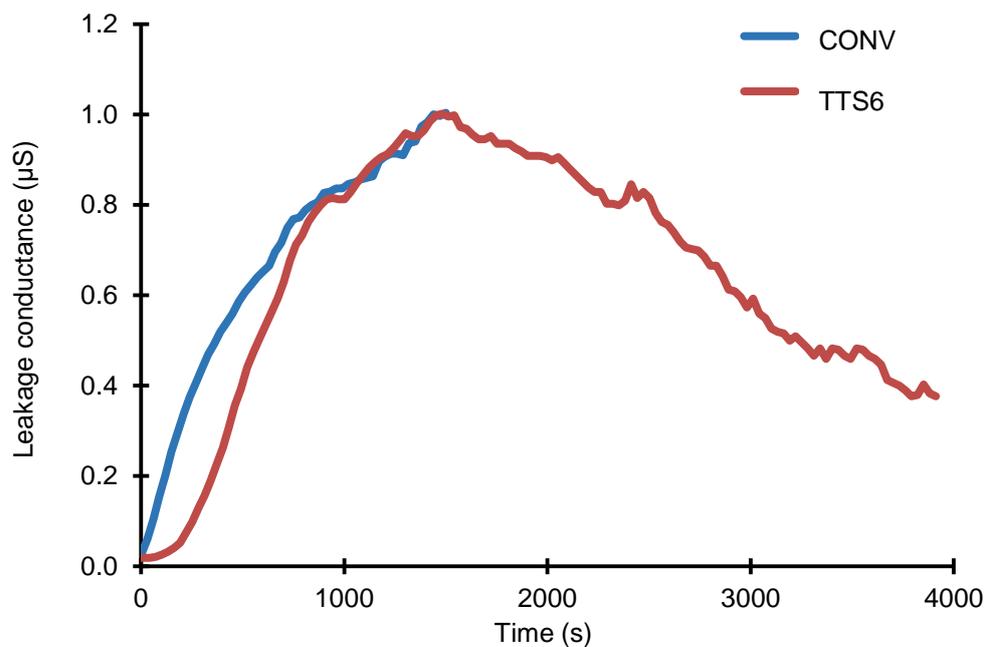
Figure 5-10: AC leakage current for ESDD 0.21 mg/cm²: conventional (CONV) and texture (TTS6).

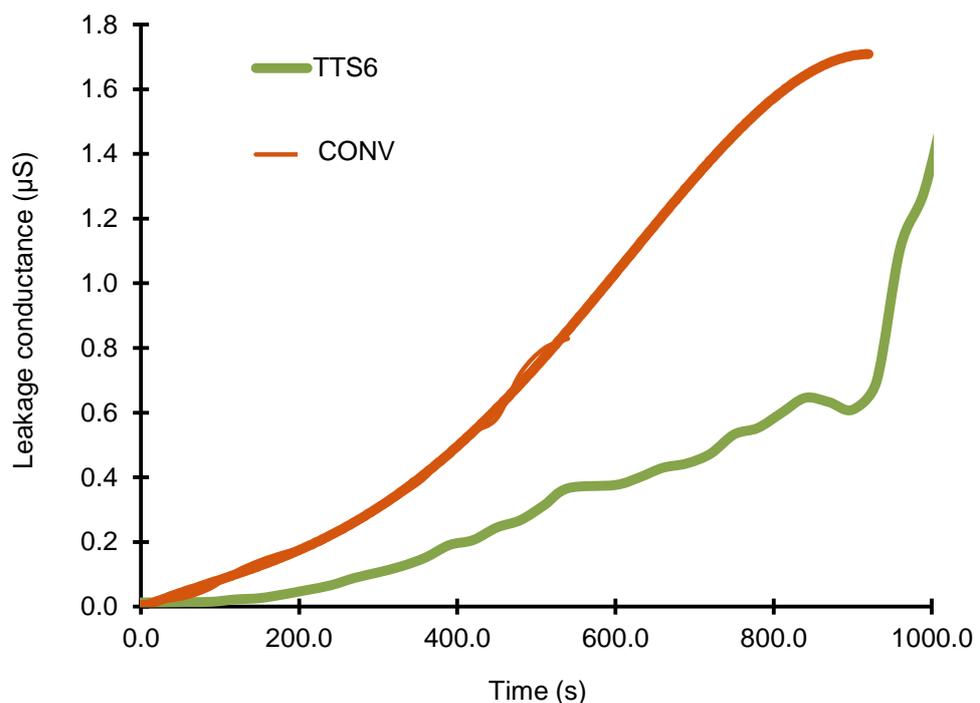
Figure 5- 11: AC leakage current for ESDD 1.20 mg/cm^2 : conventional (CONV) and texture (TTS6).

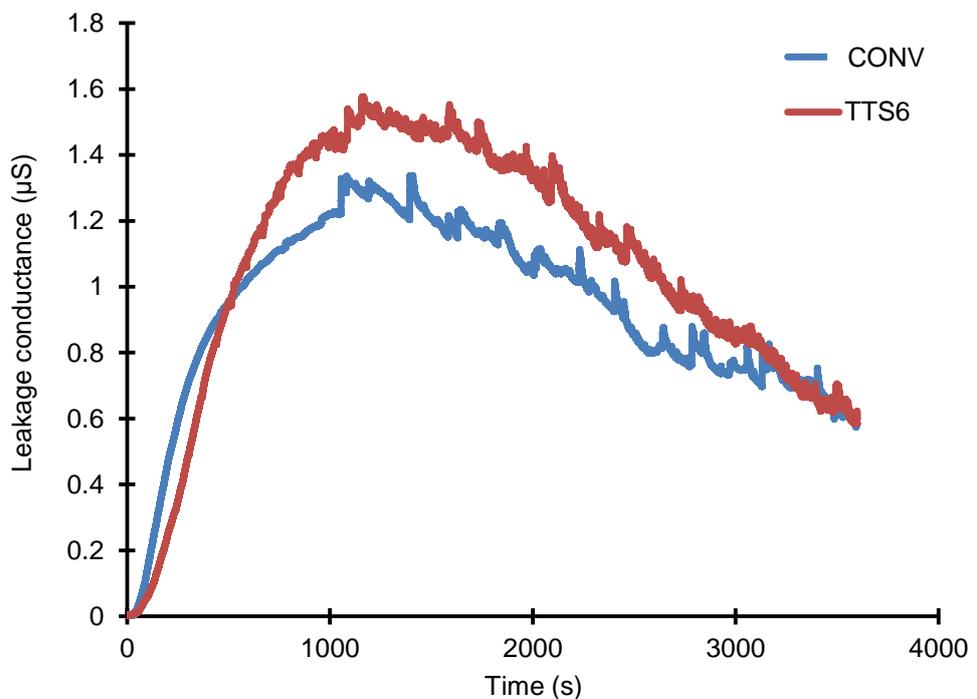
Figure 5-12: DC leakage current for ESDD 0.21 mg/cm²: conventional (CONV) and texture (TTS6).

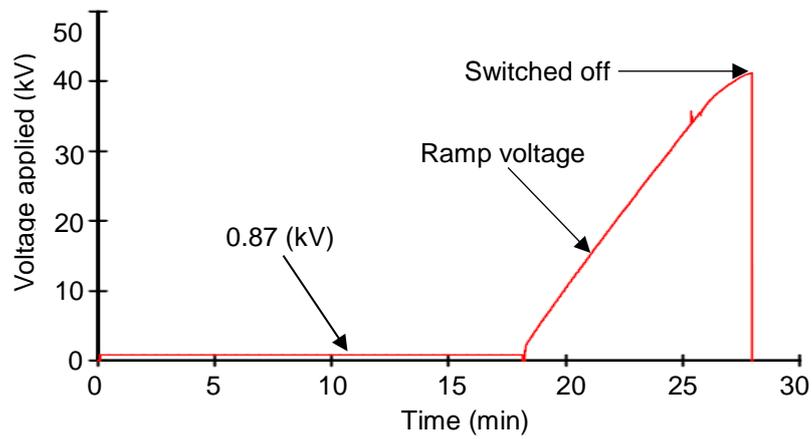
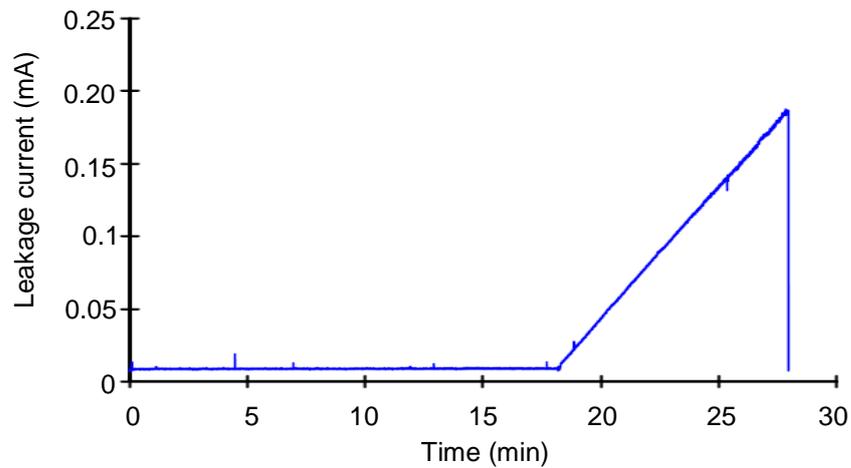
(a) RMS voltage applied

(b) RMS leakage current

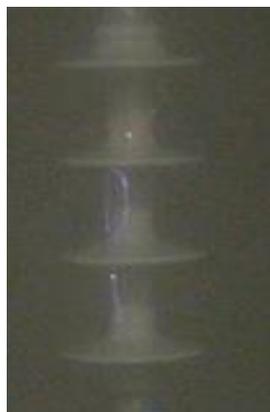
Figure 6-2: Visual records of a clean SiR insulator at 42 kV.

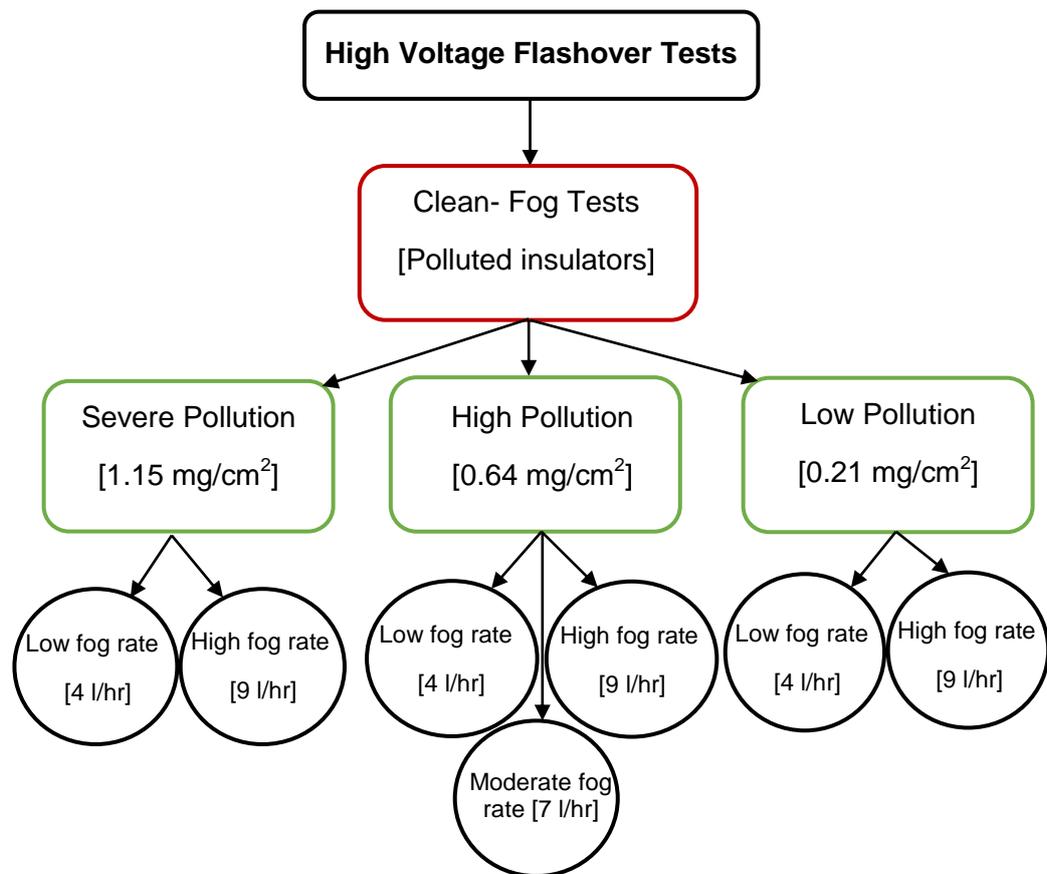
Figure 6-3: High voltage flashover tests

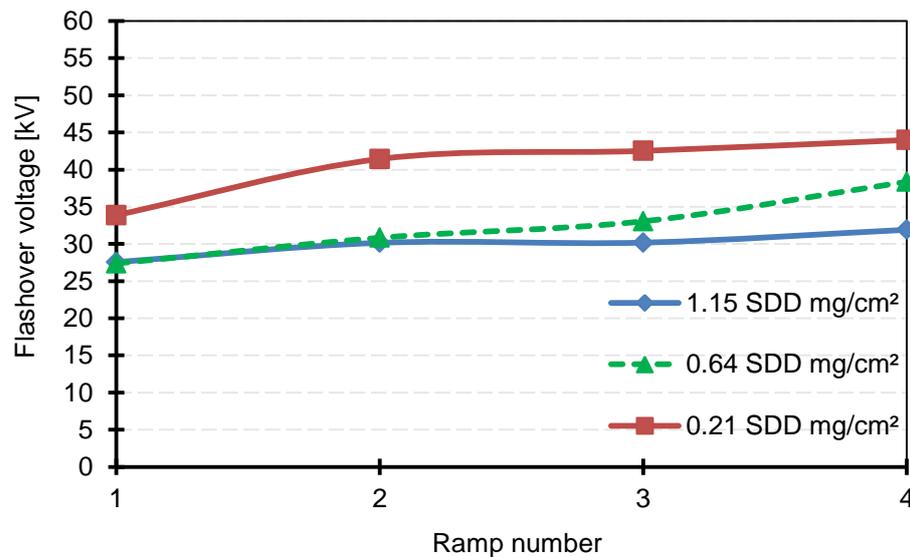
Figure 6-5: Ramp voltage test series for fog rate 9 l/h: effect of pollution severity level on FOV. Red curve ESDD 0.21 mg/cm², Green curve 0.64 mg/cm², and Blue curve 1.15 mg/cm².

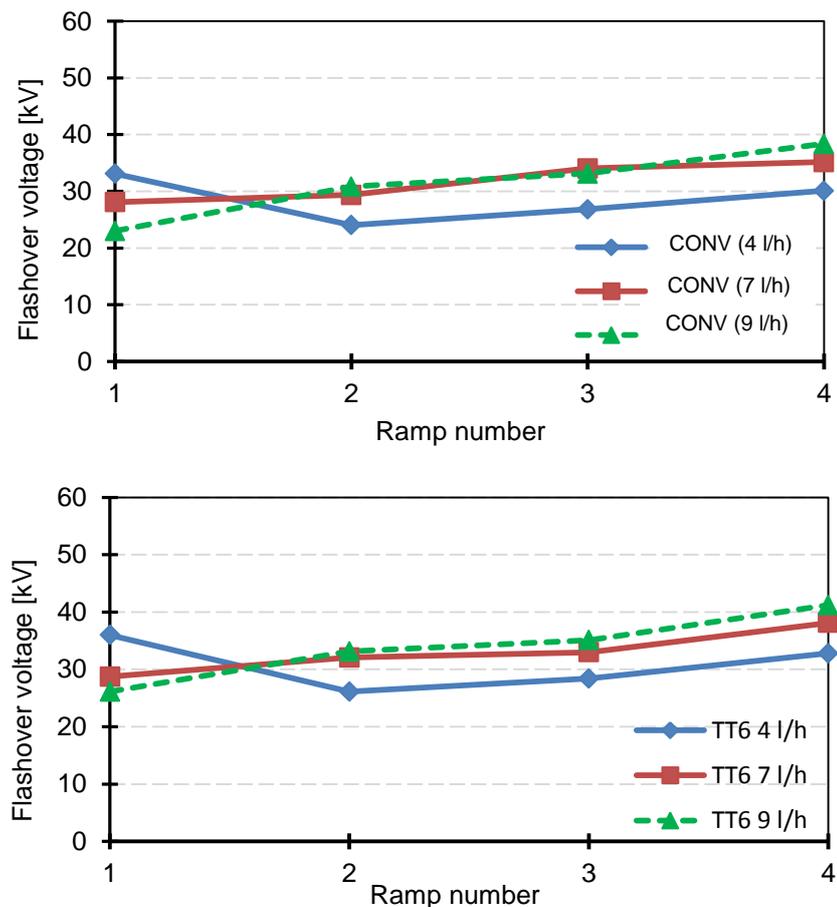
Figure 6-7: Average FOV of 3 test series for CONV and TT6 SiR insulators: effect of wetting rate on FOV. ESDD 0.64 mg/cm^2 . Fog rates 4, 7 and 9 l/h.

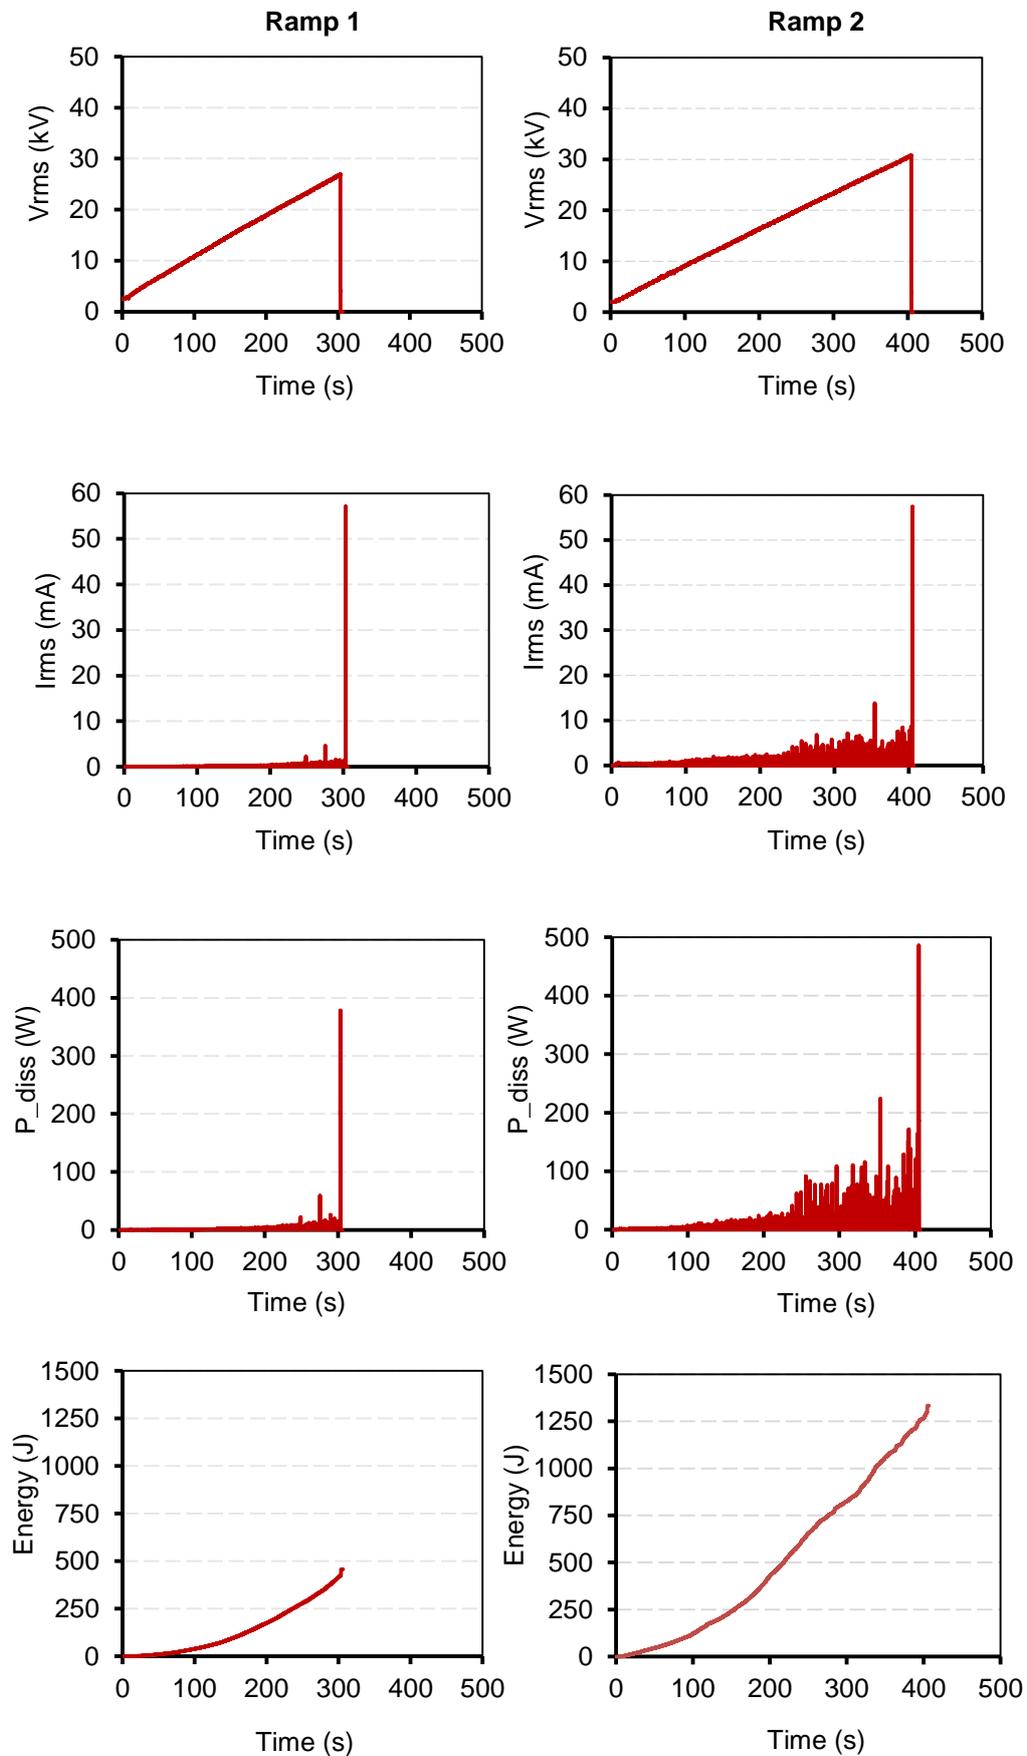
Figure 6-8: Ramp 1 and 2 of test series for CONV insulator under conditions of ESDD (0.64 mg/cm^2) and fog rate (7l/h). Ramp 1: FOV 26.96 kV at 303s; Ramp 2: FOV 30.76 kV at 407s.

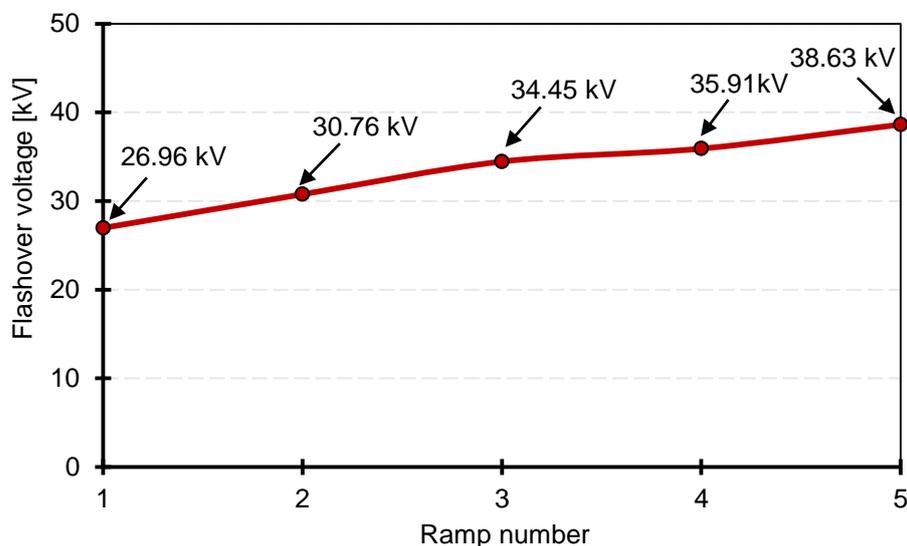
Figure 6-9: Ramp voltage test series for CONV SiR insulator under conditions of ESDD (0.64 mg/cm²) and fog rate (7 l/h).

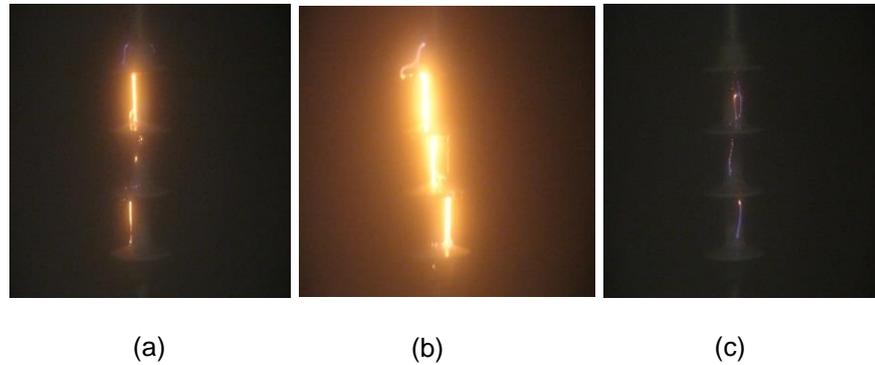
Figure 6-11: Captures images of the conventional insulator during flashover fog test at 32 kV: (a) sparks bridging part of insulator trunk (b) bridging of sheds (c) small streamer discharges.

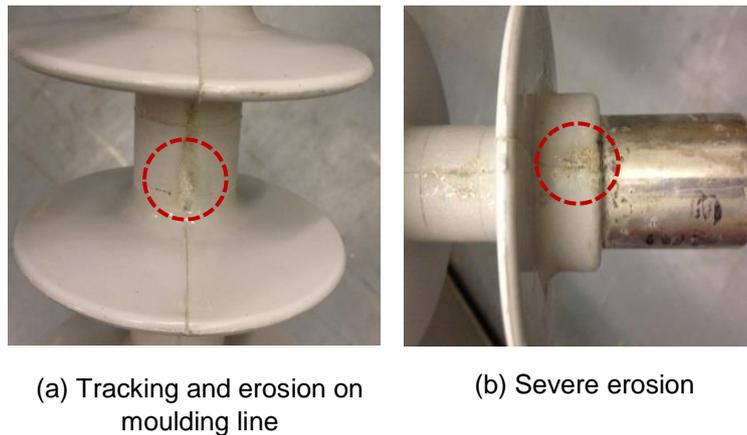
Figure 6-17: The Visual appearance of tested insulators.
