*Fatigue of welded high strength steels for automotive
chassis and suspension applications*

Thesis submitted for the degree of Doctor of Philosophy

Cardiff University

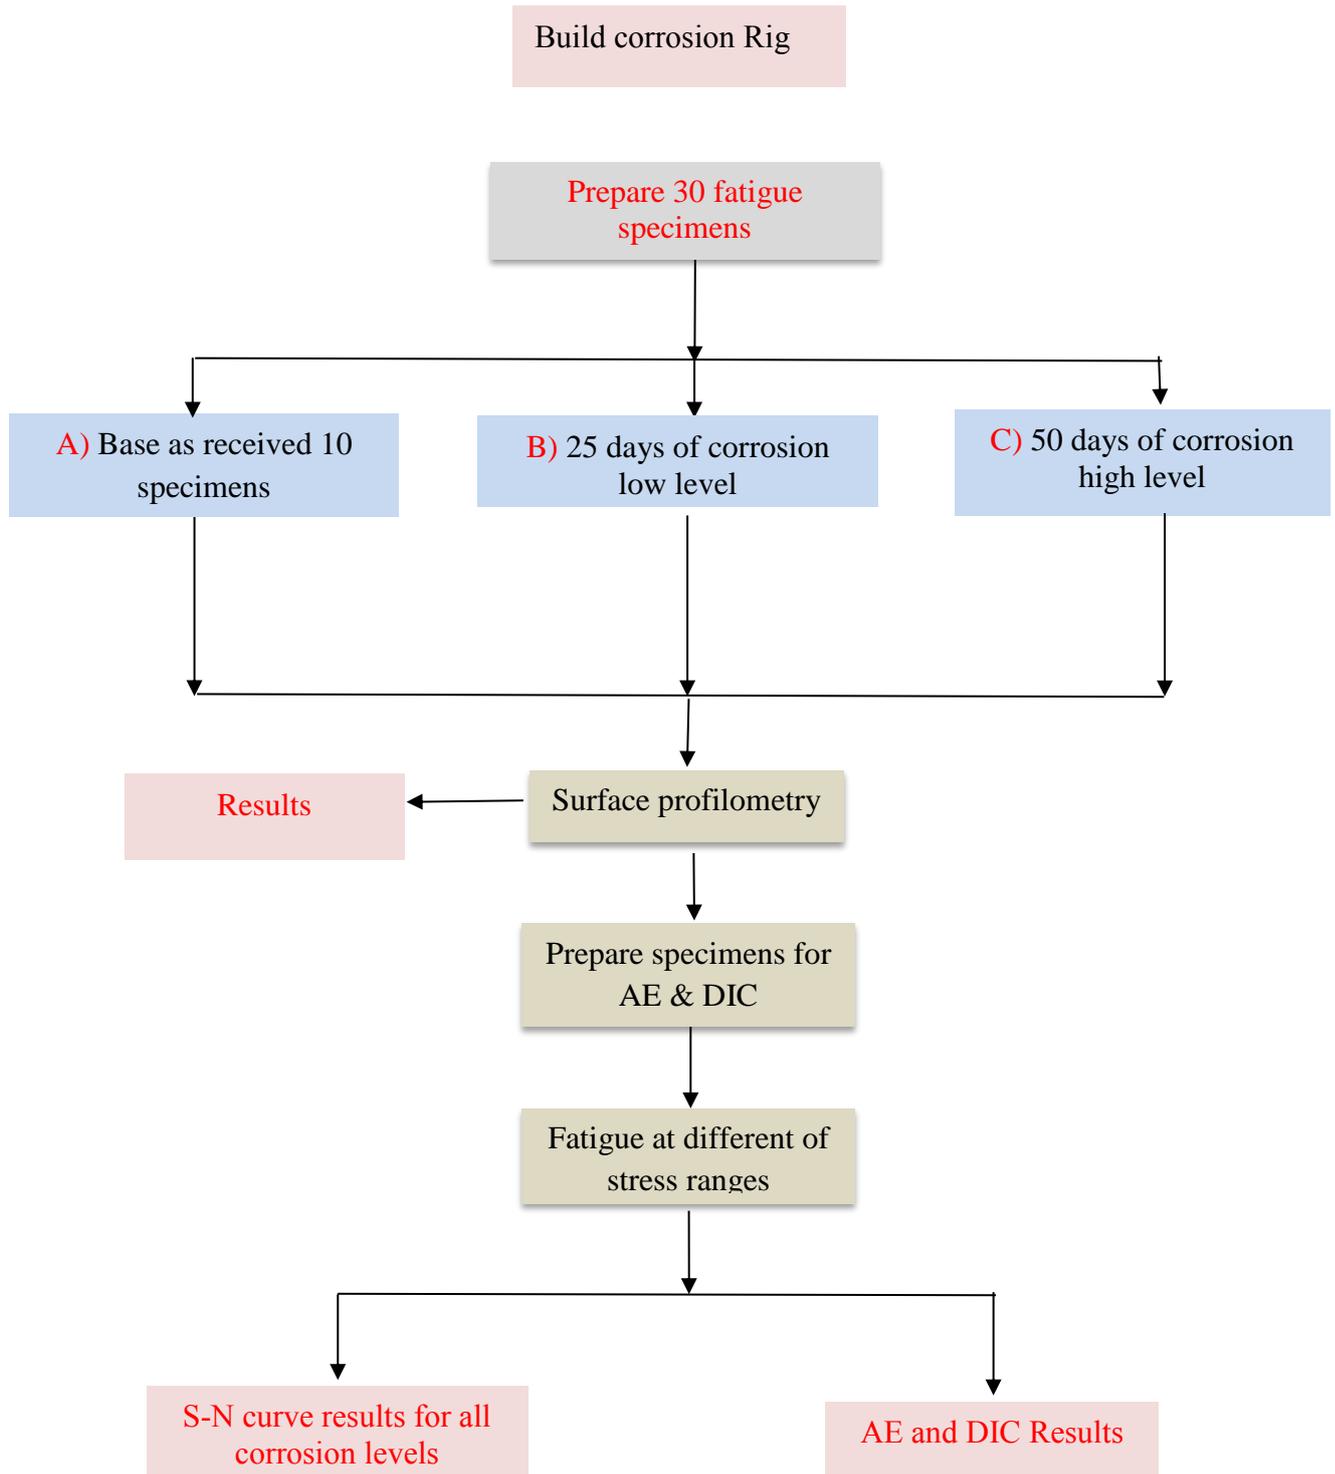
Figure 1.1: Mild steel work plan.

interpretation of the AE data. This combination of AE and DIC can also provide much useful information in attempting to distinguish the different AE signals originating from various possible failure mechanisms such as plastic deformation, delamination of corrosion product or DIC paint, and crack initiation and propagation. The research presented in this study also includes a wider project which ultimately aims to develop a fatigue test monitoring system to identify crack initiation from background noise for both mild steel and high strength steel (FB590) and its welded structure which is produced by Tata steel, after overcoming the problems such as background noise, time misalignment with cycles and so on. Figure 1.1 shows the first work plan which was implemented on mild steel and Figure 1.2 shows the developed work plan which was applied to FB590.

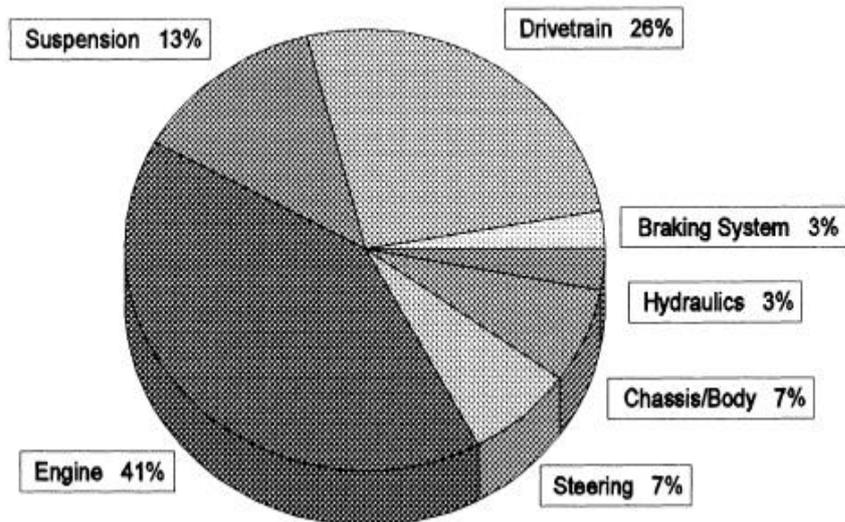
Figure 2.4: The distribution of component failures (Heyes 1998).

as presented in Figure 2.4. The most common component failures occur within the engine (41%) and chassis/body is responsible for only 7% of the reported failures. However, failures of the chassis and associated components can be catastrophic with serious consequences. In some cases, these in-service failures result in the recall of all affected vehicles with associated costs and negative publicity (Heyes 1998; Veloso et al. 2009). Therefore, many tests can be performed on strip steel to show its mechanical properties. These properties can be connected to tensile performance, fatigue performance, formability, hardness etc. However typically only three properties are determined to characterise the delivery condition of each coil, these three are the UTS, yield stress and elongation to failure (Bright 2012). Chassis components structural durability design has to be performed through a consideration of all possible types of service loadings as shown in Figure 2.5 (Hägele and Sonsino 2014). However, until now there is a lack of information for automotive chassis steel in term of fatigue performance under all possible types of service environments, which is the focus of the current study. These data and information will help engineers understand the true mechanical properties of the material and component under various environments that are anticipated.

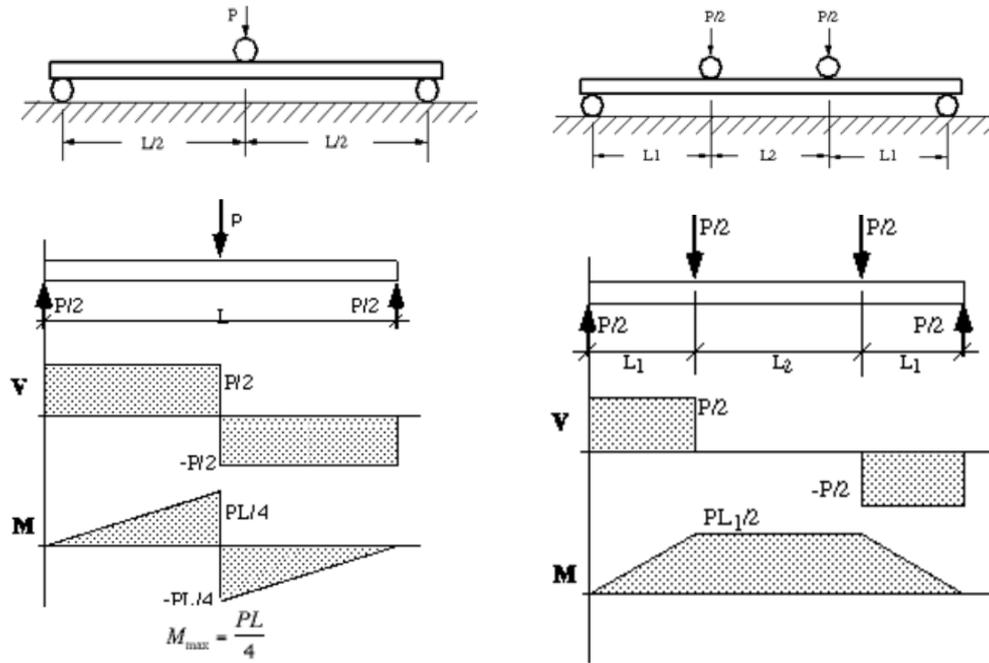
Figure 2.10 (a) Three-point bending beam (b) Four-point bending beam (Dupen 2015).

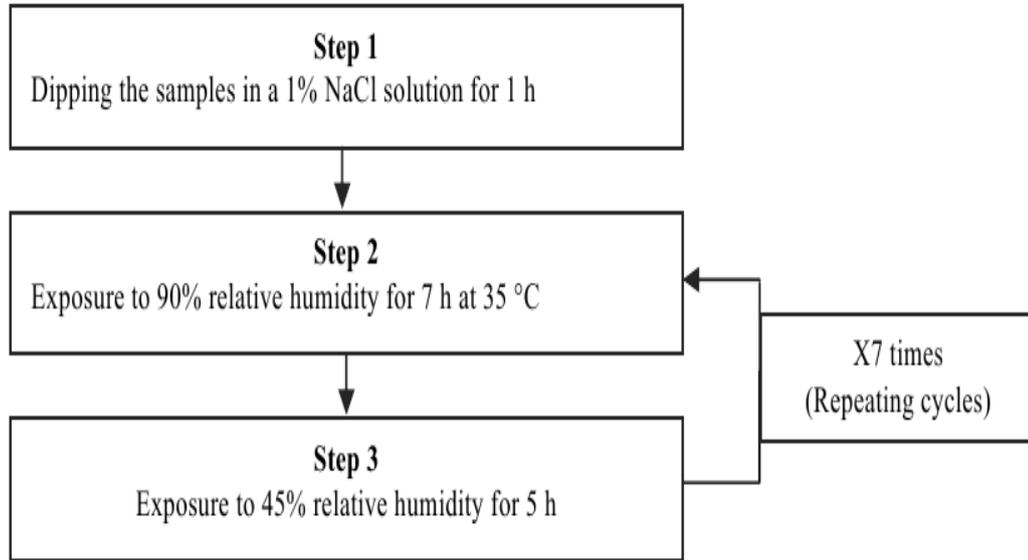
Figure. 2.12: Experimental procedure of VOLVO corrosion test (Katundi et al. 2010).

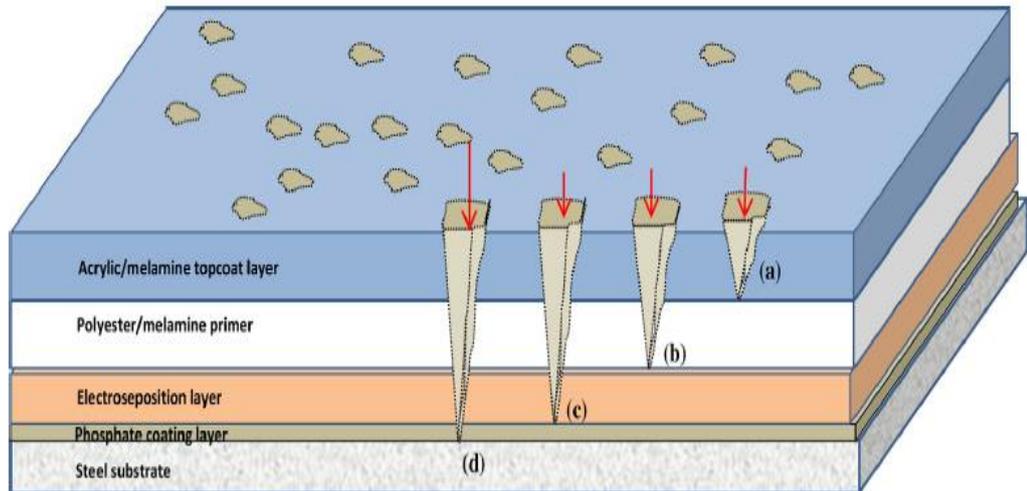
Figure 2.15: Schematic illustration of a coating system after chipping test; various types of damages including (a) topcoat layer damage, (b) primer layer damage, (c) ED layer damage and (d) phosphate layer damage (Razin et al. 2015).

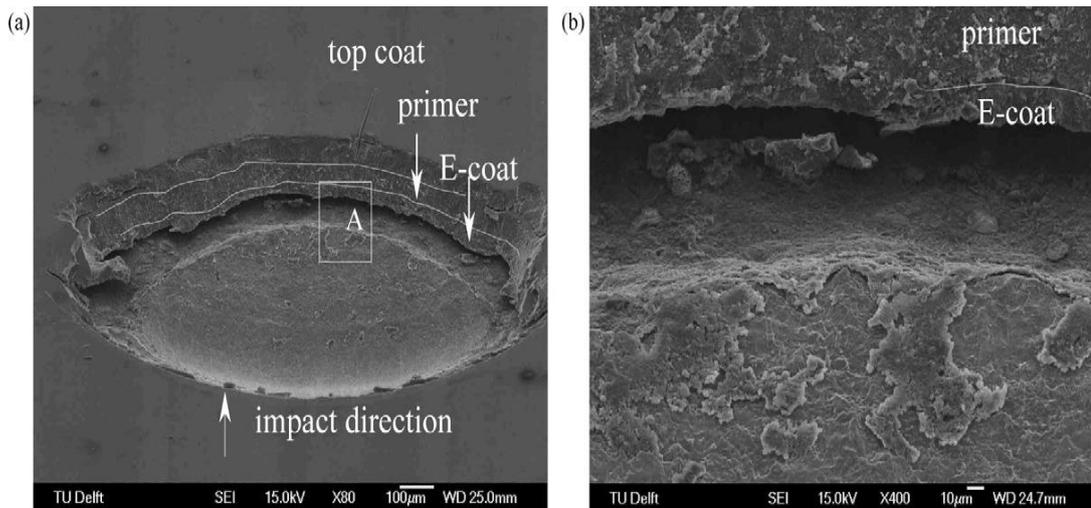
Figure 2.16: Typical damage caused by projectile impact for coating systems (a) general view, (b) magnified view of area A (Lonyuk et al. 2008).

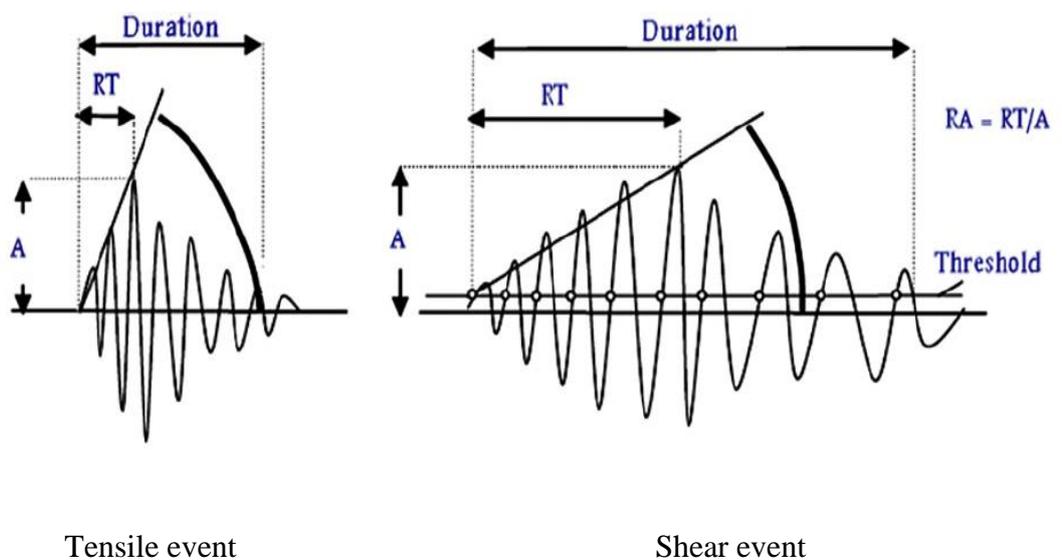
Figure 2.22: Cracking modes and corresponding AE signals (Elfergani et al. 2013).

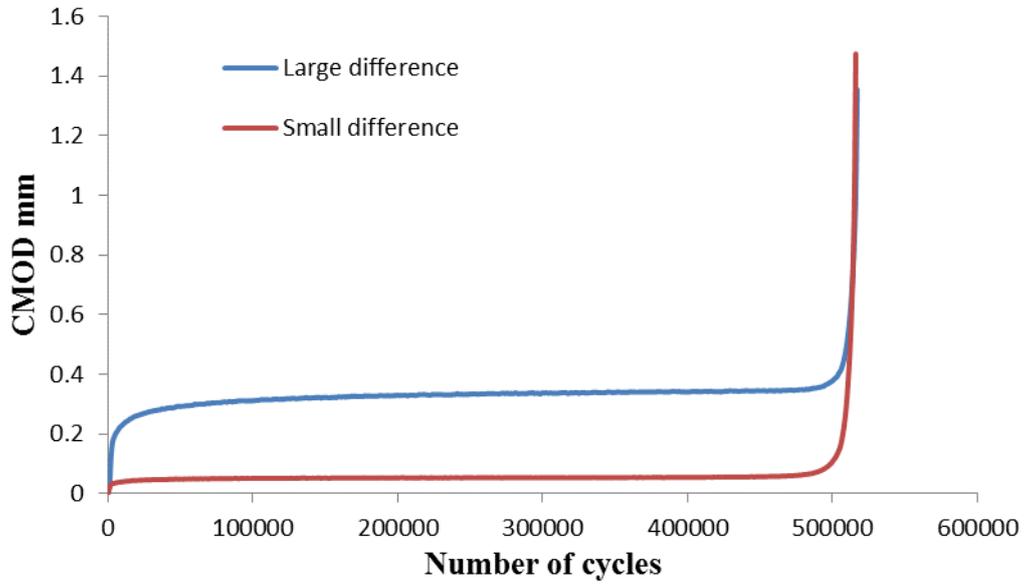
Figure 3.20: Mild steel corroded specimen under 250MPa, the blue line for the large difference between the two points (initial analysis) and red line for the points close to each other.

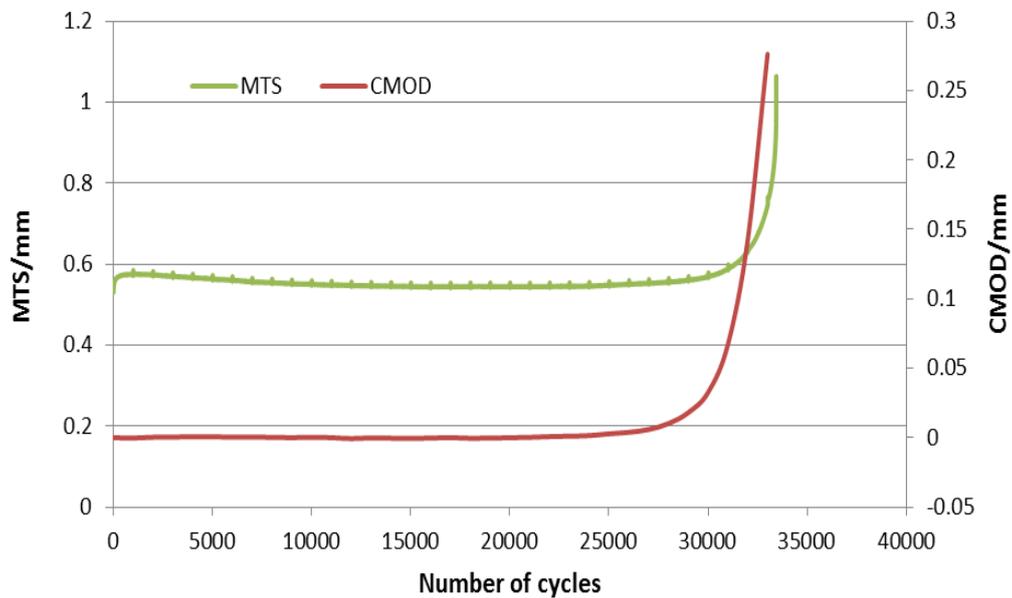
Figure 3.21: The comparison between extension (MTS) and DIC result for as received FB590 welded specimen under 400MPa.

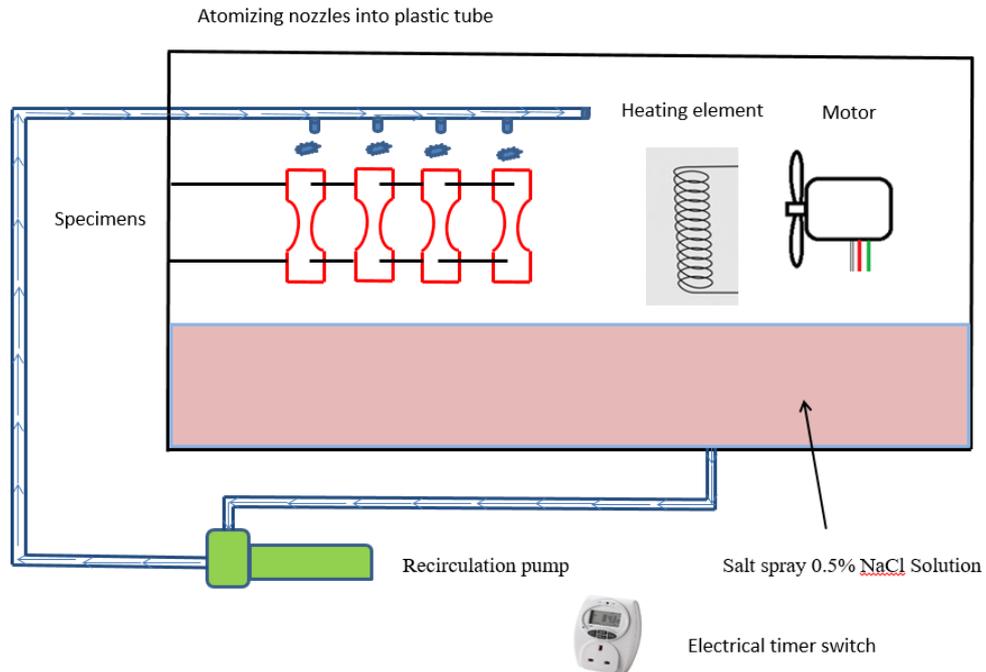
Figure 3.26: A schematic of the self-built corrosion chamber.

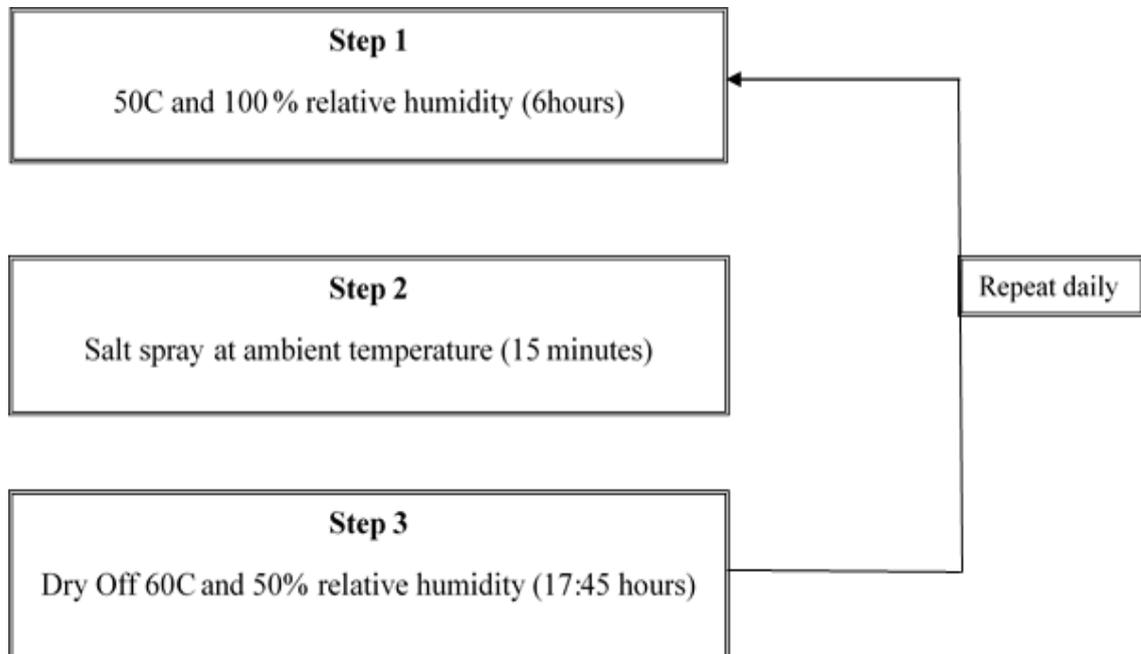
Figure 3.27: Cosmetic corrosion Laboratory test cycles 7 day/ week –automatic operation (SAEJ2332 2002).

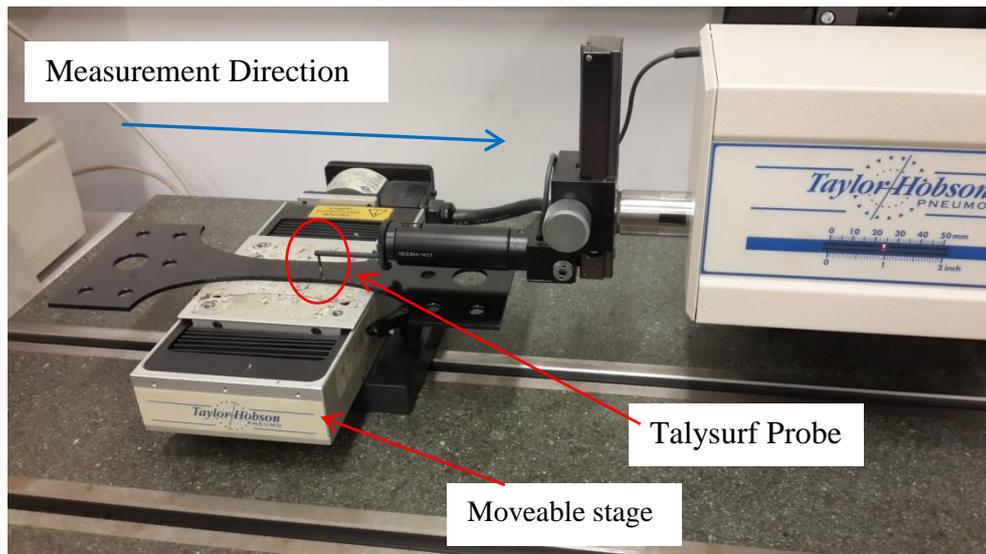
Figure 3.28: Talysurf with specimens mounted on moveable stage.

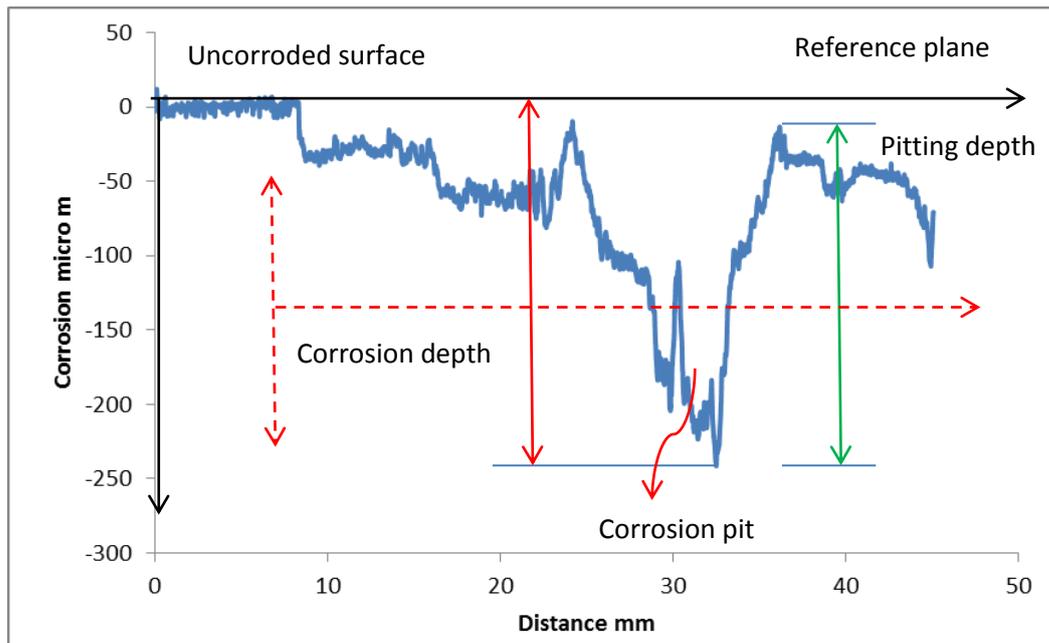
Figure 3.30: Surface profile and the principle to obtain the pitting characterization parameters (red dash line indicates 3D roughness, red indicates corrosion depth, and green indicates pitting depth).

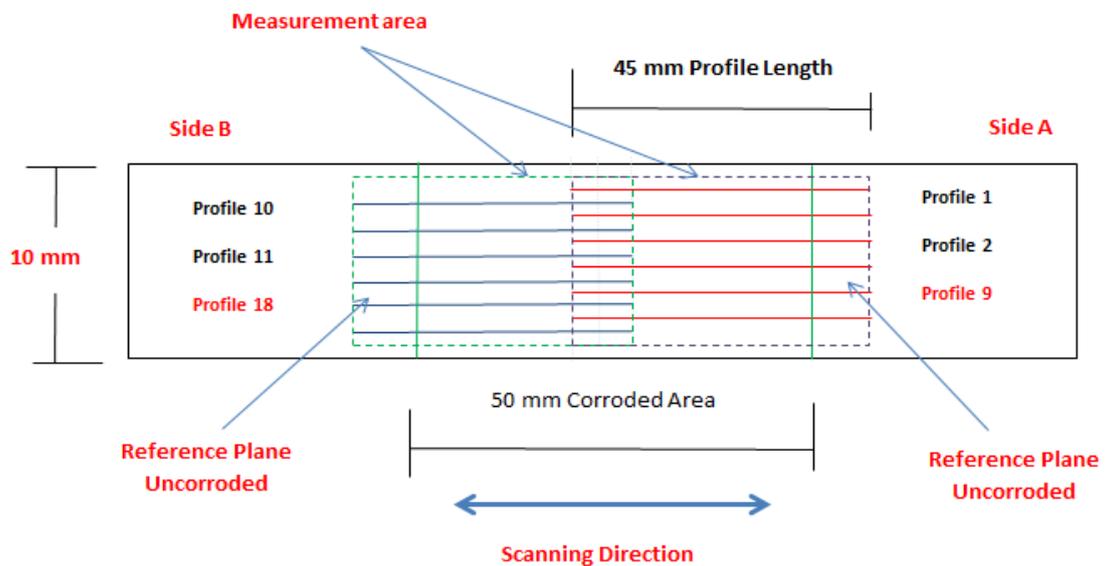
Figure 3.31: shows mild steel specimen with 18 sampling lengths of 45mm.

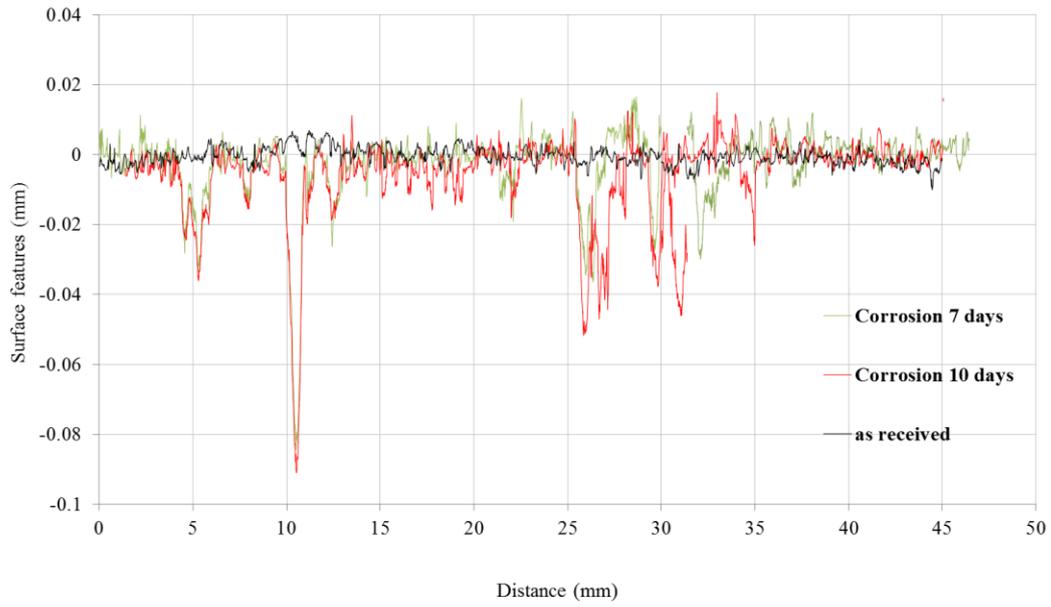
Figure 3.32: Shows corrosion depth against distance for specimen (0,7, and 10) days for side B2 p1 sample length.

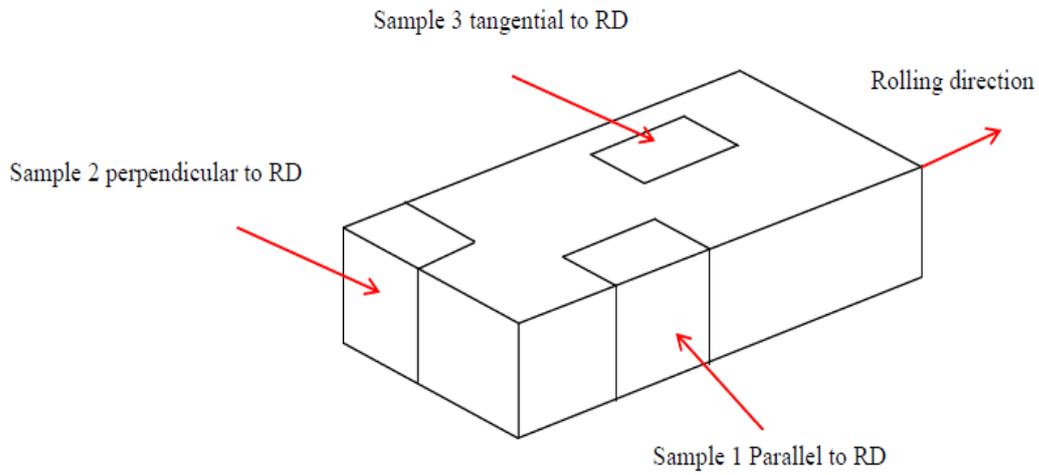
Figure 3.33: sections of specimen from different directions relative to rolling direction.

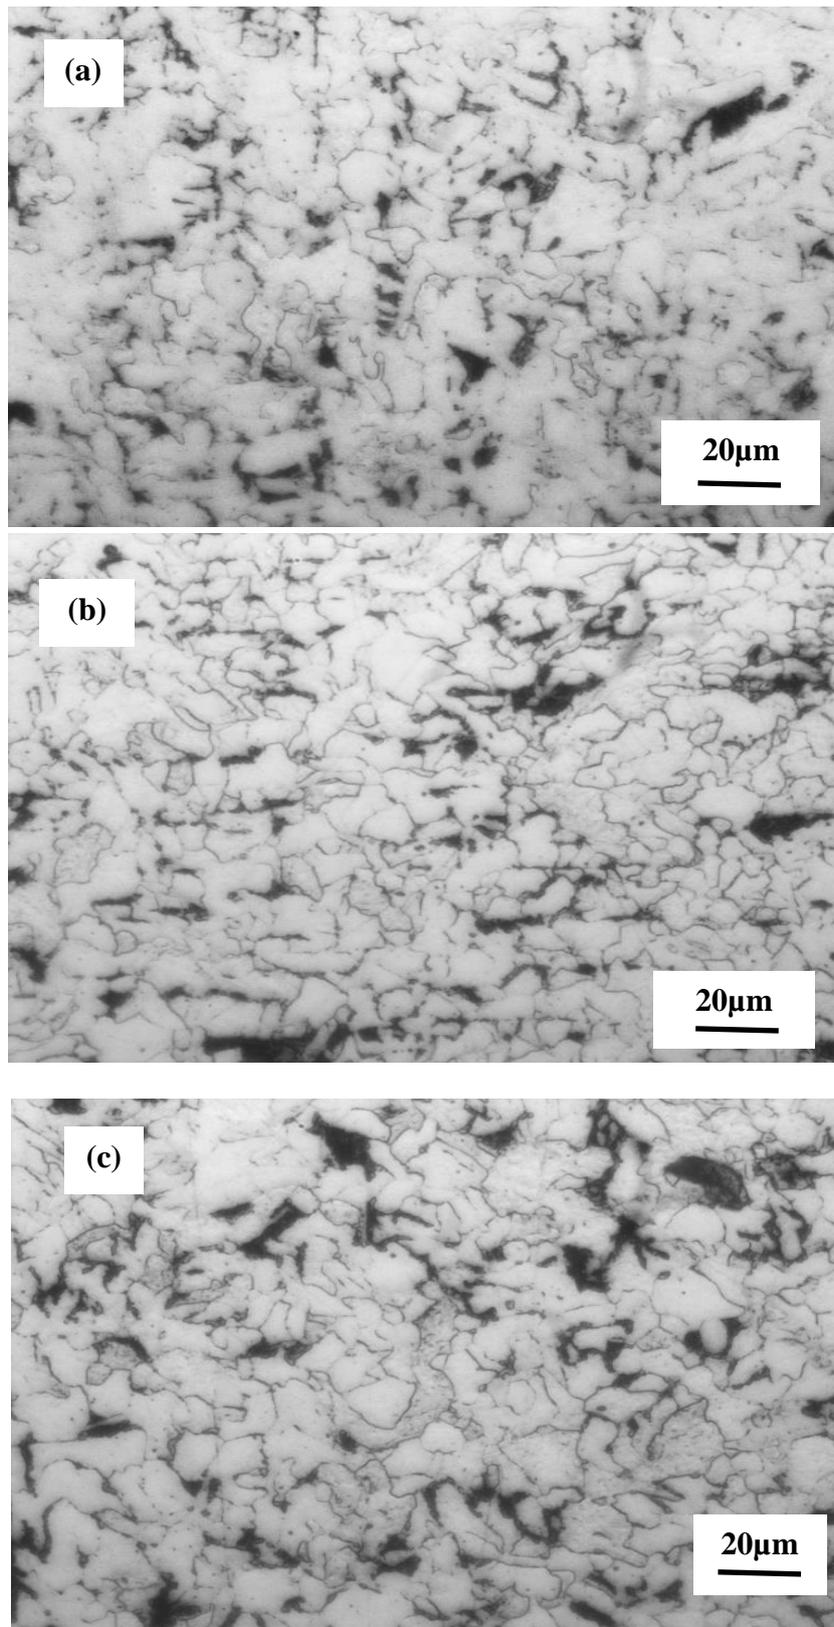
Figure 3.34: Mild steel microstructure (a) parallel to rolling direction (b) perpendicular to rolling direction (c) on the surface.

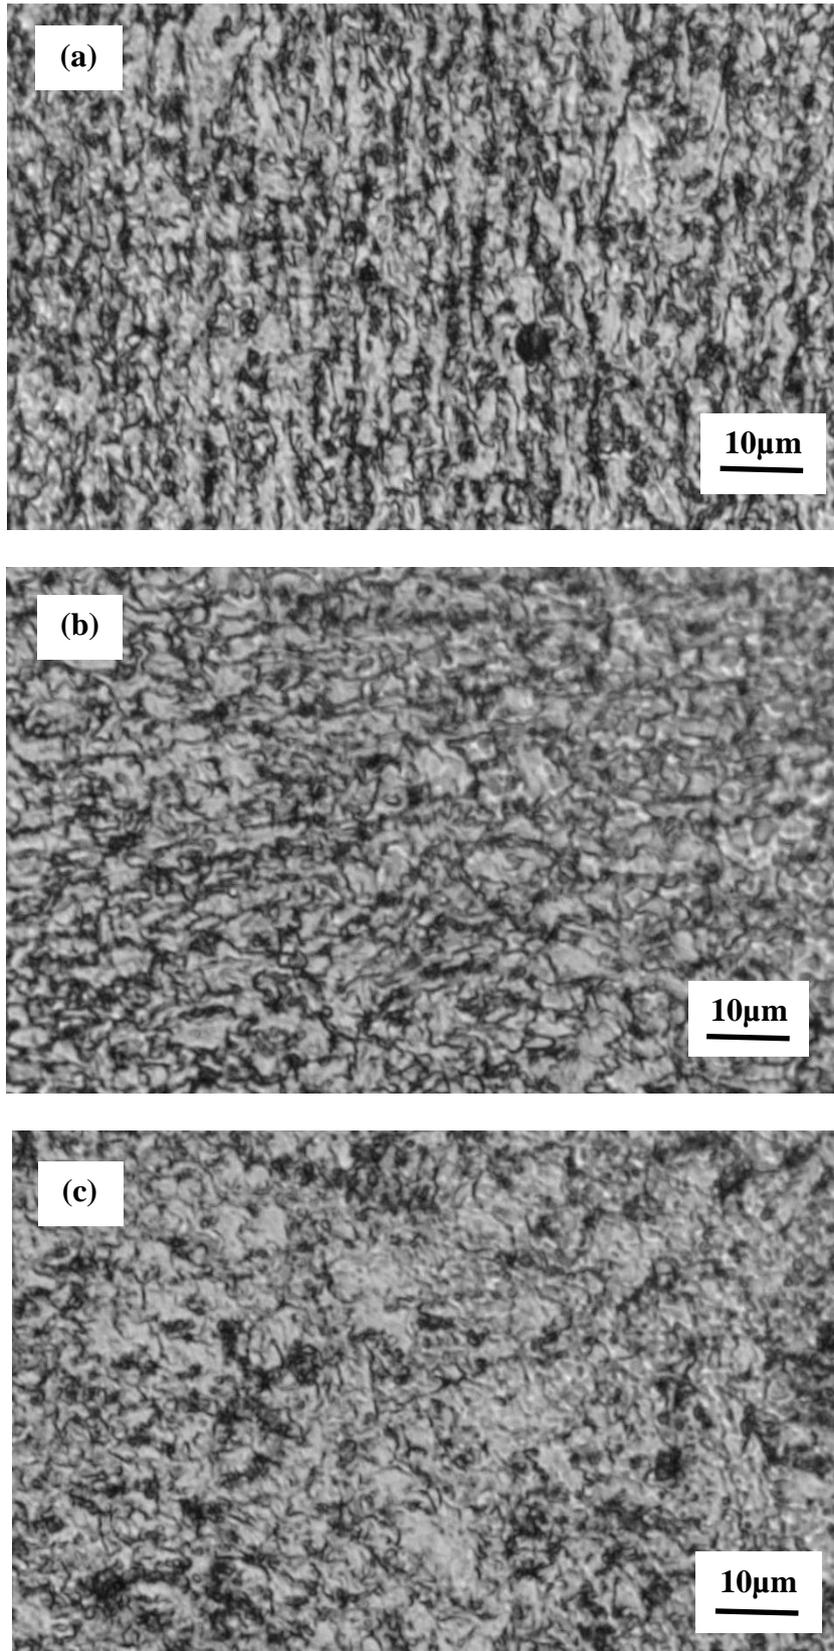
Figure 3.35: FB590 microstructure (a) parallel to rolling direction (b) perpendicular to rolling direction (c) on the surface.

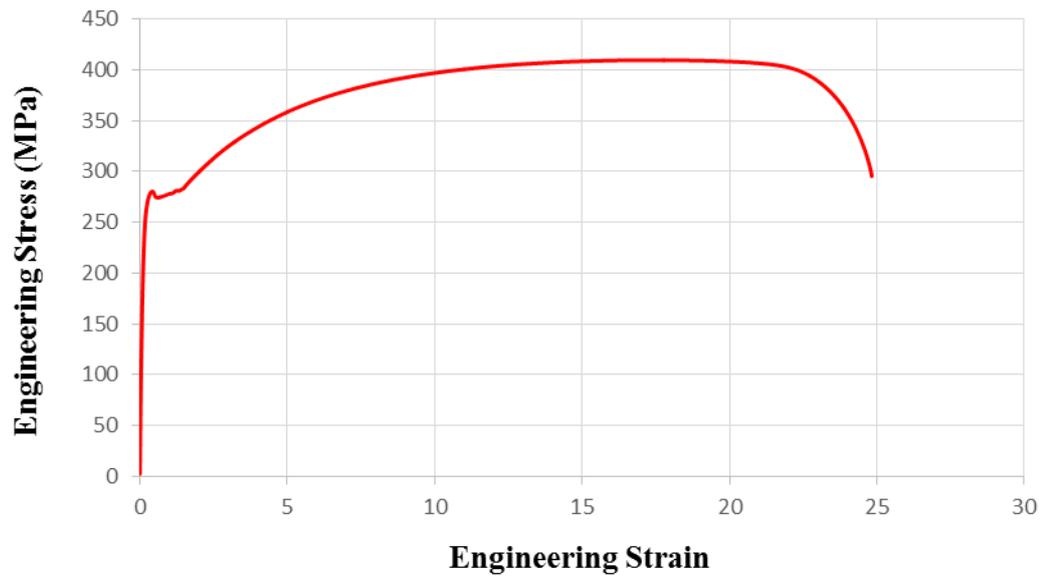
Figure 4.1: Stress strain curve of mild steel.

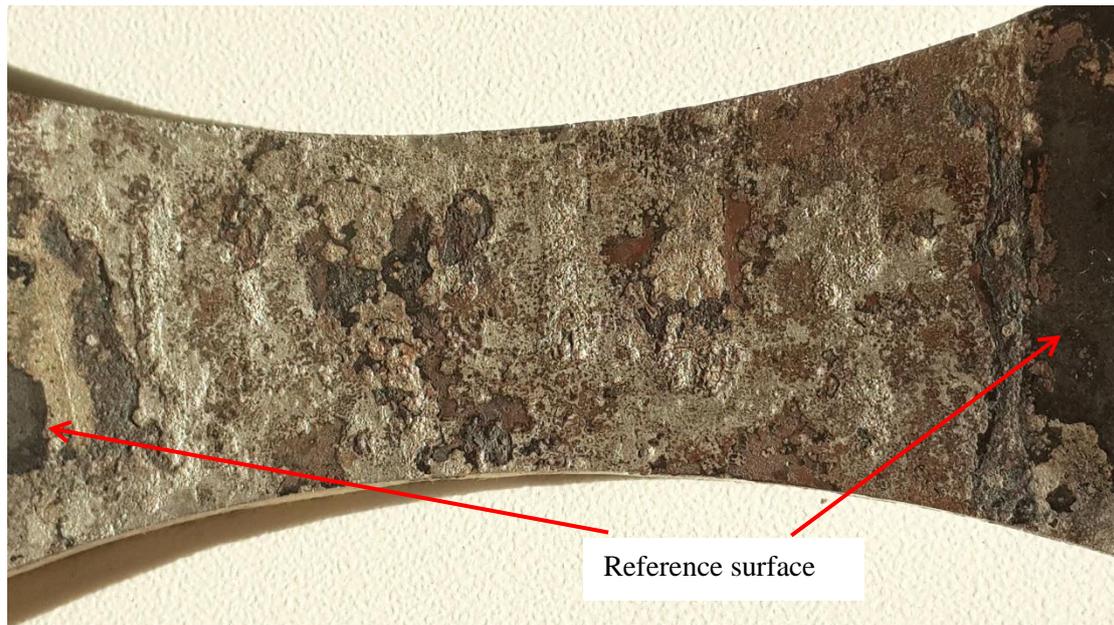
Figure 4.5: The typical appearance of the specimens after removing the rust.

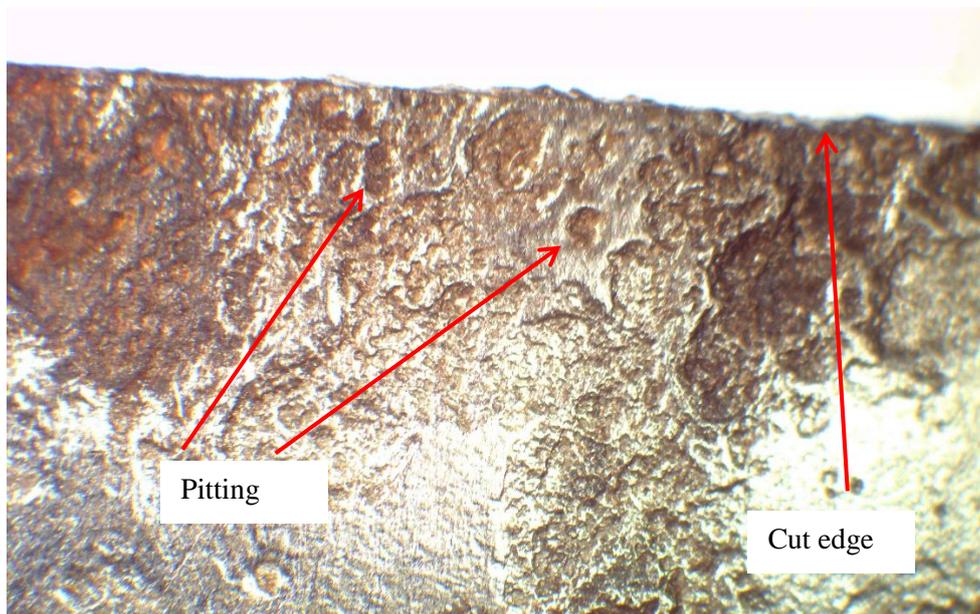
Figures 4.6: Stereo optical microscope image of corroded surface.

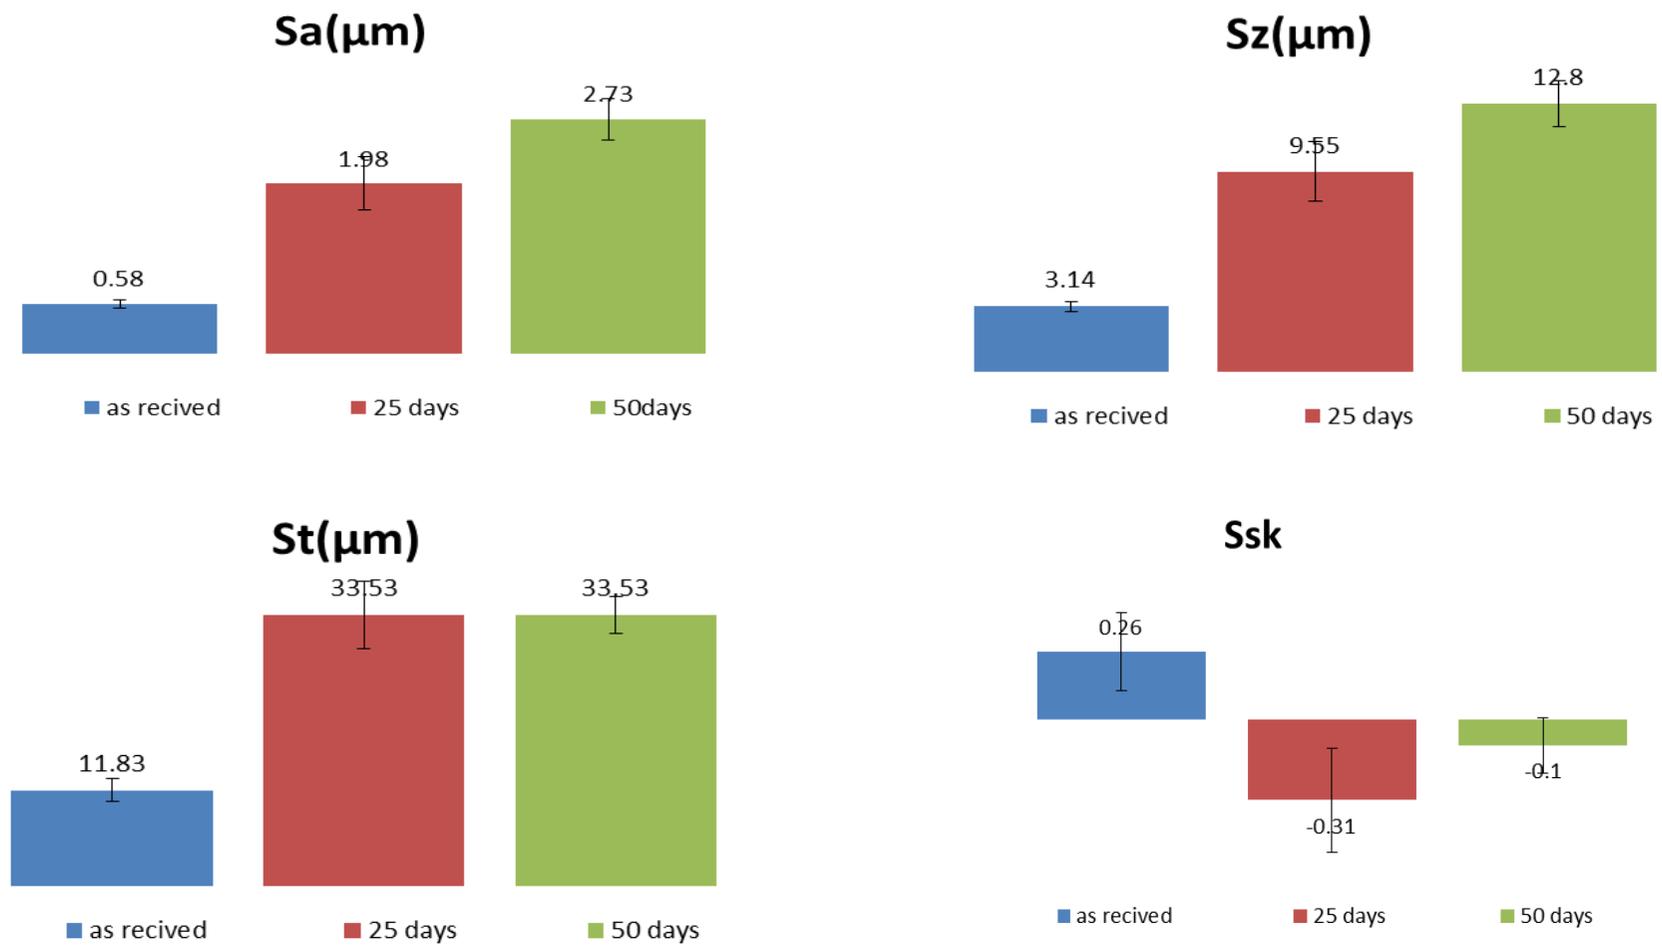
Figure 4.7: Roughness parameters increasing with time of corrosion.

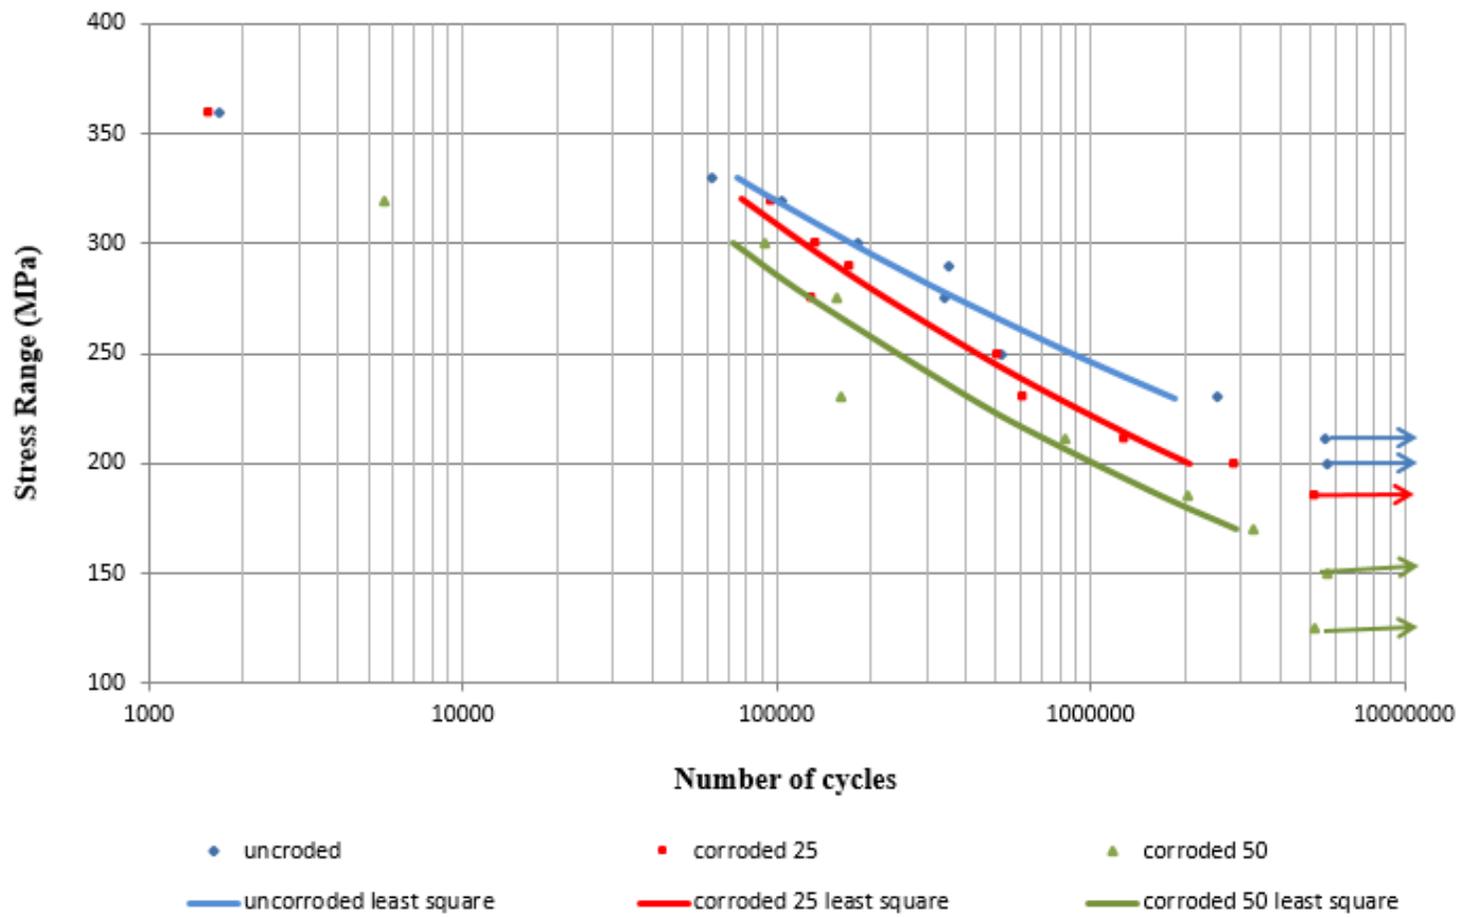
Figure 4.8. shows S-N curve comparison of the uncorroded and corroded specimen.

Mild Steel Data Set	Basquin Coefficient (A), (MPa)	Basquin Exponent (b)
As received	1161.4	-0.112
Low level of corrosion	1589.5	-0.142
high level of corrosion	1677.5	-0.154

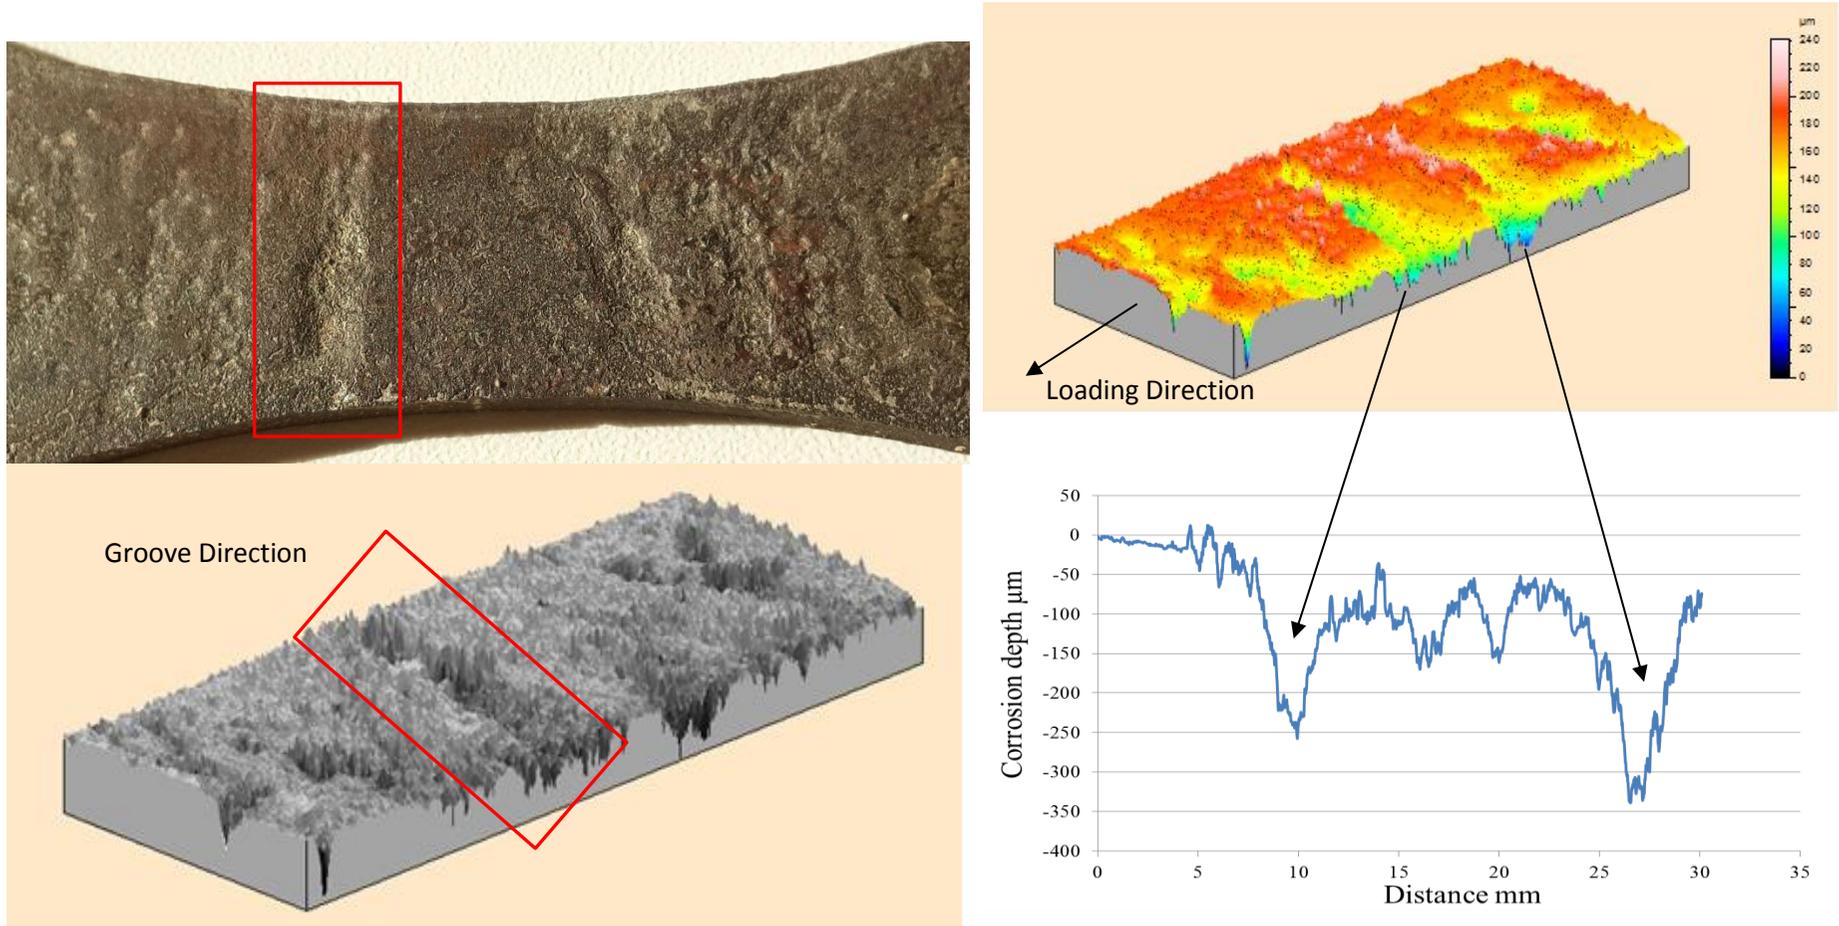
Figure 4.9 Grooves perpendicular to direction of the loading.

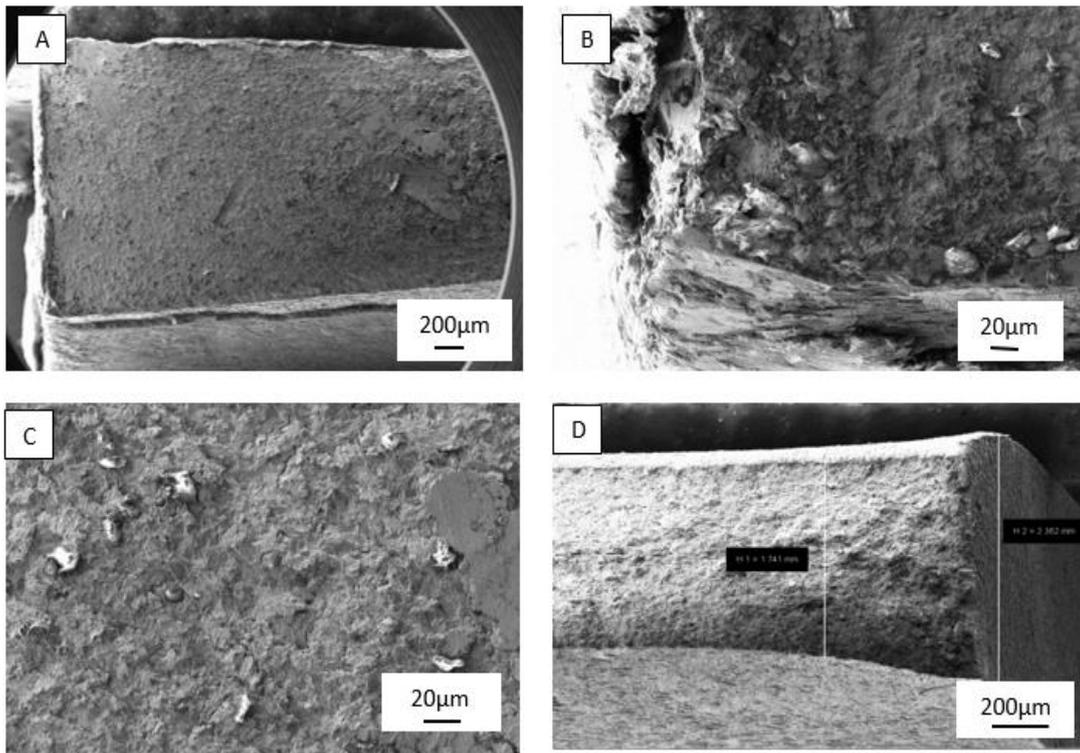
Figure 4.10: SEM micrographs taken from fracture surfaces of fatigue tested specimens Case I (a) showing the general appearance and no necking (b) indicates the crack initiation corner opposite to DIC cameras, (c) shows that dimple coalescence was not obvious in the specimen tested at 230MPa (d) indicates ductile fracture and reduction in cross-section.
