*Fatigue of welded high strength steels for automotive
chassis and suspension applications*

Thesis submitted for the degree of Doctor of Philosophy

Cardiff University

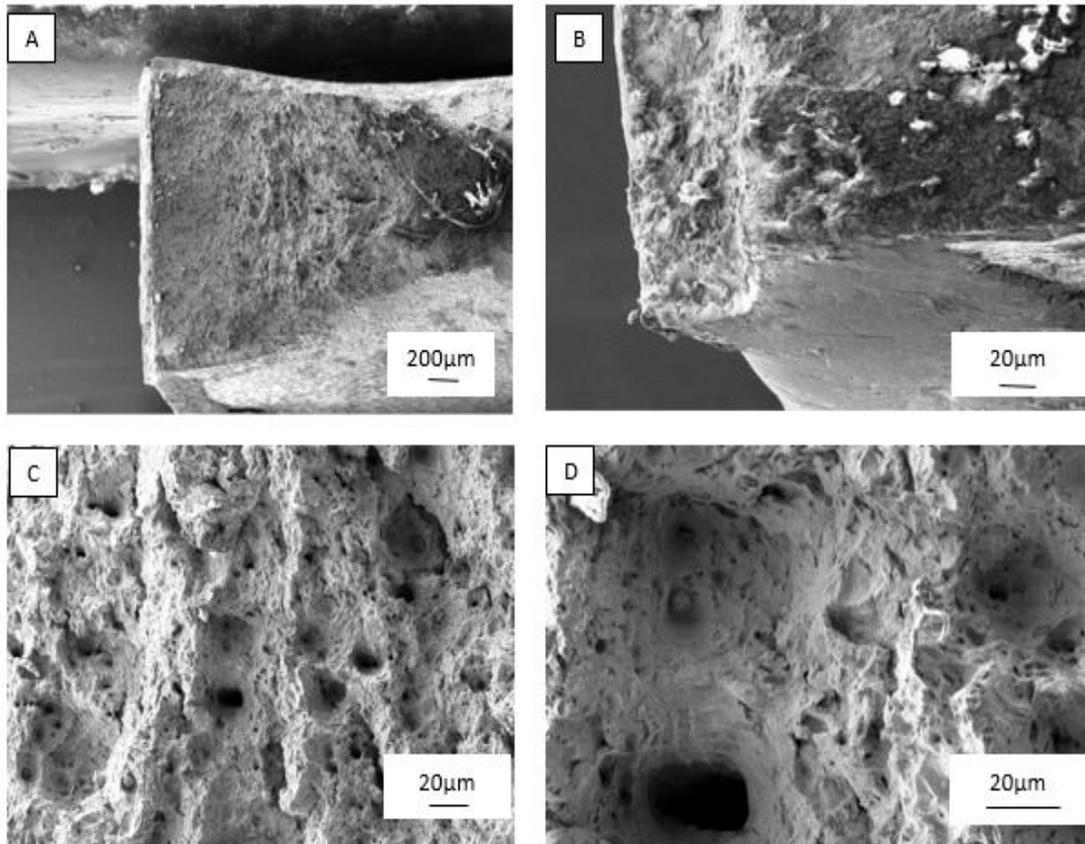
Figure 4.11: SEM micrographs taken from fracture surfaces of fatigue tested specimens Case II (a) showing general appearance and necking, (b) site of crack initiation (c and d) indicates elongated shape of some voids and dimple coalescence.

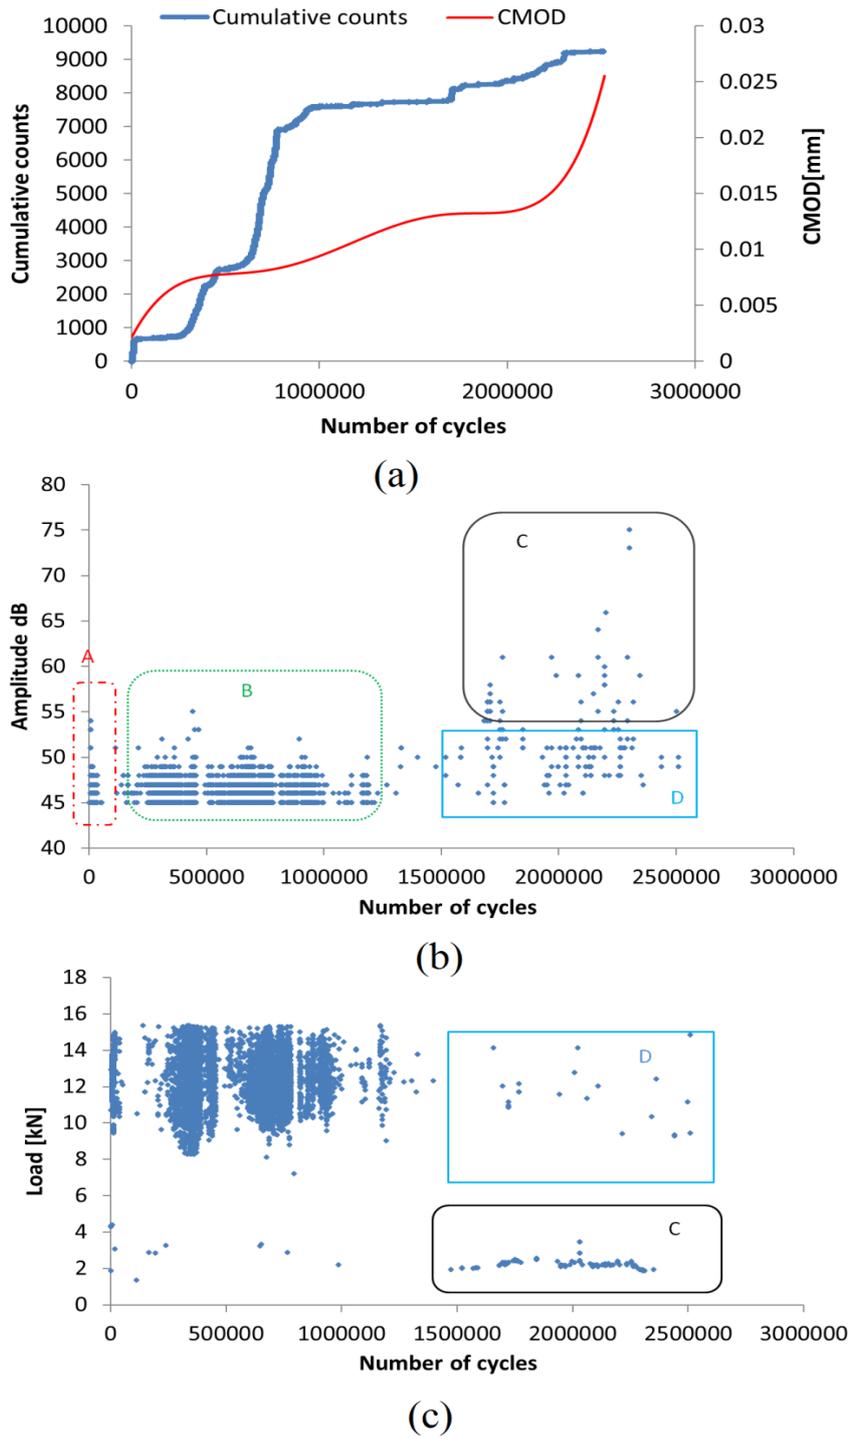
Figure 4.12: (a) Cumulative counts on primary axis and CMOD on secondary (b) Amplitude (c) Load vs Number of cycles for uncorroded specimen under 230MPa Case I.

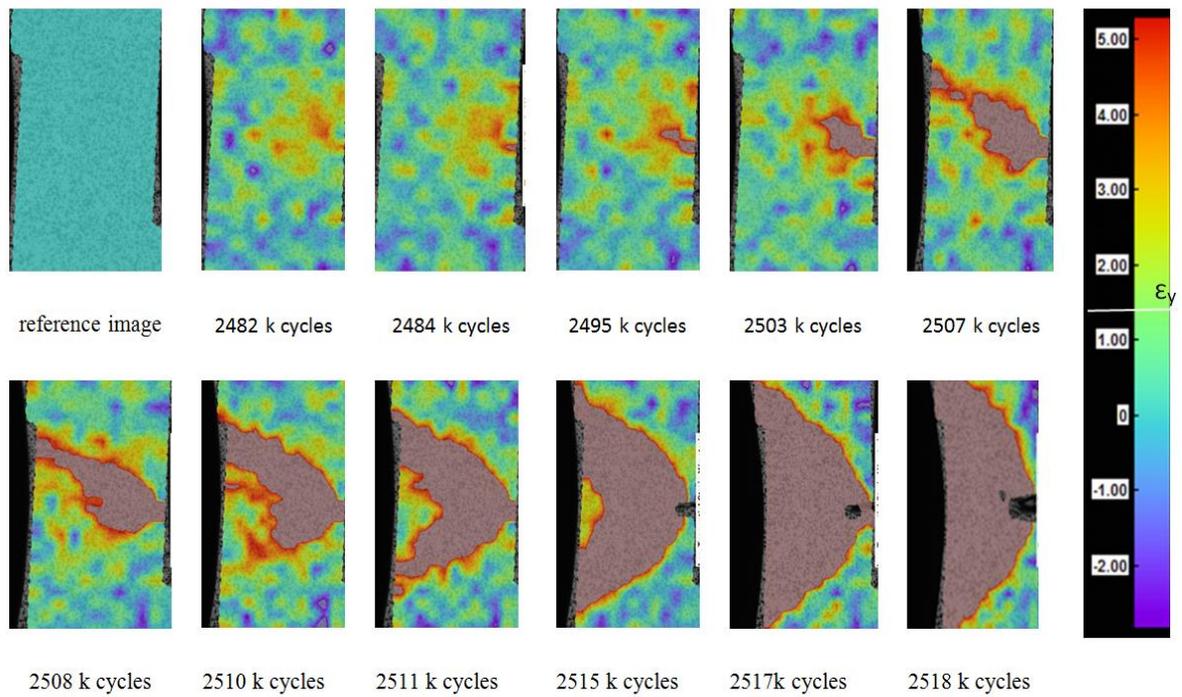
Figure 4.15. Development of microstrain during fatigue loading for case I.

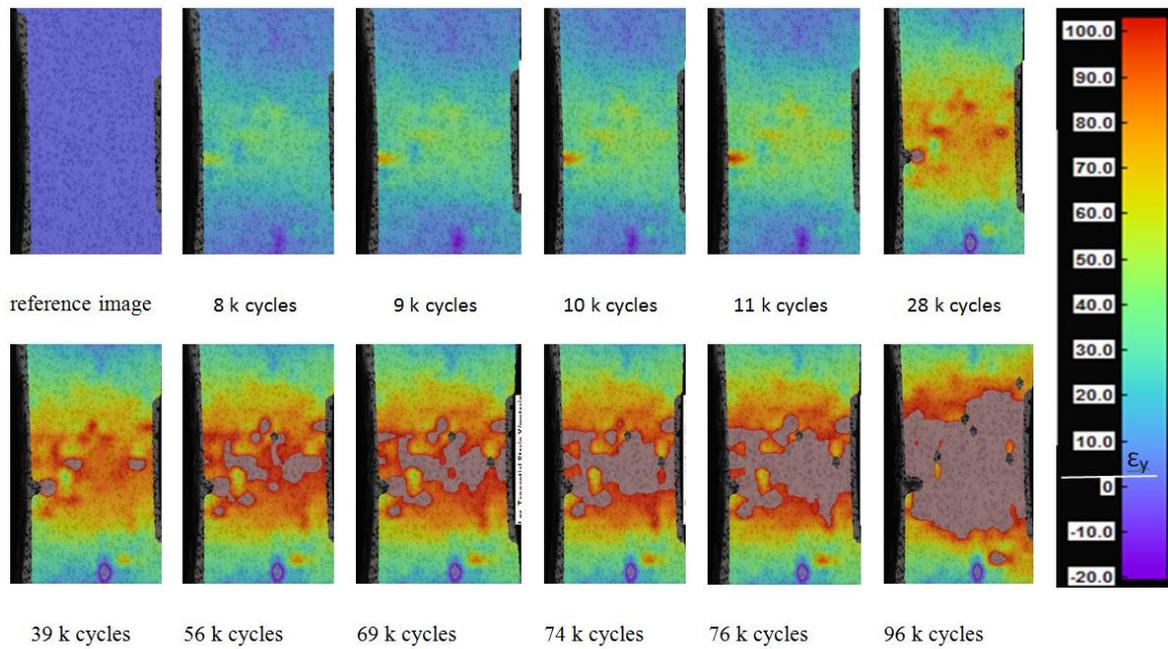
Figure 4.16. Development of microstrain during fatigue loading for case II.

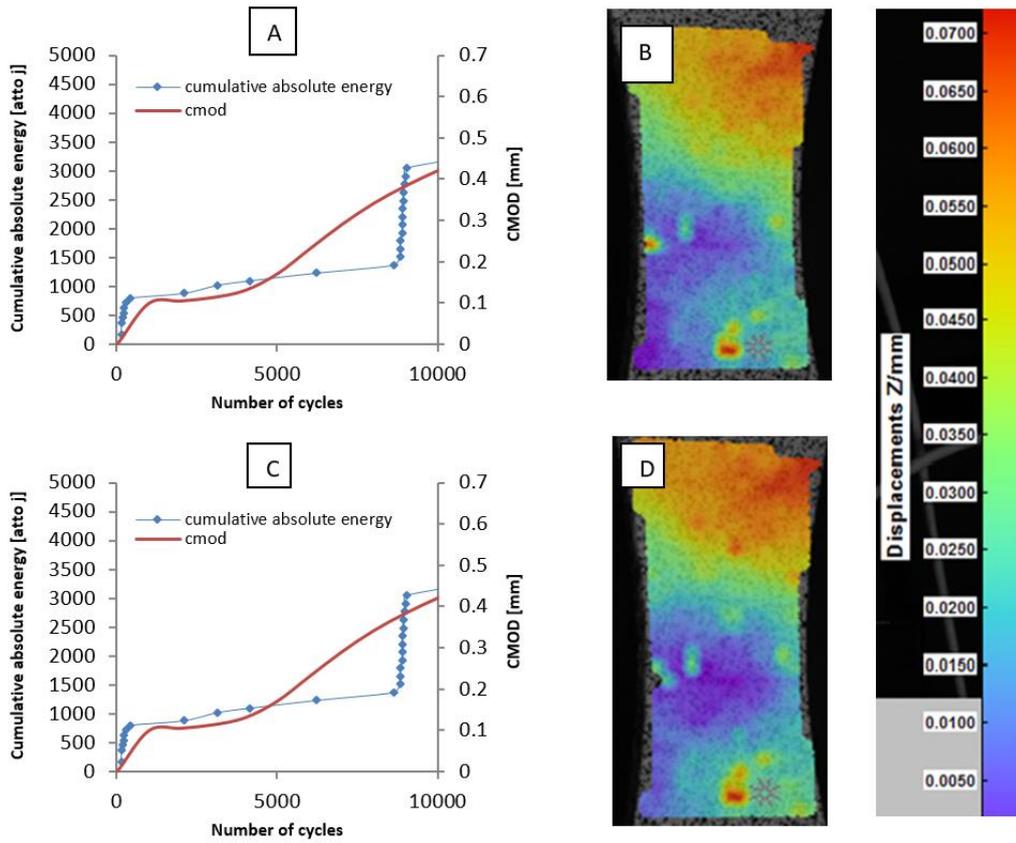
Figure 4.17. (a) Focused view of Figure 4.13 at 8 k cycle and (b) corresponding DIC images (c) focused view at 16 k cycle (d) DIC images at 16 k cycle.

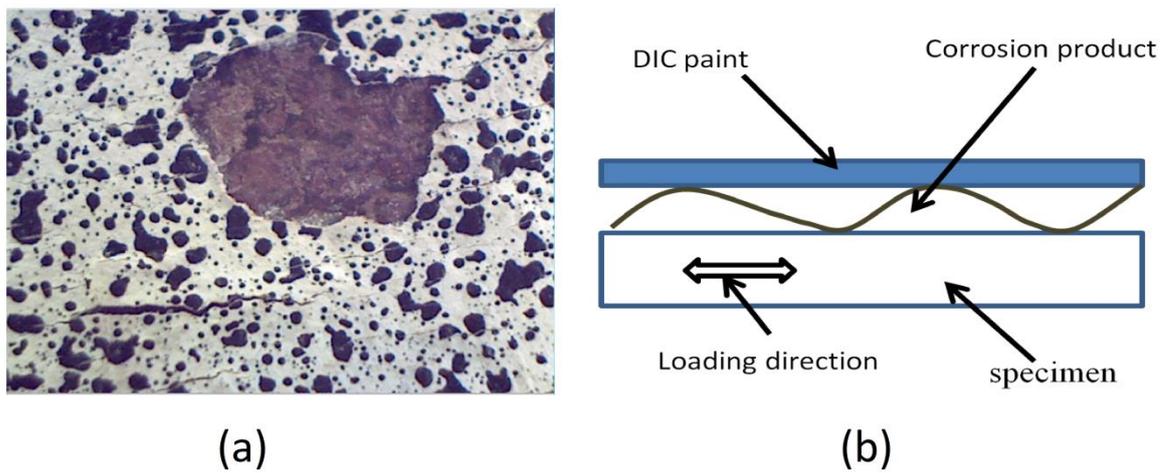
Figure 4.18. Schematic explain the rubbing of the damaged corrosion product underneath DIC paint with specimen surfaces around the crack path.

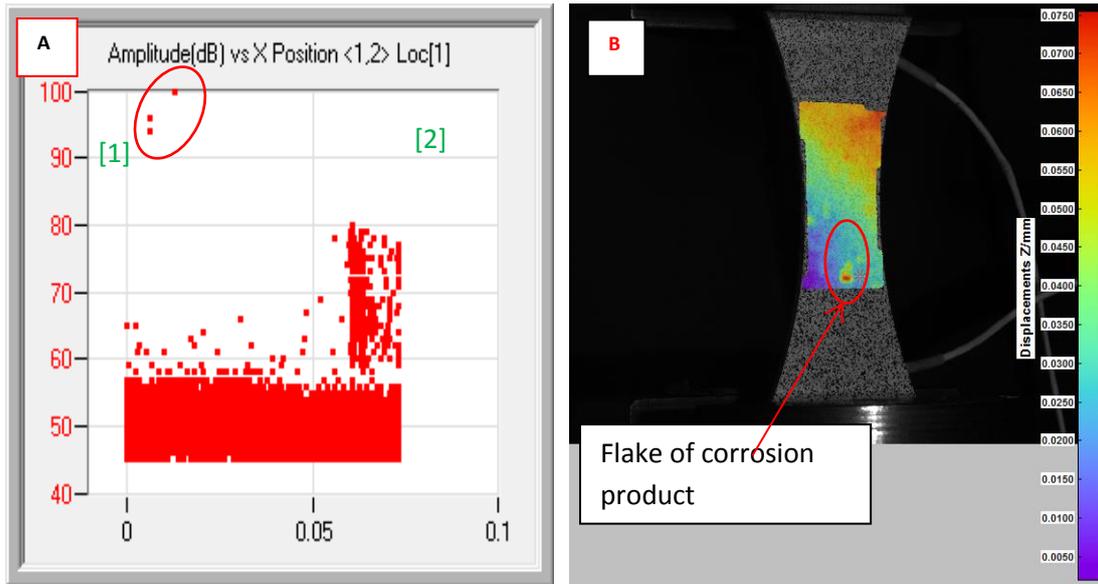
Figure 4.19: reveals the flake in the corrosion product by DIC and AE methods.

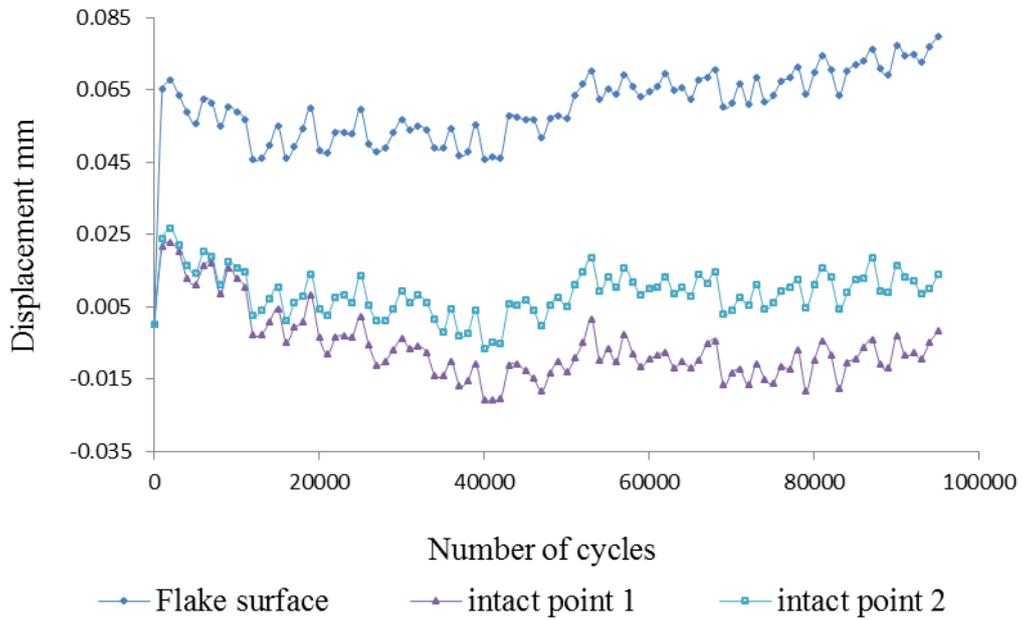
Figure 4.20. Out of plane displacement for intact and flake surface.

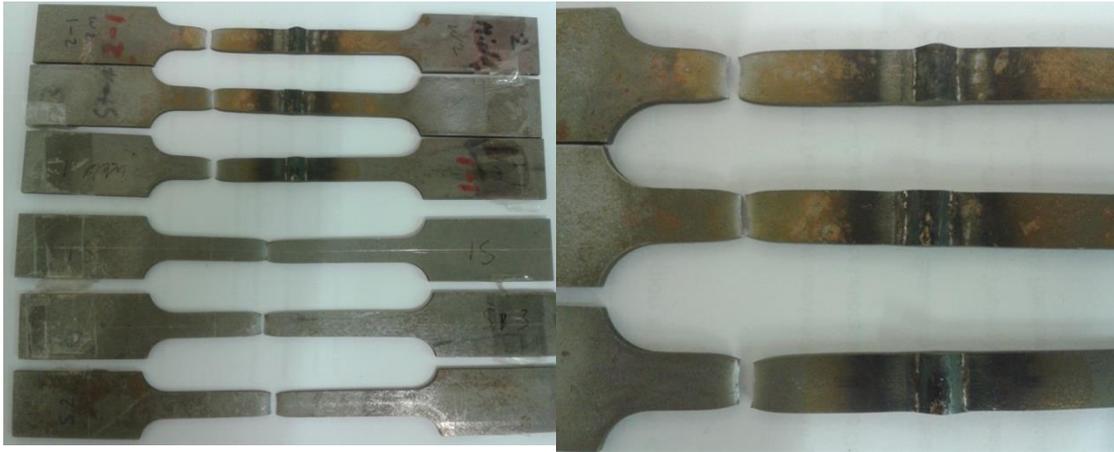
Figure 5.1: (a) Failed un-welded and welded tensile specimens after test (b) welded specimens failed in base metal region.

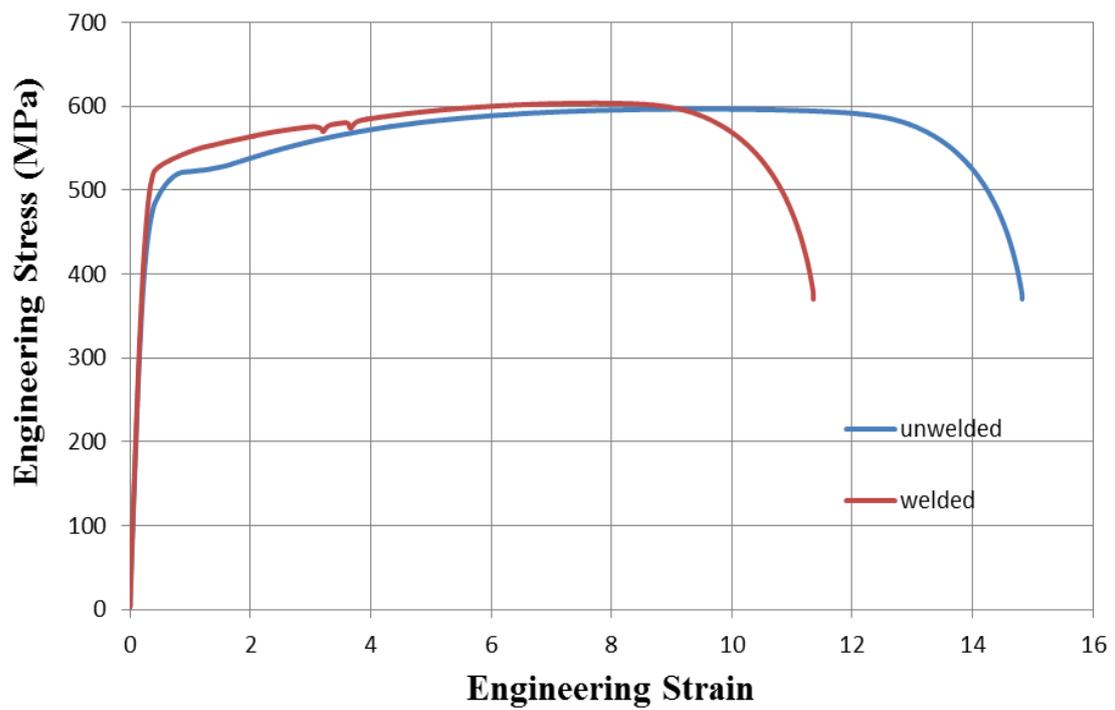
Figure 5.2: Tensile performance of MIG welded FB590.

Ident. Mark	Width mm	Thickness mm	Area mm.2	0.2% Proof.	Ultimate	Elongation	Elastic Modulus kN/mm2
				Stress N/mm.2	Stress N/mm.2	%	
1	19.32	2.678	51.73896	495.62	617.6	21.13	155.2
2	19.313	2.696	52.06785	492.43	616.4	18.72	167.3
3	19.313	2.738	52.87899	489.49	608.98	19.79	169.2
4	19.321	2.746	53.05547	488.71	603.67	20.95	139
5	19.351	2.748	53.17655	483.79	605.18	22.13	171.9
6	19.365	2.755	53.35058	483.23	599.3	20.26	155.1
7	19.37	2.682	51.95034	489.94	612.76	19.18	166.8
8	19.382	2.656	51.47859	492.92	6013.41	20.01	155.5
Average				489.51	609.66	20.27	160

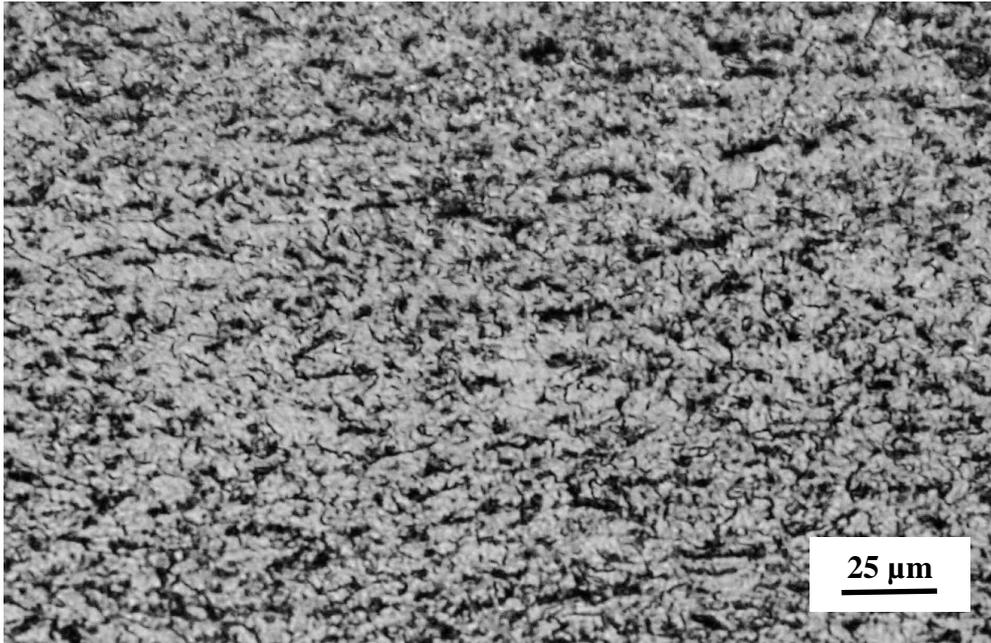
Figure 5.5: Base material micrograph (FB590).

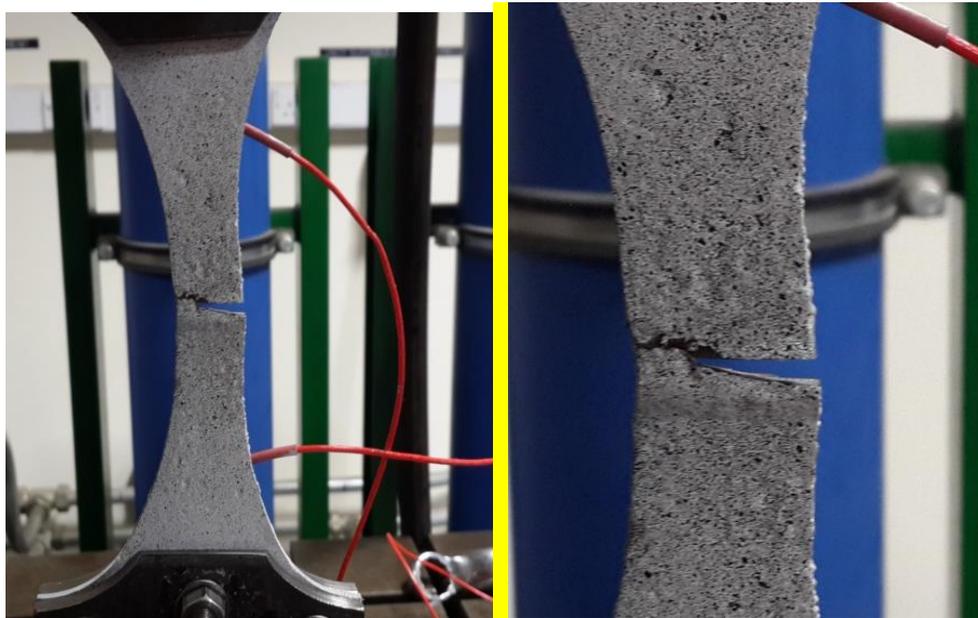
Figure 5.14: Photo of failed test specimen.

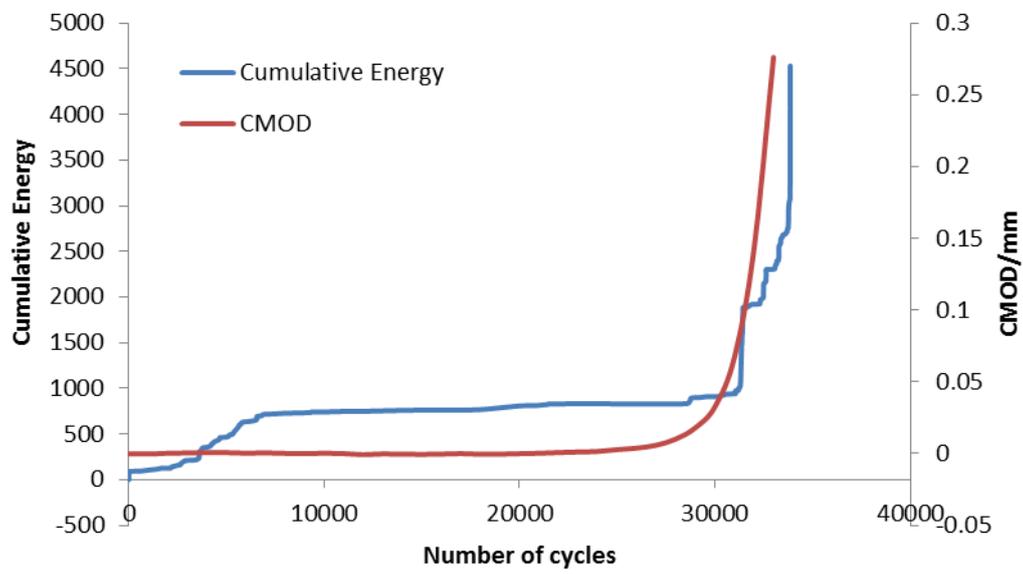
Figure 5.16: Trend of event rate for fatigue test and CMOD.

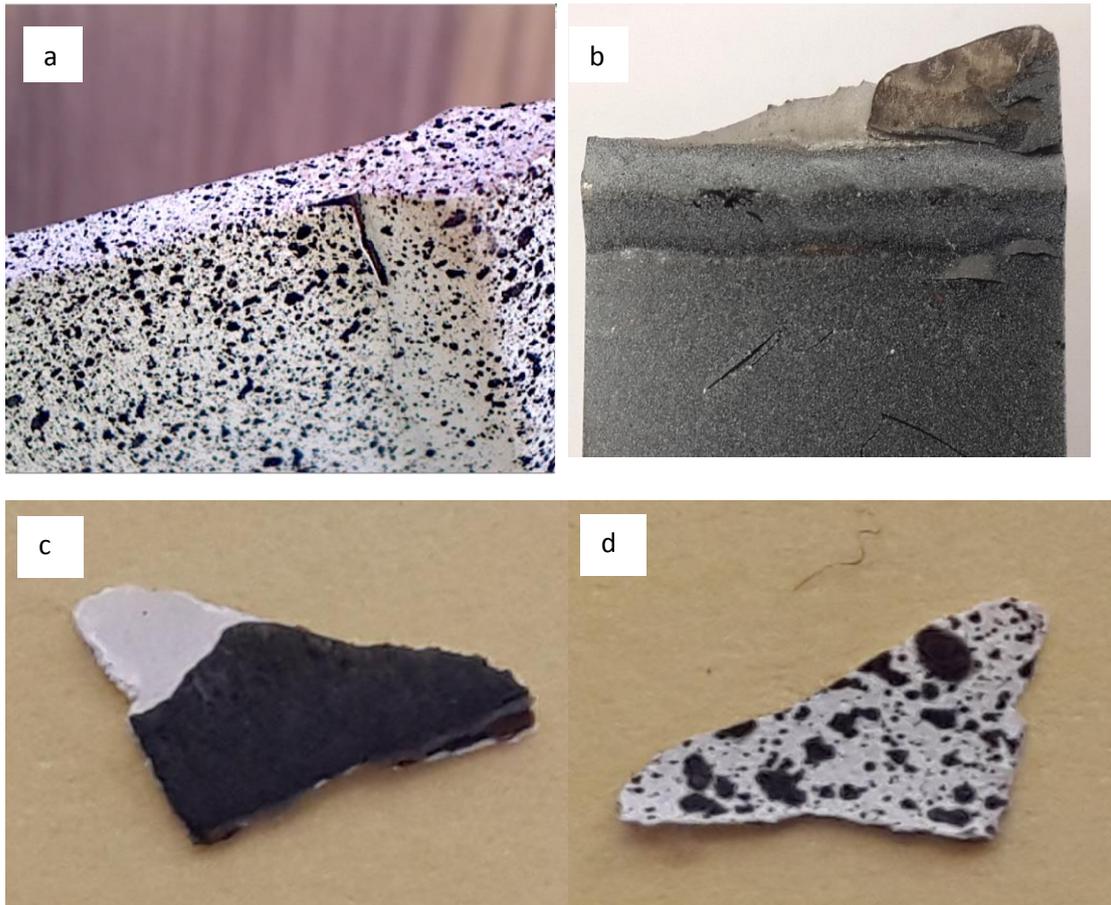
Figure 5.18: specimen after fracture (a) front side (b) rear side which is opposite side to DIC cameras (c,d) reveals the flake in the ecoating layer and DIC paint.

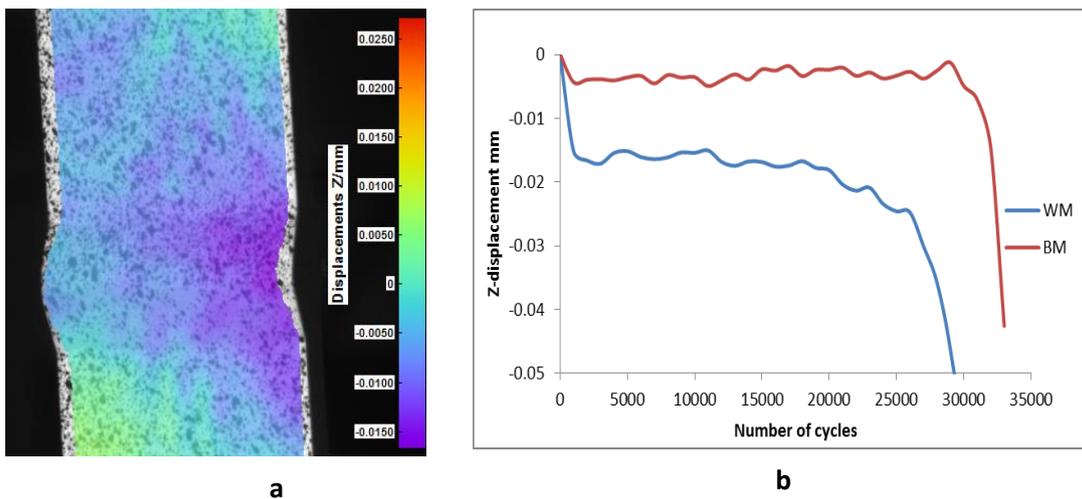
Figure 5.19: (a) reveals the flake in the DIC paint (b) Out of plane displacement for base metal and weld surface.

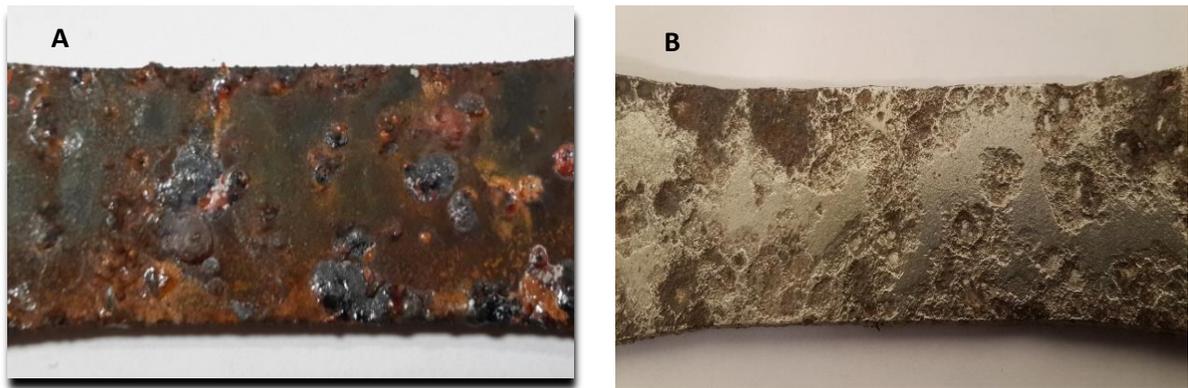
Figure 6.8: The typical appearance of the specimens (a) before and (b) after removing the rust.

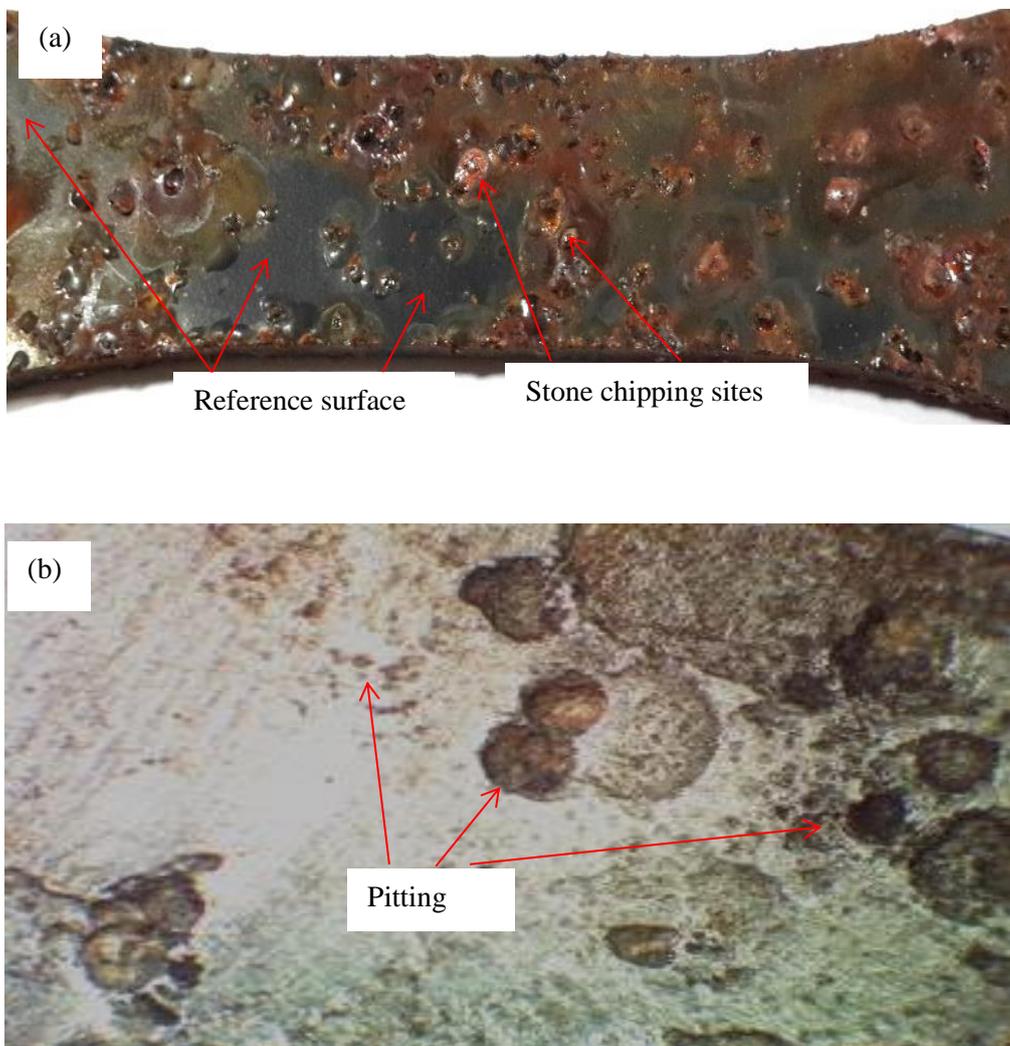
Figures 6.9: (a) shows the unaffected surface (ecoated) was considered as a reference surface, (b) Stereo optical microscope image of corroded surface.

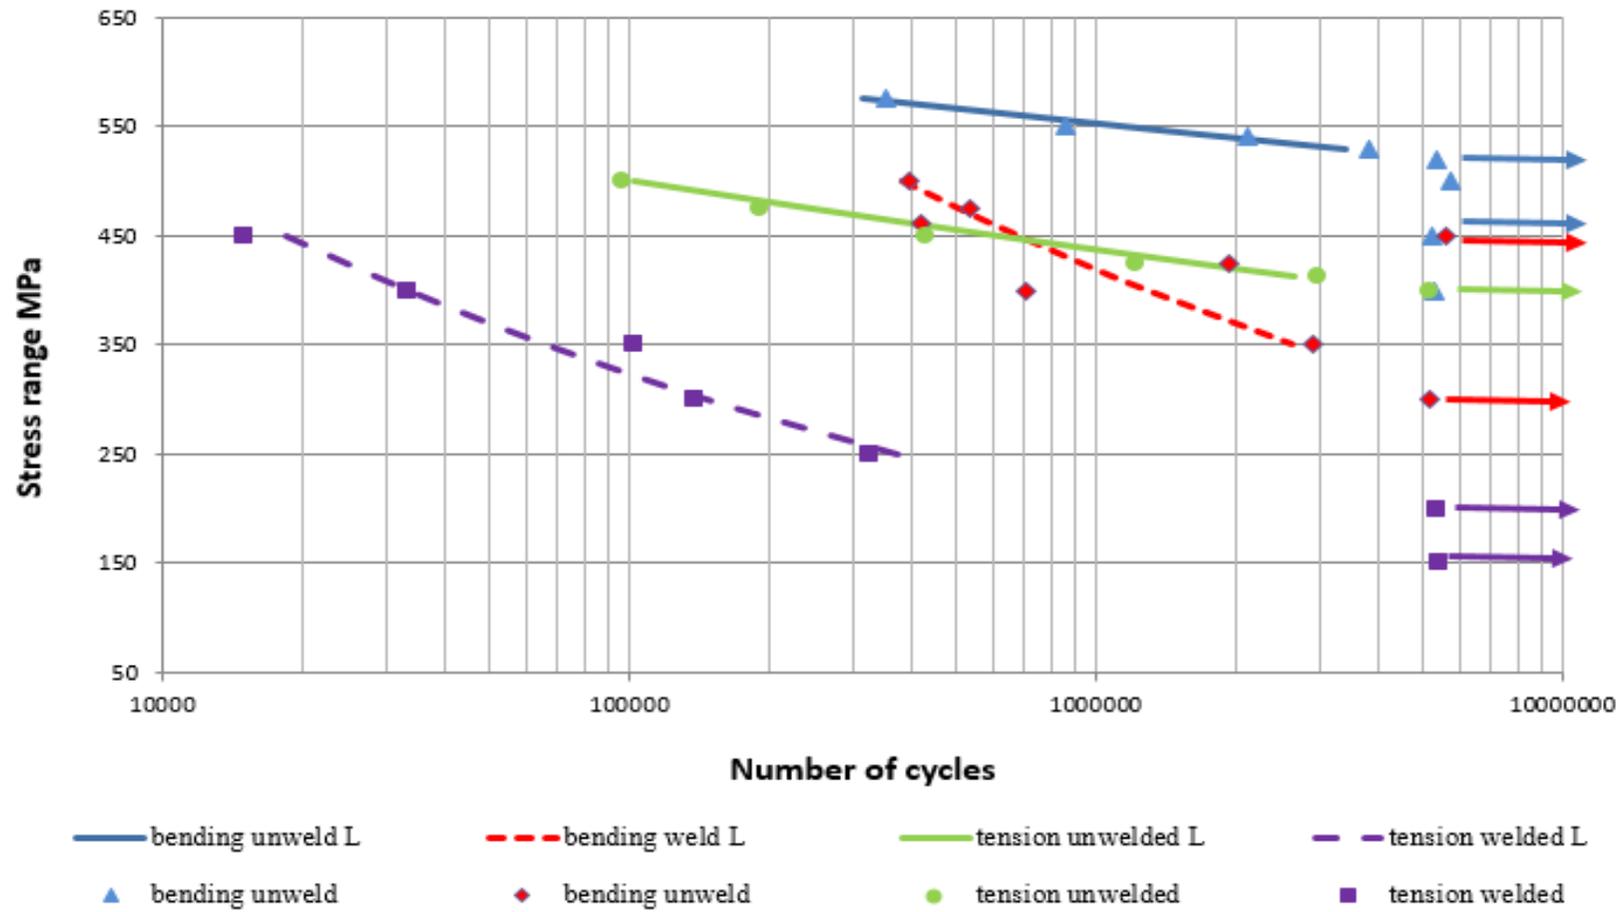
Figure 6.10: All S-N curves of Group 1.

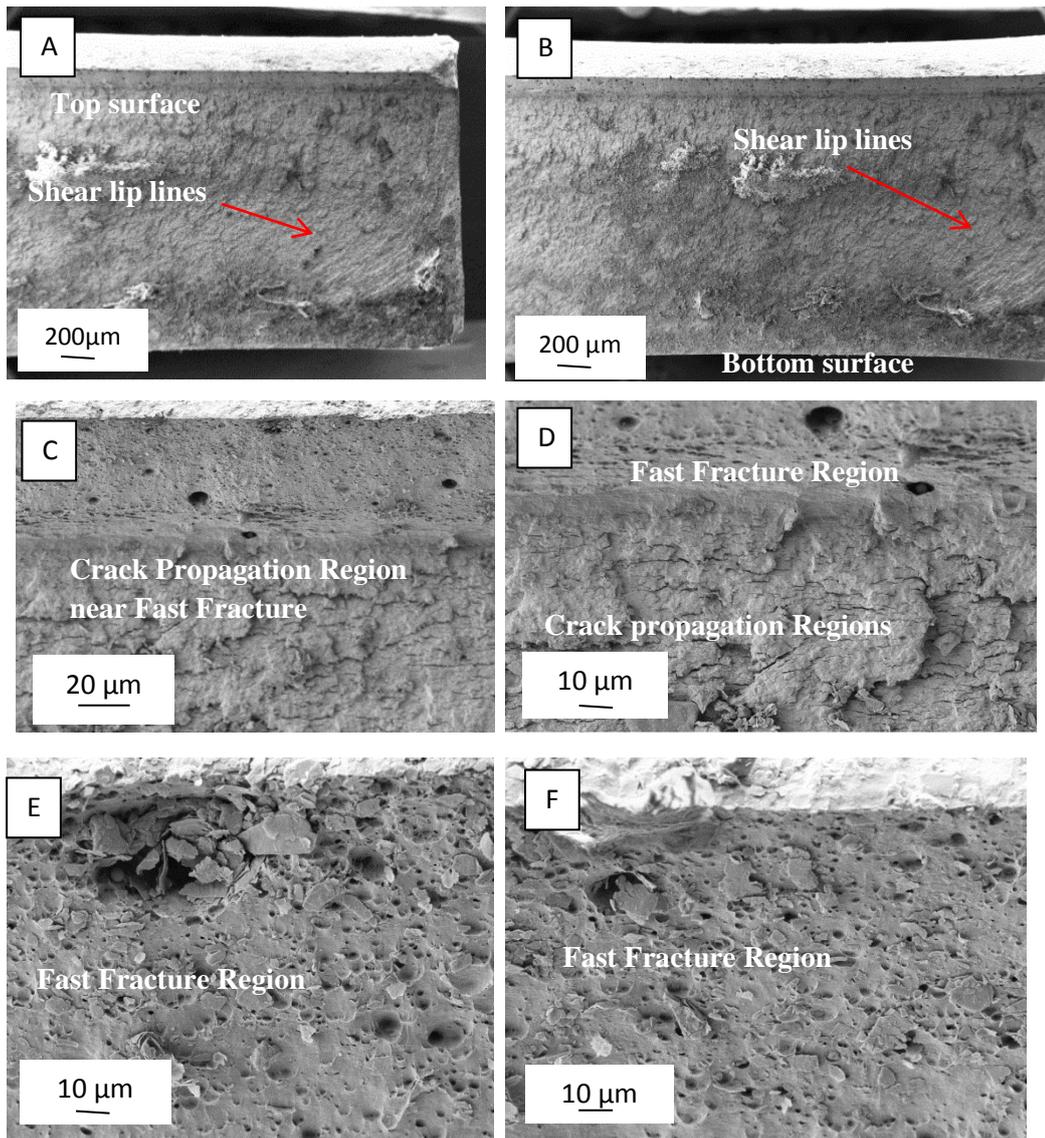
Figure 6.20 SEM micrographs taken from fracture surfaces of bending fatigue specimens where the stone chipping was on the top surface (a) shear lip lines general appearance (b) indicates ductile fracture in the last stage of the test, (c) The boundary between the fast-fracture and crack propagation regions, (d) fatigue striations in the crack-propagation region (e ,f) Fast-fracture region, non-uniform small and large dimples.

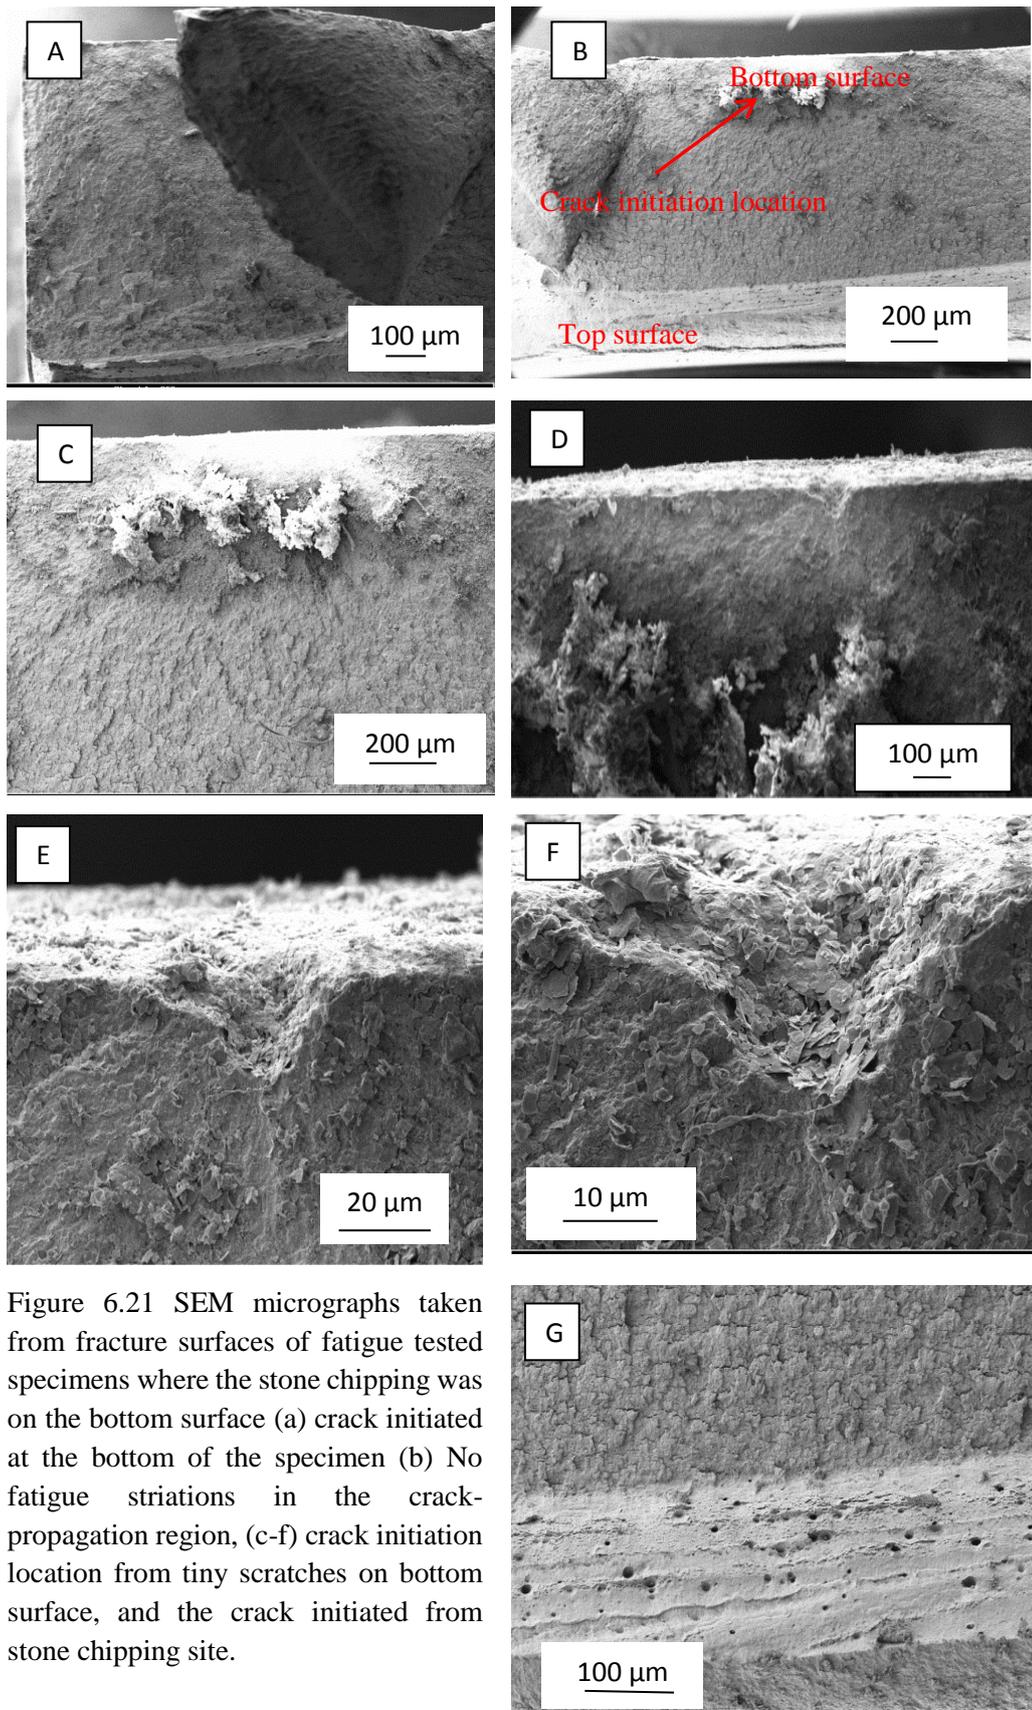
Figure 6.21 SEM micrographs taken from fracture surfaces of fatigue tested specimens where the stone chipping was on the bottom surface (a) crack initiated at the bottom of the specimen (b) No fatigue striations in the crack-propagation region, (c-f) crack initiation location from tiny scratches on bottom surface, and the crack initiated from stone chipping site.

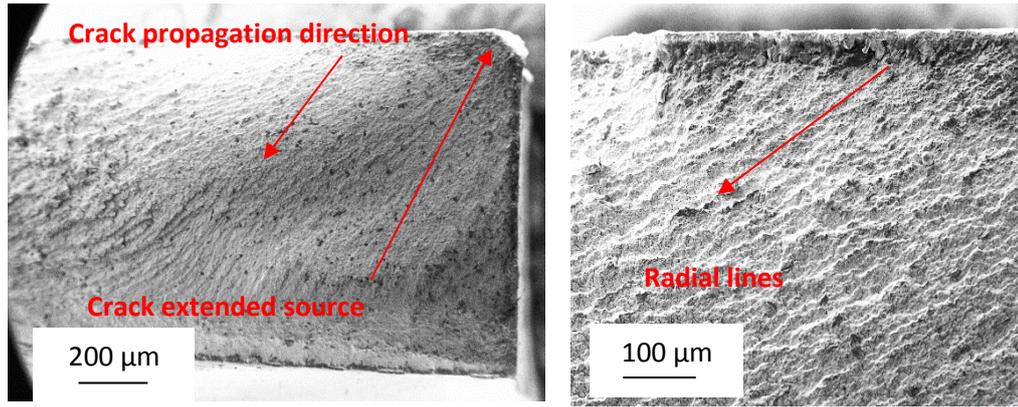
Figures 6.22: (a) An overview of the fracture surface micrograph of the uncorroded specimens (b) show the radial lines towards the left down direction.

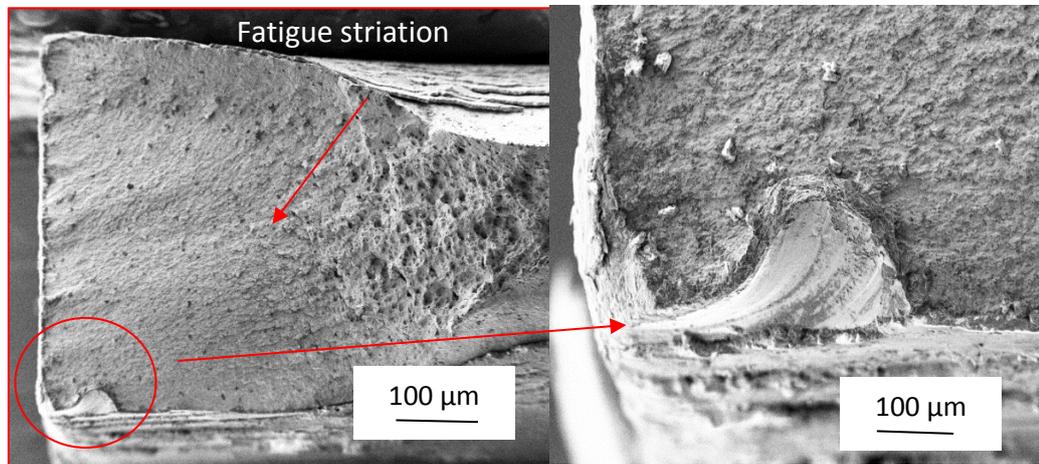
Figure 6.23: overview and a closer view showing fatigue fracture started from stone chipping site.

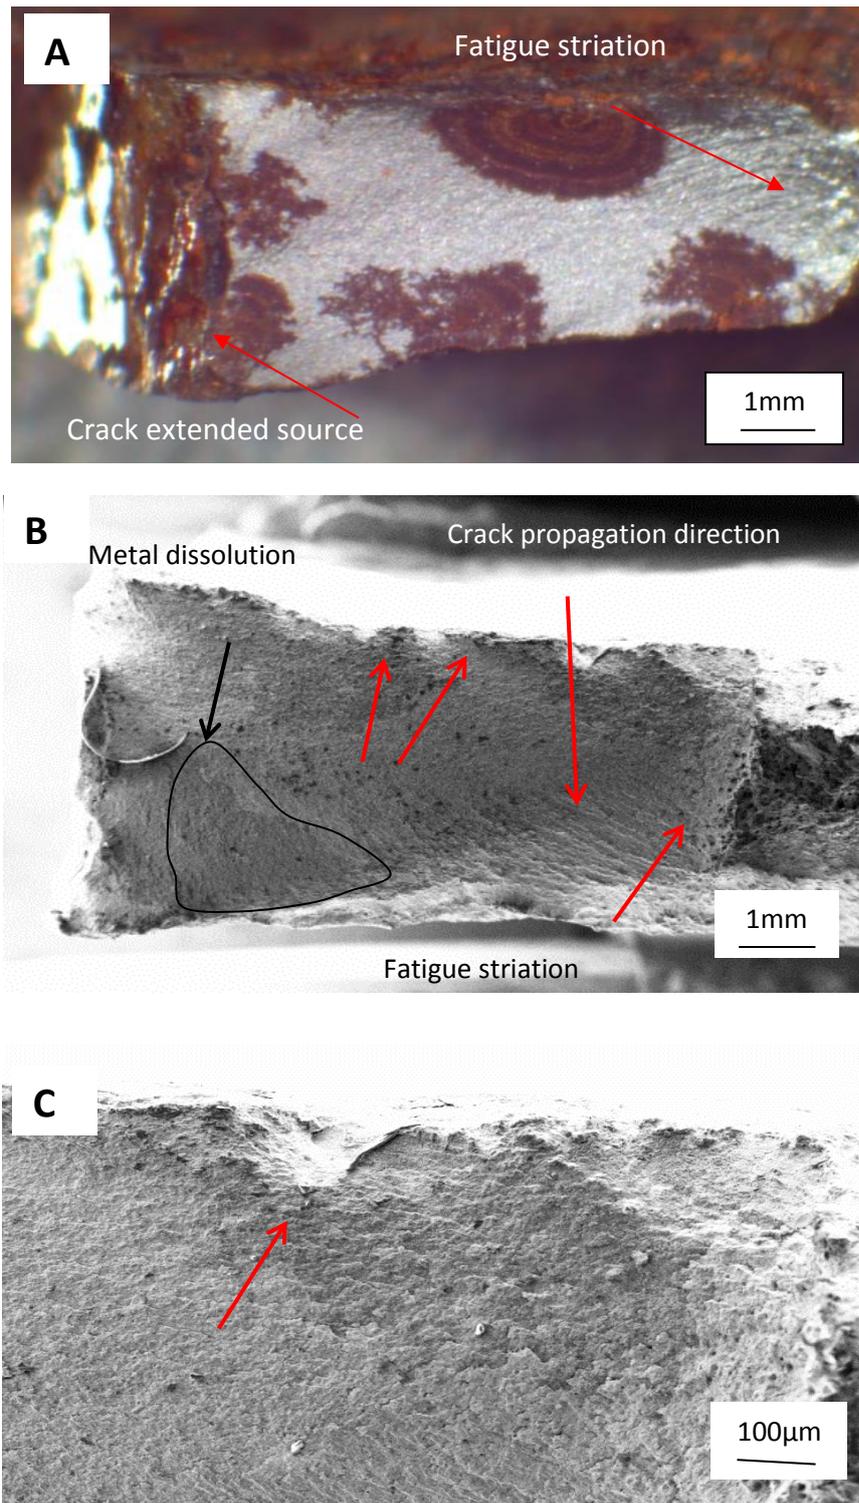
Figure 6.24: An overview of the fracture surface for corroded specimen. Pits are shown in the exposed surface to the slate solution. Arrows indicate location of several pits at the fracture surface.

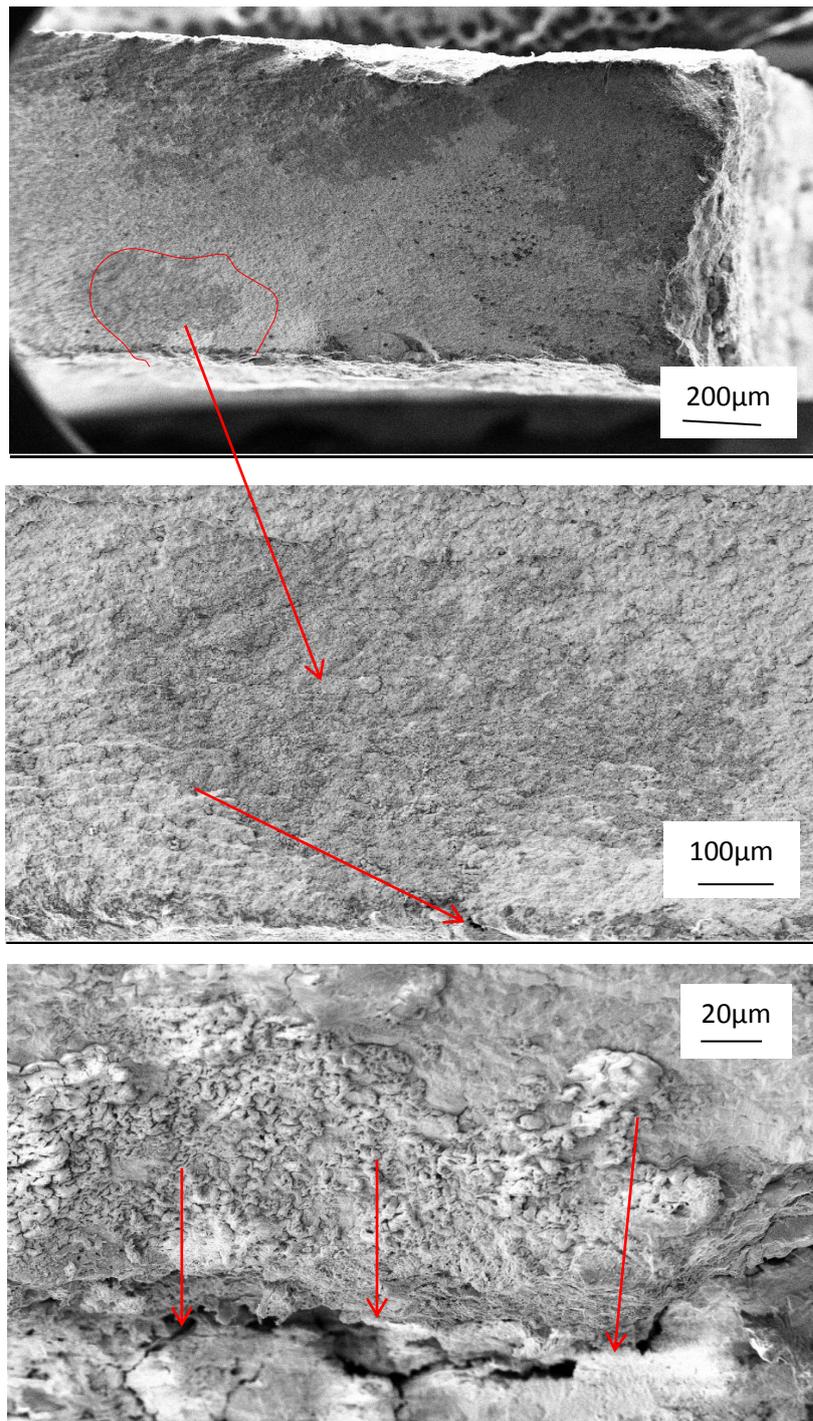
Figure 6.25: SEM micrographs for specimen showing (a) An overview of the fracture surface for corroded specimen (b & c) tunnelling and subsurface pitting, arrows indicate direction of subsurface pit growth by tunnelling.

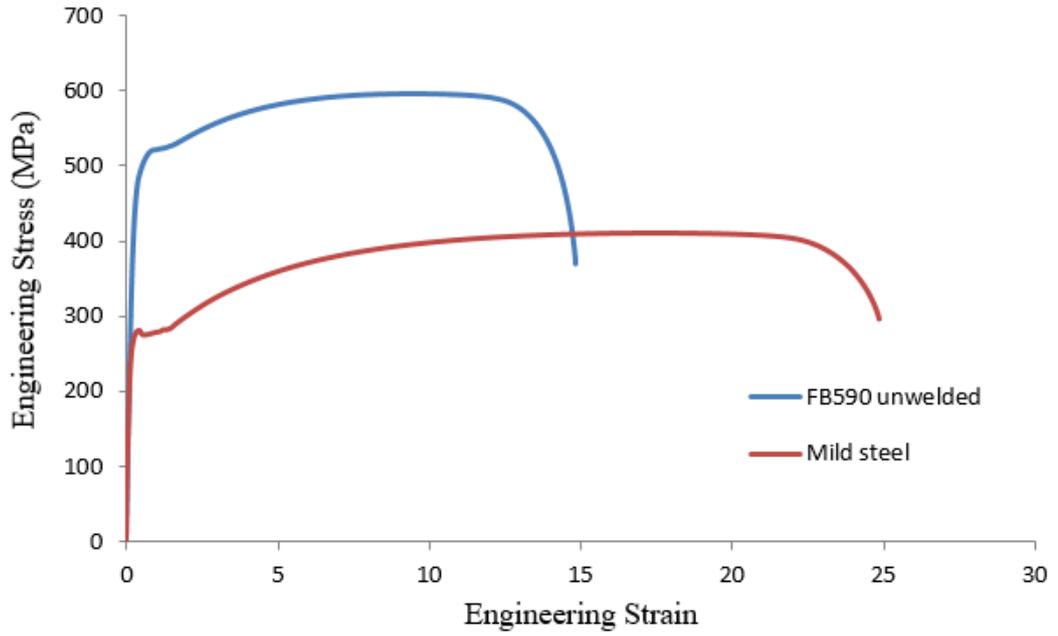
Figure 7.1 comparison between tensile properties of mild steel and FB590.
