*Fatigue of welded high strength steels for automotive
chassis and suspension applications*

Thesis submitted for the degree of Doctor of Philosophy

Cardiff University

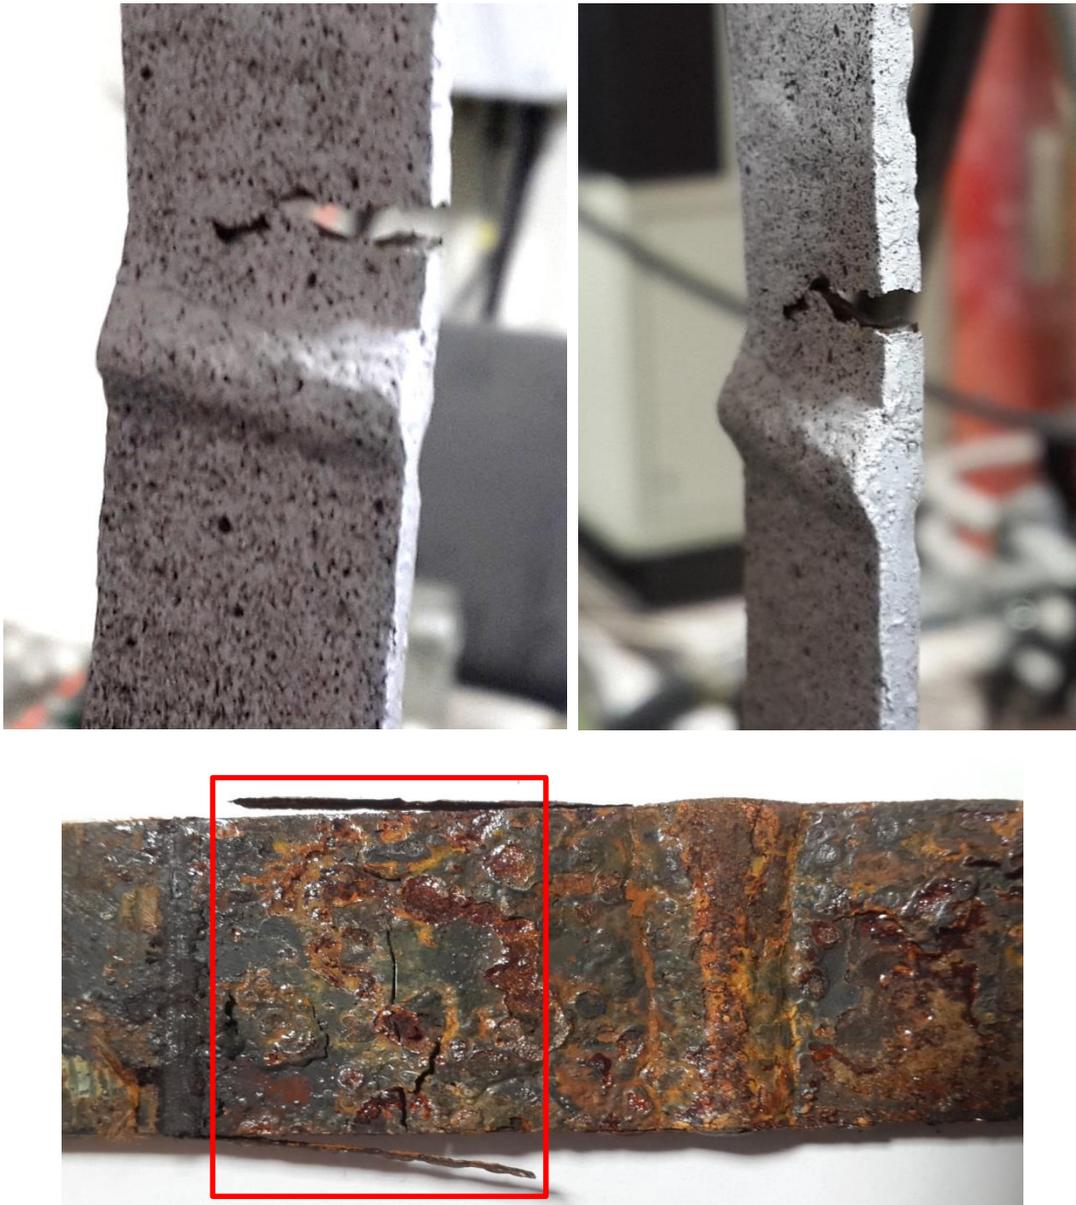
Figure 7.12: shows specimen fracture far from the welding location (a) tension specimen (b) bending specimen.

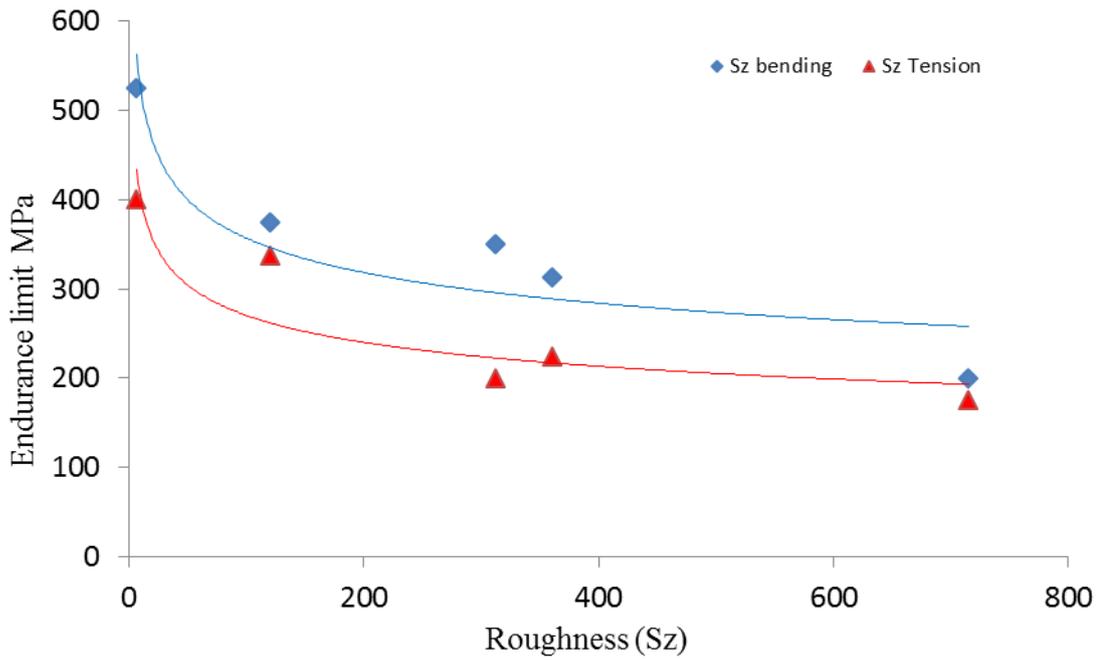
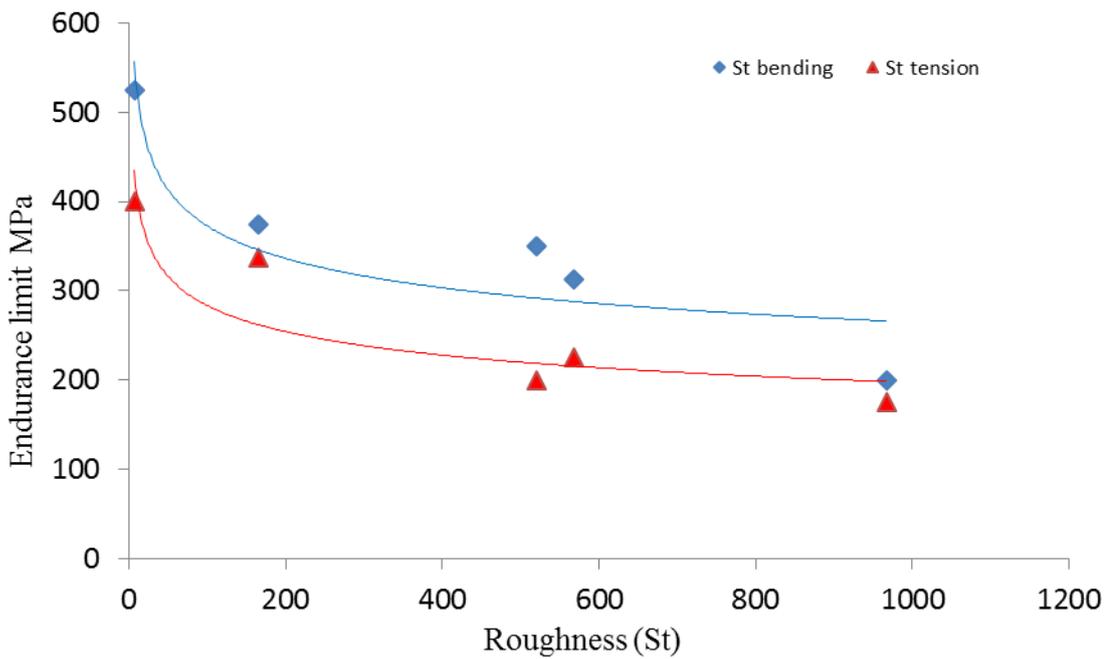
Figure 7.13 shows endurance limit of FB590 vs roughness parameters (a) S_z Maximum height of the asperities (b) S_t Maximum height of the profile.

Figure 7.14: shows endurance limit of mild steel vs Roughness parameter (a) S_z Maximum height of the asperities (b) S_t Maximum height of the profile.

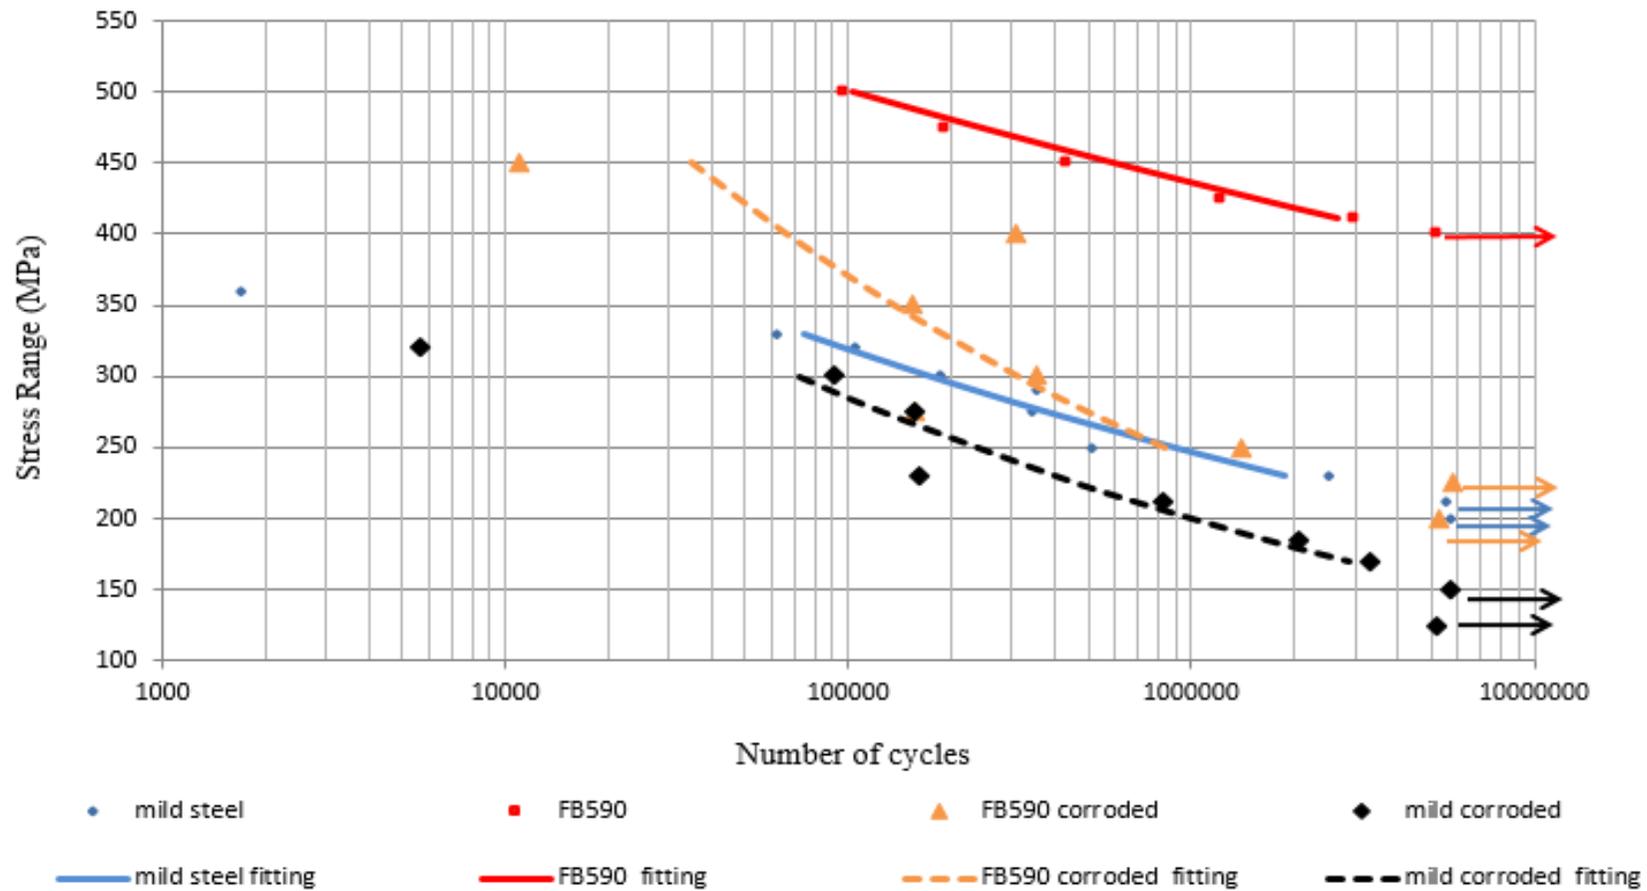
Figure 7.15 shows as received and corrosion for two months of high strength steel and mild steel.

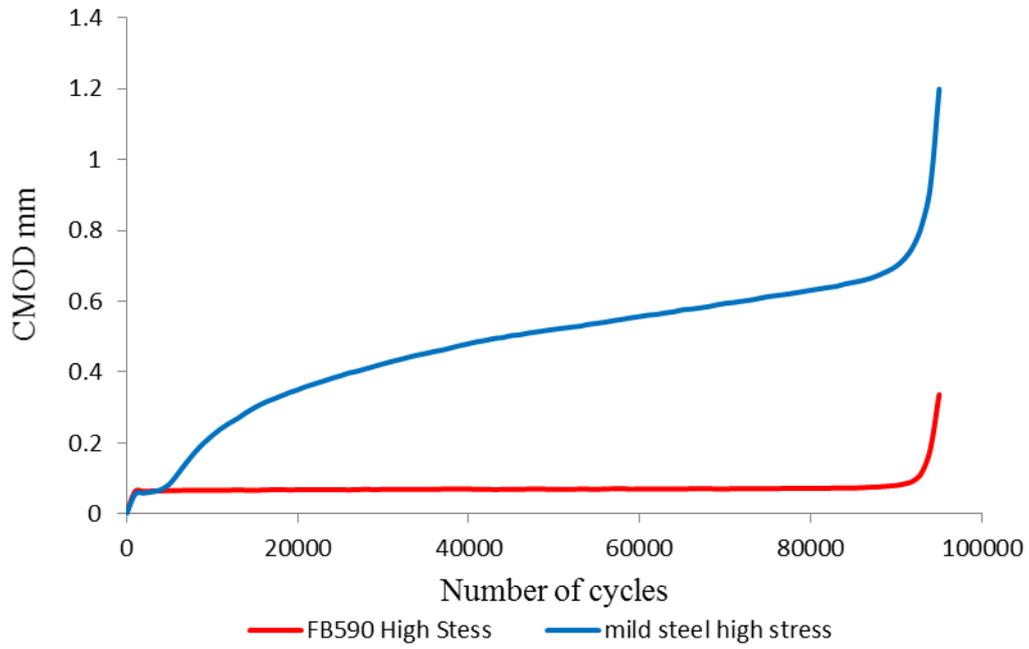
Figure 7.16 crack mouth opening displacement for mild steel and FB590.

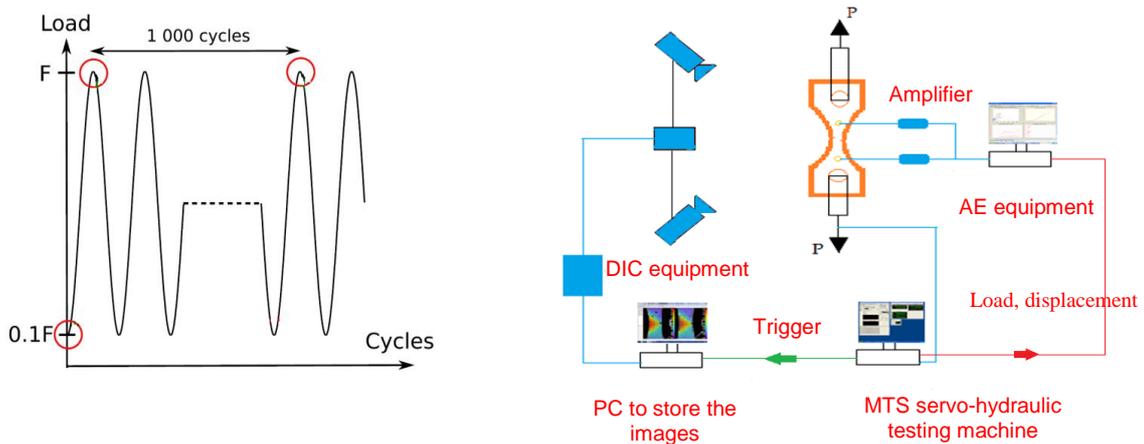
Fig. 2. (a) DIC Image capture during the load history, (b) schematic diagram of fatigue test

The test was stopped at 1000 cycle intervals, peak load applied and DIC images captured as shown in the load history shown in Figure 2a [6, 10]. Figure 2b schematically shows the fatigue specimen is held on pinned joints in a Losenhausen servo-hydraulic testing machine (maximum force 100kN) with an MTS FlexTest controller and equipped with AE and DIC equipment in order to track the crack growth during fatigue test. The relative movement of two pixel subsets for either side of the crack was used to provide a crack mouth opening displacement (CMOD) measurement in order to validate and support the understanding of the collected AE data. Using DIC offers significant advantages over foil crack gauges and traditional crack mouth opening displacement gauges. Both these traditional methods can introduce acoustic emission sources into the experiment either through glue cracking in foil gauges or frictional noises from the CMOD gauge contact point with the specimen. DIC images were collected every 1000 cycles using a Dantec Dynamics Q-400 system which was triggered from the MTS controller while holding briefly at maximum load.

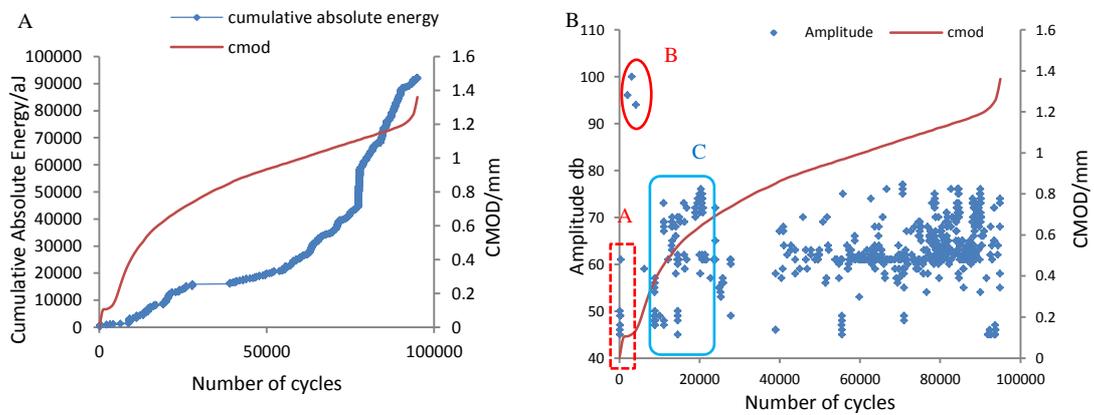
Fig. 3. (a) Cumulative absolute energy (b) Amplitude on primary axis and CMOD on secondary axis vs number of cycles for corroded specimen under 320MPa maximum stress

Here it was observed that the plastic deformation effect was accompanied by pronounced AE activity due to the dislocation glide and deformation twinning [15, 16]; this is clear from the significant AE activity at the onset of the test which is represented by group A (dashed line rectangle) in Figure 3b. It can be seen from this figure that those signals which are emitted from plastic deformation had an amplitude of around 45-50 dB, which agrees with the findings of Barsoum [13].

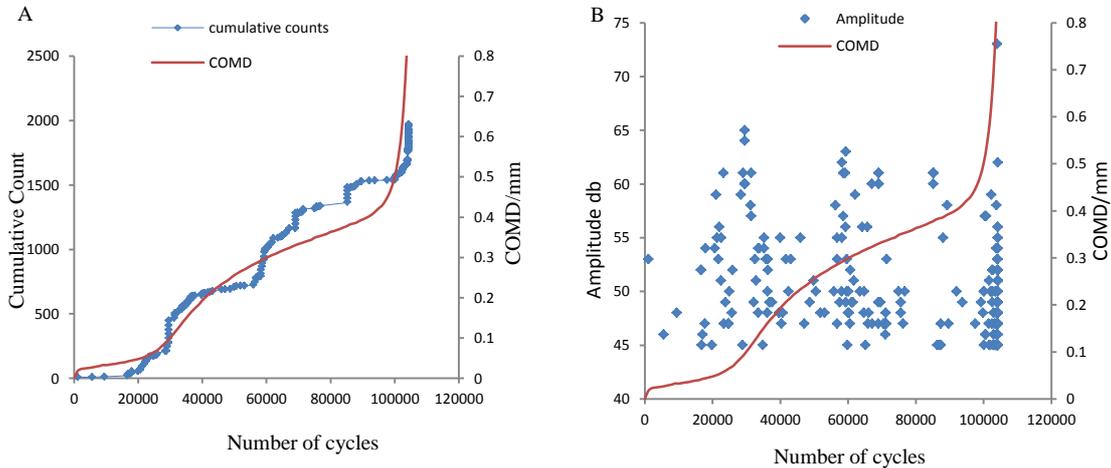
Fig. 4. (a) Cumulative counts (b) Amplitude on primary axis and COMD on secondary axis vs number of cycles for un-corroded specimen under 320MPa maximum stress

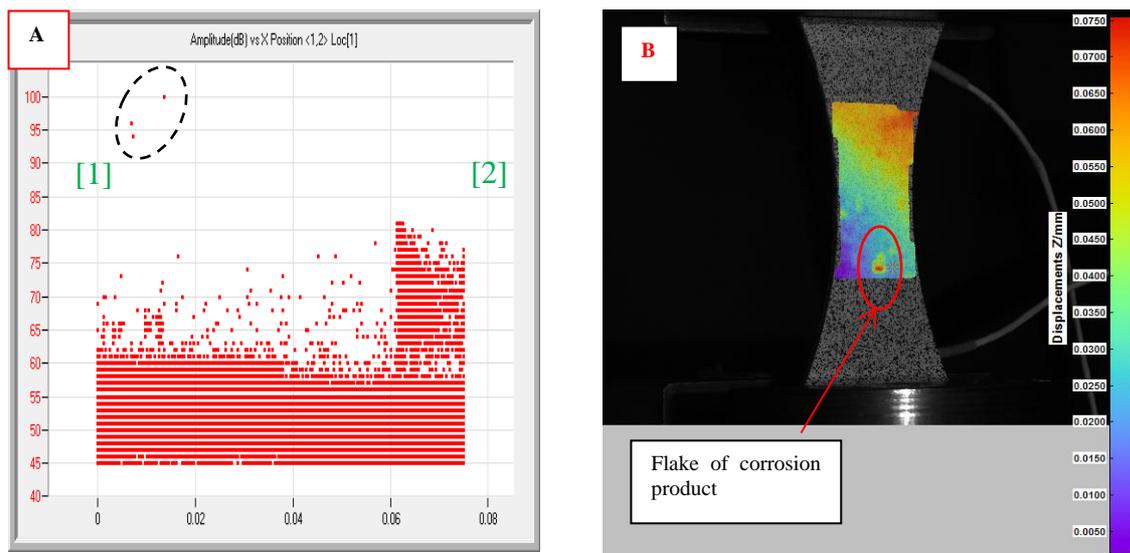
Fig. 5. reveals the flake in the corrosion product by DIC and AE methods

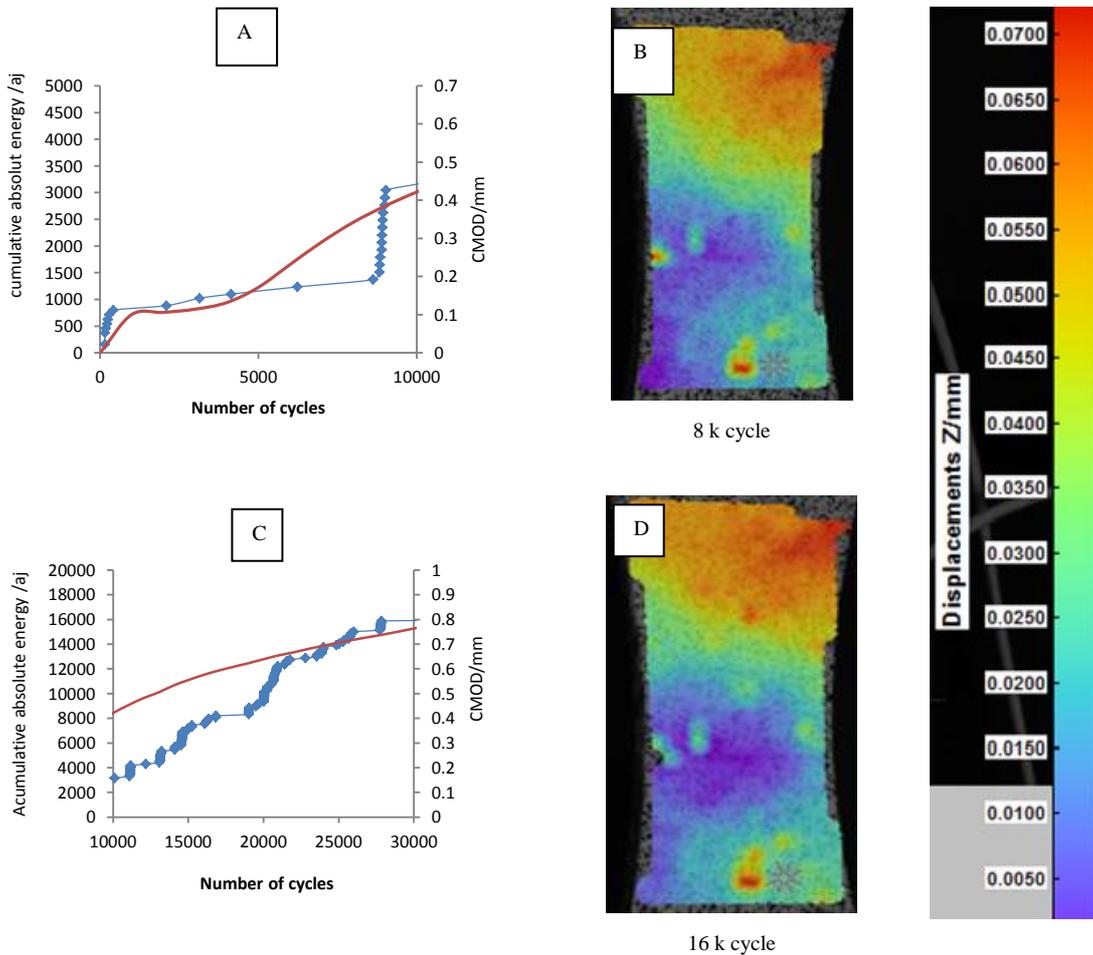
Fig. 7. Focused view of Figure 3 and corresponding DIC images

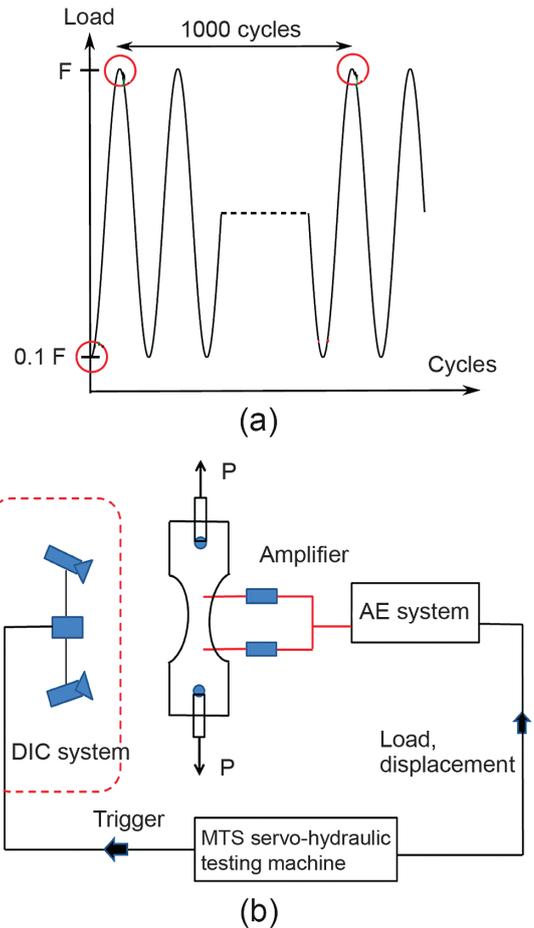
Figure 2. (a) DIC image capture during the load history; (b) schematic diagram of the fatigue test

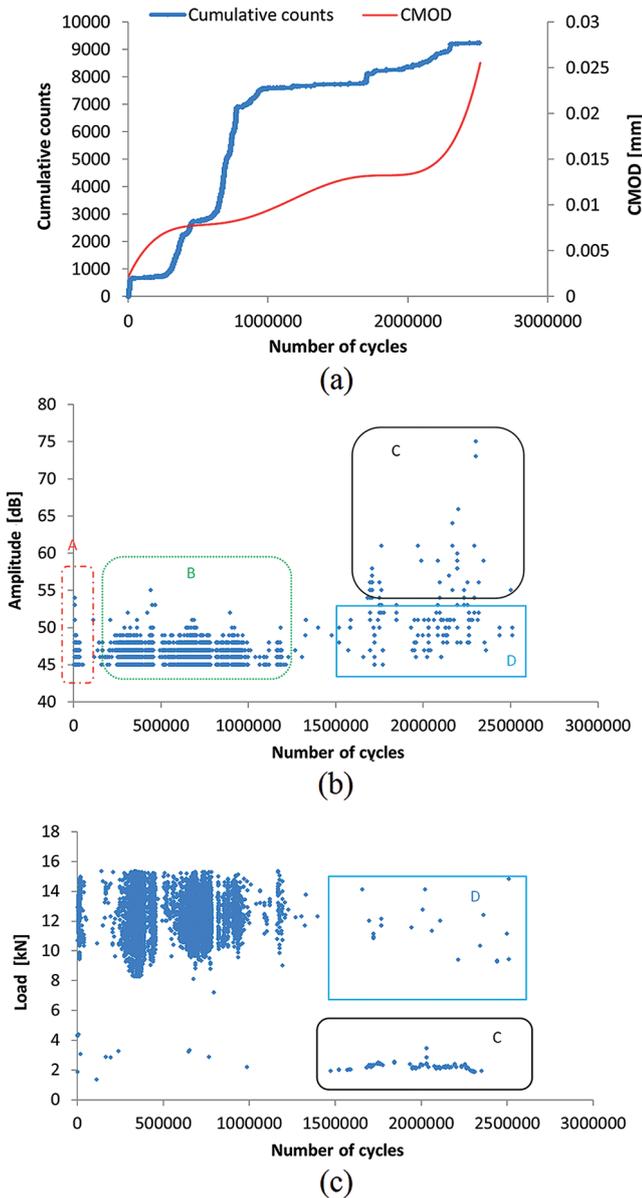
Figure 5. (a) Cumulative counts on primary axis and CMOD on secondary; (b) amplitude; (c) load versus number of cycles for uncorroded specimen under 230 MPa, Case I

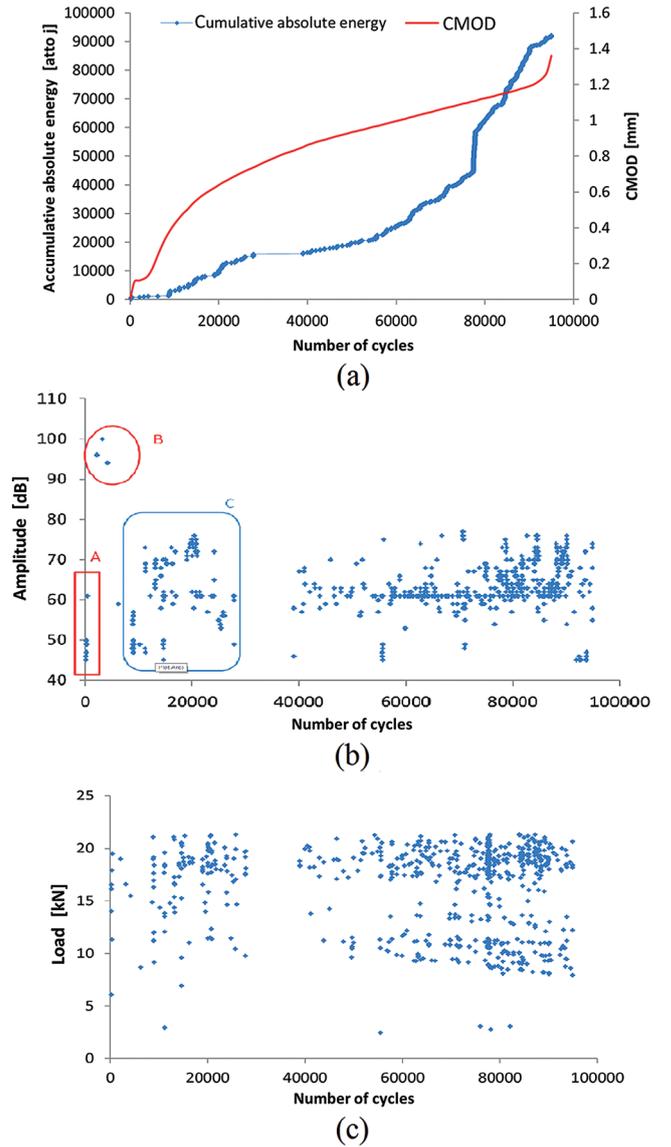
Figure 6. (a) Cumulative absolute energy on primary axis and CMOD on secondary; (b) amplitude; (c) load versus number of cycles for corroded 25 day specimen under 320 MPa, Case II

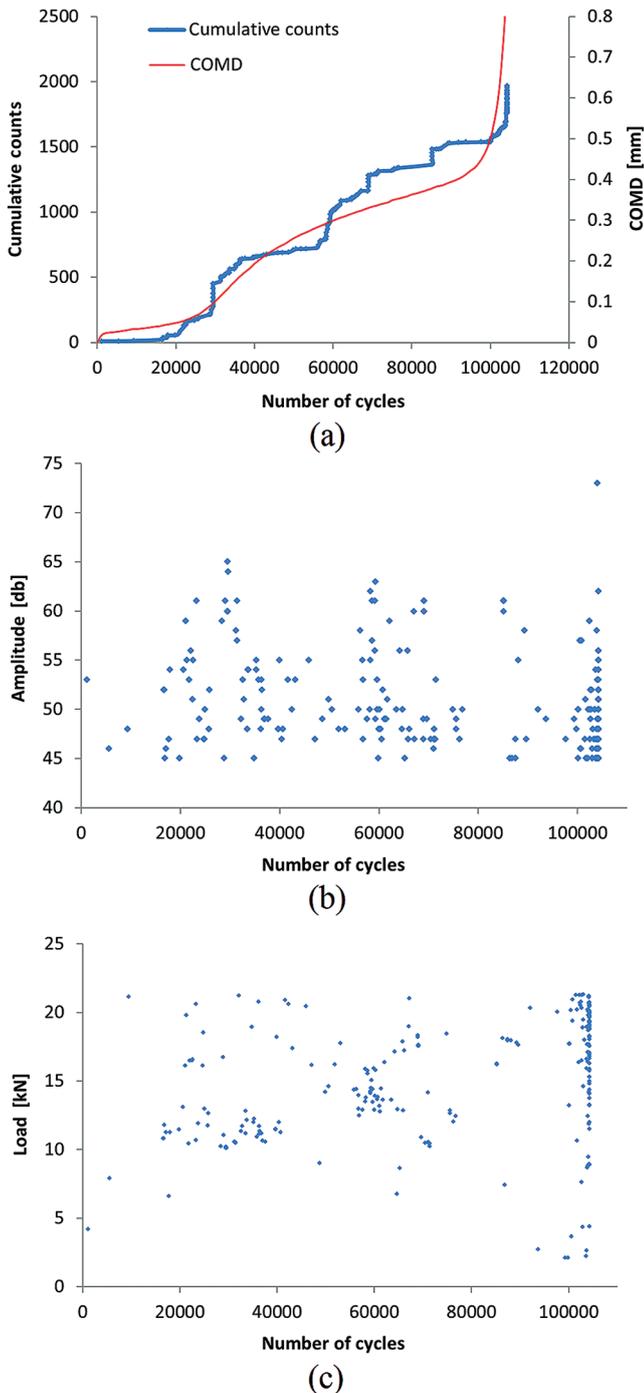
Figure 7. (a) Cumulative absolute energy on primary axis and CMOD on secondary; (b) amplitude; (c) load versus number of cycles for corroded 25 day specimen under 320 MPa, Case II

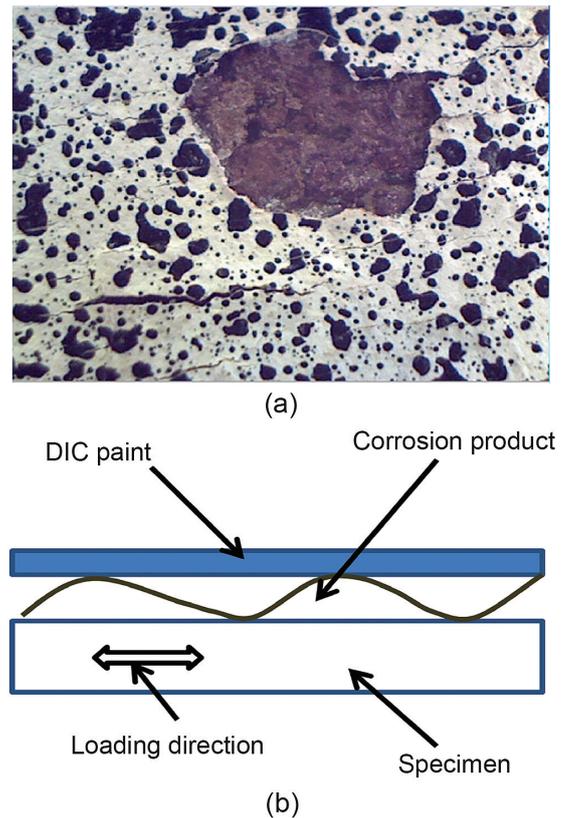
Figure 10. Schematic explaining the rubbing of the damaged corrosion product underneath DIC paint with specimen surfaces around the crack path

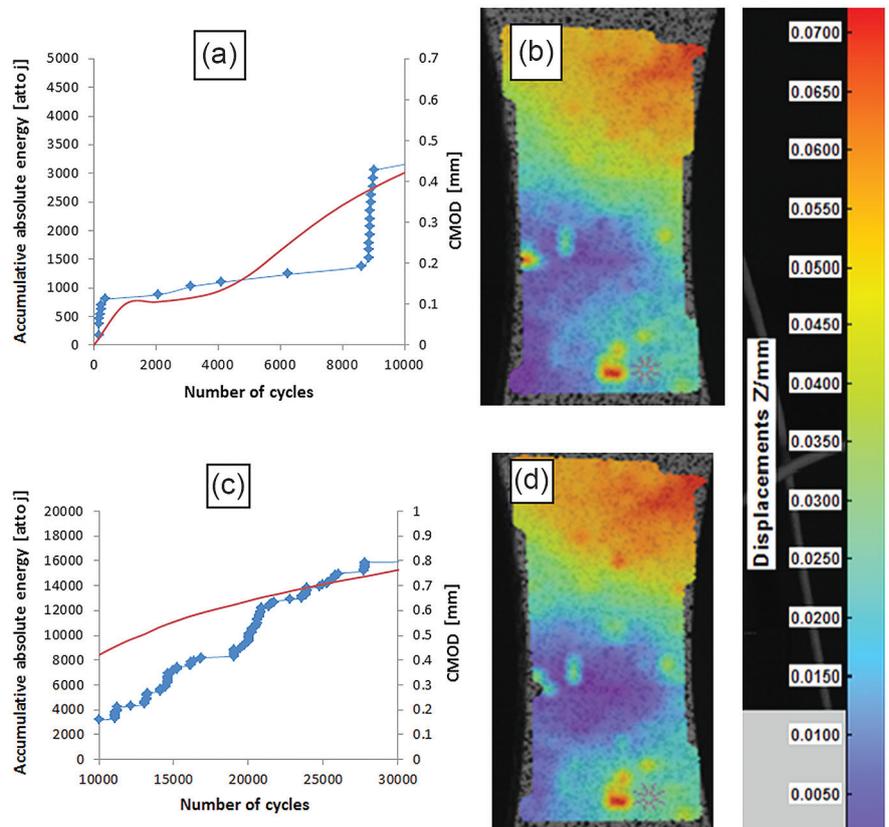
Figure 11. (a) Focused view of Figure 6 at 8 k cycle; (b) corresponding DIC images; (c) focused view at 16 k cycle; (d) DIC images at 16 k cycle
