Evaluating Incidental Thermal Performance Improvements of a Historic Timber-Framed Building in Central Hereford

Christopher J Whitman¹

¹Welsh School of Architecture, Cardiff University, Cardiff, Wales, CF10 3NB, UK.

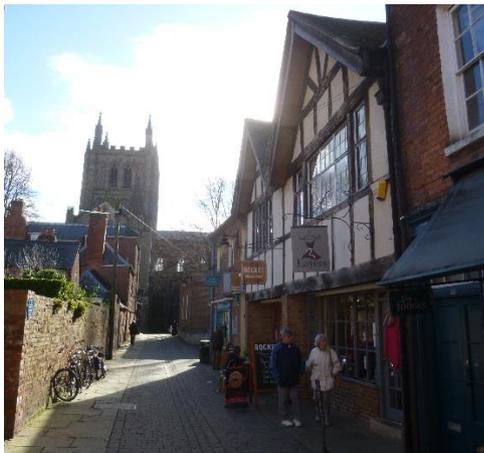
Figure 1. Nos.24 and 25 Church Street, Hereford. Source: (Author's own, 2016)

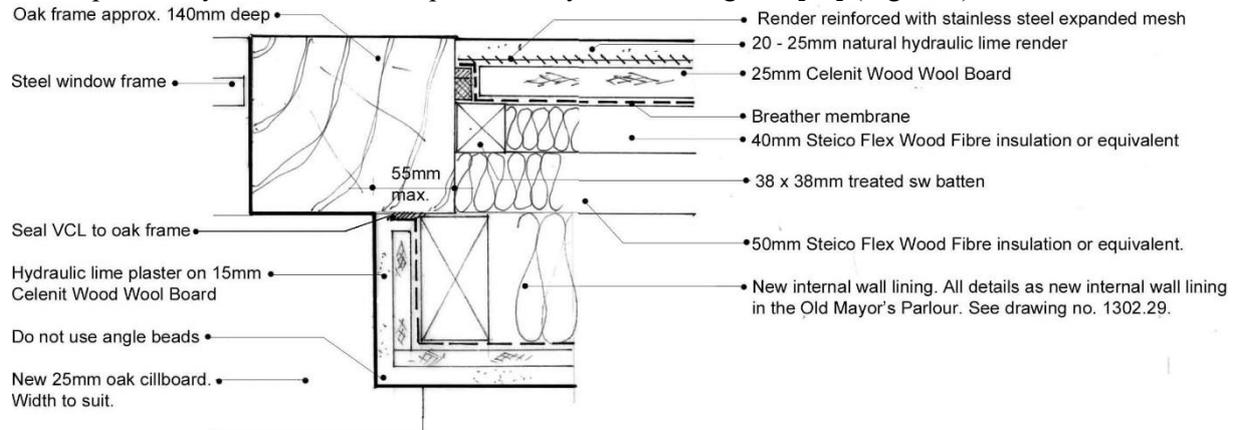
framed east façade of both the OMP (no.24) and no. 25 and replaced with wood-fibre insulation based on the previously mentioned detail published by Historic England [14] (Figure 3).

Figure 3. OMP replacement panel infill detail with internal lining. Source: (Project Architect, 2014)

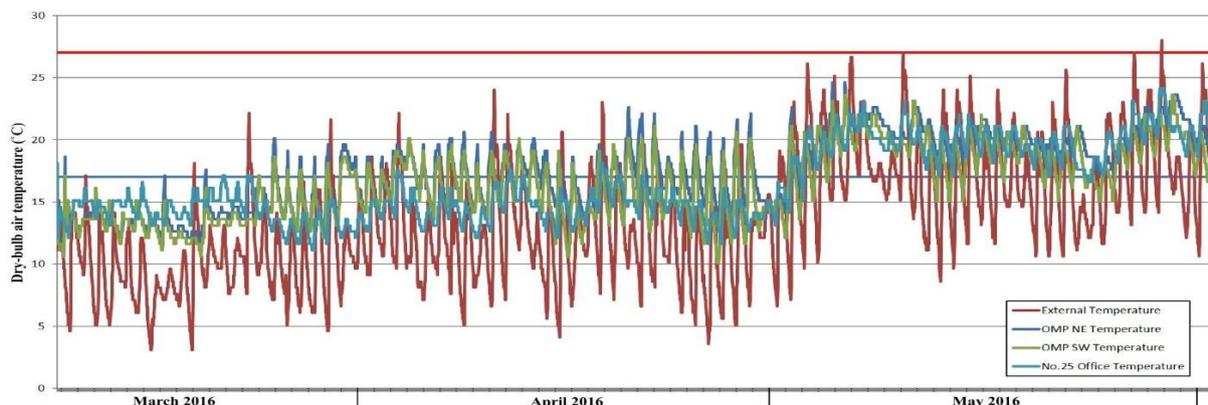
The second stage of monitoring 10/03/16 – 04/06/2016 showed that once in use for exhibitions, the temperatures in the OMP did exceed 17°C for parts of the working day (Figure 6). However, the office of No.25 did not begin to enter the thermal zone until the external temperatures rose in early May.

Figure 6. Dry-bulb air temperatures 10/03/2016 to 04/06/2016. Source: (Author's own, 2017).

During opening hours (09:00-17:00) over the four and a half months of monitoring, hygrothermal comfort was achieved 50% of the time in the east end of the OMP, 55% of the time at the west end but only 28% of the time in no.25. The difference between the east and west end of the OMP may be due to the door to the semi-external staircase being located towards the east, although the electric heater is also located at this end of the room.
