Building Performance Evaluation of a 14th Century Pargetted House: Hygrothermal comfort and energy efficiency

CHRISTOPHER J. WHITMAN¹

¹Welsh School of Architecture, Cardiff University, Cardiff, Wales, UK

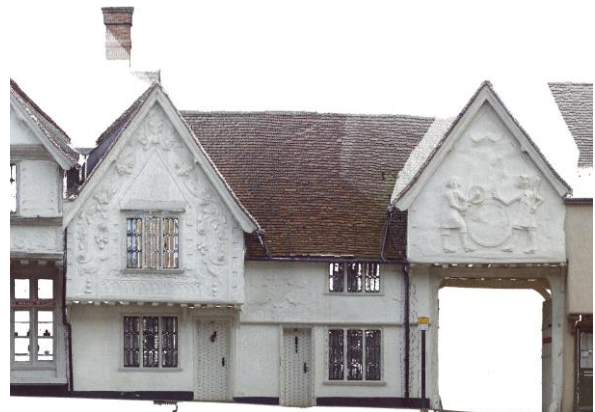
Figure 1. Laser Scan of North elevation. Eastern cross wing to the left and western to the left. Source: (Author's Own, 2017)

On the first occasion (12/03/17-02/04/17) the U-value was measured in two locations (M1 and M2 in Fig.6) on the first-floor elevation of the east cross wing (left in Fig.1).
