Damage detection in a composite wind turbine blade using 3D scanning laser vibrometry

Ryan Marks¹, Clare Gillam¹, Alastair Clarke¹, Joe Armstrong² and Rhys Pullin¹

Abstract

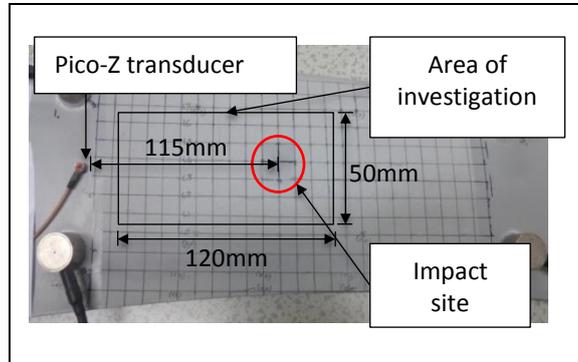
Figure 2. Dimensions of the area of investigation and location of the impact

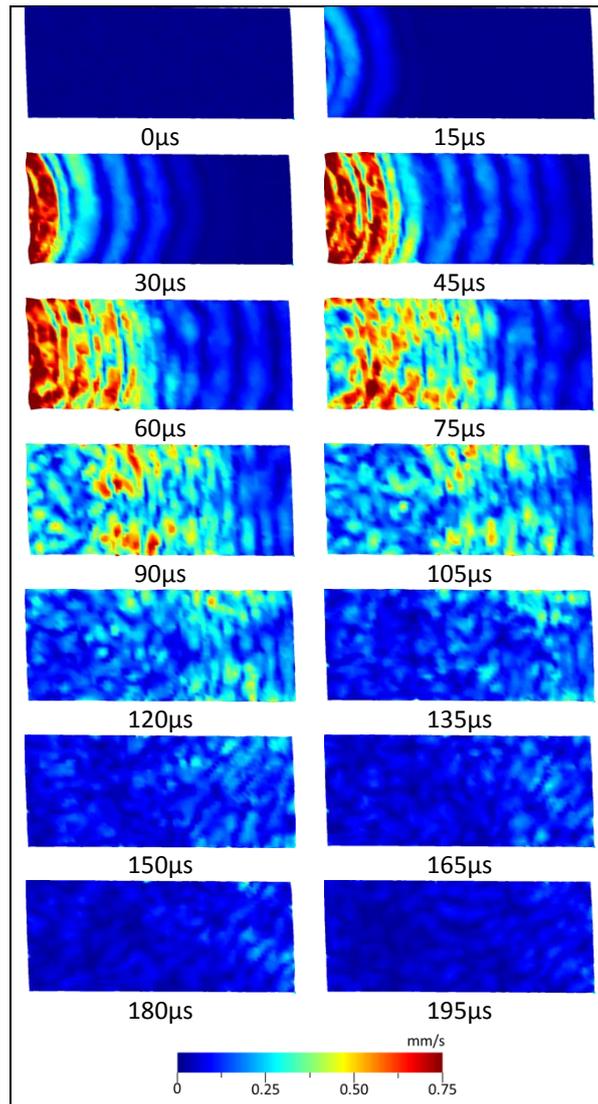
fibre distribution in the material. As the fibres are randomly distributed, it results in a inhomogeneous microstructure⁵⁹. This can cause scattering of the Lamb waves which results in a high level of noise in the propagating wave⁶⁰. This is observed from 90 μ s onwards.

Figure 4. Resultant magnitude results of the 100kHz excitation vibrometry scan of the blade pre-impact

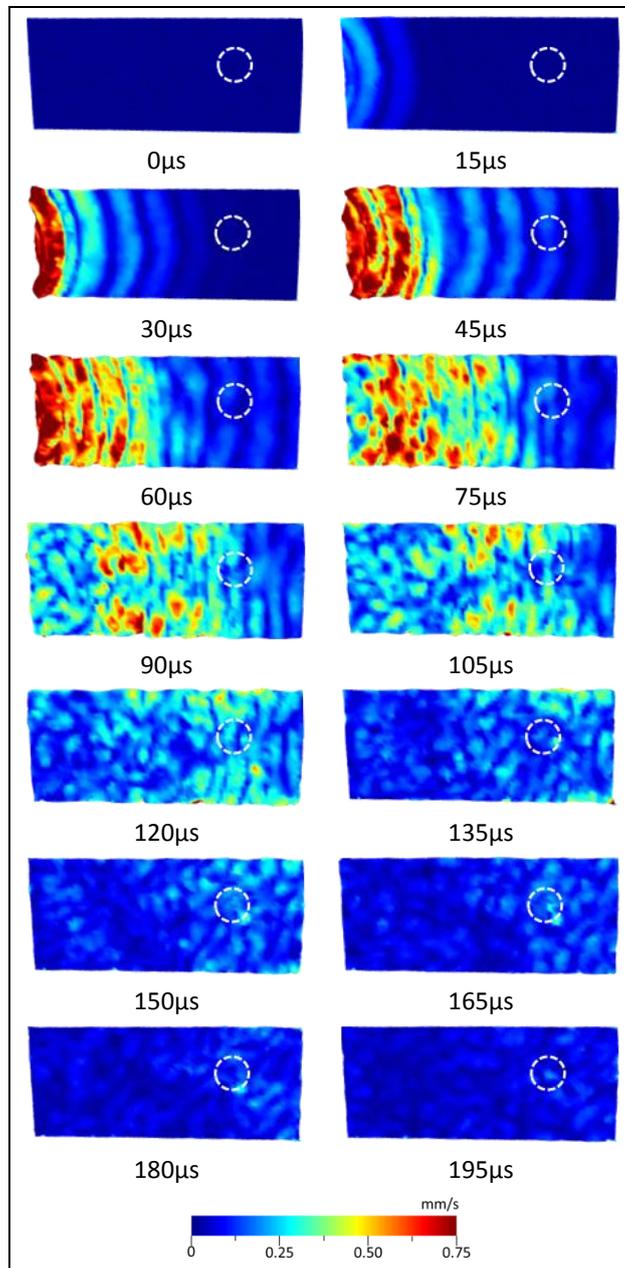
Figure 5. Resultant magnitude results of the 100kHz excitation vibrometry scan of the blade post-impact. Comparing the two sets of results, the S_0 mode appears to be mostly unaffected by the presence of the impact damage. This concurs with the findings of Grigg *et al.*⁵³. The A_0 Lamb mode does appear however

to be affected by the presence of the impact damage. This can be seen in the results at $90\mu\text{s}$ - $120\mu\text{s}$ although it is not clear when the resultant magnitude is plotted.

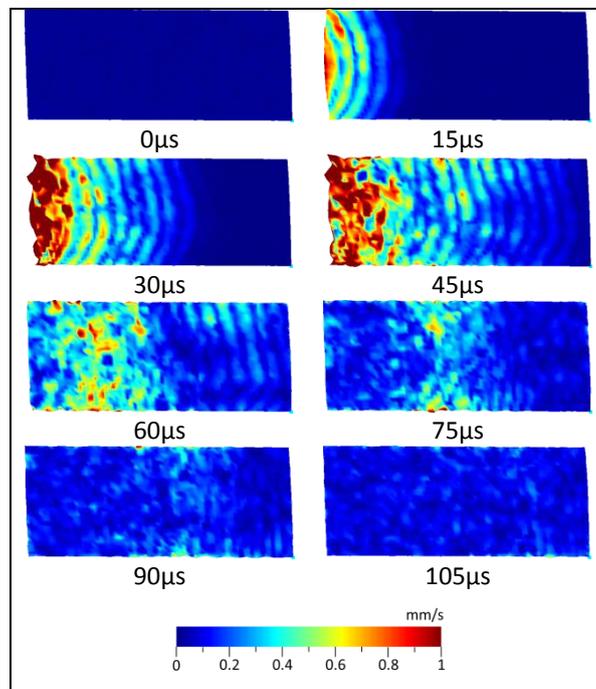
Comparing these results to those from the 100kHz excitation there is an increase in amplitude of the measured Lamb wave. This can be attributed to this 200kHz being inside of the transducer's operating resonance.

Figure 7. Resultant magnitude results of the 200kHz excitation vibrometry scan of the blade pre-impact. As with the results from the 100kHz excitation, the S_0 mode appears to be unaffected by the presence of the impact damage in the resultant magnitudes results. Comparing the S_0 propagation in both the pre and post impact results at 45μs it is not possible to distinguish the presence of damage by visual observation.

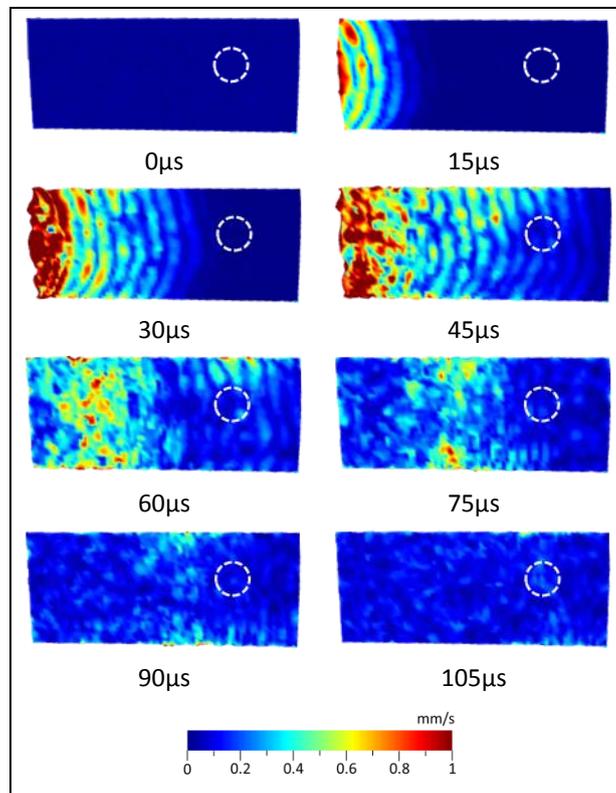
The effects of attenuation and dispersion of higher frequency waves, coupled with high levels of noise, resulted in a highly disrupted, low amplitude A_0 wave front by the time the mode reaches the impact site as shown at $90\mu\text{s}$. As with the 100kHz results, this makes it difficult to determine whether the Lamb wave interacted with the damage through means of visual observation alone.

Figure 8. Resultant magnitude results of the 200kHz excitation vibrometry scan of the blade post-impact

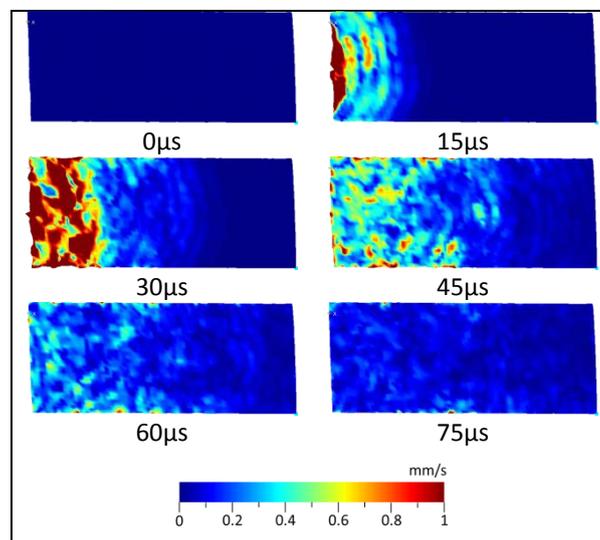
The increased wave velocity due to dispersion is apparent when compared to the results of the 100kHz excitation. As with the two other excitation frequencies, the S_0 mode in the resultant magnitude results appears to be mostly unaffected by the impact damage. However, by the time the S_0 mode interacts with the impact damage, the amplitude has significantly reduced.

Figure 10. Resultant magnitude results of the 300kHz excitation vibrometry scan of the blade pre-impact. The increased attenuation of the higher frequency excitation is apparent in this results set. The A_0 mode is measured in the area of investigation with a peak amplitude of 1mm/s. At 45 μ s the amplitude of the wave has significantly decreased. This decrease in amplitude with the added effects of edge reflections and scattering due to the microstructure makes it near impossible to determine Lamb wave interaction from just studying the resultant magnitude time-domain results alone. In turn, adjusting the colour scale to study the low amplitude Lamb wave activity does not help to clarify the results.

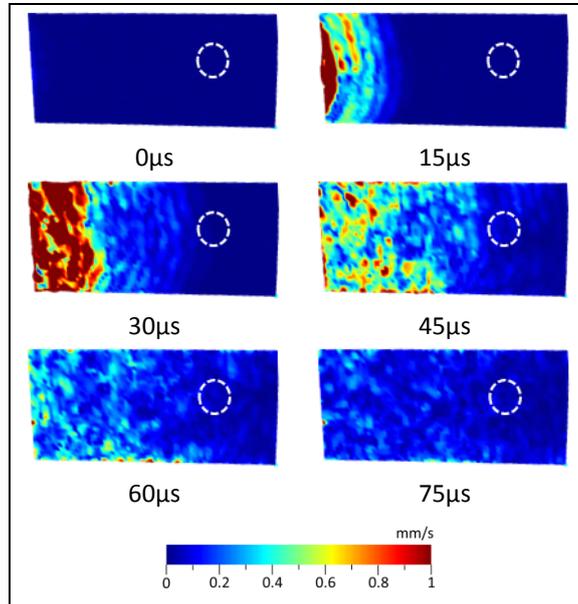
Figure 11. Resultant magnitude results of the 300kHz excitation vibrometry scan of the blade pre-impact. As with the results from the previous two excitation frequencies, the out-of-plane mode was isolated and presented in Figure 12.
