# Impact monitoring of CFRP composites with acoustic emission and laser Doppler vibrometry

**Keywords:** acoustic emission, laser Doppler vibrometry, composites, impact

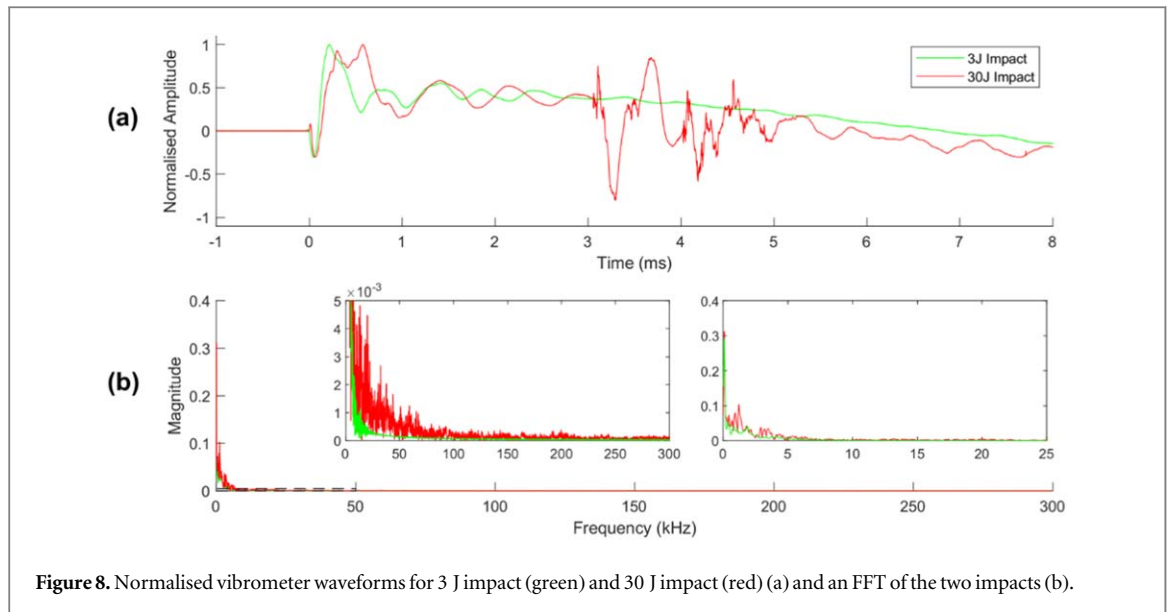
**Figure 8.** Normalised vibrometer waveforms for 3 J impact (green) and 30 J impact (red) (a) and an FFT of the two impacts (b).

Presented in figure 8(a) is a comparison of a vibrometer recording from an impact that caused substantial damage (30 J) with a trial specimen which was impacted with only 3 J where no damage was seen from phased array data. The 30 J impact had a peak amplitude four times higher than that of the 3 J impact. However, after normalisation, the initial 1 ms of wave, where only flexural mode is present, was very similar, indicating that prior to the initiation of damage the waves produced are similar when scaled. This is supported by the FFT results in figure 8(b) which show that below 10 kHz the signals are very similar. However, above this, there is a clear difference in the frequency content of the two waveforms, with the 3 J impact having little signal above 20 kHz. This supports the findings of Mahdian *et al* [16] where waves of this frequency were associated with the impact process, but not damage.

For the filtered data in figure 10(b), like the unfiltered data if only considering the high impact data points, a linear relationship exists. The 3 J impact does not fit the trend, and is near zero, due to its minimal high frequency content, as shown in figure 8. Further testing at impact energies between 3 J and 30 J would identify the relationship, and at what impact energy high frequency waves began to be observed by the vibrometer.

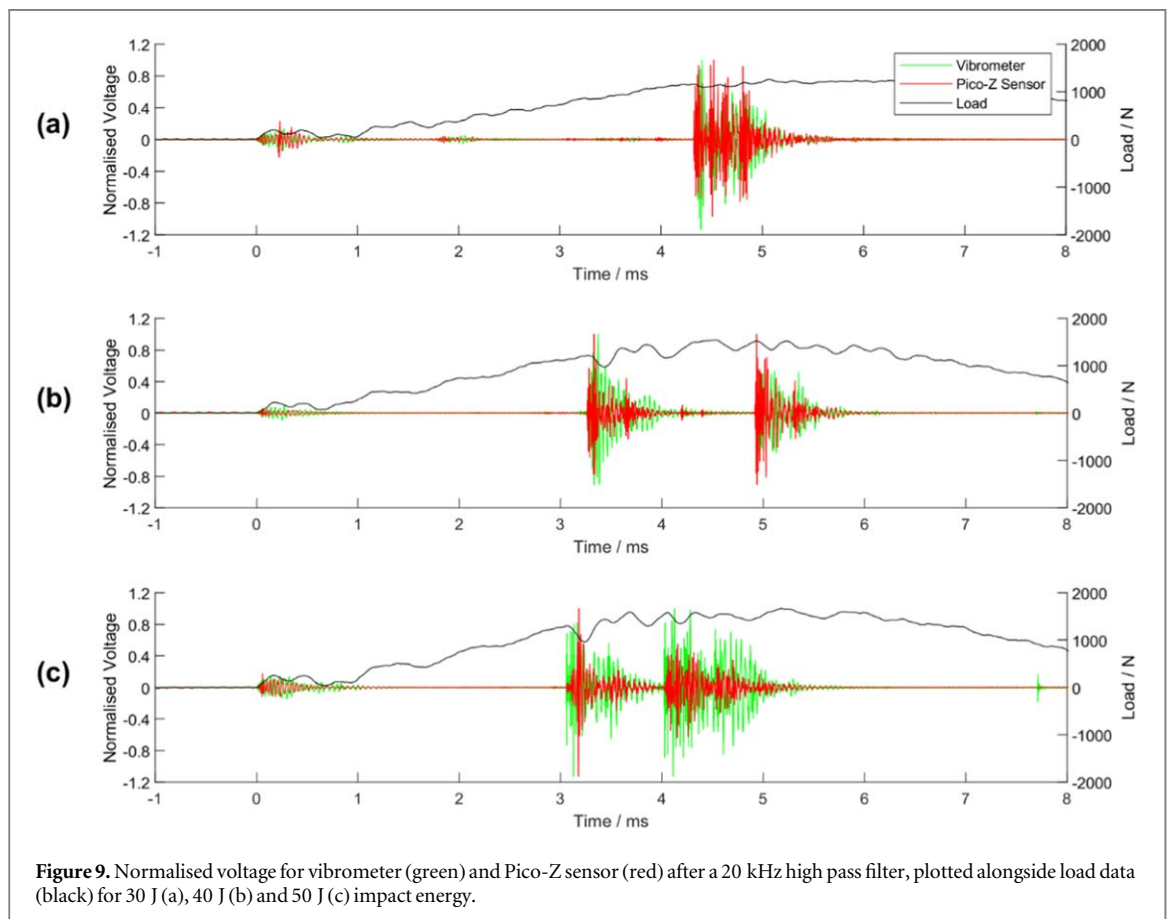
**Figure 9.** Normalised voltage for vibrometer (green) and Pico-Z sensor (red) after a 20 kHz high pass filter, plotted alongside load data (black) for 30 J (a), 40 J (b) and 50 J (c) impact energy.

As the vibrometer detected significantly greater low frequency flexural mode than the AE sensor, it was difficult to compare the extensional modes. In order to do this the waveforms were passed through an Infinite Impulse Response (IIR) high pass digital filter with a pass frequency of 20 kHz and a Butterworth window. Figure 9 shows the normalised output of the filters on the vibrometer and Pico-Z sensor waveforms for each of

the 30 J, 40 J and 50 J impacts. Although significantly different in amplitudes, when normalised, as they have been in figure 9, the two observed signals showed very similar trends; however, are not identical signals. This difference is likely to be a result of the resonance of the sensor, its damping on the panel and any inconsistencies in the panels caused by the two different locations.

Although as the number of data points is severely limited, so making any conclusions difficult to draw with certainty, the data in figure 10 shows that the Pico-Z AE sensor data has a likely outlier, either the 40 J or 50 J impact. It is believed that the 50 J is the outlier as in figure 9(c) the energy of the Pico-Z compared to the vibrometer is much lower, whereas in (a) and (b), it matches much better. This is further supported by the lower high frequency content in the signal, shown in figure 7(c). Calibration testing confirmed that the sensor was bonded correctly and not damaged prior to the test, meaning the most likely problem was that the high impact energy caused the sensor to partially decouple, and so have a lower response. For these reasons only, the vibrometer data will be considered in the following discussion.

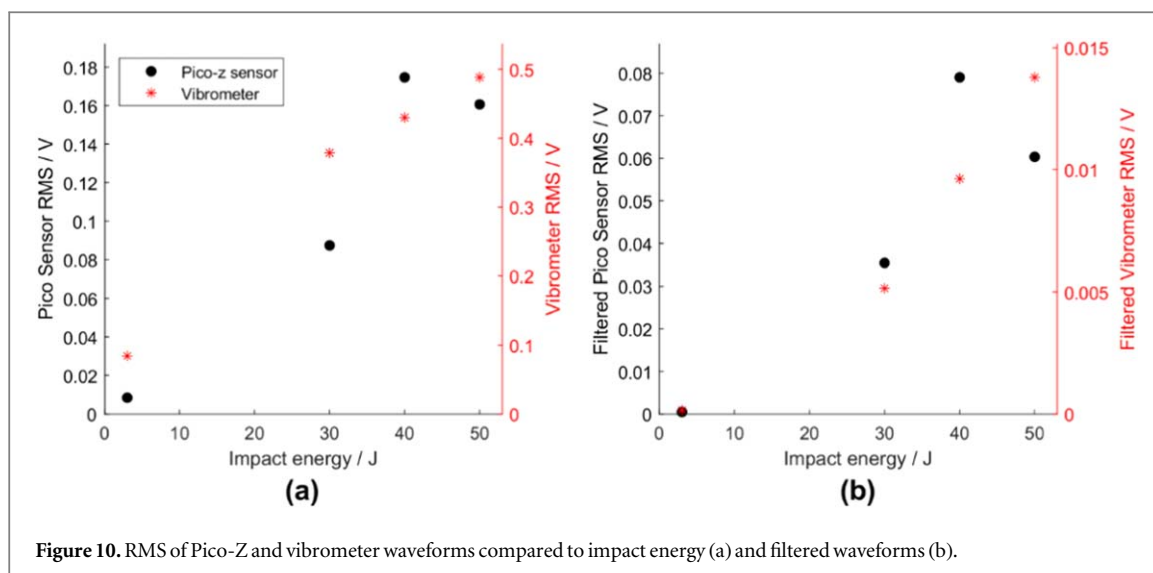
Figure 10. RMS of Pico-Z and vibrometer waveforms compared to impact energy (a) and filtered waveforms (b).

Table 1 shows that an increase in impact energy caused both an increase in force through the impactor, and an increased damage size. The absolute Root Mean Square (RMS) of the raw signals acquired from the Pico-Z sensor and vibrometer, compared to impact energy, are shown in figure 10(a). The absolute energy of the signals after the 20 kHz high pass filter is shown in figure 10(b). The 3 J trial impact has also been included in these plots.

From the work of Mahdian *et al* [16], it is known that AE waveforms will have low frequency content due to the impact process. Figure 10(a) demonstrates that this was the case at low energy and increased as the impact energy was greater. The limited number of data points makes trends difficult to identify reliably; however, the three higher impact energies can be seen to have a relatively linear relationship. More data points would be required in order to adequately predict the trend of AE RMS versus impact energy. This trend would not be expected to be linear throughout, due to delamination and fibre breakage taking place and absorbing energy, so reducing the rate that wave RMS increases as impact energy is increased [30, 31].
