The Influence of Water Absorption on Unidirectional and 2D Woven CFRP Composites
and their Mechanical Performance

Faisel Almudaihesh, Karen Holford, Rhys Pullin, Mark Eaton.

Key words: Water absorption, Fibre architecture, Water ingress mechanism, Interfacial condition, and Mechanical properties.

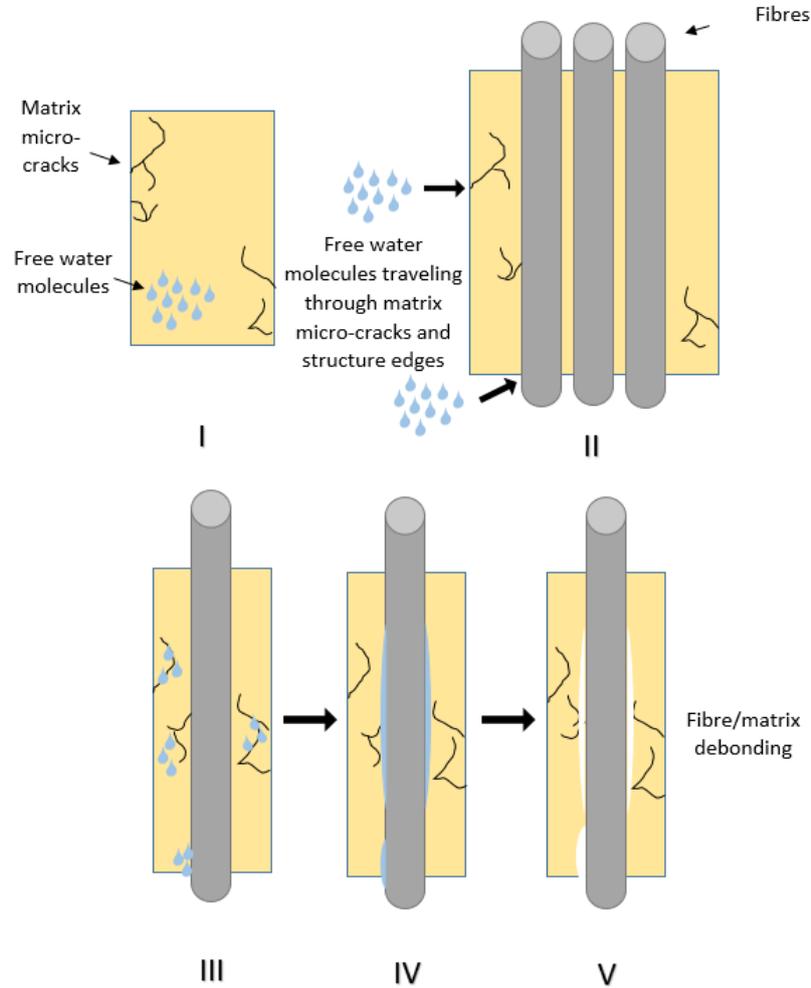
Fig. 1. Water ingress mechanism in fibrous reinforced polymers composites.

In the case of thermoset polymers, it has been known for some time that the matrix and fibre-matrix interface dominated properties are most affected by moisture adsorption Selzer and Friedrich [12] showed that for unidirectional carbon fibre reinforced epoxies, transverse, compression and interlaminar fracture properties reduced significantly following moisture absorption, whereas no discernible change was observed in fibre direction tensile properties. This corresponds to the accepted mechanisms of moisture absorption in CFRP laminates, which starts with free water molecules at the surface travelling through surface micro-cracks and voids (**Fig. 1** (stage I-III)). This leads to

hydrolysis, which has a plasticizing effect leading to a reduction in properties. When water molecules reach the fibre-matrix interface the resultant degradation leads to the reduction of stress transfer [9,13] (**Fig. 1** (stages IV)). Ultimately debonding can occur as the polymer continues to degrade [14–16] (**Fig. 1** (stage V)). This process is dependent on time, temperature, fibre architecture, layup, fibre volume fraction, void content, polymer type, fibre sizing or surface treatment, water type, and contact area [4,9,15,17–19]. However, the extent to which each of these factors affects the final properties of a composite is not clear. The variety of constituent materials, hydrothermal conditioning and properties measured in the current literature makes it challenging to draw consistent conclusions.

This is in line with the proposed theory in **Fig. 1.** where the water penetration mechanism is initially breaking through the matrix increasing the crack density and subsequently detaching the fibre-matrix interface. A similar response is seen for the plain and twill woven architectures as shown by the SEM images in supplementary

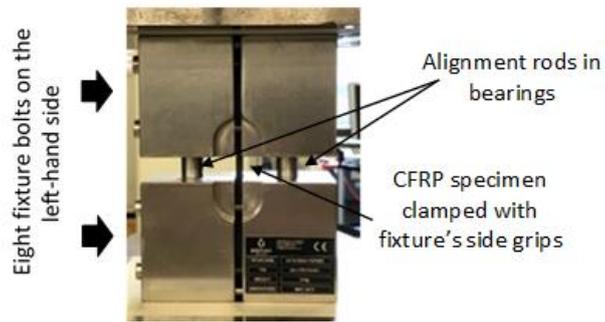
Fig. 2. CLC test configuration.

A Combined Loading Compression (CLC) test illustrated in **Fig. 2** was used to determine the laminate compressive strength for un-aged and water-immersed CFRP specimens in accordance with ASTM D 6641 [25]. Ten specimens were prepared for each fibre architecture (five un-aged and five aged). Specimens were 140mm (± 0.3 mm) long by 13mm wide and a gauge length of 13mm was used. Samples consisted of sixteen plies with a layup of $[0/90]_{45}$ and $[(0/90)]_{16}$ for UD and woven (plain and twill) materials producing thicknesses of 3.1mm and 3.5mm, respectively. These stacking sequences create an identical distribution of fibre directions between the unidirectional and woven specimens for comparison purposes. A 1 mm thick aluminium caul plate covered with nylon was used inside the vacuum bag to ensure both surfaces of the samples were smooth and suitable for the CLC fixture grips. The matrix volume fraction and void content for compression specimens were obtained from three 20mm by 13mm specimens cut from the manufactured panels. An Avery-Denison loading machine with 600kN load cell with fixed loading platens was used to apply load to the CLC fixture at a rate of 1.3mm/min. The CLC fixture screws were tightened with a torque of 3.5N-m as recommended in the standard.

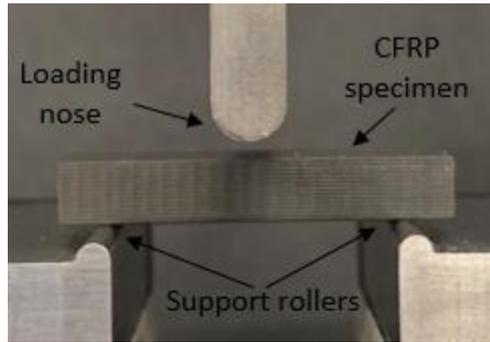
Fig. 3. 3PB test configuration.

The interlaminar strength was investigated by employing the short-beam strength test method by using a three-point bend (3PB) fixture shown in **Fig. 3**. The diameter of support rollers is 3mm, the diameter of the loading nose is 6mm and the span is 24mm. A Zwick Roell Z050 load machine, with 50kN load cell, was used to apply load at a crosshead rate of 1mm/min in accordance with ASTM D2344 [26]. Ten specimens with dimensions 36mm by 12mm were prepared for each fibre architecture (five un-aged and five aged). Samples consisted of thirty plies with a layup of $[0/90]_{15}$ and $[(0/90)]_{30}$ for UD and woven (plain and twill) materials with thicknesses of 5.8mm and 6.4mm, respectively. Due to the sample thickness a debulking operation (5 minutes vacuum) was undertaken after each five plies [27]. The fibre volume fractions and void content for these specimens were obtained from three 12mm by 10mm specimens cut from the manufactured panels.

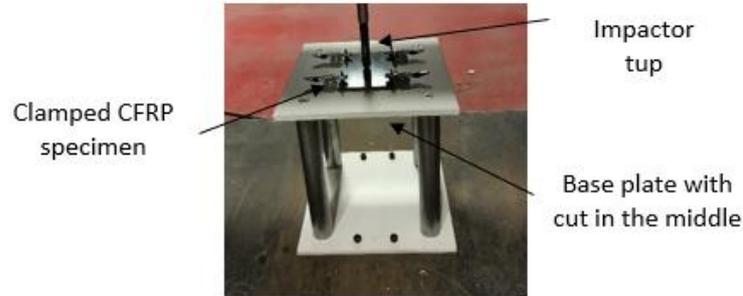
Fig. 4. IDR test configuration.

The Impact Damage Resistance (IDR) was assessed in accordance with ASTM D 7136 [28] with the fixture shown in **Fig. 4**. Specimens were prepared with dimensions of 150mm (± 0.25 mm) by 100mm (± 0.25 mm) and layups of $[45/0/-45/90]_{3s}$ and $[(45/-45)/(0/90)]_{6s}$ for unidirectional and woven (plain and twill) materials, giving thicknesses of 4.5mm and 4.8mm, respectively. A perforated release film and double layer of breather fabric were used in order to facilitate air/gas removal from these larger panels. The fibre volume fractions and void content were obtained from an average of three 20mm by 15mm specimens cut from the as manufactured panels. To investigate the influence of impact damage on water uptake 10 specimens of each fibre architecture were impacted prior to aging. Five were impacted with an energy of 20J, and 5 with an energy of 70J to represent Barely Visible Impact Damage (BVID) and Visible Impact Damage (VID), respectively. A further five specimens were left undamaged for comparison. The undamaged specimens were subsequently impacted with 70J following aging, in order to investigate the influence of moisture absorption on impact resistance. Impact testing

was undertaken using an Instron 9250-HV drop tower, with a 16mm (± 0.1) diameter hemispherical impact tup and a mass of 5.5kg.

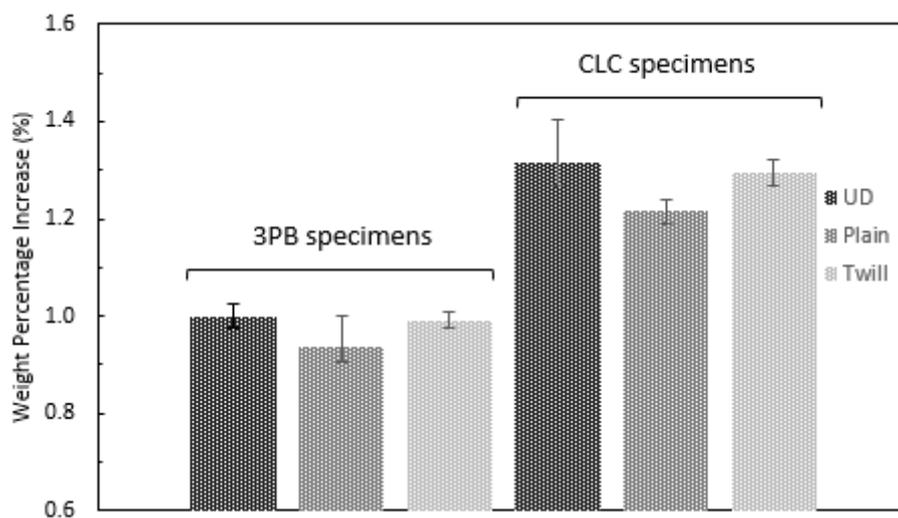
Fig. 5. Average weight percentage increase in CLC and 3PB specimens.

For CLC and 3PB specimens, the mass change was measured at the start and end of the water experiment and the results are presented in **Fig. 5**. Error bars represent the maximum and minimum values observed from five specimens. It is noted that the 3PB specimens had an initial, un-aged, weight that varied between 3.5 to 4g, which is below the minimum of 5g recommended in ASTM D5229 [24]. The total percentage mass gains for all specimens are presented in **Table 2**, along with the mass gain as a percentage of the matrix only (using data from **Table 1**) and the surface area to volume ratios.

The total mass gains, for the composite, vary quite significantly between sample types and smaller variations occur between fibre architectures within each sample type. These variations are seen to correlate strongly to the surface area to volume ratio of the samples. Plotting the surface area to volume ratio against total mass gain shows a linear correlation with an R^2 value of 0.95 (supplementary information **Fig. S1**) suggesting that

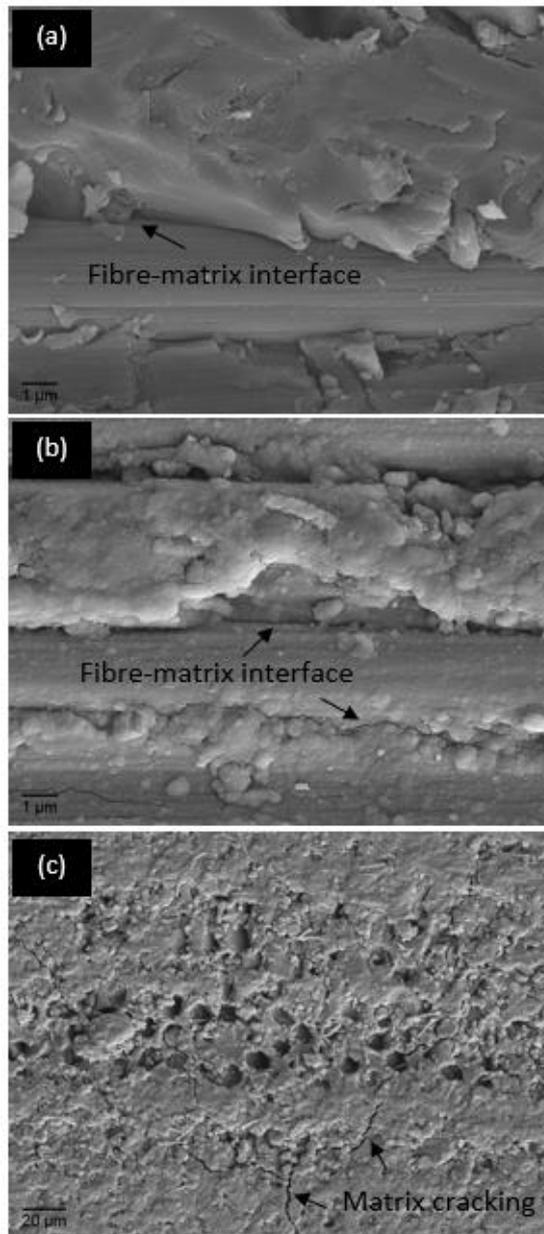
Fig. 6. SEM micrographs of UD surface: (a) interface of un-aged UD specimen; (b) interface of aged UD specimen; (c) matrix cracking in aged UD specimen.

these variations result from geometry and not material differences. When considering the mass gain as a percentage of the matrix only the same correlation is observed, however, mass gain is greater for a given surface area to volume ratio in the UD samples (supplementary information **Fig. S2**). This suggests that diffusion rates are greater in the UD material and this can be correlated to the linearity of the fibre paths, providing direct water ingress into the structure along the fibre matrix interface (**Fig. 1** Stage IV) [30]. In woven architectures, the weave patterns are believed to act as barriers, providing a longer path for moisture ingress along the fibre-matrix interface. This effect may be exacerbated by the sizing levels, as the UD fibre have a lower sizing level and therefore may allow easier degradation of the fibre matrix interface. Evidence of the degradation of the fibre-matrix interface is seen in the Scanning Electron Microscope (SEM) images in **Fig. 6** (b-c) for the aged UD material.

reduction in strength is seen in all cases for the aged samples. This results from the degradation of the fibre-matrix interface (seen in **Fig. 6**) allowing the easy initiation and propagation of interlaminar shear cracks. The greatest reduction is again seen for the UD material with a 7.8 % reduction compared to 6.7 % and 6.5% reductions for the plain and twill weaves, respectively. This again correlates to the higher moisture uptake, as a percentage of the matrix, seen in the UD material. It particularly highlights a greater degradation of the fibre-matrix interface in this material which may also be influenced by the lower levels of sizing in the UD material.

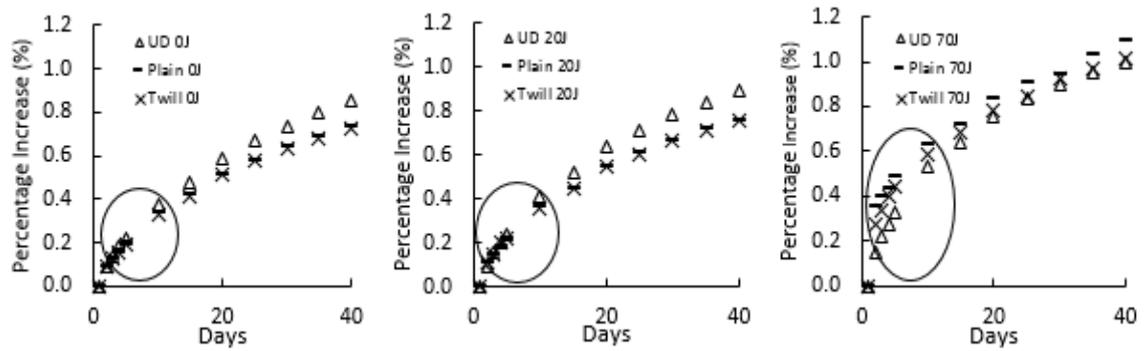
Fig. 7. Percentage of weight increase in IDR specimens

In the case of the IDR specimens, additional mass change measurements were made throughout the water absorption experiment in order to study the influence of impact damage level on moisture uptake. The curves of mass gain versus time are shown in **Fig. 7** for each damage level and the total mass gains are presented in **Table 2**. The total percentage mass gain in the undamaged IDR sample is lower, compared with the CLC and the 3PB samples, due to their lower surface area to volume ratio (**Table 2**). Differences in mass gain between the IDR sample types also correlate to the surface area to volume ratio. This correlation remains at the 20J (BVID) damage level (with only marginal increases in total mass gain observed, compared with undamaged samples) but not at the 70J (VID) damage level due to the effects of the increasing damage volume. The greatest increase in mass for the damage samples, shown in **Fig. 7**, occurs in the earlier stages of the moisture absorption experiment up to the 'knee' in the curve at approximately 10 days. The gradients after this point are very similar for all specimens, suggesting that moisture ingress in to the free volume in the damage region is driving this increase. The larger mass gain seen in the 70J damage level samples results from a higher damage volume but also a larger amount of surface cracking allowing rapid ingress to the damage volume. This results in the woven architectures now absorbing more water than the UD material. **Fig. 8** shows cross-sectional micrographs of the damage induced by 70J impacts and demonstrates how more significant through thickness damage links to surface cracks in the woven architectures, explaining why the

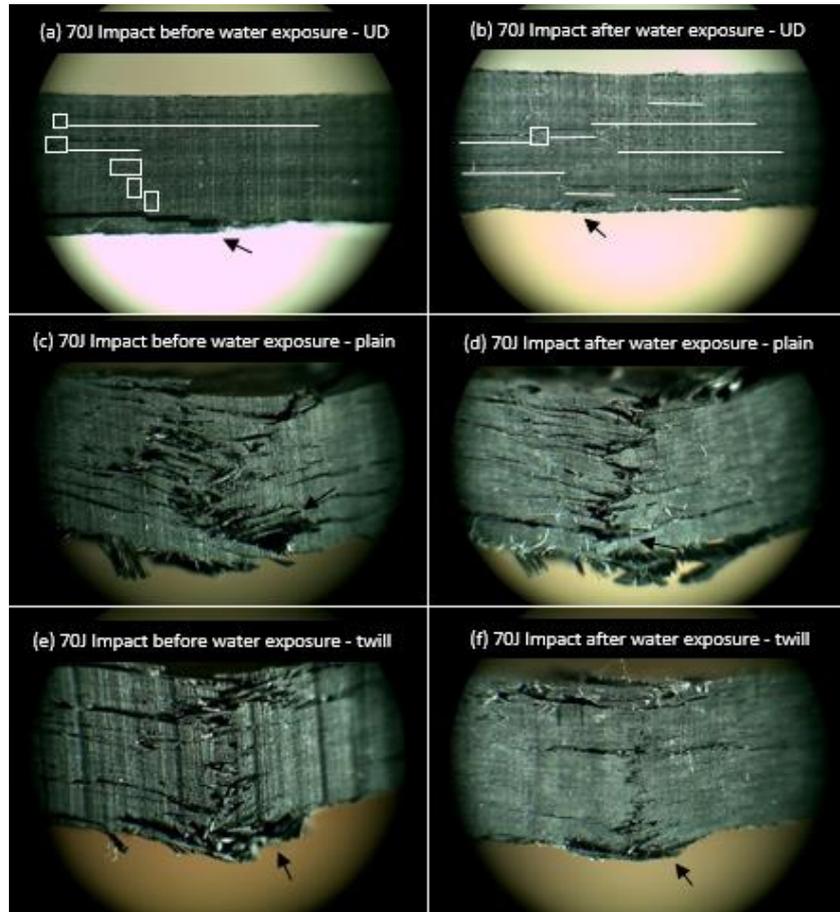
Fig. 8. IDR specimens after failure; images are showing a length of 12mm (± 0.25 mm) of the middle section of the specimen's impact damage area.

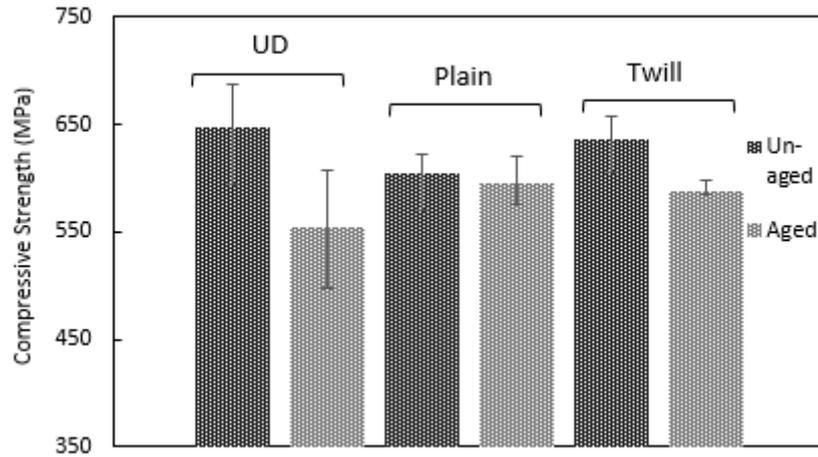
Fig. 9. Compressive strength for un-aged and aged CFRP specimens

The results of compressive strength achieved by CLC testing are presented in **Fig. 9**. In the case of the un-aged samples the UD fibre architecture exhibits the highest strength, followed by the twill weave and then the plain weave. As compressive failures are initiated by microbuckling of the fibres it makes sense that the strength would reduce in this way, as the fibres are misaligned in the woven architectures with the plain weave having the greatest misalignment along with the fact that Pyrofil TR50S featured slightly

higher tensile strength compared with Pyrofil TR30S. The moisture absorption process in the aged specimens induces plasticisation of the matrix, along with microcracking, which reduces the support of the fibres [12,31–33]. Hence, a reduction in strength is observed in all aged specimens, however, the magnitude of the reduction varies greatly. The woven architectures exhibit much smaller reductions in strength, because the distorted fibres already have a propensity to buckle, particularly in the case of the plain weave where a negligible reduction (1.34%) is seen. The reduction increases to 7.5% for the twill weave where the straighter fibres rely more on the support of the matrix to resist buckling. The largest reduction is seen in the UD material at 14.6% where the straight fibres require good support of the matrix to carry higher stresses and therefore fail at much lower loads in the aged samples [34–36]. The occurrence of microbuckling in UD fibres is usually preceded by either local matrix yielding or debonding of the fibre-matrix interface [37]. This correlates to the greater mass gain as a percentage of matrix content observed in the UD samples (**Table 2**), which suggests either greater plasticisation or interface degradation has occurred and would therefore promote an earlier failure in these samples. The lower level of fibre sizing in the UD samples could also exacerbate this behaviour. Importantly the reduction in strength of the aged UD material is significantly large that it becomes weaker than both of the woven fibre architectures in an aged condition. This has great significance when considering material selection and safety factors for carbon fibre composites operating in moist environments.

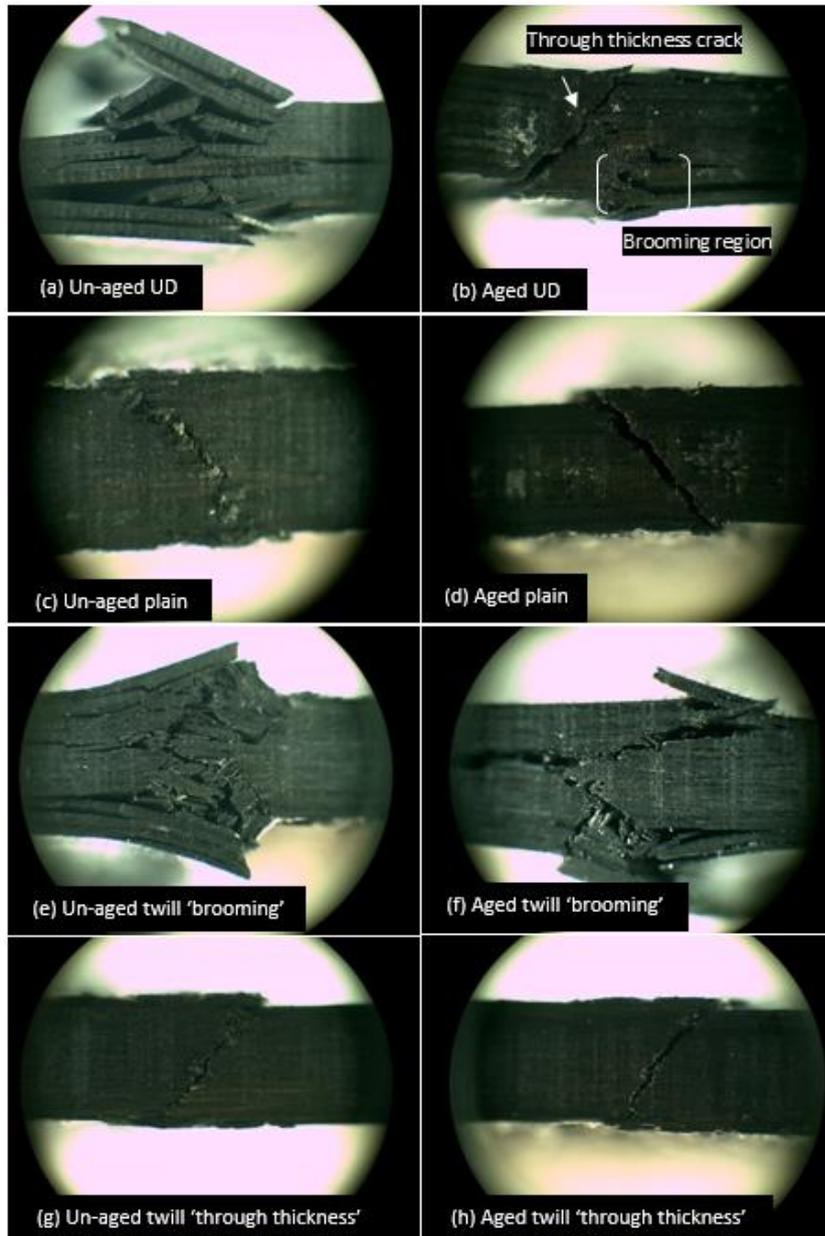
Fig. 10. CLC specimens after failure; images are showing a length of 12mm (± 0.25) of the middle section of the specimen's gauge area.

This corresponds to the observed failure modes in **Fig. 10** where the relative ease of microbuckling induced failure in the plain weave samples leads to a through thickness crack in the un-aged samples. Conversely significant brooming is seen in the failure for the un-aged UD samples, whereas the twill weave samples exhibit both brooming and through thickness cracking. After aging all samples exhibited significantly less interlaminar cracking / brooming, which corresponds to the increased ductility and toughness of the matrix [38]. The aged UD samples exhibited mostly through thickness cracking with a significant reduction in the presence of any brooming, due to the premature microbuckling of less well supported fibres. The aged plain weave samples exhibited the same through thickness cracking mechanism but with less localised interlaminar cracking observed. The aged twill weave samples exhibited more through thickness cracking with much less brooming and interlaminar fracture observed. It is noted that all failure modes observed were deemed acceptable in accordance with those reported in ASTM D 6641 [25].

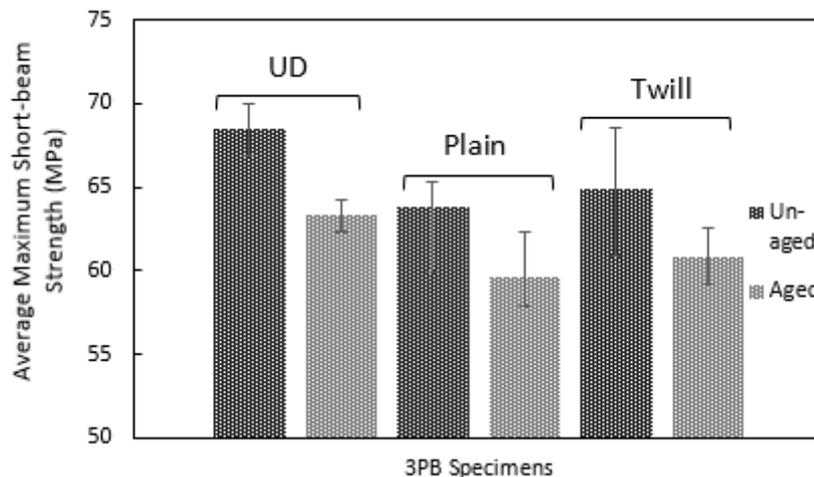
Fig. 11. Short-beam properties for un-aged and aged CFRP specimens.

The short beam shear strength of the materials are presented in **Fig. 11** where the woven architectures exhibit the highest unaged strengths, with the through thickness shear stresses that develop from alternating 0,90 layers leading to failure initiation at a lower stress in the UD samples. This type of interlaminar shear failure is dominated by matrix properties and the fibre-matrix interface strength and hence a corresponding

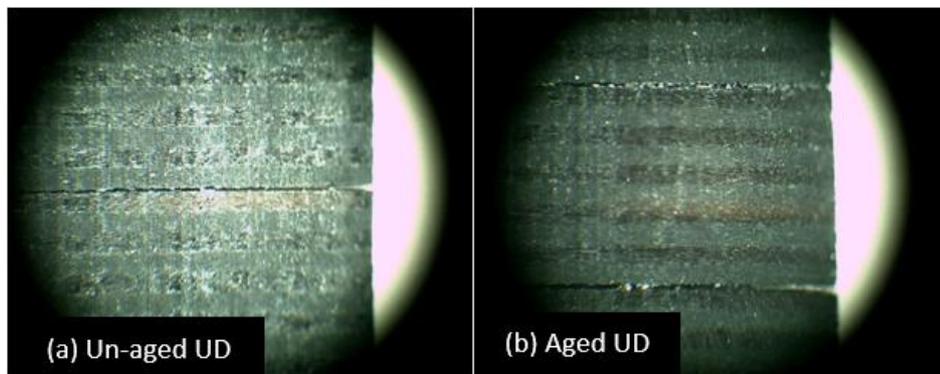
Fig. 12. Failure modes of 3PB UD specimens.

A single delamination along the longitudinal axis and near to the mid-plane was observed for all un-aged UD specimens, with more than one delamination observed in all aged UD specimens as seen in **Fig. 12**. It is believed that the degradation promoted by water exposure in UD specimens has increased the crack density in the interlaminar regions particularly in the fibre-matrix interface region observed from the SEM micrographs which in turn favoured several longitudinal cracks as reported by Barbosa Et al [5]. Similar behaviour was observed for woven specimens with a single longitudinal
