Advanced Acoustic Emission Source Location in Aircraft Structural Testing

S Grigg, C A Featherston, M Pearson & R Pullin

Abstract. Acoustic emission (AE) is an in situ Structural Health Monitoring (SHM) technique, where a structure is monitored for the ultrasonic waves produced due to crack growth. A major challenge with AE when applied to aircraft, and other complex structures, is that wave propagation is significantly affected by stiffeners, holes, thickness changes and other complexity. This reduces the accuracy of traditional source location techniques, that are based on a singular propagating wave speed. The Delta-T method enables higher levels of accuracy by mapping the structure and accounting for these changes. In this work AE monitoring equipment was installed on a section of an aluminium Airbus A320 wing. Location trials showed the Delta-T technique improved the average error from 85mm to 23mm, for artificial Hsu-Nielson sources, compared to the commercial standard technique. Testing under fatigue however demonstrated the challenges encountered when inspecting 3D structures (due to multiple signal paths) with significant levels of background noise. Of two cracks identif

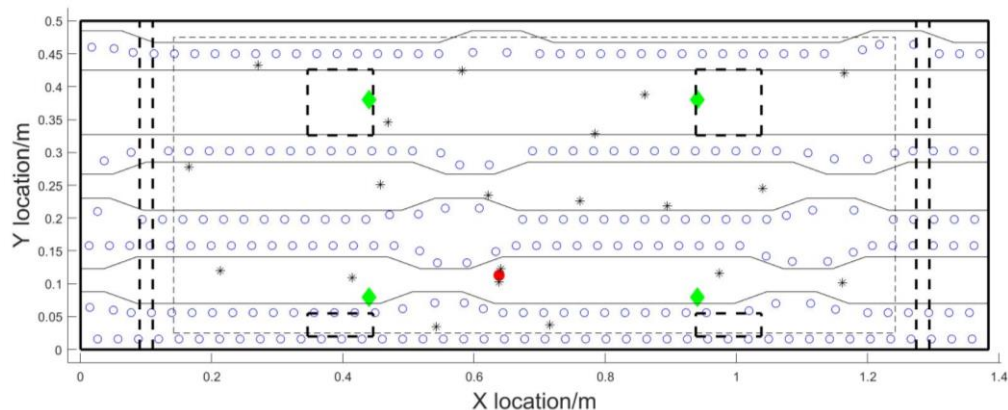
Four Mistras Nano-30 sensors, which have a good frequency response from 125 – 750kHz, were bonded onto the inside of the panel, on the skin of the structure between the stiffeners. The four sensors were located in a rectangle 0.5m x 0.3m in the centre of the panel, shown by the diamonds **Figure 2**. On the outside skin of the panel a 1.2m x 0.45m area was mapped (indicated as thin dashed lines in **Figure 2**) with a density of 50mm, a total of 210 points. 20 points were then selected within the mapped area, 18 of these at random and the other two either side of where a hole was later drilled. At each of these points 10 H-N sources were conducted to test the map's accuracy at locating them with both the TOA and Delta-T technique. AE data was collected with a commercial 4 channel Mistras system, with 2/4/6 preamplifiers, set to 40 dB gain.

Figure 2. Diagram of A320 aircraft wing panel. Sensor locations shown as diamonds and test locations as '*'. Stiffeners as thin solid lines, the edge of the panel as thick solid lines, mapped area as thin dashed lines and loading points as thick dashed lines. The location of the hole is shown as a filled circle.

To reduce the noise the specimen was instead loaded in a four point bend test as shown in Figure 3, the locations of the roller supports and pads on top of the stringers are shown in **Figure 2** as thick dashed lines. Prior to any loading in this configuration a crack was visible from the notch, because of the six-point bend testing. Twenty loading cycles were performed in this configuration, each consisting of between 1,000 and 10,000 cycles. During the first 12 tests the load was gradually increased, up to a max load of 80kN, the remaining tests were always at this load. Between tests, at a 5kN static load, the notch was photographed with a DSLR camera, with a macro lens to identify and track any crack growth.

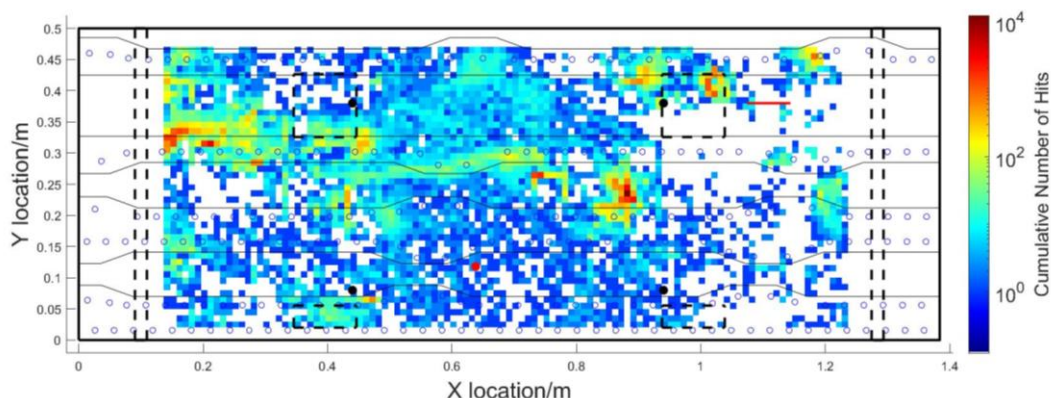
A test of interest, that prompted additional examination of the structure, which is covered below, was test 15. Figure 6 (b) and (c) show a 2mm growth in crack occurred during this test, which consisted of 10,000 cycles of 5kN – 80kN at 0.5Hz. A map of the cumulative number of hits accumulated during this test, and located with the Delta-T approach is shown in Figure 7.

Figure 7. Cumulative AE located within each 10mm squared for Test 15. Circle at $x = 0.65$, $y = 0.1$ indicates hole and line at $x=1.1$, $y = 0.4$ indicates crack on stiffener. Note scale is logarithmic.

Figure 7 shows the location of the hole and notch, unfortunately there is no cluster of AE located at this point. Instead a major hotspot has been located at $x = 0.9$ m and $y = 0.25$ m. Additional hotspots are also present, however the aforementioned has the highest energy.

After test 15, the specimen was thoroughly inspected using dye penetrant spray. No other cracks than from the notch were identified in the skin of the panel. An inspection was then conducted on the other side of the specimen. With visual inspection nothing was detected, however the dye penetrant revealed a 60m crack on one of the stiffeners. This is shown in Figure 8 and its location indicated as a line in Figure 7.

In addition to the AE generated from the crack on the stiffener, Figure 7 shows other hotspots of AE. As no cracks were located at these locations, they are likely to be due to movement/rubbing between the specimen and the test fixtures. This highlights the need for classification of data, to distinguish between damage and background noise.
